PHASE 2

ENVIRONMENTAL REPORT

| site address | 9 Miry Lane, Thongsbridge, Holmfirth HD9 7SA | | |

Report on a Phase 2 Environmental Investigation

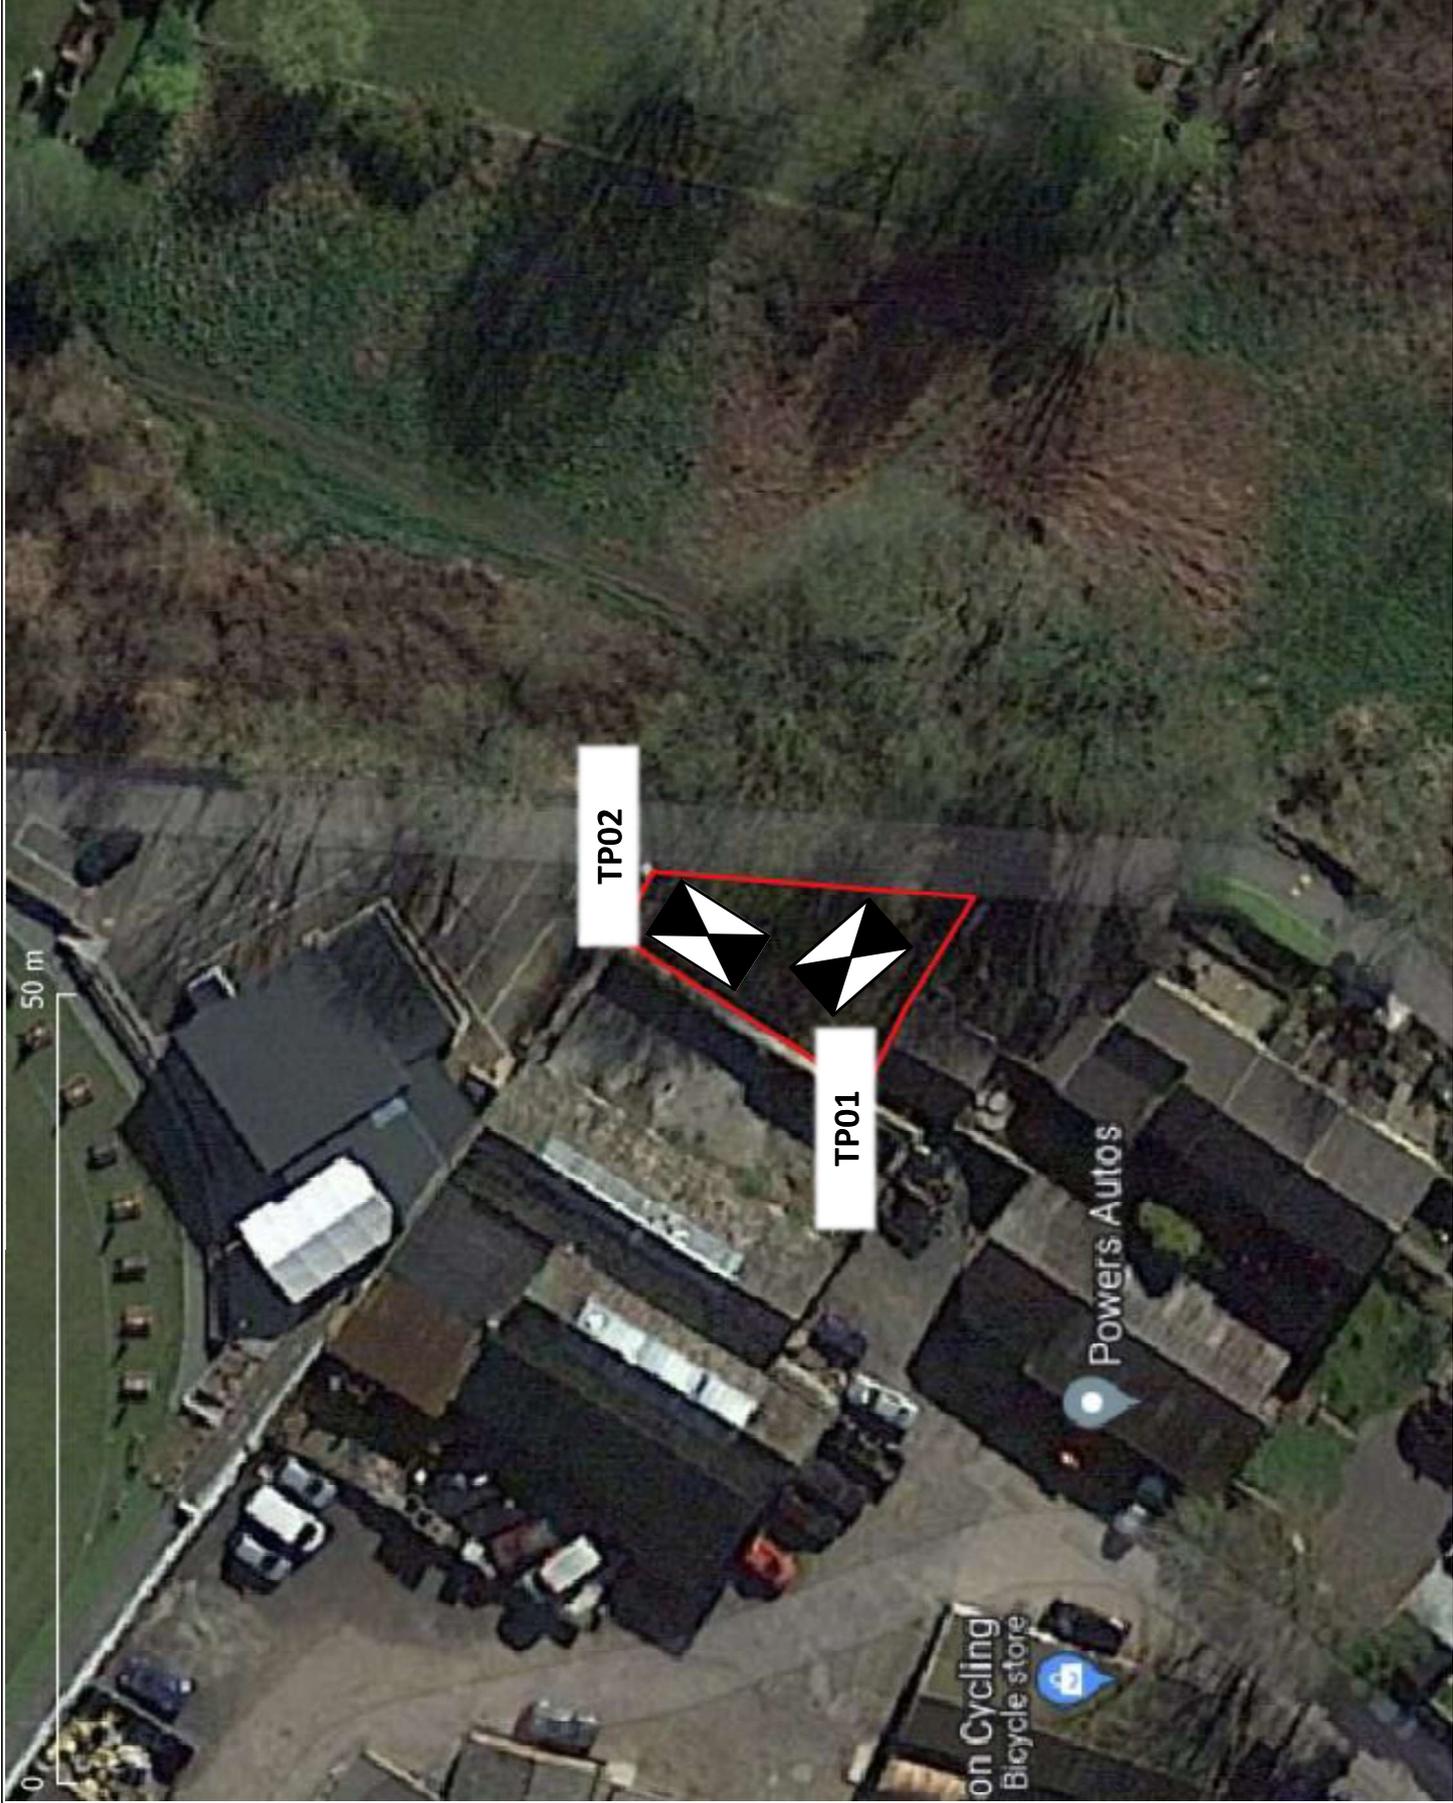
Site Plan

Notes:

W/S/CP091, positions approximated from site operative's notes.

The investigatory locations are shown on the site plan which is presented in Appendix 1 to this report.
