Ceramic Panels - Condition Note and Repair Strategy
 Articulation in Movement - One large ceramic panels (18 feet x 18 feet) forming a single work of art made by Fritz Stahler and fixed between 1969-1970 (panels 1-9) and the double sided panel 10 created and fixed in 1973. For more detail see 'Journal of the Tile & Architectural Ceramic Society Volume 13 2007'.

Key Elevation (East)
1 : 200

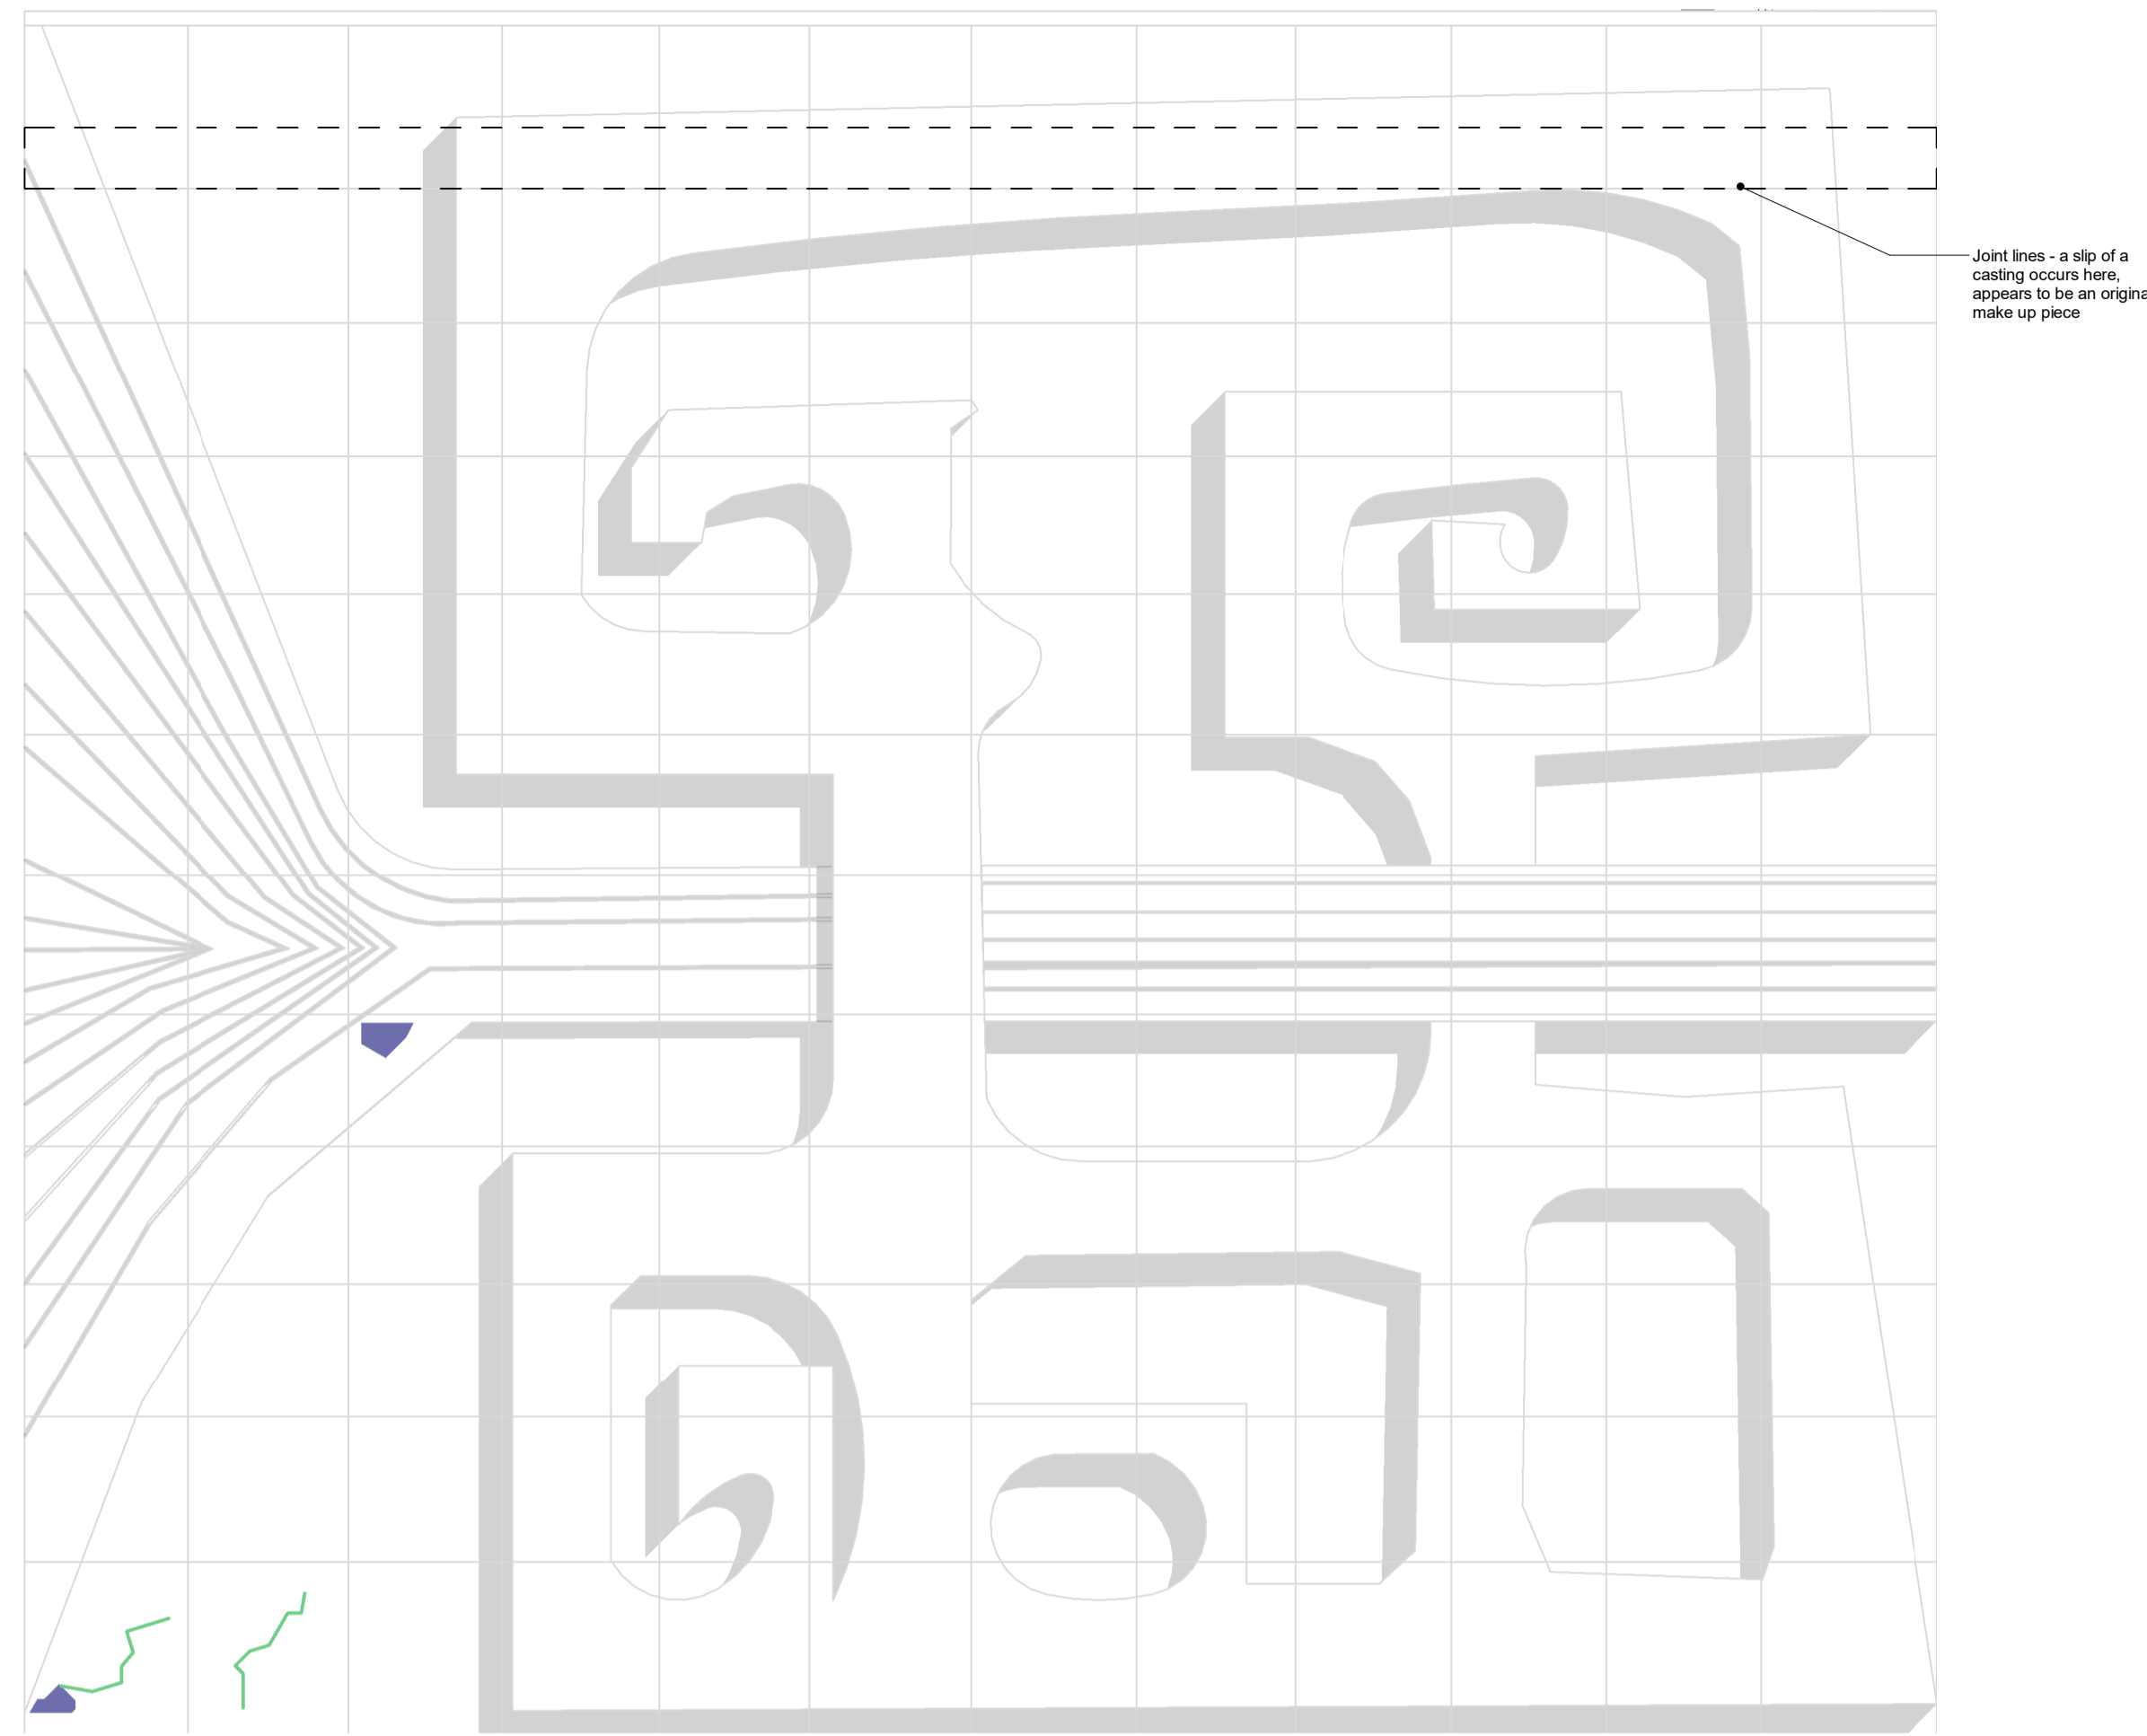
1 Main Elevation (East) - Ceramic Panel 01
1 : 20

Condition
 Visual inspection has confirmed that the ceramic panels are largely in good repair with damage present but in limited volumes. There are a variety of cracks with areas of repair from different times since 1969. Many areas of cracking appear to have occurred in firing. Other cracks or broken units have been reassembled with a dark mortar like that used to bed the units. These may be units that failed in the firing or later and have been reassembled for use. A few units appear to have been mortar repaired with the mortar mixed in an attempt to match the tone of the ceramic. Some degradation in panel 10 is indicative of changes in the mix of the clay and possible lower firing temperatures. The later fabrication of this panel could offer some explanation for the difference in its condition as it is thought the original kiln had been dismantled by the time panel 10 was sculpted.

Conservation and Repair
 The intention is for a further detailed survey of the sculpture to be undertaken so that consolidation and repair designs can be resolved. The intention is:
 - Panels to be cleaned.
 - Failed and loose pointing to be renewed.
 - Damaged units to be mortar renewed.
 - Damaged units to be mortar repaired (mix to match).
 - Missing elements to be investigated and where appropriate reinstated.
 - New lead / hard metal weathering capping to be fitted at the head.

Proposed Repairs
 - 50% repointing
 - 100% duff / thermotech cleaning
 - Localised mortar repairs
 - 12 no. specialist replacement panels approx 480mm square
 - Remediation of corroding fixings where damage has been caused to the ceramics
