Geo-environmental Ground Investigation Report

PROPOSED RESIDENTIAL DEVELOPMENT

**LAND EAST OF PENISTONE ROAD,
FENAY BRIDGE**

E23/8060/R001A

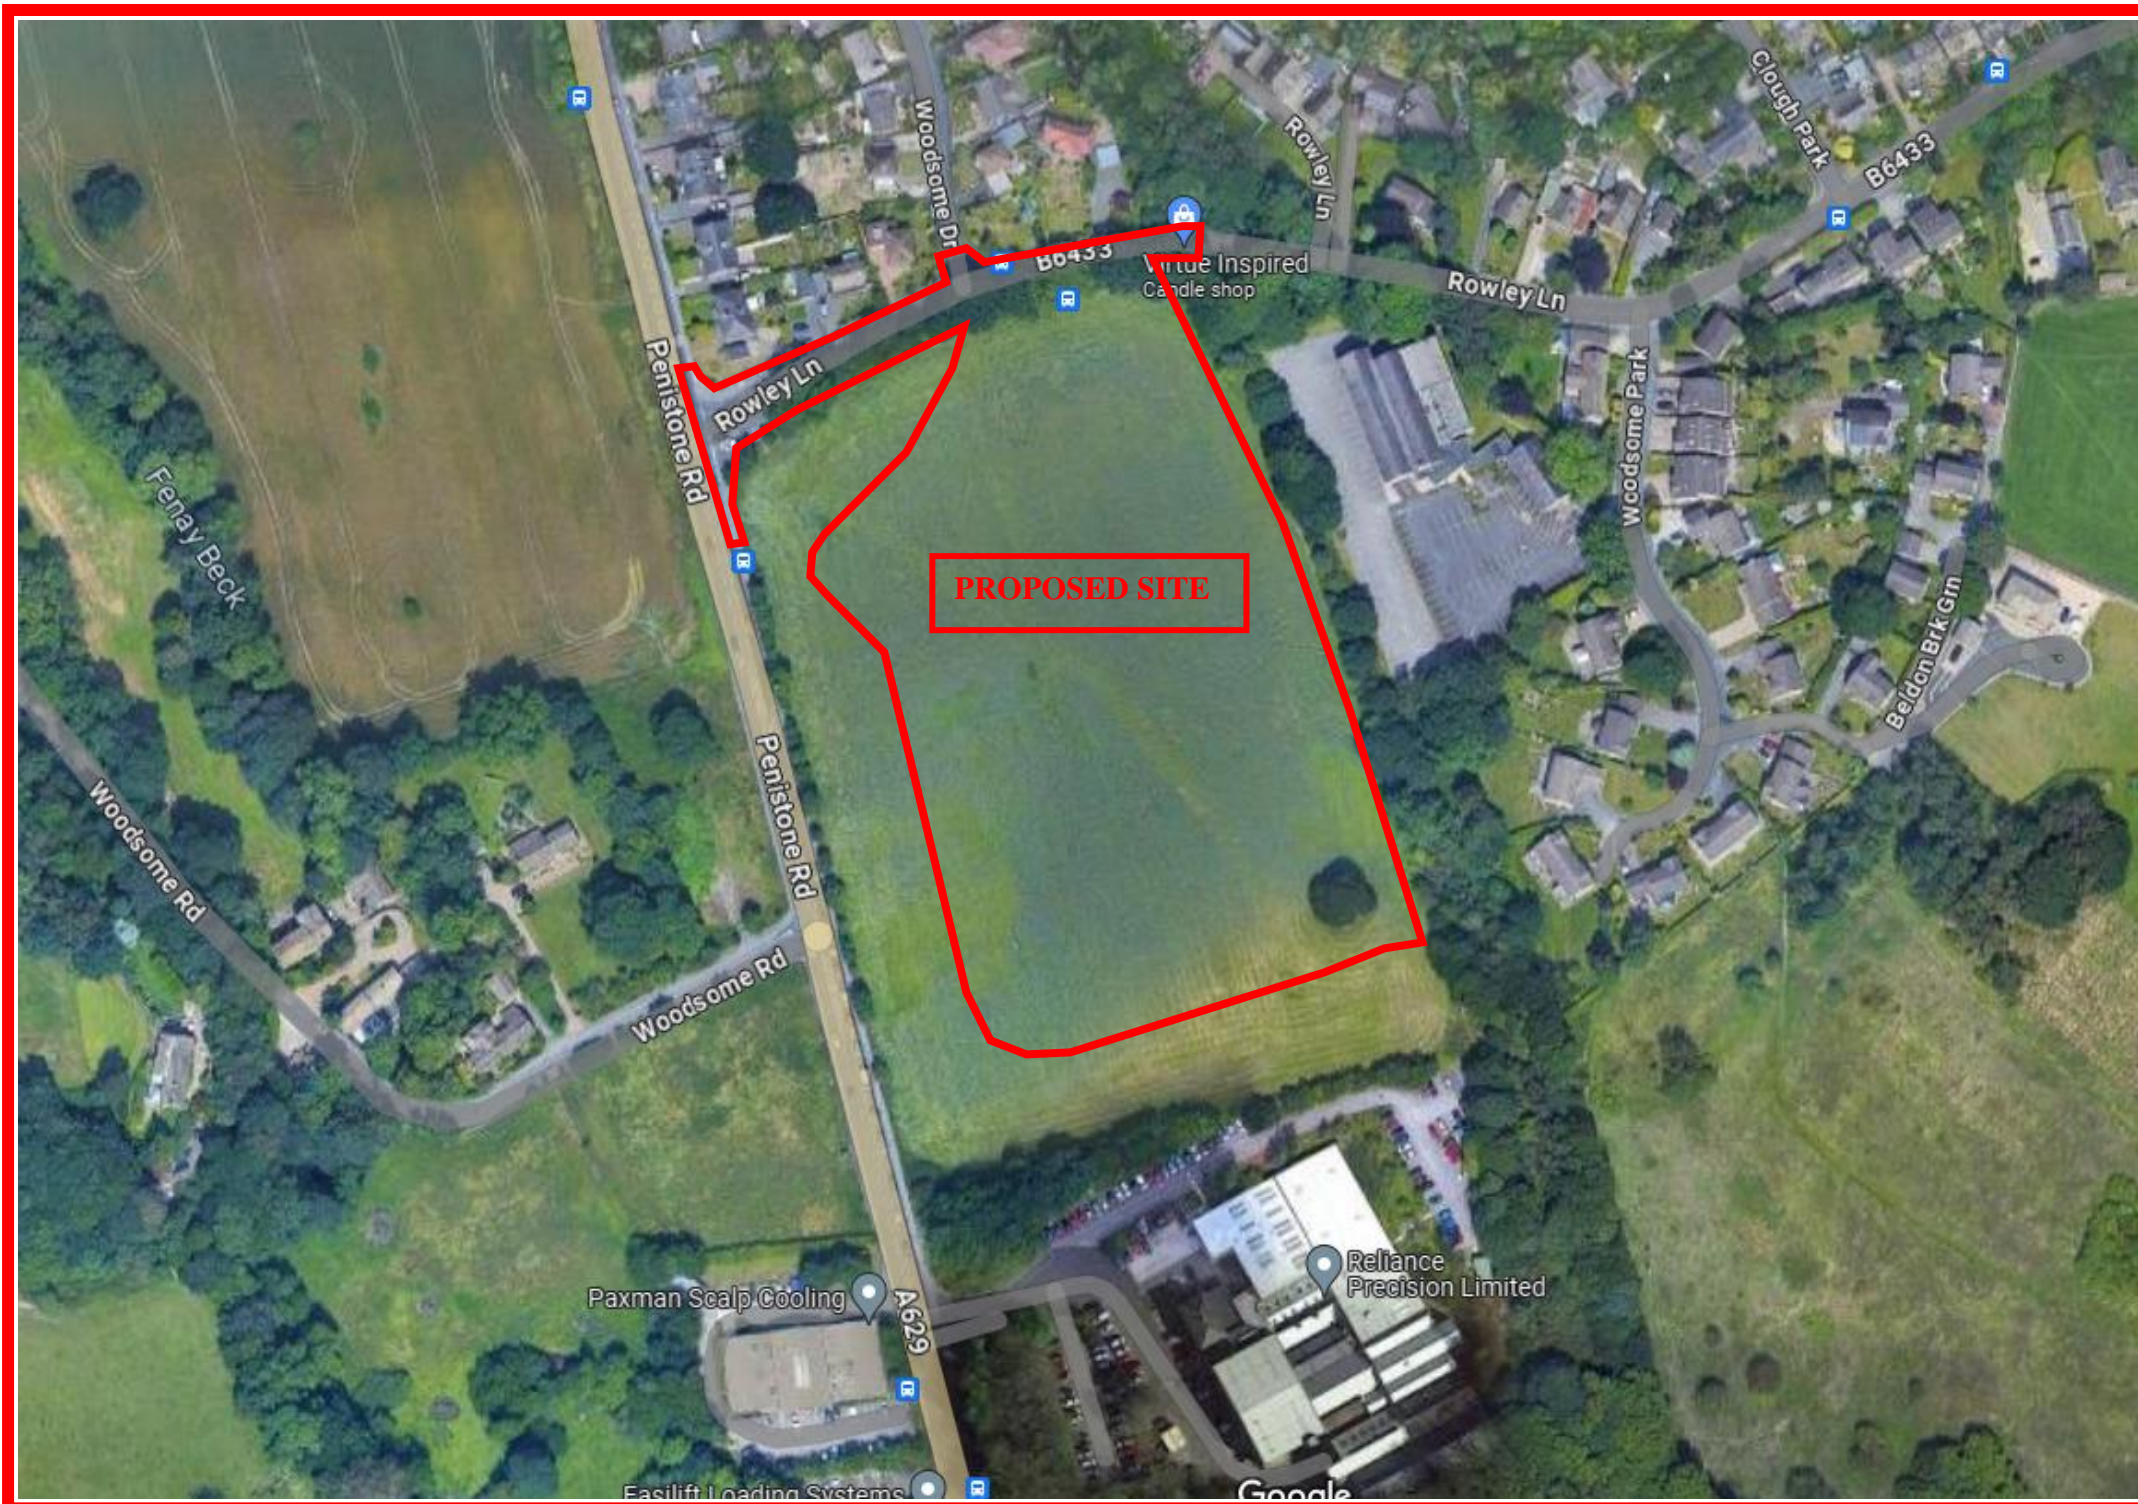
Land off Penistone Road

OS Grid Reference : SE187144
Easting : 418748
Northing : 414489

Topographical Survey carried out
using GPS.
