Ashley Bamford  
Bamford Architectural

2<sup>nd</sup> February 2024

**Subject: Land to Rear of 1 West View, Denby Dale – Ecological Walkover Survey - Letter Report**

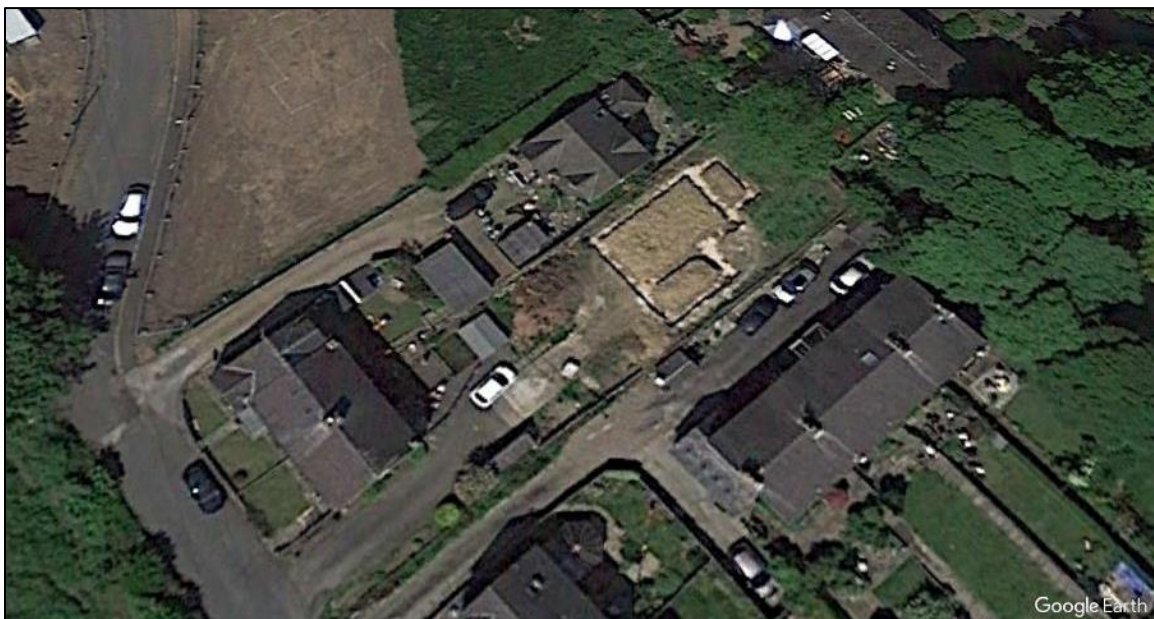
**Figure 2. 2016 aerial image of the site**

Historical aerial imagery (Google earth) suggests the site formerly comprised a garden, which was cleared c.2016 (Figure 2), with the foundations of a new dwelling appearing to have been excavated on the site at this time.

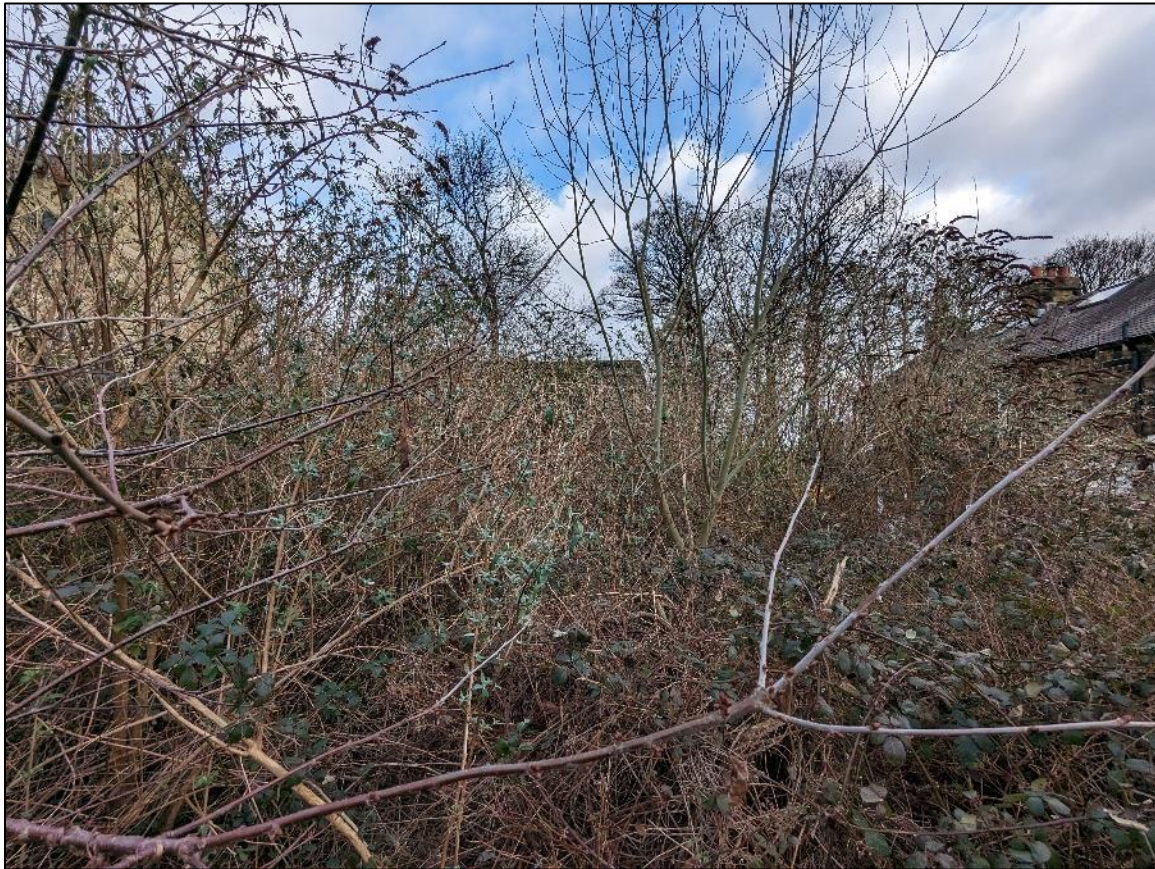
**Plate 1. Southeast end of dense scrub on site**

At the time of survey, the main section of the site comprised a stony area of ground intersected by several c.0.5 m deep trenches and covered by dense scrub. Scrub species presented included abundant bramble *Rubus fruticosus*, frequently occurring buddleia *Buddleja davidii*, occasional cherry *Prunus* spp., goat willow *Salix caprea*, cherry laurel *Prunus laurocerasus*, broom *Cytisus scoparius* and rarely occurring wych elm *Ulmus glabra*. The grass species Yorkshire fog *Holcus lanatus* was also present together with the climbing plant ivy *Hedera helix*. No buildings were present on the site and none of the vegetation present within the site displayed any bat roost potential.

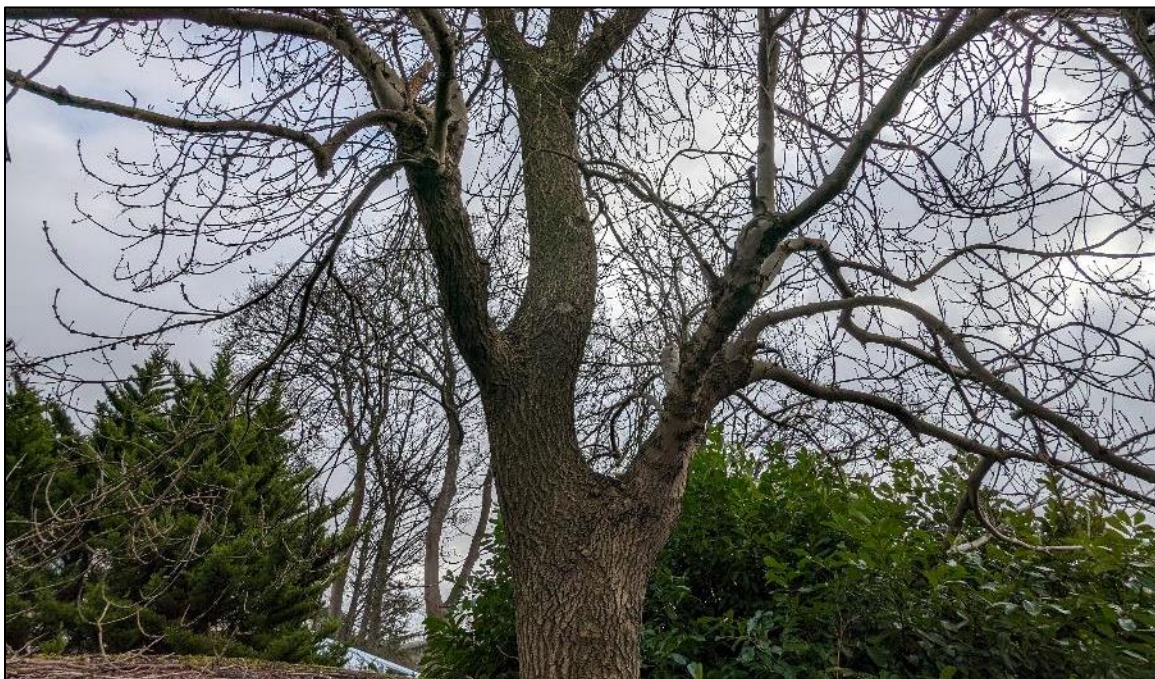
**Plate 3. Semi-mature ash tree on northeast boundary**

The site was bordered on all sides by domestic dwellings, access drives and/or gardens. A semi-mature ash *Fraxinus excelsior* tree was present leaning towards the site's northeast boundary. No potential bat roost features were recorded from the ash tree, which was considered to display a negligible level of bat roost potential.
