Phase 2 Intrusive Site Investigation Report

LOCATION	23 New Lane, Skelmanthorpe, Huddersfield HD8 9EH
ISSUE DATE	February 2024
FOR	Wendy Campbell
CLIENT REF.	
OUR REF.	G23419

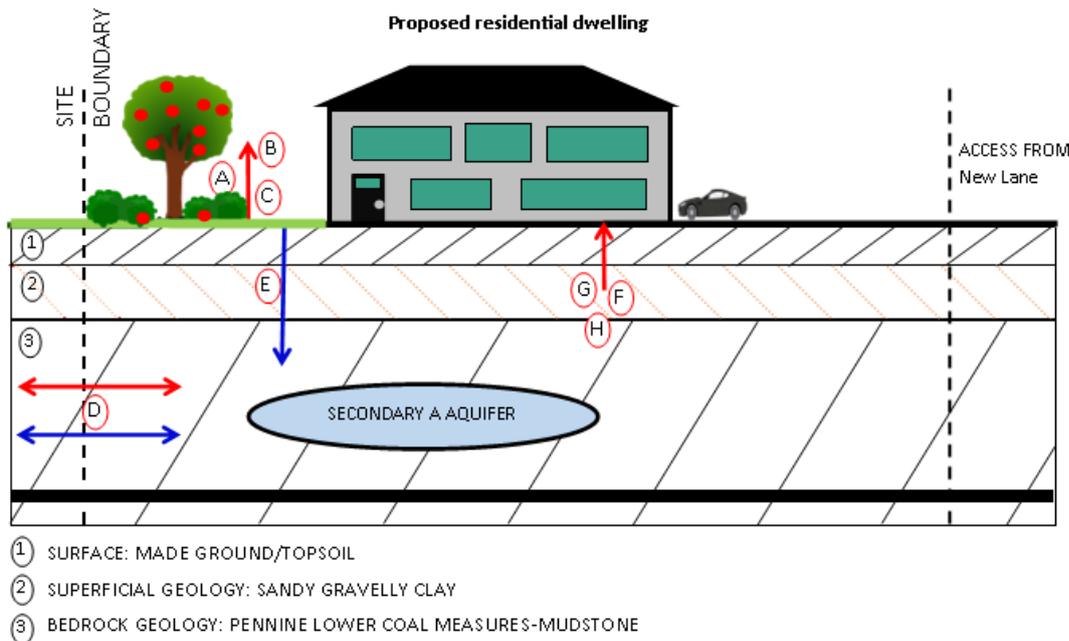
Figure 1: CGHM – Conceptual cross section of site including a Source, Pathway and Receptor Model

The conceptual ground hazard model (CGHM) presented below shows the potential hazards and pollutant linkages which have been considered at the site, all of which are considered to have been satisfactorily disproven.

- Possible presence of made ground and historical contamination thereof by past land use and development works at the site.
- Potentially contaminative historical land uses on nearby/adjacent sites including existing dwelling on site
- Possible hazardous gas risk from shallow historical coal mining.
- Potential ground stability issues associated with shallow historical coal mining.

- A— End Users through Direct Contact / Inhalation / Ingestion. Buildings and hard standing will encompass some of the site, removing any pathway to end users through direct contact in these areas.

- D— Neighbouring Sites through lateral migration (in soil and water, including surface water run off).
 - E— Groundwater through leaching of sub-soil.

- F— Buildings and services through direct contact.
- Linkages A-F broken due to low/negligible contamination and leachate analysis results.
- G— End users and buildings through ground gas migration.

- Linkage G broken, site falls into CS1 based on two initial gas monitoring visits.
- H— Geotechnical risks to buildings and services.
- No coal workings found within rotary boreholes.

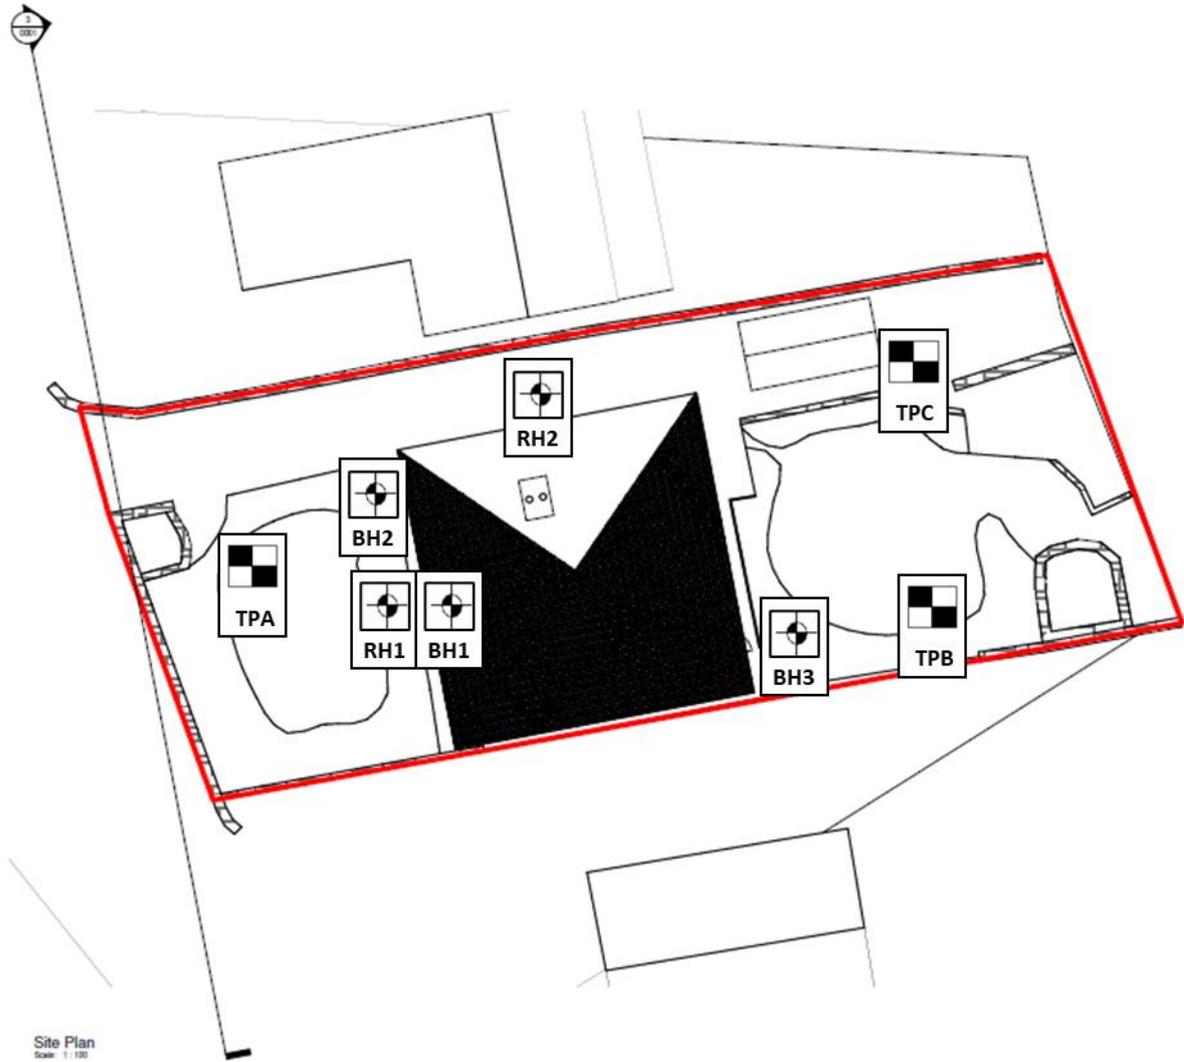
OUR REF: G23419	YOUR REF:	SITE PLAN (NOT TO SCALE)
DATE: 15/01/24	LOCATION: 23 New Lane, Skelmanthorpe, HD8 9EH

The trial pit and borehole positions are shown on the plan provided in Appendix 1.

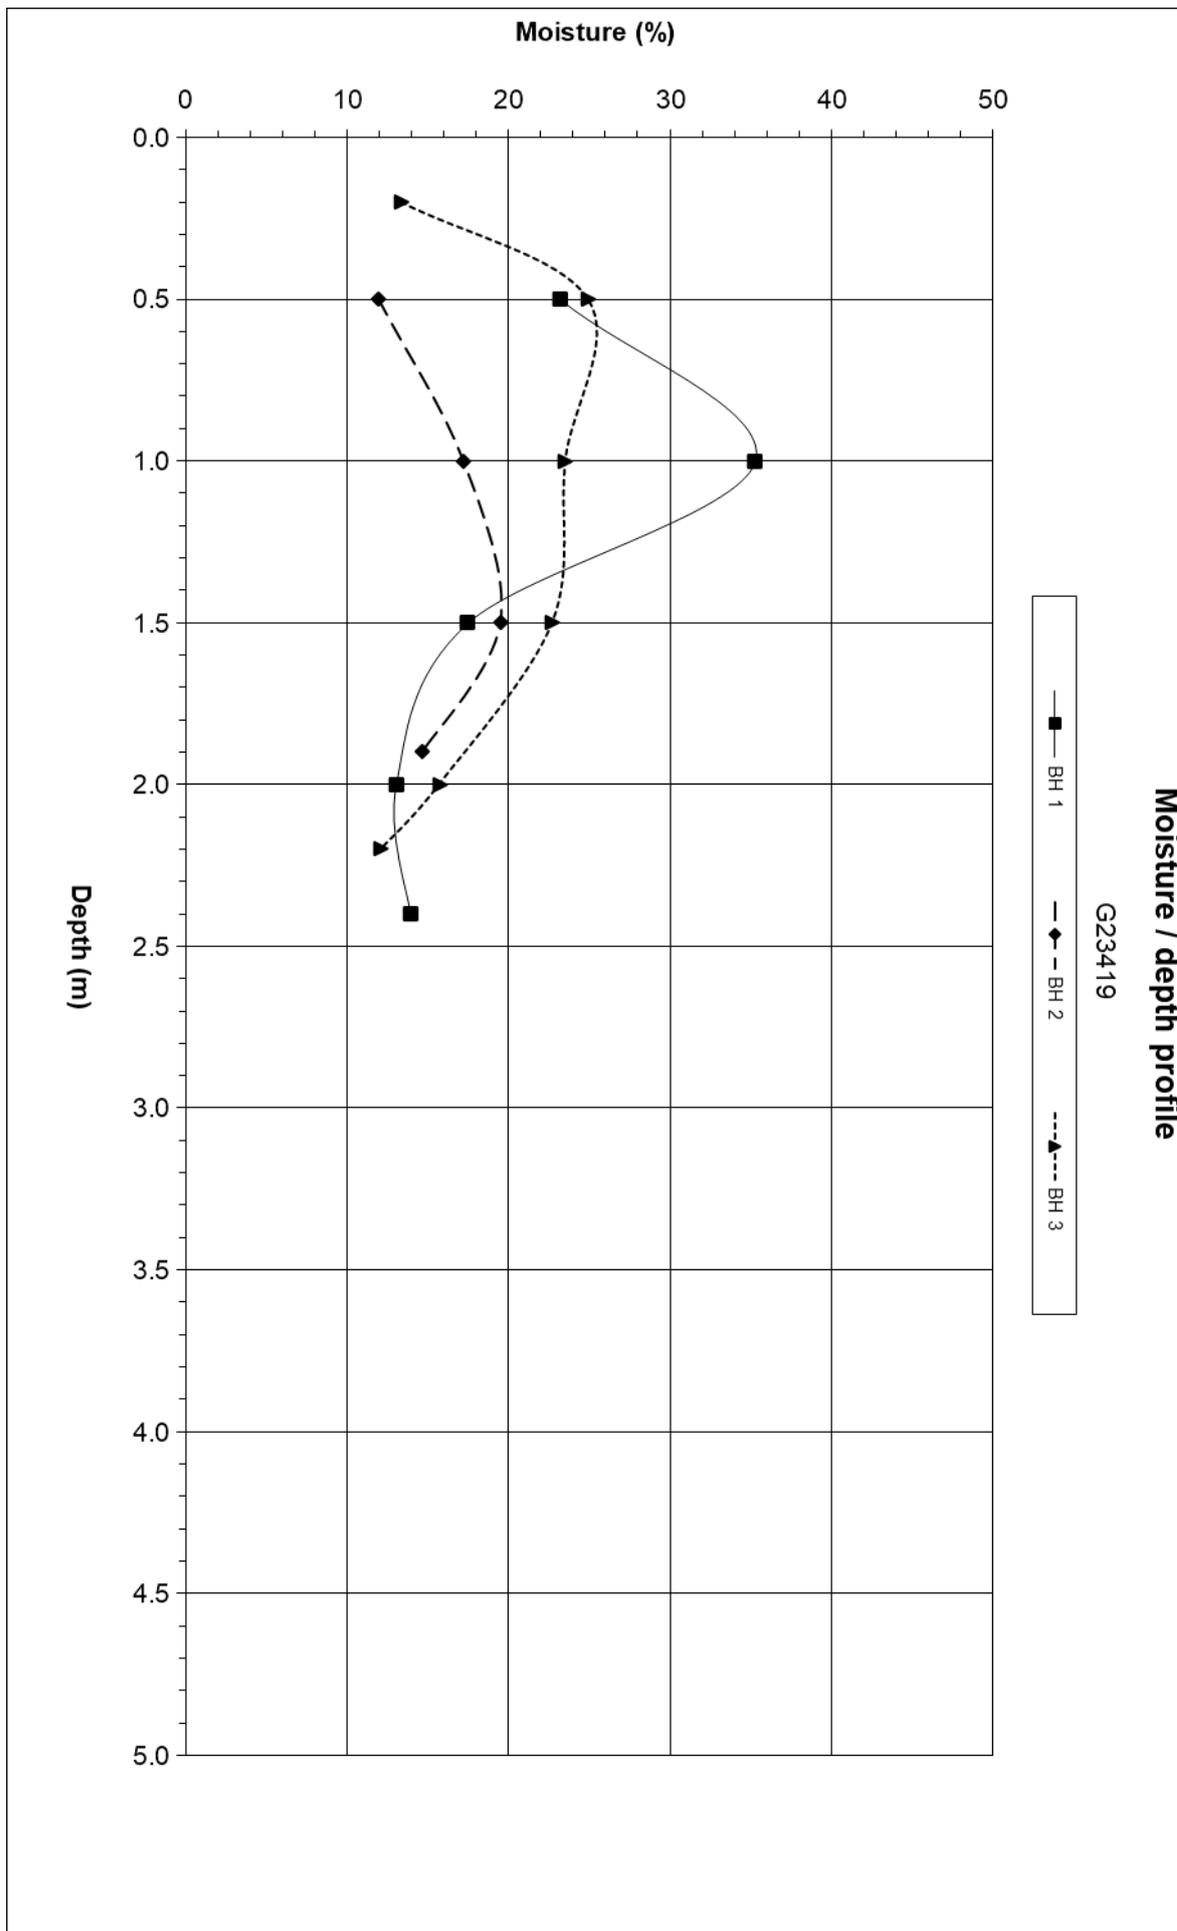
Borehole moisture profiles are presented in Appendix 2. Moisture contents between 11.9% and 24.9% were reported within the made ground. The natural cohesive strata recorded moisture contents between 17.2% and 23.5%. The weathered mudstone returned moisture contents of between 12.2% and 19.5%.

Atterberg Limit testing returned Plasticity Indices (PIs) between 14.8% and 27.4%. The cohesive soils therefore classify as Clay of Low (CL) to High (CH) Plasticity according to BS 5930. These results correspond to Low and Medium Shrinkage Soils (volume change potential) according to NHBC Section 4.2 Building Near Trees.

TP / BH No.	Sample Depth (m)	Insitu Moisture Content (%)	% Passing BS 425 Micron Sieve	Corrected Moisture Content (%)	Plastic Limit (%)	Liquid Limit (%)	Plasticity Index (%)	Soil Classification BS5930 [1999]
1	0.50	23.2						
	1.00	35.3						
	1.50	17.5	89.4	19.6	22.0	42.9	20.9	CI
	2.00	13.1						
	2.40	13.9						
2	0.50	11.9						
	1.00	17.2	86.9	19.8	28.2	55.6	27.4	CH
	1.50	19.5						
	1.90	14.7						
3	0.20	13.4						
	0.50	24.9						
	1.00	23.5						
	1.50	22.7	64.3	35.4	22.0	36.8	14.8	CI
	2.00	15.8						
	2.20	12.2
