**Yew Tree Farm, Farnley Tyas,
West Yorkshire**

Archaeological Watching Brief

Report no. 4252
February 2025

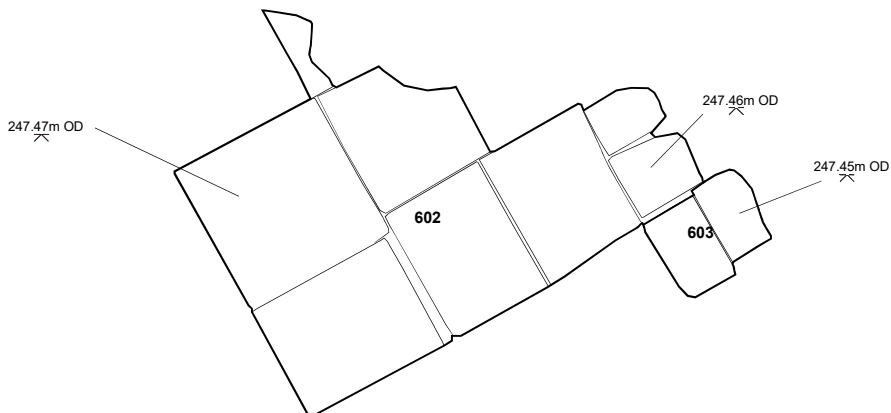
Fig. 3

Following the removal of a modern concrete surface within Structure 6, part of an earlier sandstone floor was identified (Fig. 3, Plates 15-16). Floor 602 measured 3m long and 2.6m wide and was constructed of unbonded sandstone flags laid over a thin layer of sand. The floor butted up to post base 603. Post base 603 was built from two sandstone blocks with a chiselled, square post-setting present on the upper surfaces, and was laid over the same thin sand layer as floor 602 suggesting contemporaneity.

Plan of former flagstone surface in ST6

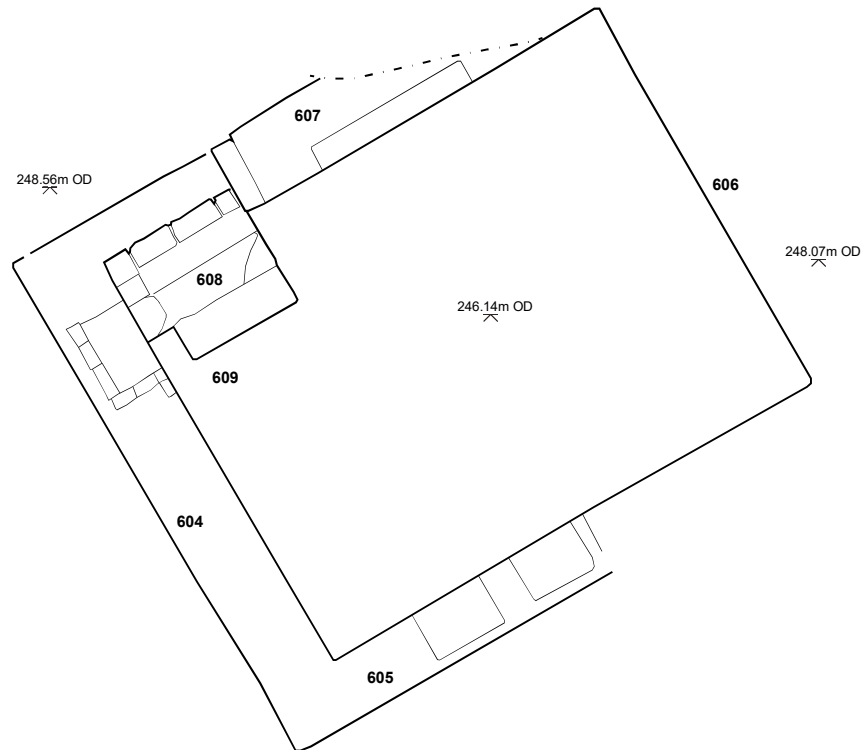
Fig. 4

Following demolition of Structure 4, the remains of a cellar was identified (Fig. 4, Plates 17-19). The cellar was built from walls 604, 605, 606, and 607, each built from a mix of handmade red brick, sandstone and a small amount of likely reused roofing slate. The internal faces of the wall had a patchy white render surviving. Alcoves were built into the internal faces of walls 604, 605, and 607. Cellar steps 608, built from sandstone blocks, were present in the northwest corner of the cellar forming access from the north. A dark grey-black silt deposit (609) was present in the base of the cellar which may indicate that an original flagstone floor of the cellar had been removed prior to demolition. Body sherds from a 20th-century teapot were recovered from deposit 609.

Plan of ST6 cellar

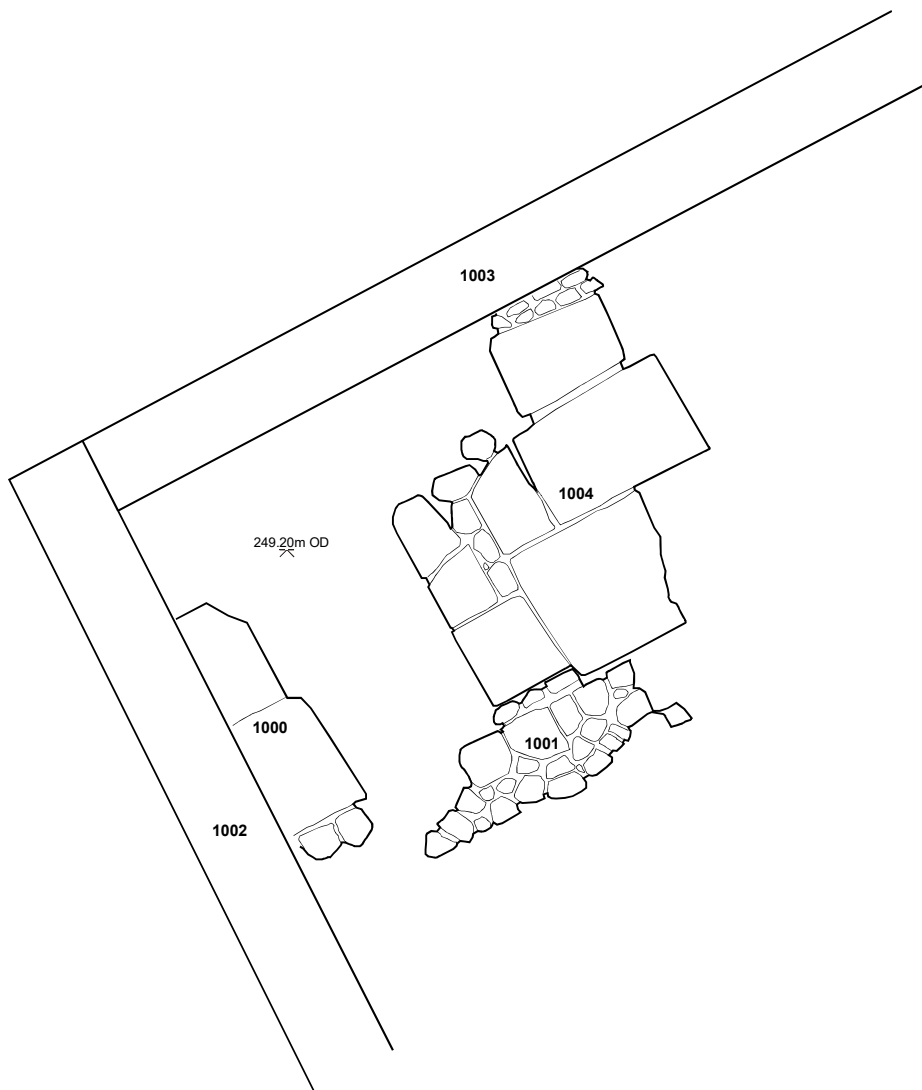
Fig. 5

Walls 1002 and 1003 formed a corner of the drystone wall that marked the site boundary. A northeast to southwest orientated wall foundation 1001 was recorded butting up to the southwest face of wall 1002. A remnant of a flagstone surface 1004 was recorded to the north of wall 1001. Two additional flagstones (1000) were identified which appeared to be continuing beneath boundary wall 1002. It is likely that they were remnants of a former outbuilding and accompanying floor.

Plan of ST10

Structure 10 was the only archaeological feature that could not be tied to an extant building. It represents a former surface with some structural elements that may have formed wall foundations. Historic mapping indicates a small structure was constructed here between 1851 and 1888 but was demolished between 1914 and 1929. It is likely that Structure 10 formed an outbuilding or shed, perhaps used for storage or keeping livestock such as pigs.

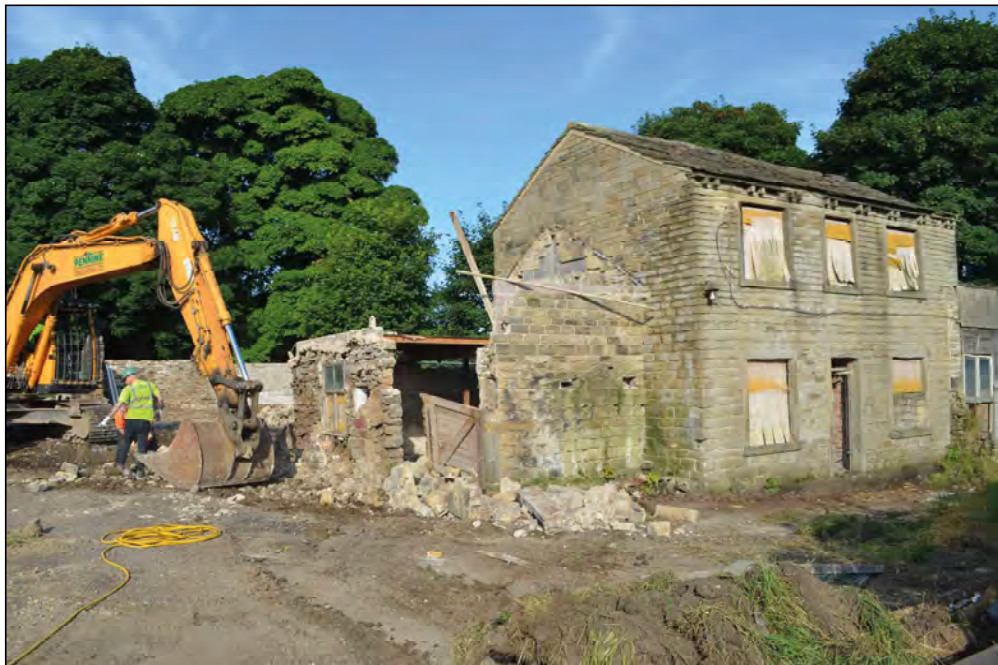
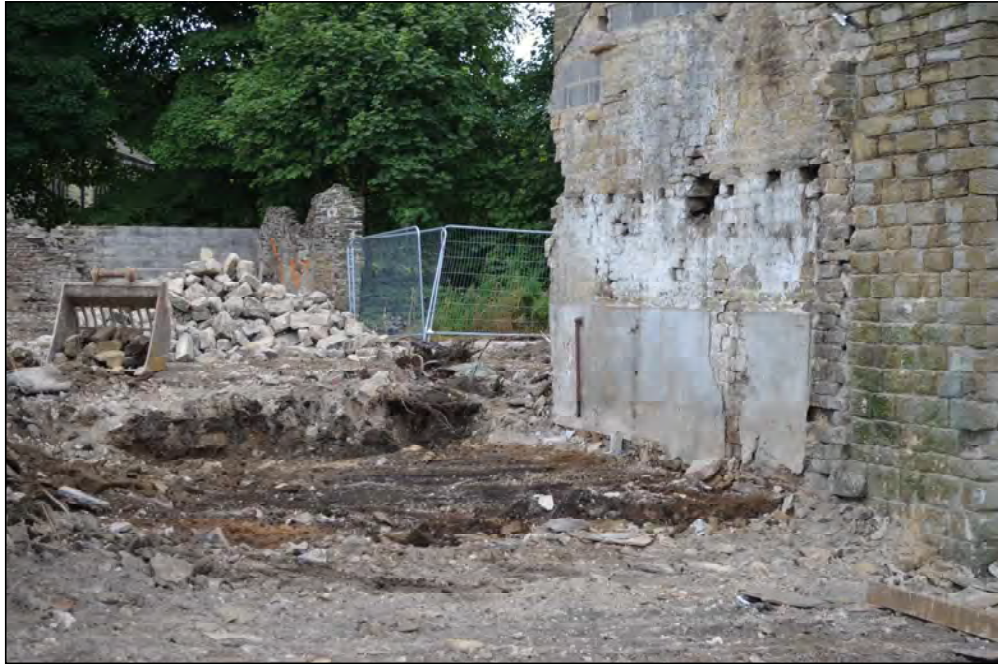
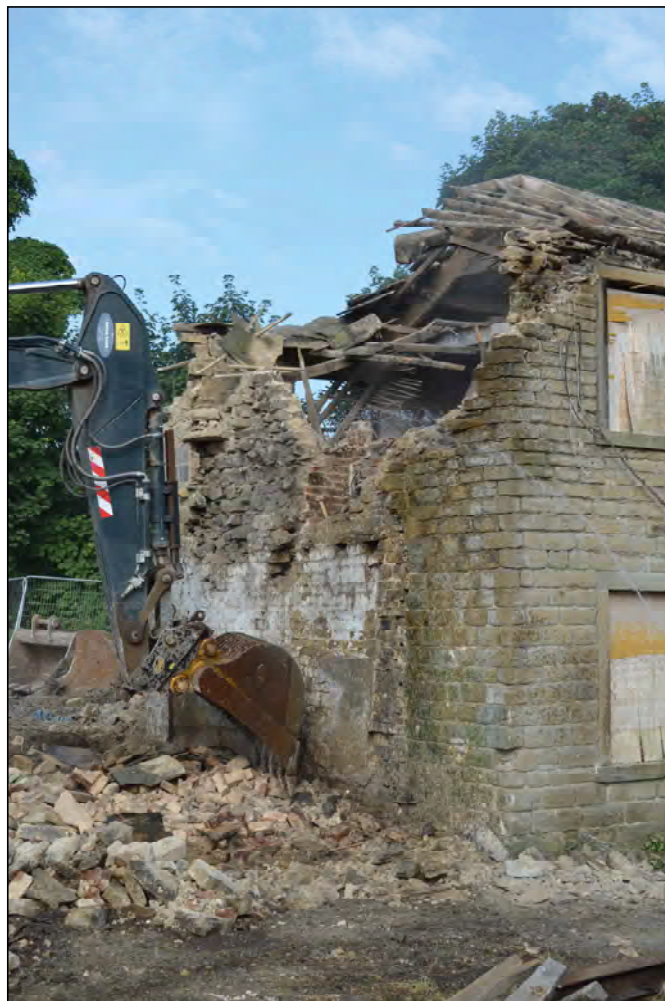
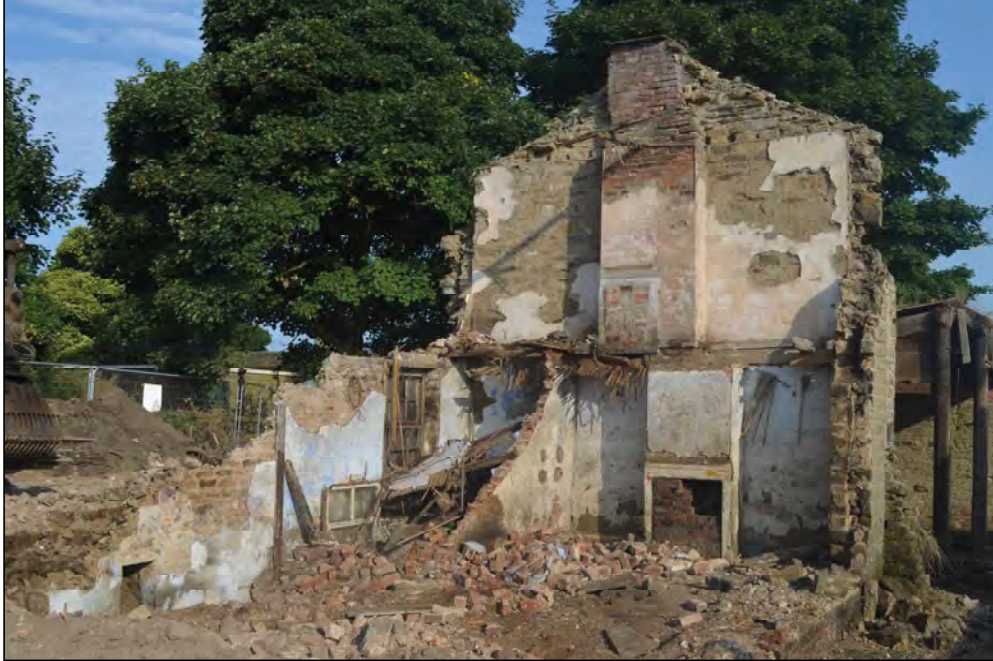
The demolition of a number of the standing buildings in the north of the site was monitored (Plates 1-5). This involved the careful dismantling of the walls and the total removal of floors and foundations. Further modern outbuildings to the south of the site had been subject to demolition prior to the watching brief. Several buildings on the site were retained for renovation as noted below in the tabulated summary (Table 1) and are not described further. The standing buildings of the site were the subject of a heritage statement (Bowman Riley 2022) carried out in advance of the watching brief.

Plate 2. Demolition of Structure 5, looking west

Plate 3. Structure 5 following demolition, looking west

Plate 4. Demolition of the southern elevation of Structure 5, looking west

Plate 5. Partial demolition of Structure 5

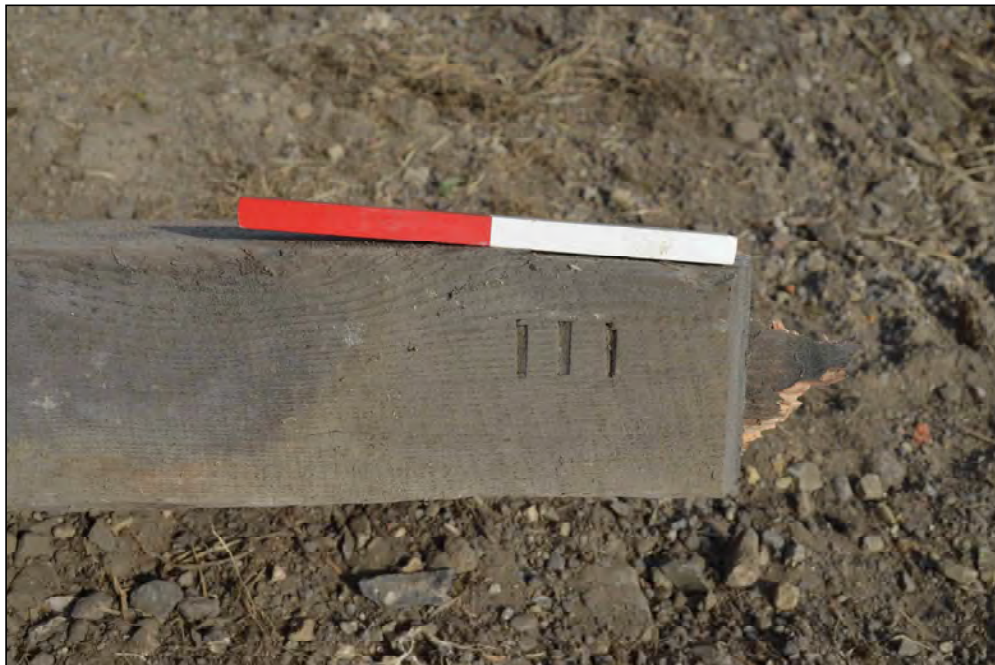
Structure 4 represents the main farmhouse which dated to the 19th century. One of the removed roof timbers had a carpenter's mark 'III' at one end. No corresponding marks were observed on any other timbers.

Plate 10. Structure 4, roof timber with carpenter mark

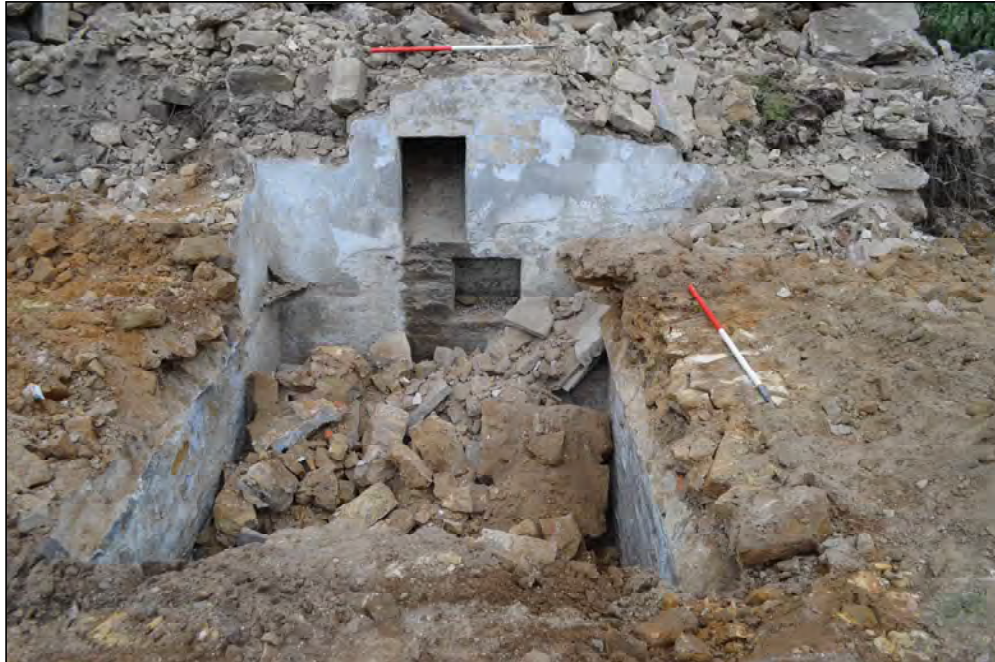
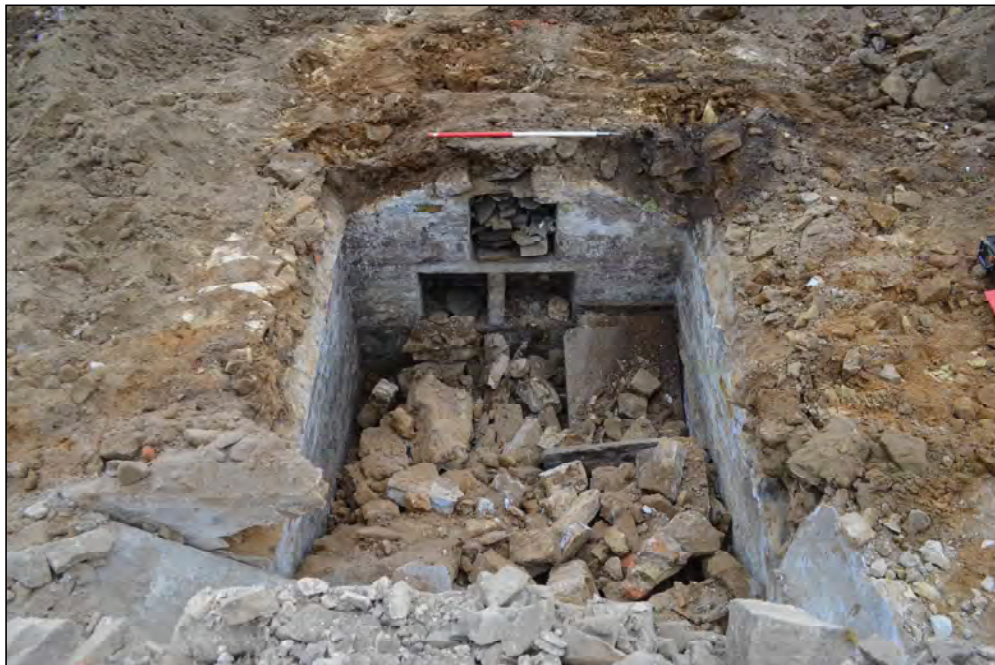
The cellar (Plates 11-12) measured 3m long and 2.20m wide internally. It was constructed from sandstone and lay beneath the south-western corner of the structure's original footprint. A series of steps accessed the cellars from the north along the western edge. A sandstone table lay in the south-eastern corner of the cellar. A series of alcove shelves were inset into the eastern elevation of the cellar and an alcove and a coal chute were found in the western elevation of the cellar. The profile of the western and eastern walls suggested the cellar originally had a barrel vaulted ceiling. Twentieth-century finds were recovered from the cellar during demolition and included instructions for both an engine and a milking machine, a key, a pottery plate and a pair of woodworking planes.

Plate 11. Structure 4, cellar, looking north

Plate 12. Structure 4, cellar, looking south

Structure 4 has been dated to the 19th century (Bowman Riley 2022) with historic mapping suggesting it was in existence by 1851. It is likely then to have been early 19th-century in date. It is presumed the cellar found in the watching brief was of contemporary date. Material collected from the structure is representative of its use as a farmhouse in the 20th century.

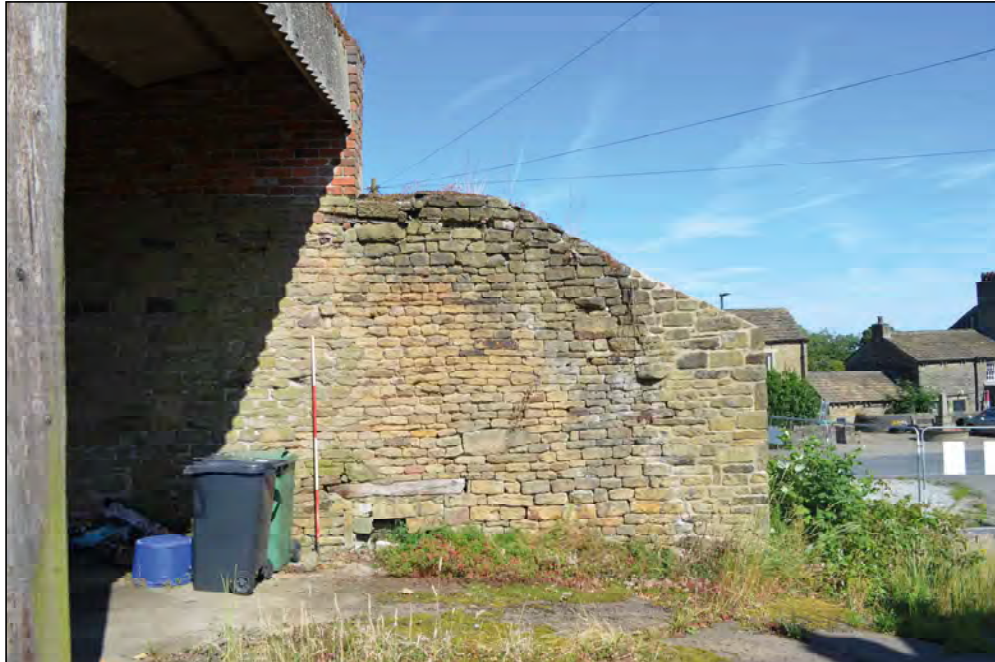
Plate 13. Structure 6, northern elevation of Structure 7

Structure 6 was most recently used as an agricultural outbuilding with an open side, facing east. It has been modified for this purpose reusing original sandstone structures with brick and timber additions (see Plate 13). Structure 6 was likely constructed as a barn attached the northern side of the farmhouse (Structure 4). Laithe house plans of this type are typical of 19th-century farms in the region. Internal structural elements (602, 603) indicate the barn contained a flagstone surface and the walls recorded represent foundations for the northern elevation. A possible setting for a timber post in one flagstone may represent internal sub-division. Historic mapping indicates a square building was originally appended to the eastern side of the barn and its footprint covers the cellar recorded here during the watching brief. The sandstone elements in northern elevation of Structure 6 (see Plate 13) represent the remains of both the northern elevation of the barn and the square building and suggests they were contemporary. The cellar itself, which underlay the square building, suggests the

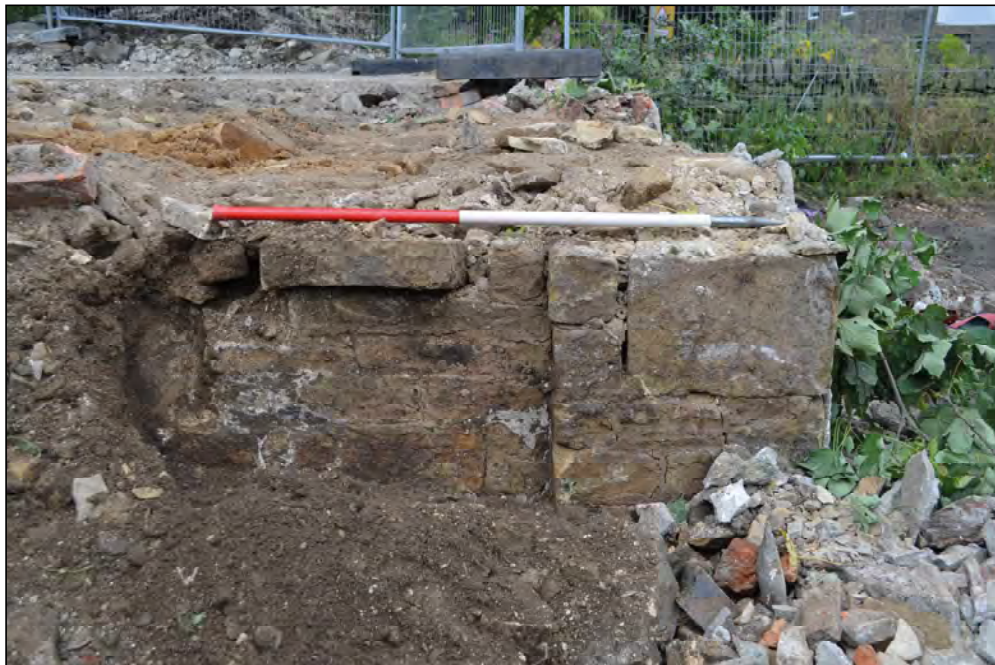
At the northern end of Structure 6 a pair of sandstone wall foundations (600, 601) were recorded. Wall 600 formed an 'L' shape in plan, extending eastwards across the northern edge of the building and turning south before ending in a clear terminus. Wall 601 abutted wall 600 and extended westwards (Plate 14). These walls are likely to represent foundations of both the external and internal dividing walls of Structure 6.

Plate 14. Structure 6, Wall 600 and 601, looking north

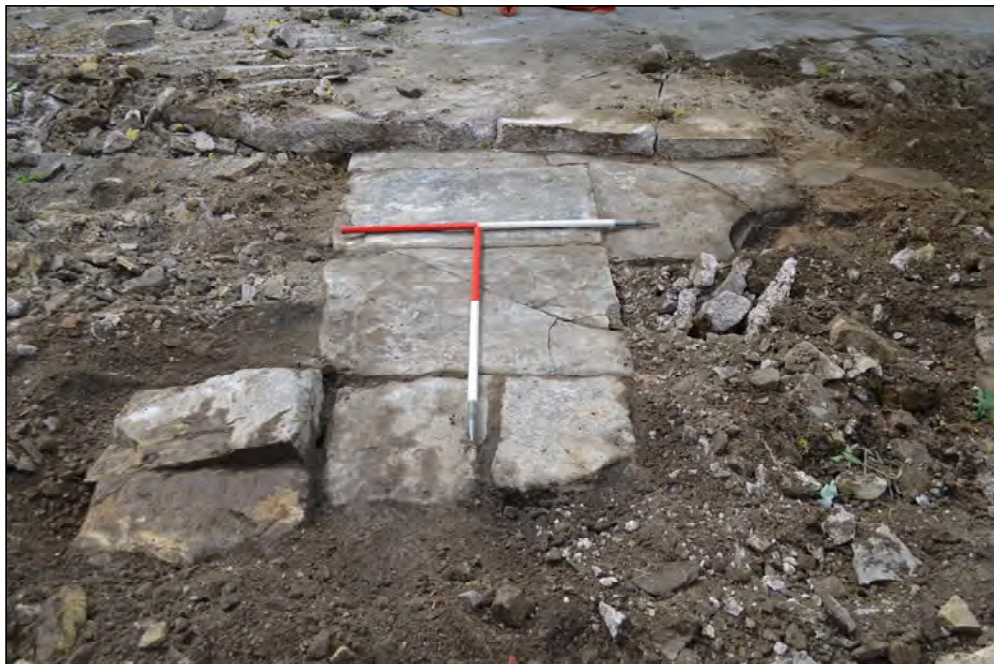
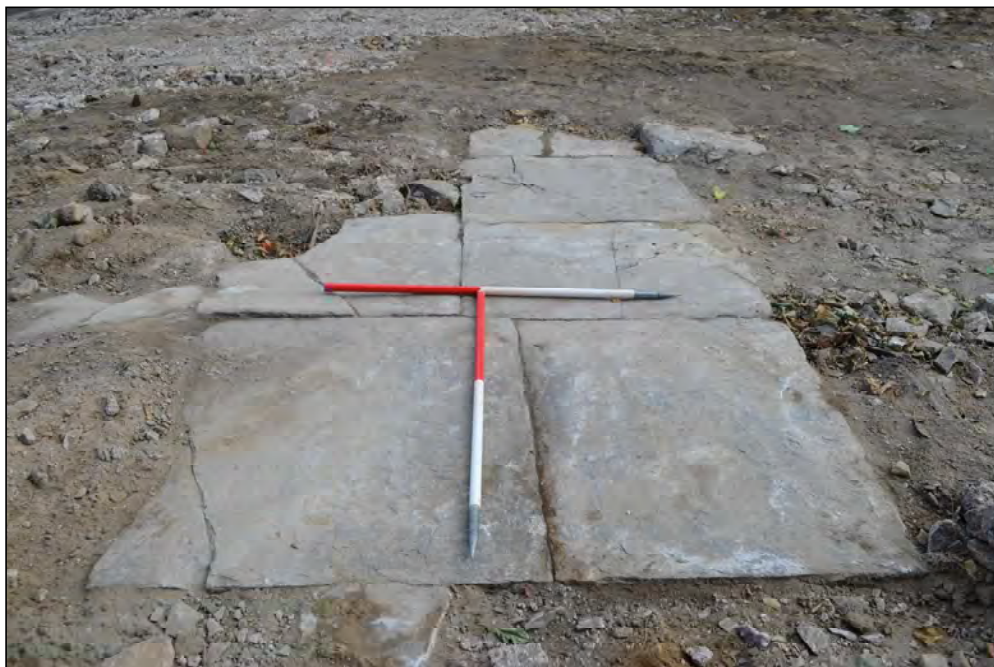
Plate 15. Structure 6, Surface 602/603, looking west

Plate 16. Structure 6, Surface 602/603, looking east

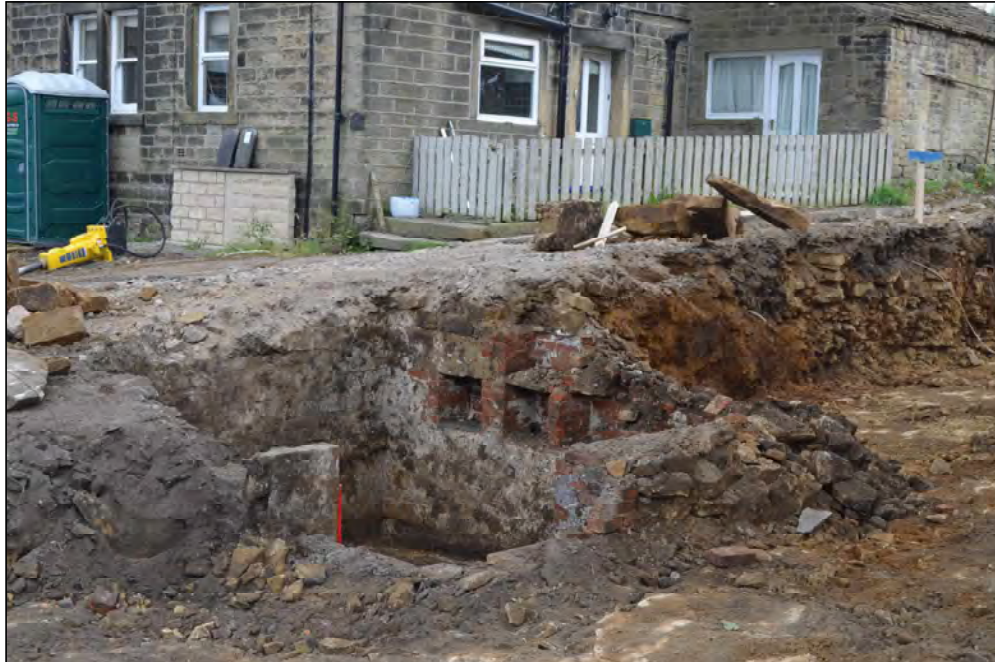
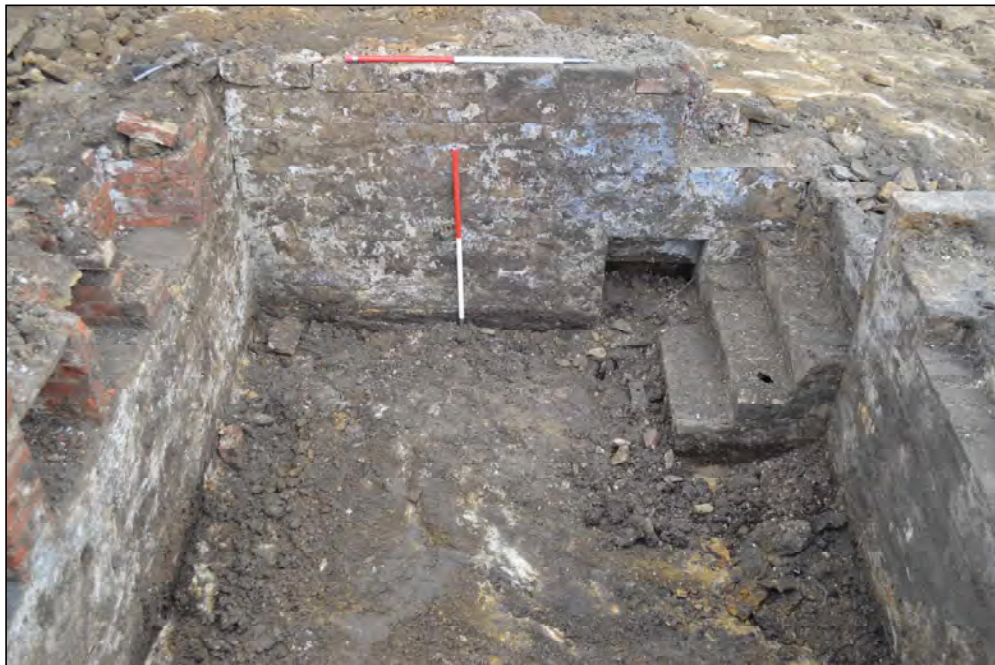
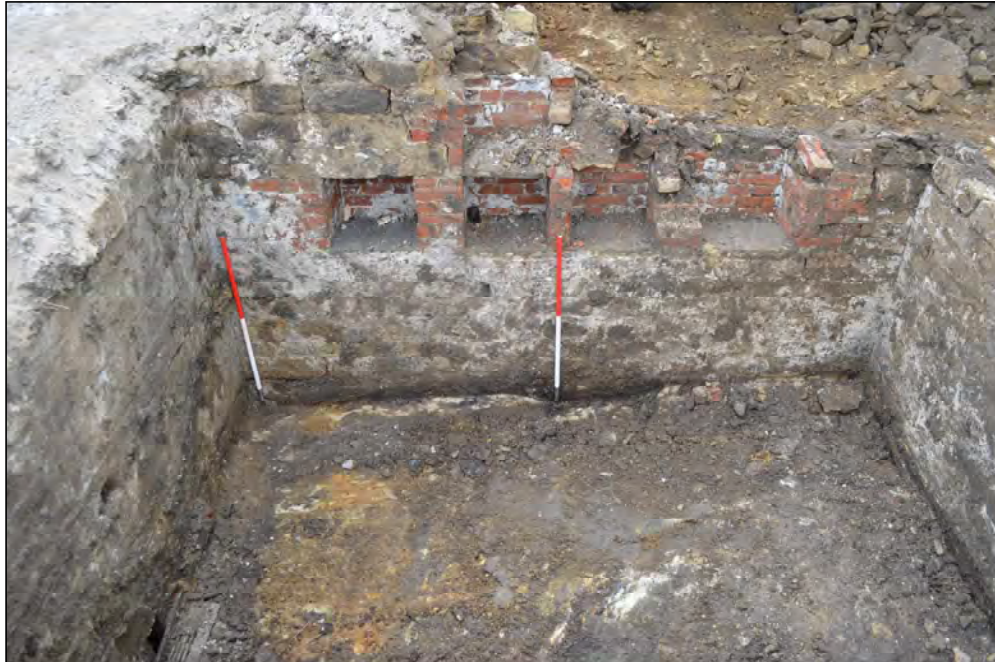
Plate 17. Structure 6, cellar, looking southeast

Plate 18. Structure 6, cellar, looking west

Plate 19. Structure 6, cellar, looking east

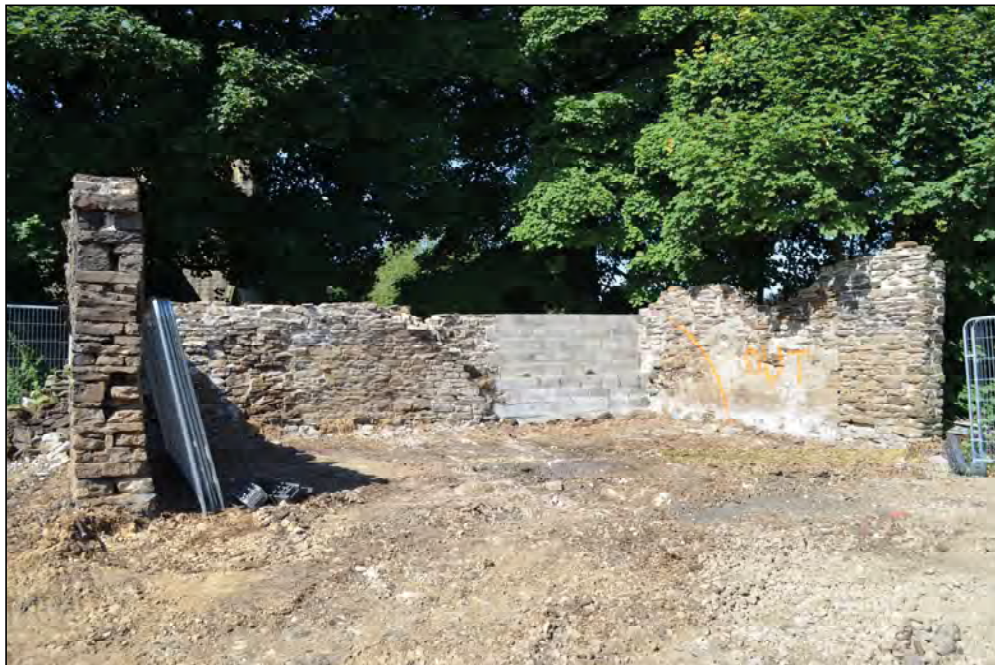
Walls 700-702 were the main exterior sandstone walls of the former outbuilding, enclosing its southern, western and northern sides, Wall 703 represented an area of concrete blockwork that either blocked a former entrance or represented repair work at the northern end of the western elevation. In the north-western corner of the outbuilding, surface 704 measured 2.12m long and 2.20m wide, was rectangular in plan and was constructed with neatly lain rectangular sandstone blocks. The surface was laid on a bed of sand (706) with clinker above (707).

Plate 20. Structure 7, prior to demolition, looking west

Historic mapping suggests Structure 7 was constructed on the footprint of a much smaller structure in the mid to late 19th century. The floor surface recorded during the watching brief is likely to be contemporary with the later, larger structure. The structure is likely to have been used as an outbuilding for storage or for keeping livestock.

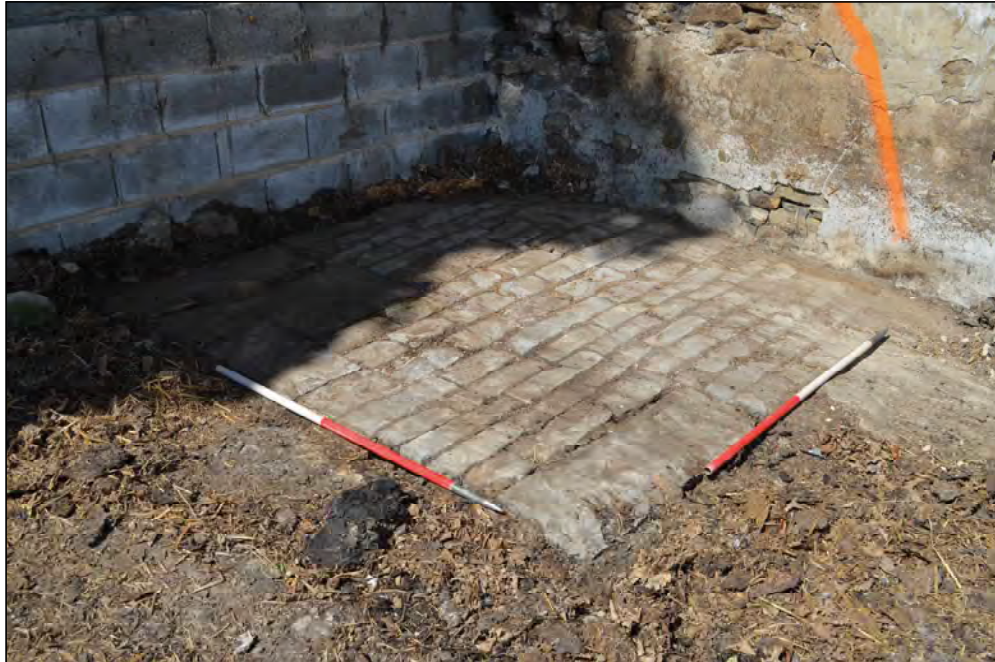
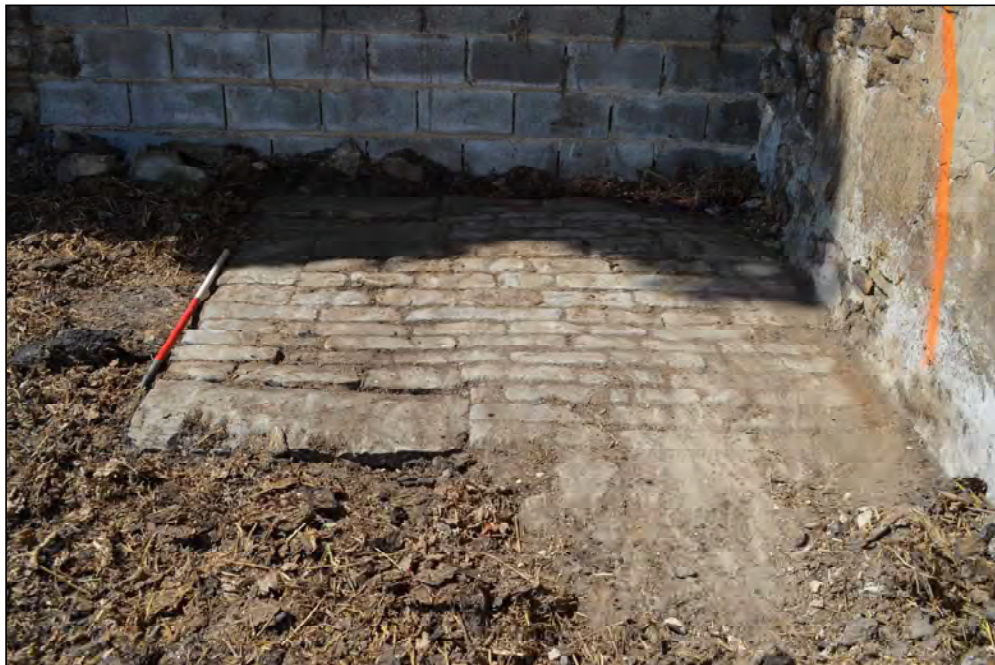
Plate 21. Structure 7, Surface 704, looking northwest

Plate 22. Structure 7, Surface 704, looking west

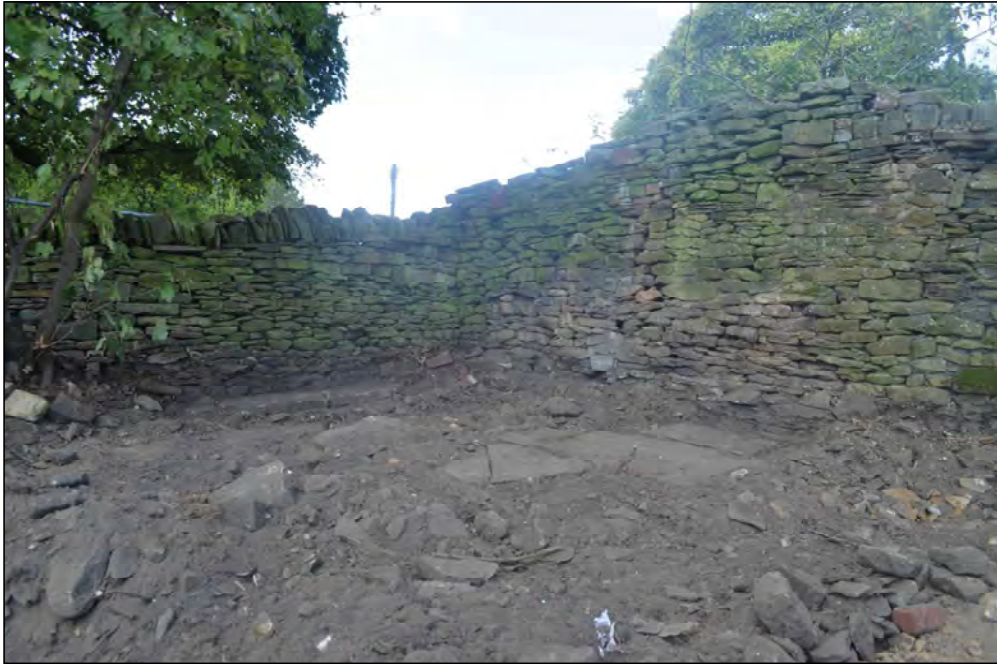
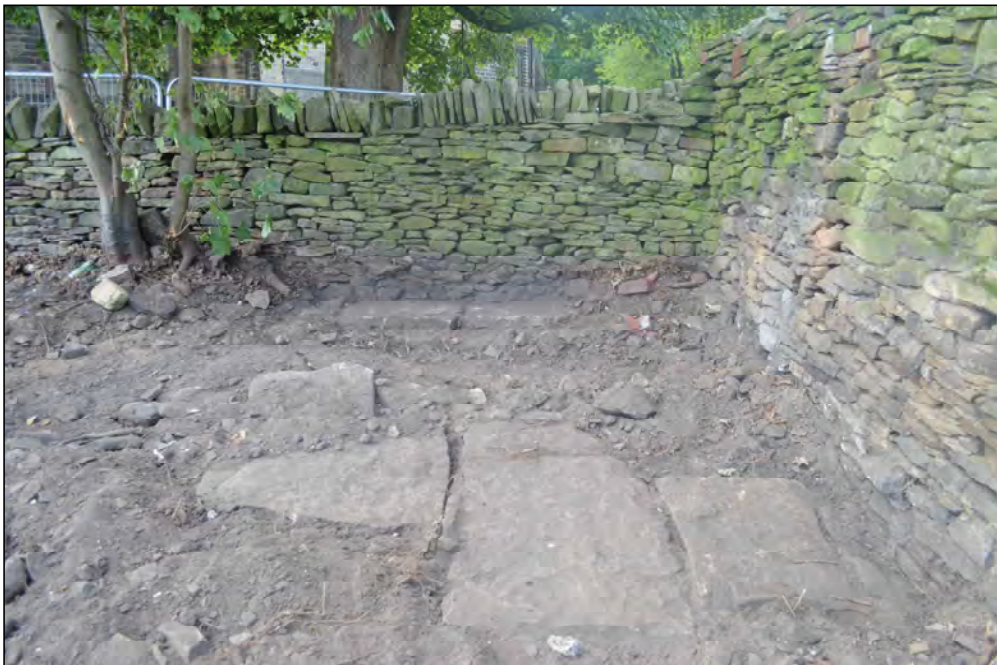
Plate 23. Structure 10, looking northwest

Plate 24. Structure 10, looking west
