**PHASE 2
SWALLOW LANE
GOLCAR, HUDDERSFIELD**

Jones Homes (Yorkshire) Limited

Report Number 3974

Geotechnical and Geoenvironmental Consultants

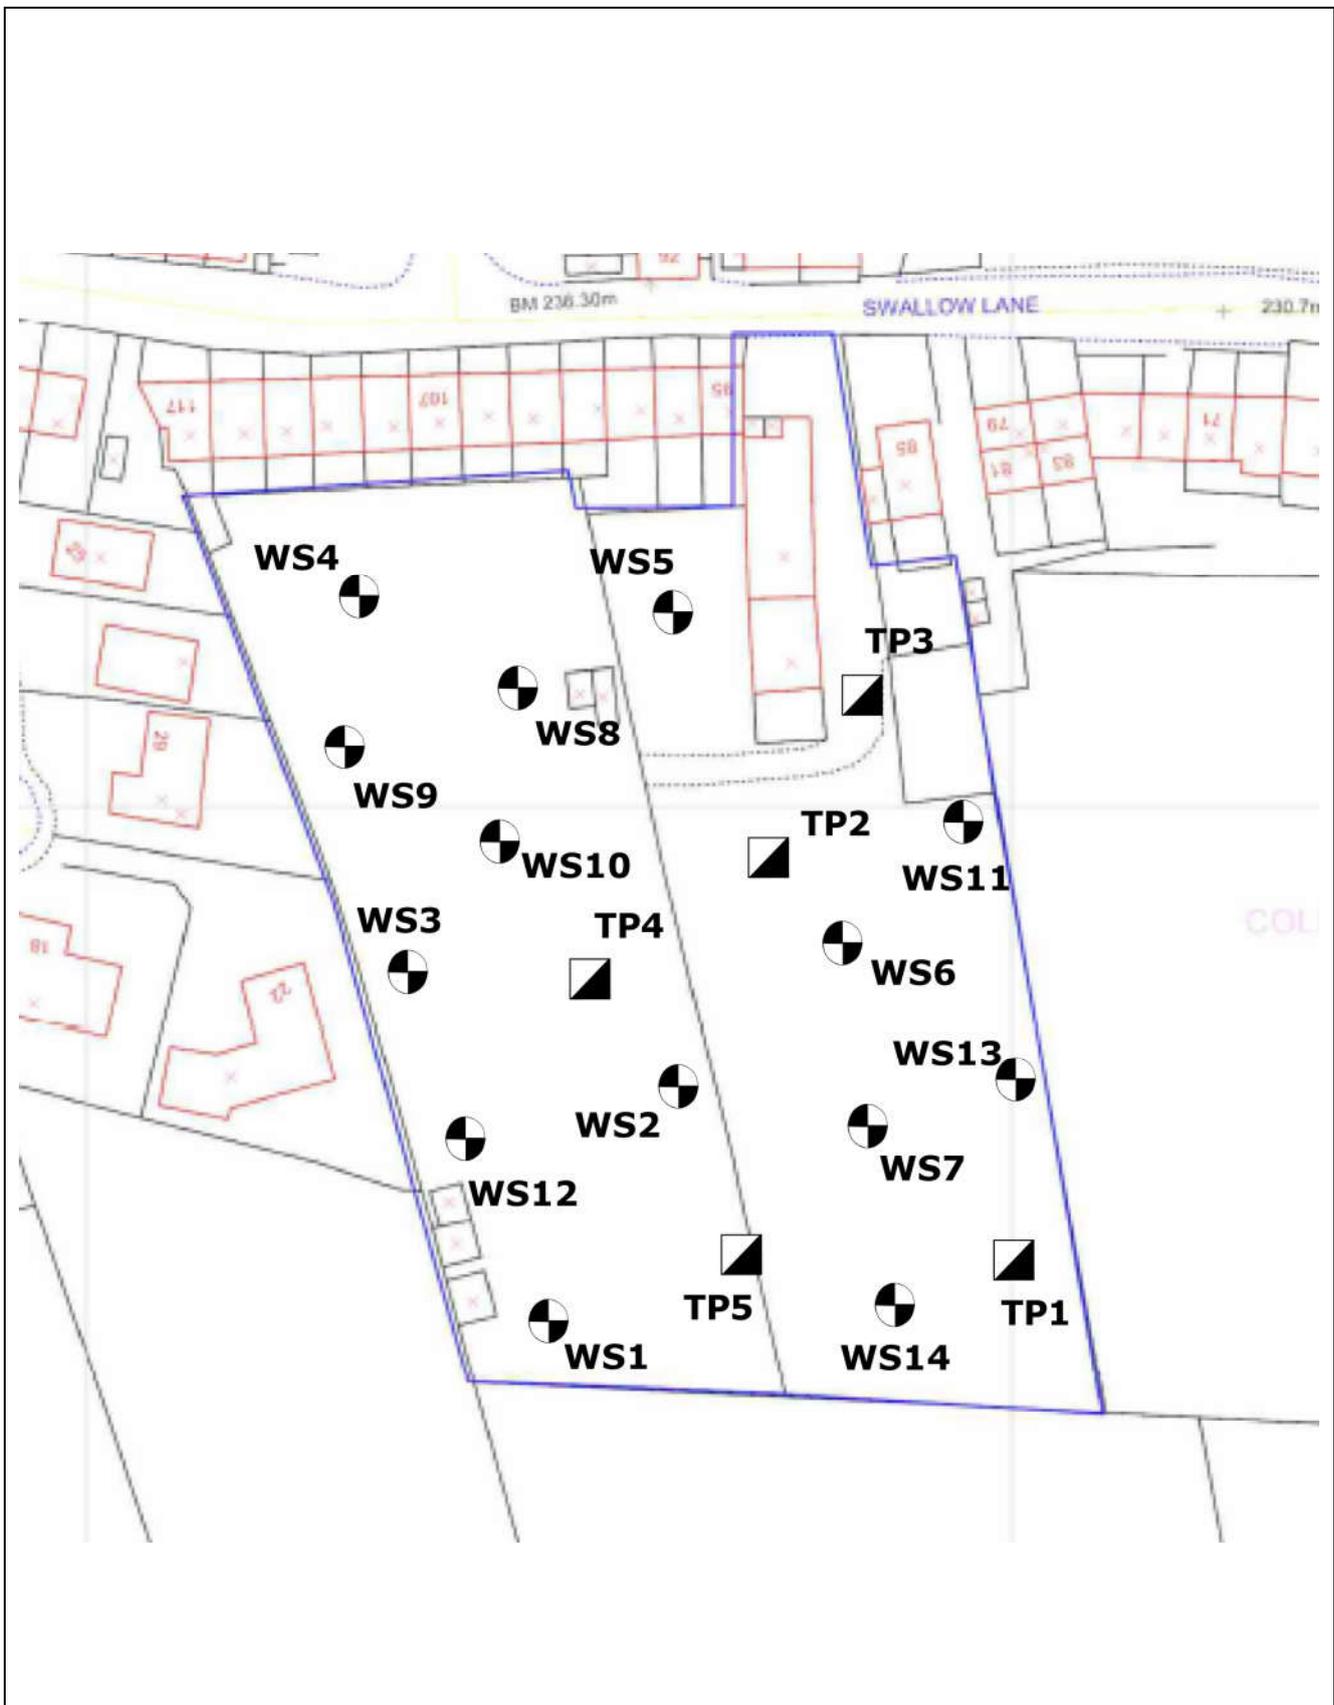
Figure: 2

Swallow Lane, Golcar – Phase 2
 Site Plan with Exploratory Window Sampling Boreholes and Trial Pits

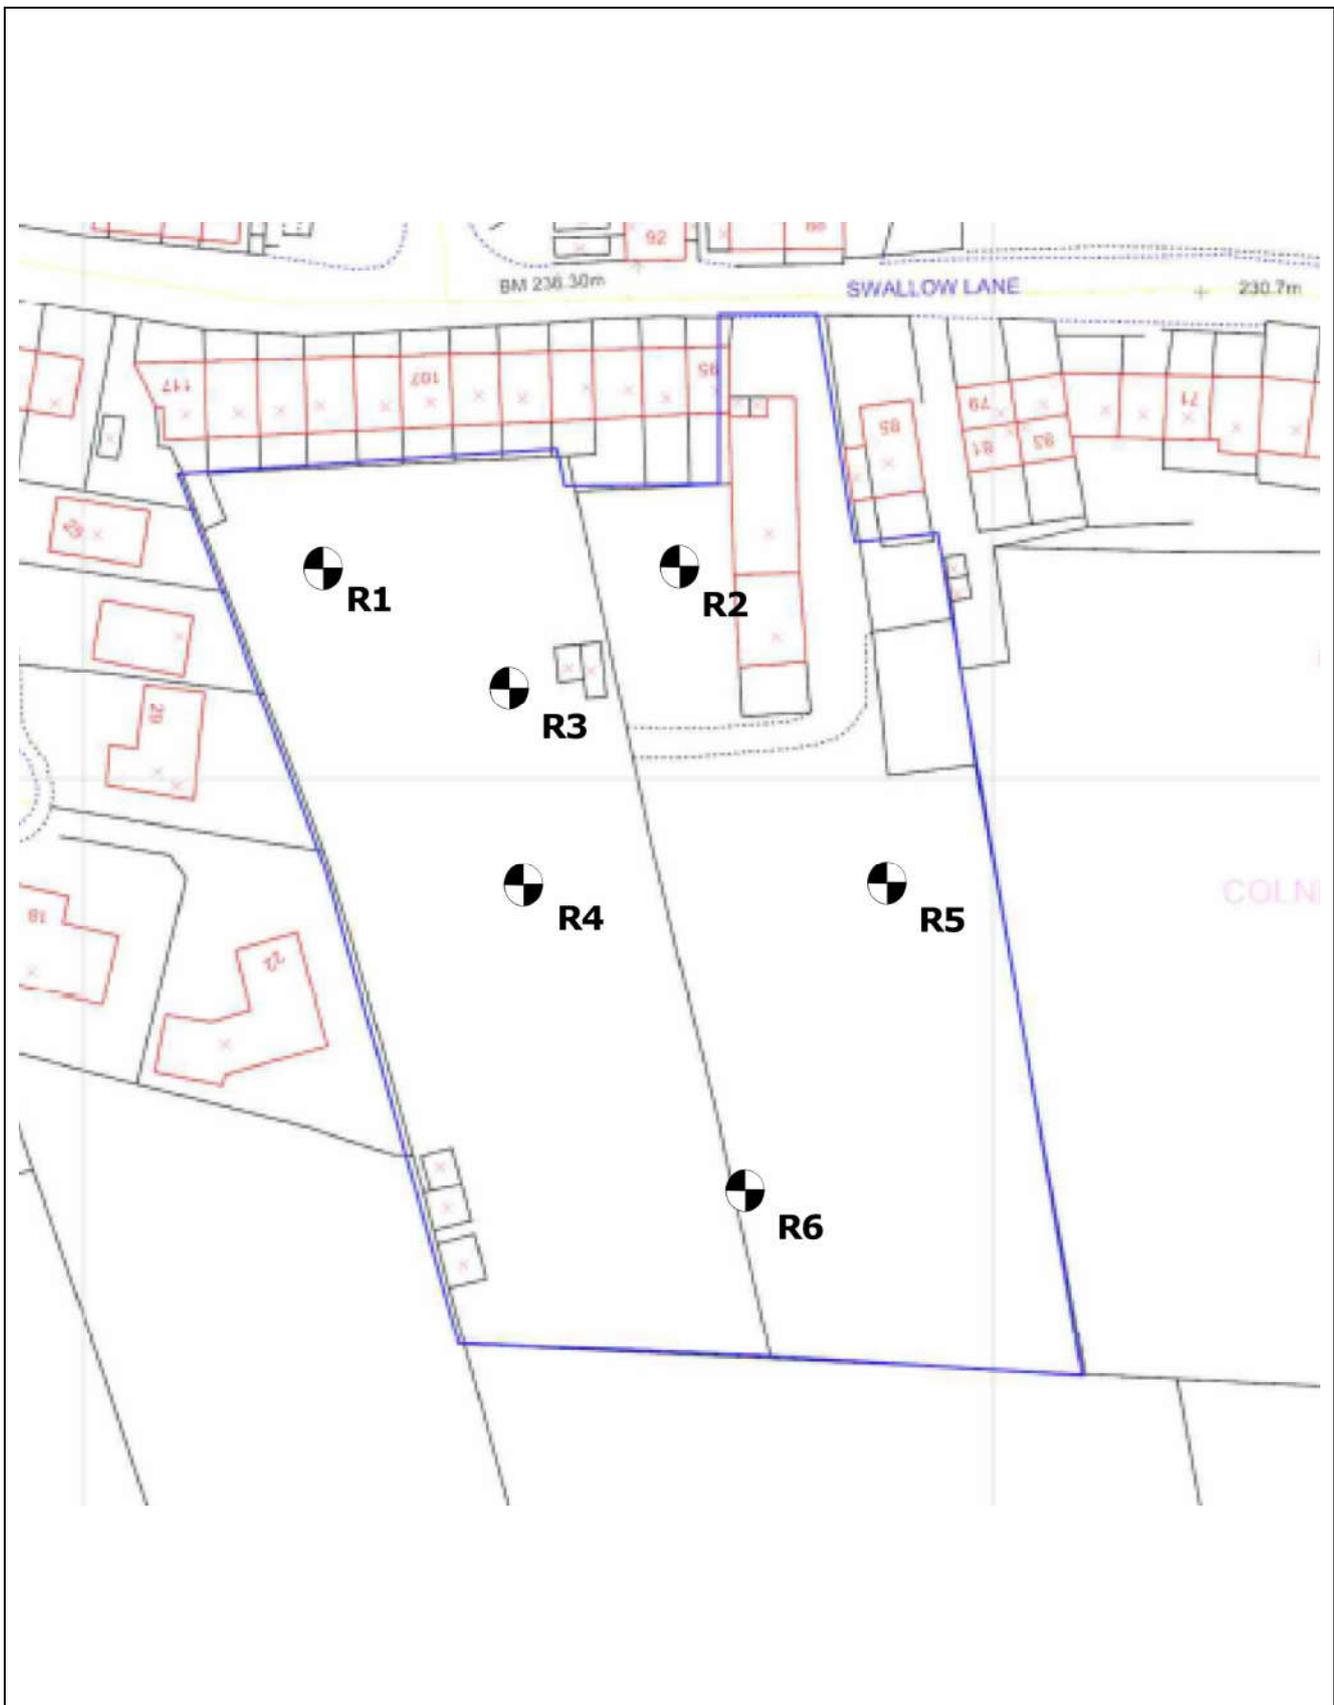
Figure: 3

Swallow Lane, Golcar – Phase 2
 Site Plan with Exploratory Rotary Borehole Positions

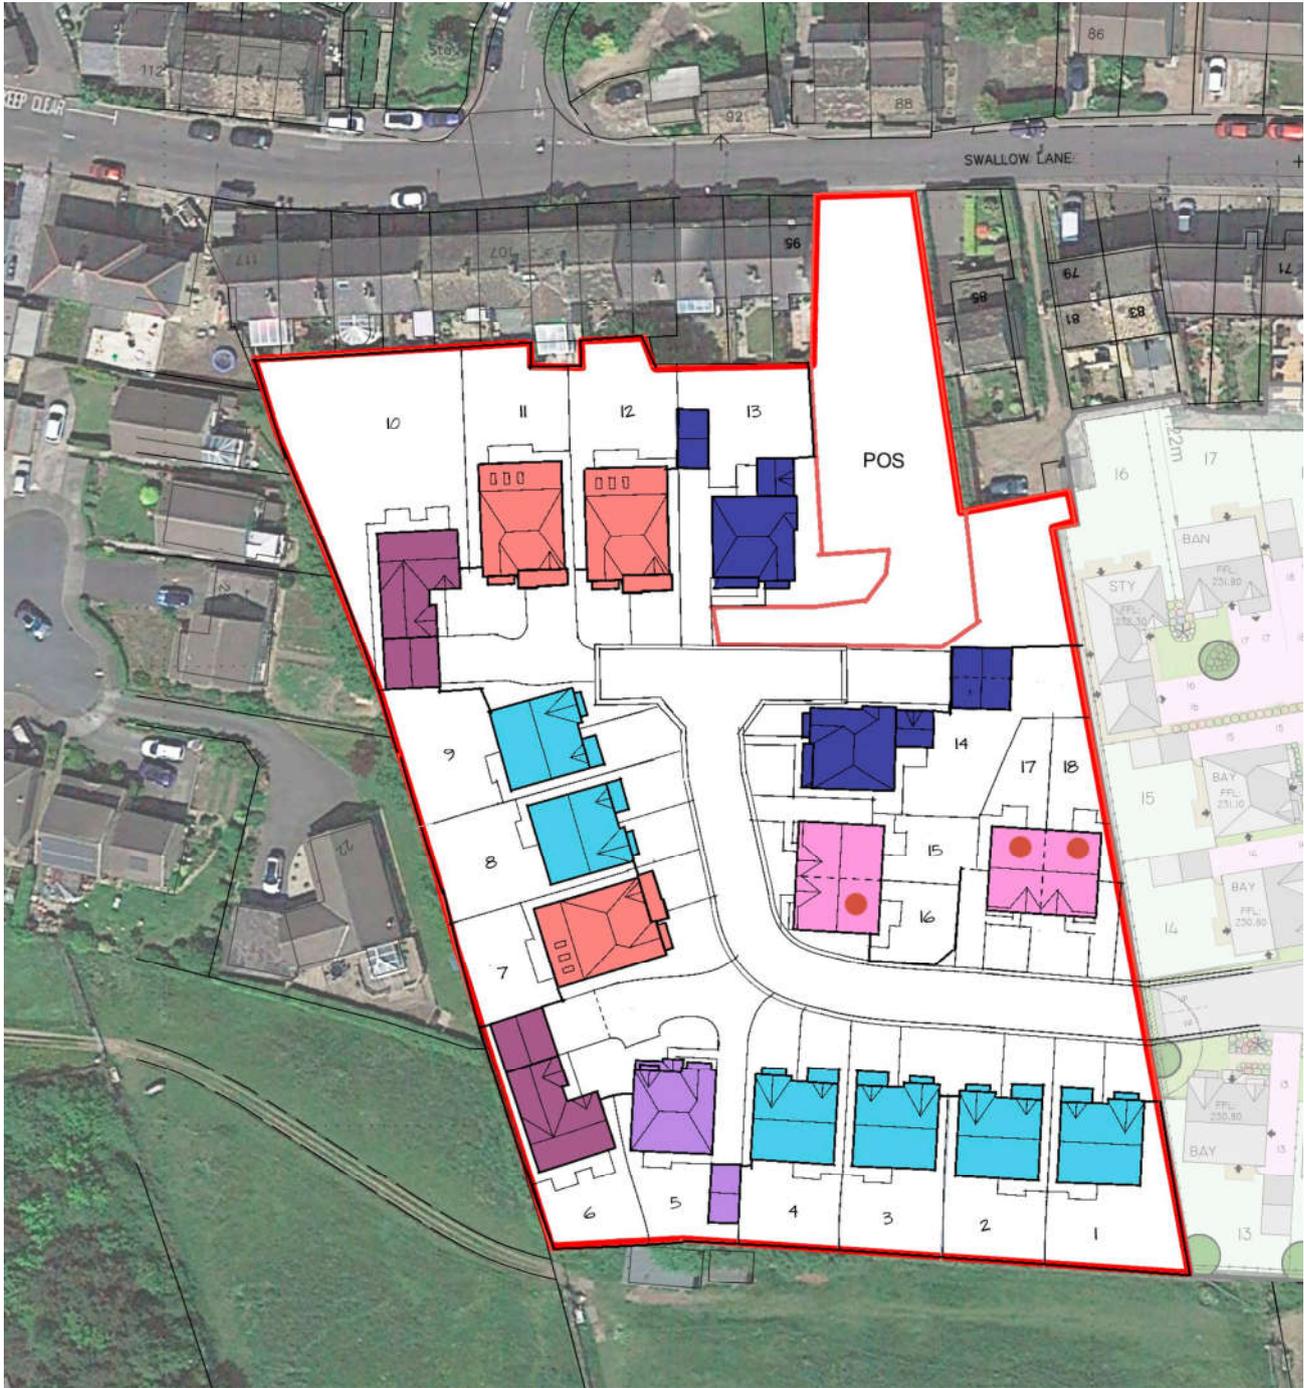
Figure: 4

Swallow Lane, Golcar – Phase 2
Development Proposals

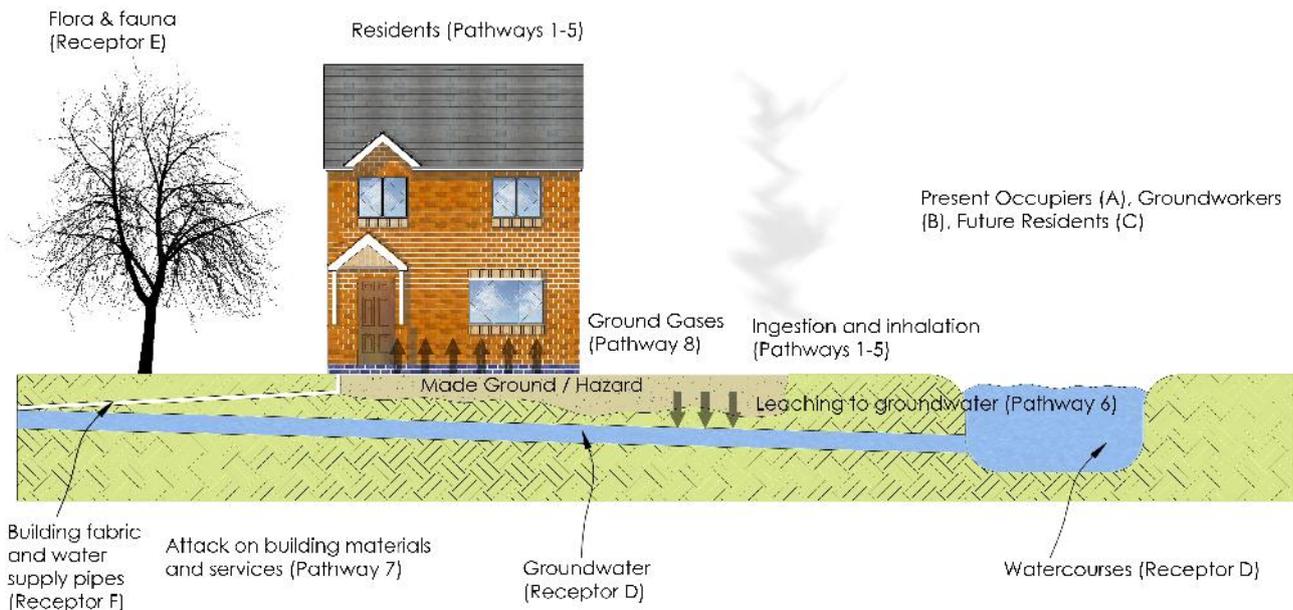
Pathways

1. Ingestion of contaminated soil/dust
2. Ingestion of contaminated food
3. Ingestion of contaminated water
4. Inhalation of contaminated vapours
5. Dermal contact with contaminated soil/dust or water
6. Pollution of controlled water and off site migration
7. Attack on building materials and services
8. Migration of landfill gases and radon

- 12.7 For any contaminant source identified, judgement is used regarding the probability of a pollution linkage occurring and the potential consequences of that linkage. Based on the probability and likely consequences, the overall risk (significance) can be established. The definitions that have been used for this purpose are given in Standard Appendix B. The probability of a hazard, combined with its consequences, can be used to assess risk. This forms the so-called Conceptual Site Model.
