**ARBORICULTURAL IMPACT ASSESSMENT  
to BS 5837:2012  
at  
Swallow Lane (Phase 2)  
Golcar  
Huddersfield  
West Yorkshire  
HD7 4NB**

Jones Homes  
(Yorkshire) Limited

15543/AJB

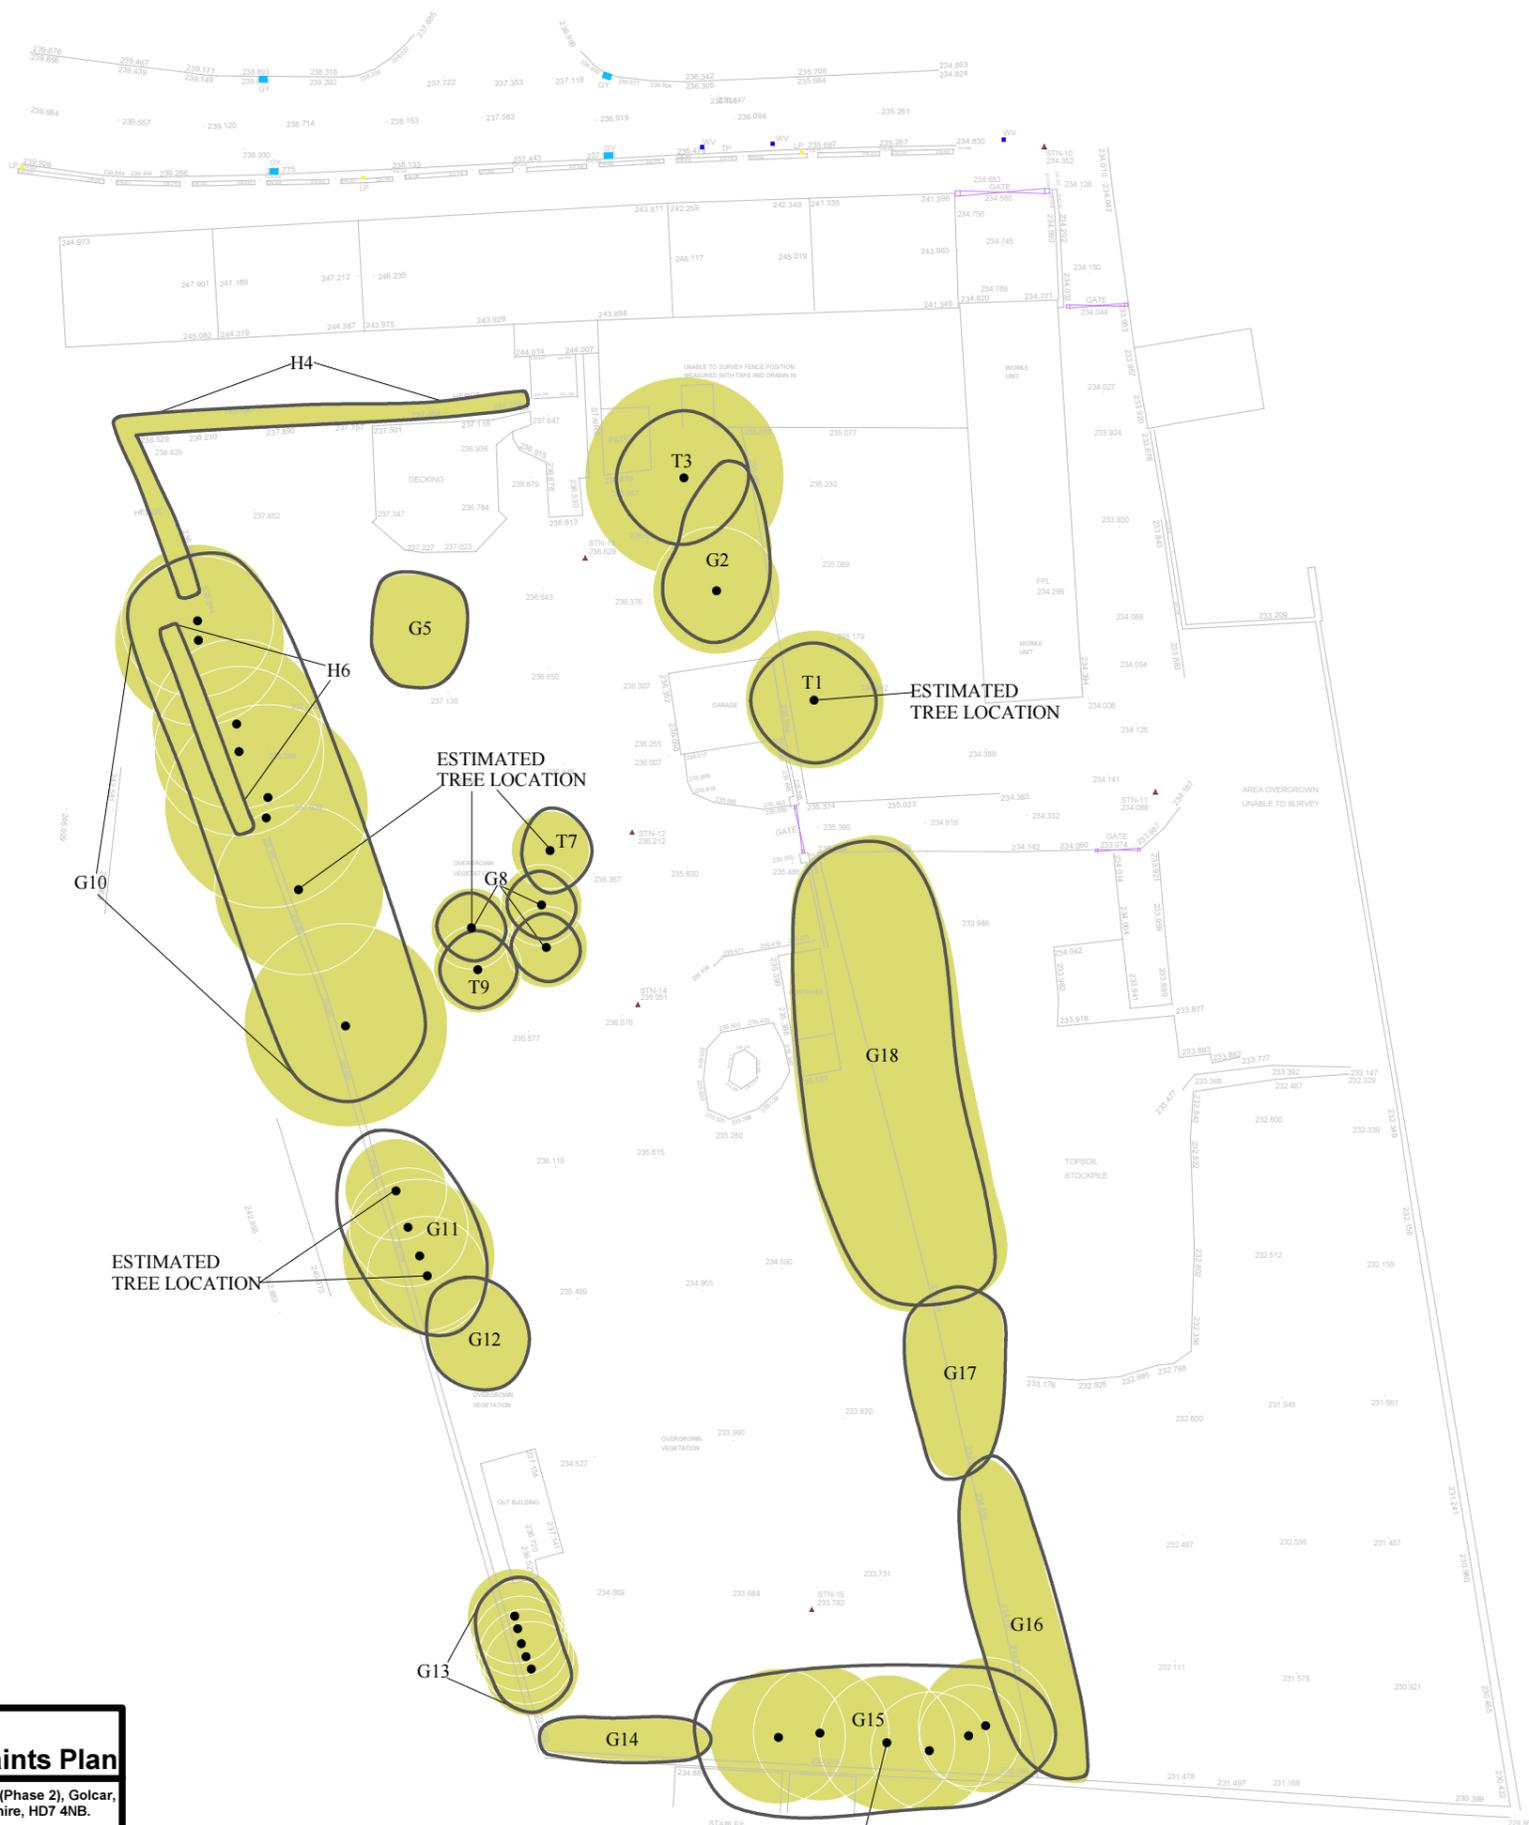
**Appendix 6:  
Tree Constraints Plan**

THE ROOT PROTECTION AREA (RPA) INDICATES THE LIKELY  
ROOTING ZONE OF A TREE.

THIS AREA SHOULD IDEALLY REMAIN UNDISTURBED IF THE  
TREE IS TO BE RETAINED.

THE DEVELOPMENT PROPOSALS SHOULD THEREFORE BE  
DESIGNED TO AVOID THE RPA OF ANY TREE WHICH IS TO  
BE RETAINED.

IF IT IS NECESSARY FOR THE DEVELOPMENT TO ENCROACH  
INTO THE RPA OF A TREE WHICH IS TO BE RETAINED THEN  
SPECIALIST CONSTRUCTION TECHNIQUES AND MATERIALS  
MUST BE CONSIDERED.

- 2.1 Full details of all individual trees surveyed are recorded in the tables at **Appendix 1**. A full explanation of the tables can be found at **Appendix 2**. Please refer also to the Tree Constraints Plan at **Appendix 6** for tree locations.

- 4.6 The protection of retained trees can be achieved by the creation of a Construction Exclusion Zone based on the Root Protection Area of a tree. The Root Protection Area of each tree or group is marked on the Tree Constraints Plan at **Appendix 6**.
