**PHASE 2  
SWALLOW LANE  
GOLCAR, HUDDERSFIELD**

**Jones Homes (Yorkshire) Limited**

Report Number 3974

November 2019

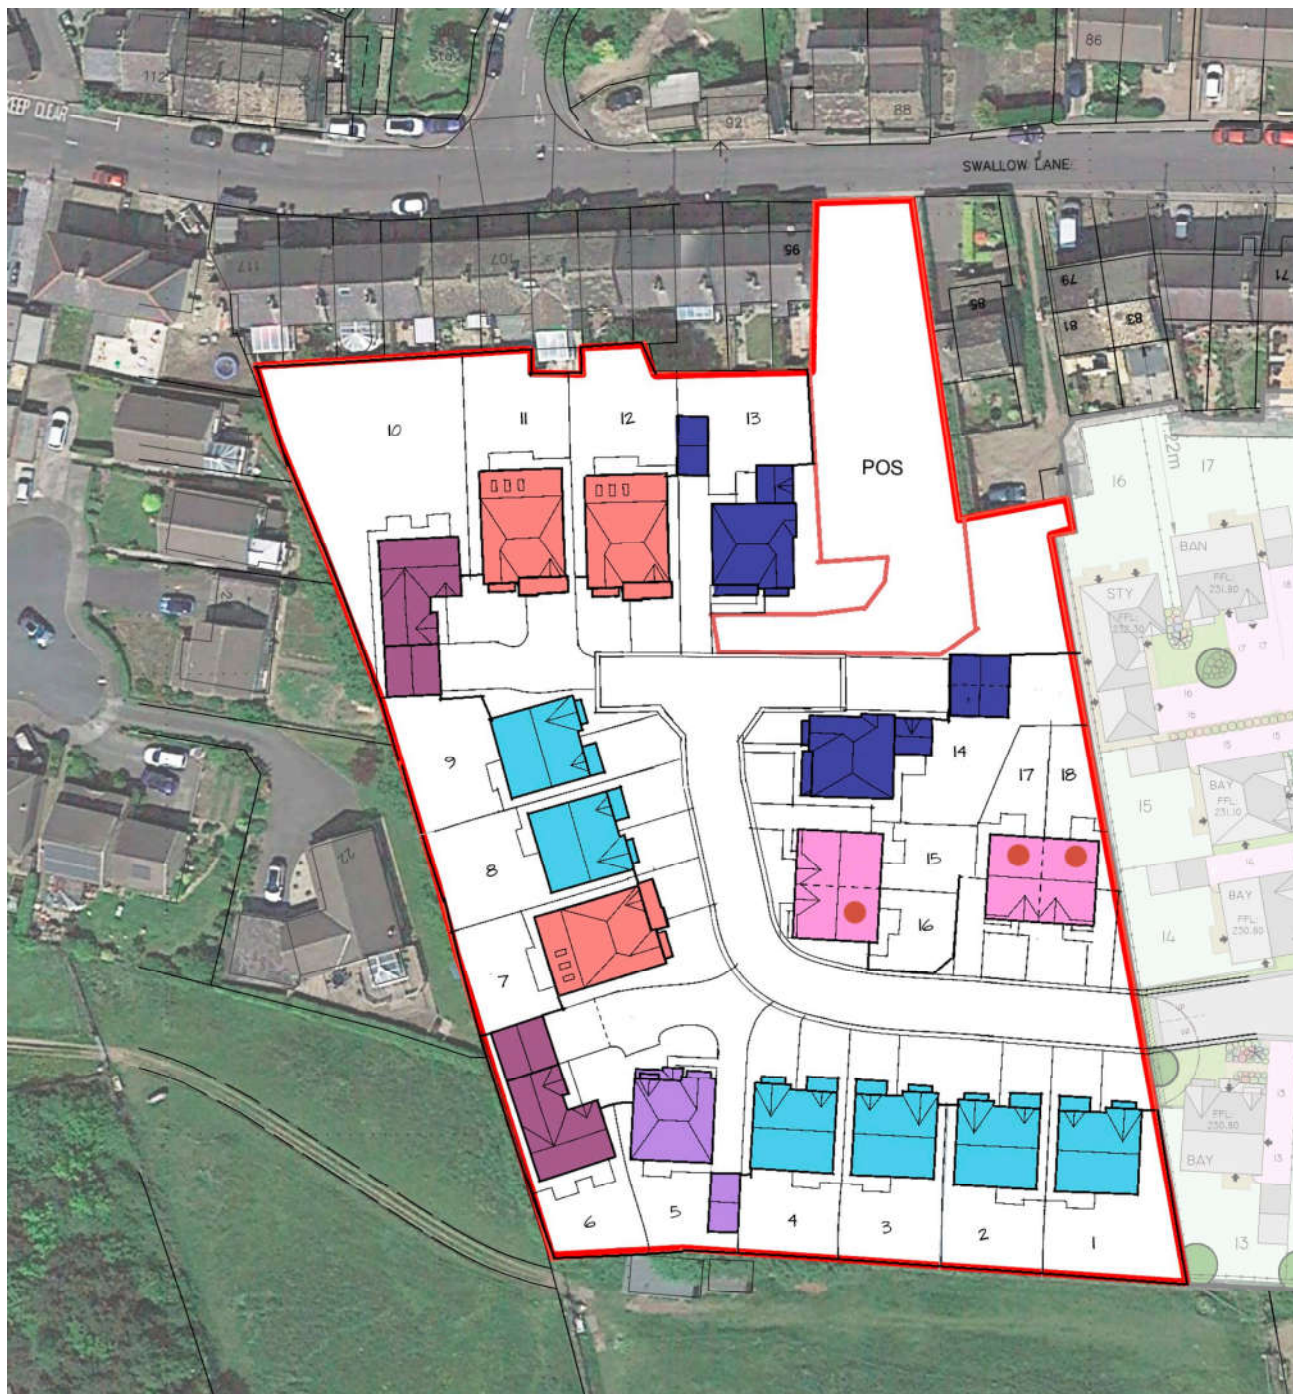
Figure: 4

**Swallow Lane, Golcar – Phase 2**  
Development Proposals
