# GEO-ENVIRONMENTAL AUDIT

## PHASE 4 Validation

**Proposed Residential Development  
Former Car Park/Land at  
Commercial Street  
Slaithwaite  
HD7 5JX**

Author: Daniel Slattery  
Client: Garside Developments  
Reference: rep-tjba-garside-commercial st-Phs4ENV  
validation-010324.docx

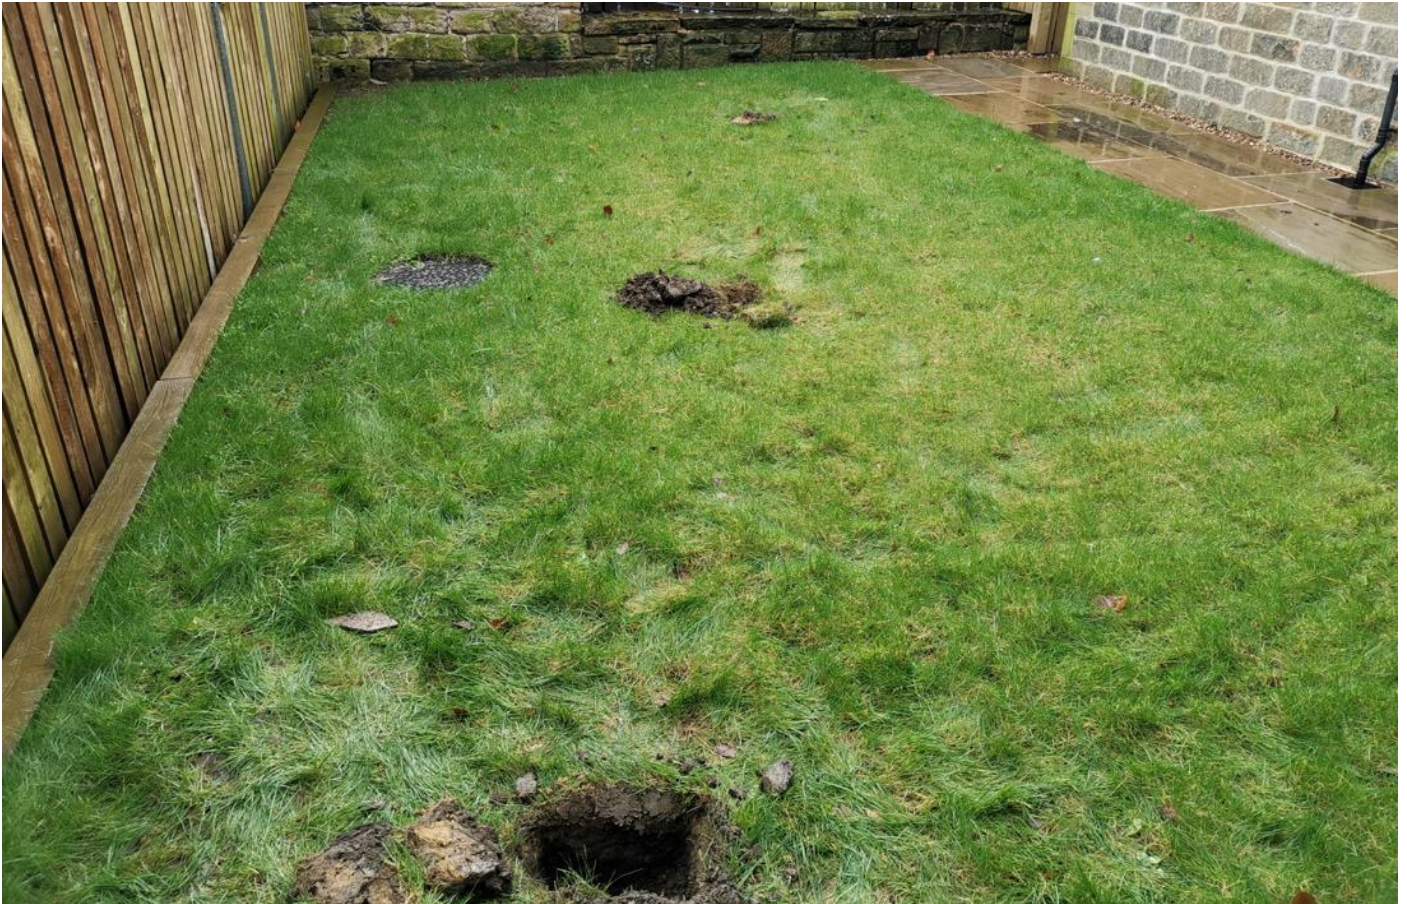
The rear garden area as noted above was approximately 30sqm and comprised a grass/turf finish.

Rear garden including Sampling locations.

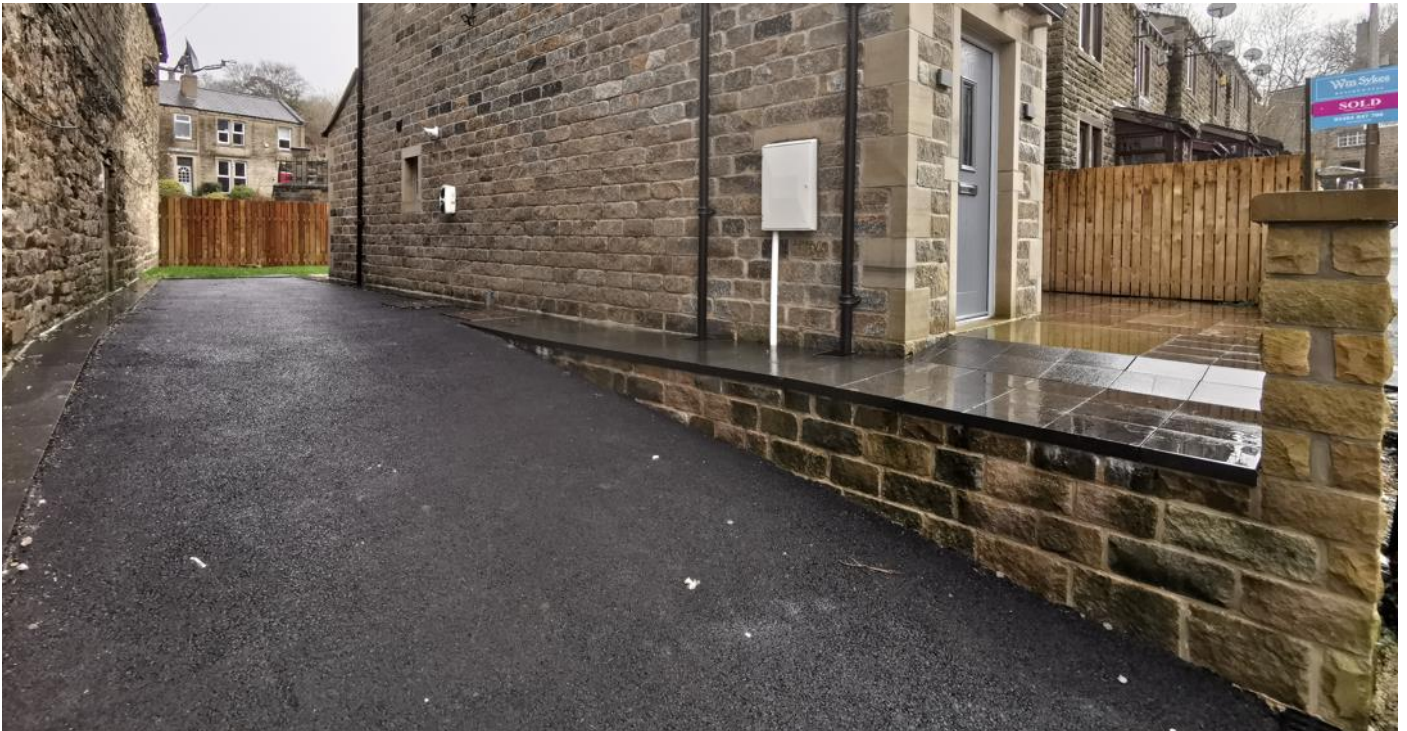
The remainder of the property comprised macadam driveway, and York stone pavements to the path surrounding the building.

Driveway and flagstone surround.

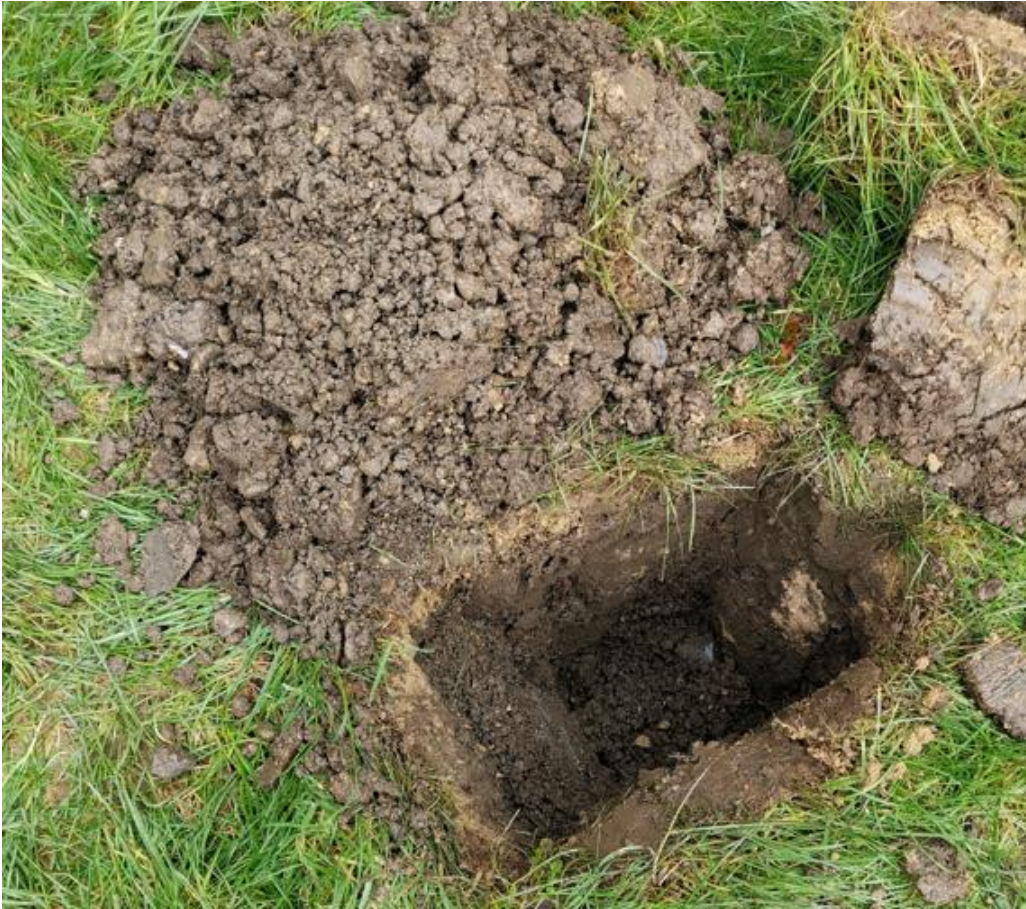
TP1/VS1.

TPs1-3/VS1-3      0-600mm      Br sandy gravelly CLAY/SILT TOPSOIL. Gravel is sandstone, rare slate & brick.

| Trial Hole/Soil Sample | Imported Soil | Mitigation/Action |
|---|---|---|
| TP1/VS1 | No contaminants noted above residential threshold levels | PASS |

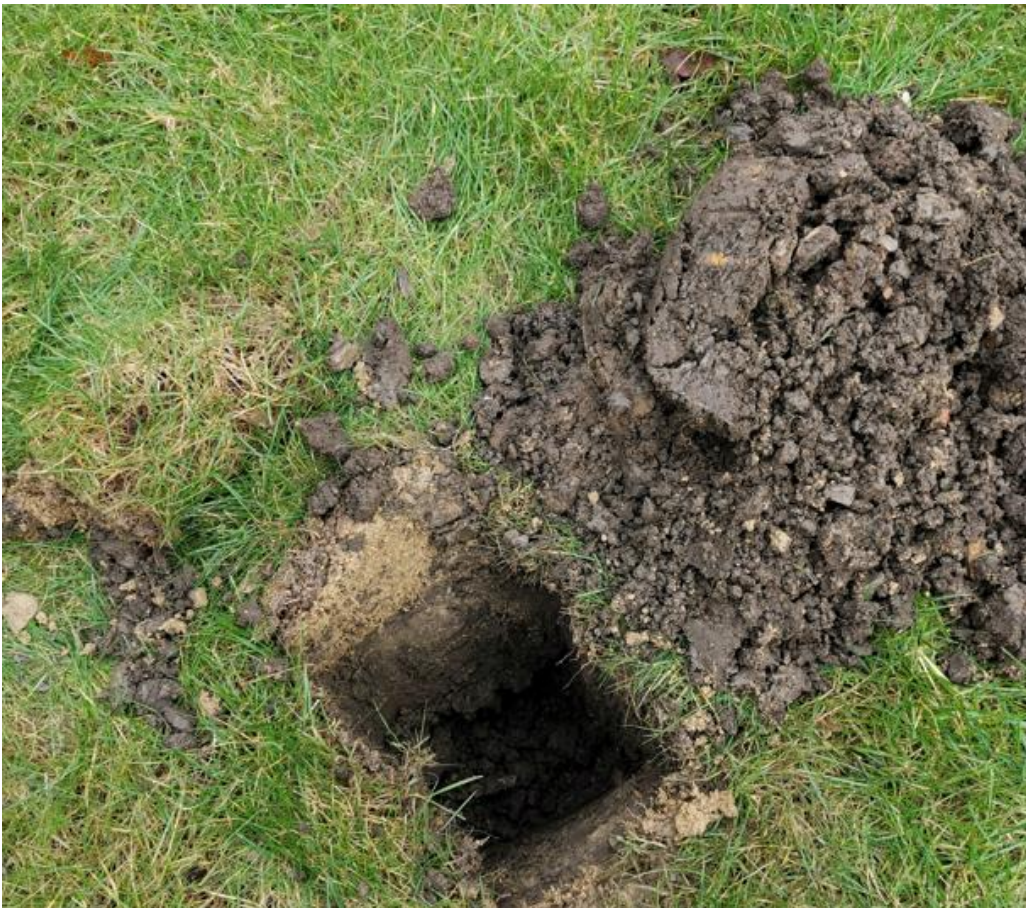
TP2/VS2.

| Trial Hole/Soil Sample | Imported Soil | Mitigation/Action |
|---|---|---|
| TP2/VS2 | No contaminants noted above residential threshold levels | PASS |

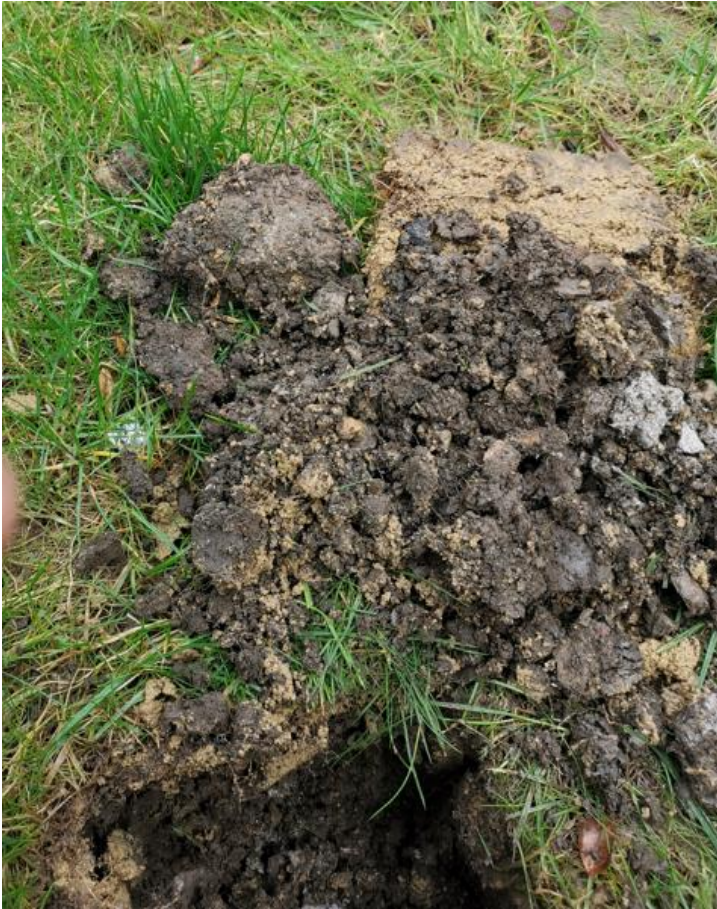
TP3/VS3.

| Trial Hole/Soil Sample | Imported Soil | Mitigation/Action |
|---|---|---|
| TP3/VS3 | No contaminants noted above residential threshold levels | PASS |

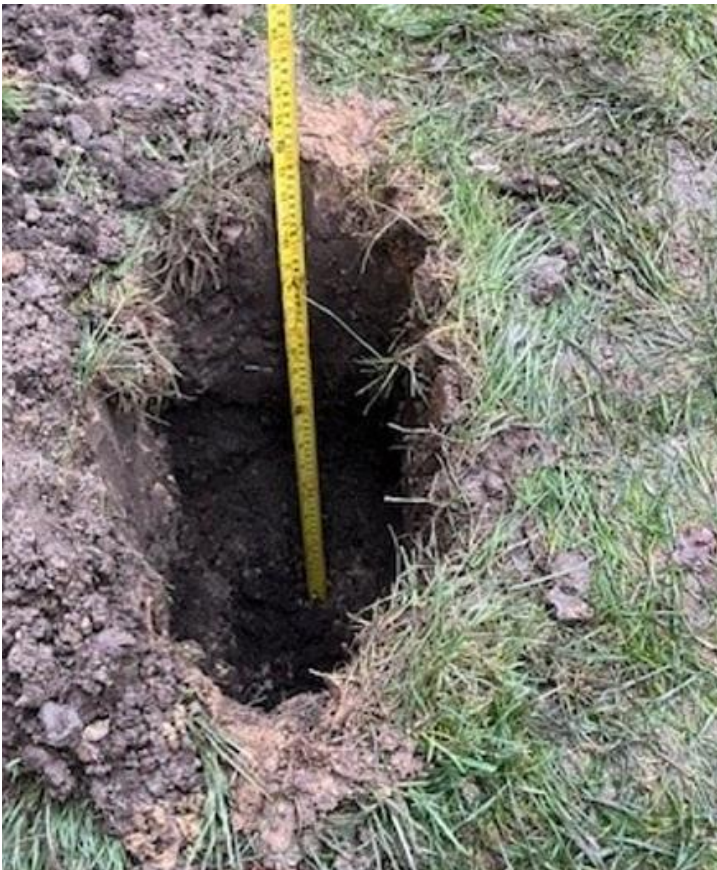
Imported soil was noted to 600mm depth and comprised uniform fill across each of the holes as follows:

Depth check to 2ft (600mm).
