Bat Scoping Survey to

Unit 9G
Carlinghow Mills
Bradford Road
Batley
WF17 8LL

3rd September 2024

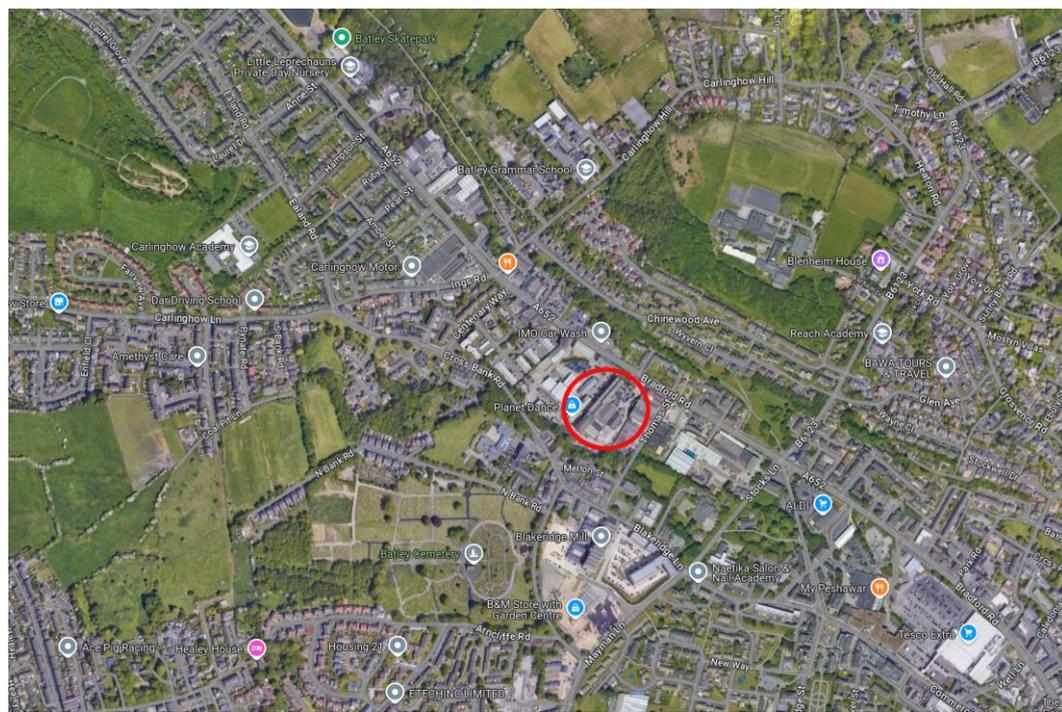
Figure 2 Aerial view of the site, surrounds and specific buildings surveyed.

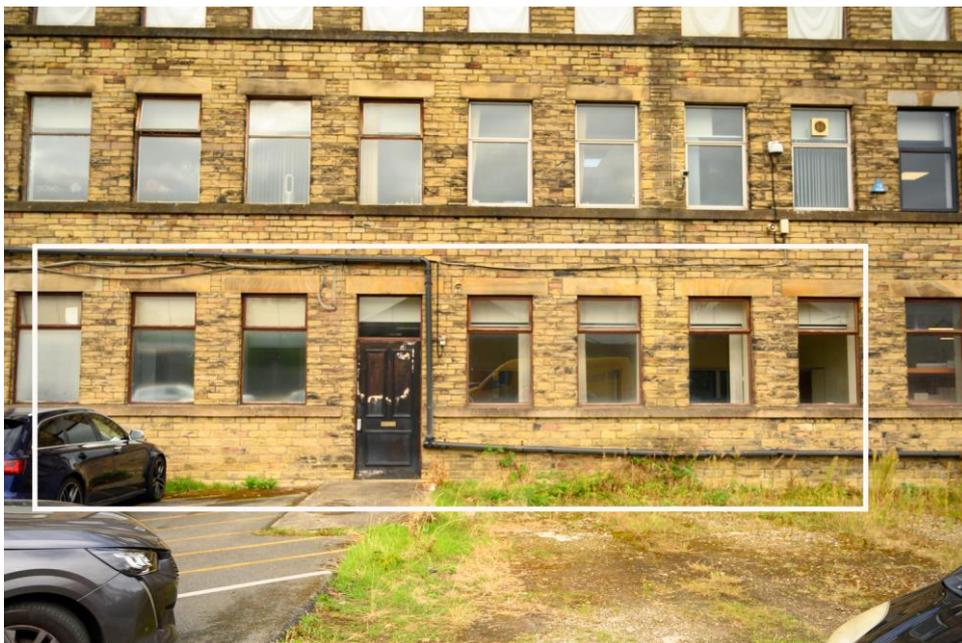
Photo1: Area of localised internal development

As the works are internal and limited to a small section of the ground floor, there will not be any impact on bats and the building, in terms of this project, has negligible bat roosting potential.
