PHASE I DESK STUDY  
&  
PHASE II GROUND INVESTIGATION

FORMER ROSE N CROWN PUBLIC HOUSE  
KNOWL ROAD, GOLCAR

SOVEREIGN DEVELOPMENT GROUP LTD

REPORT REF: SDG 3534

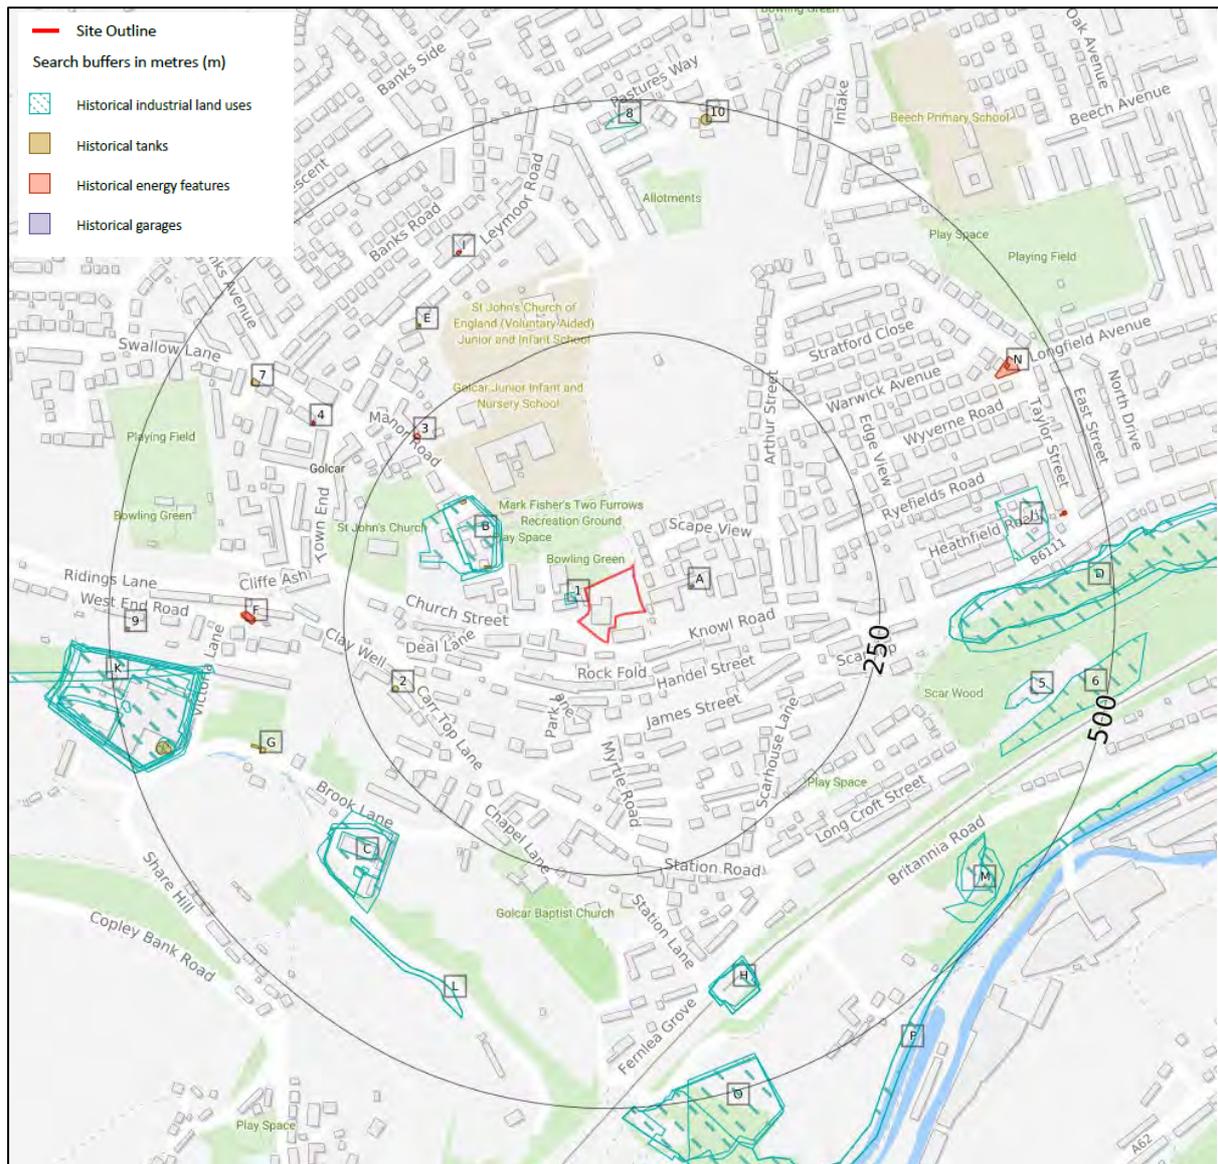
**Figure 3 Historic Industrial Land Use Plan**

Eight historical tanks existed on site circa 1893 at the earliest and 1999 more recently. All tanks are noted as unspecified with the closest and next four 55m to the east and 56m east. The remaining three are 104m to the west, 157m to the north west of site and 205m west of site, all unspecified tanks.

The historic land uses within 100m are unlikely to have detrimentally affected the soils on the site.

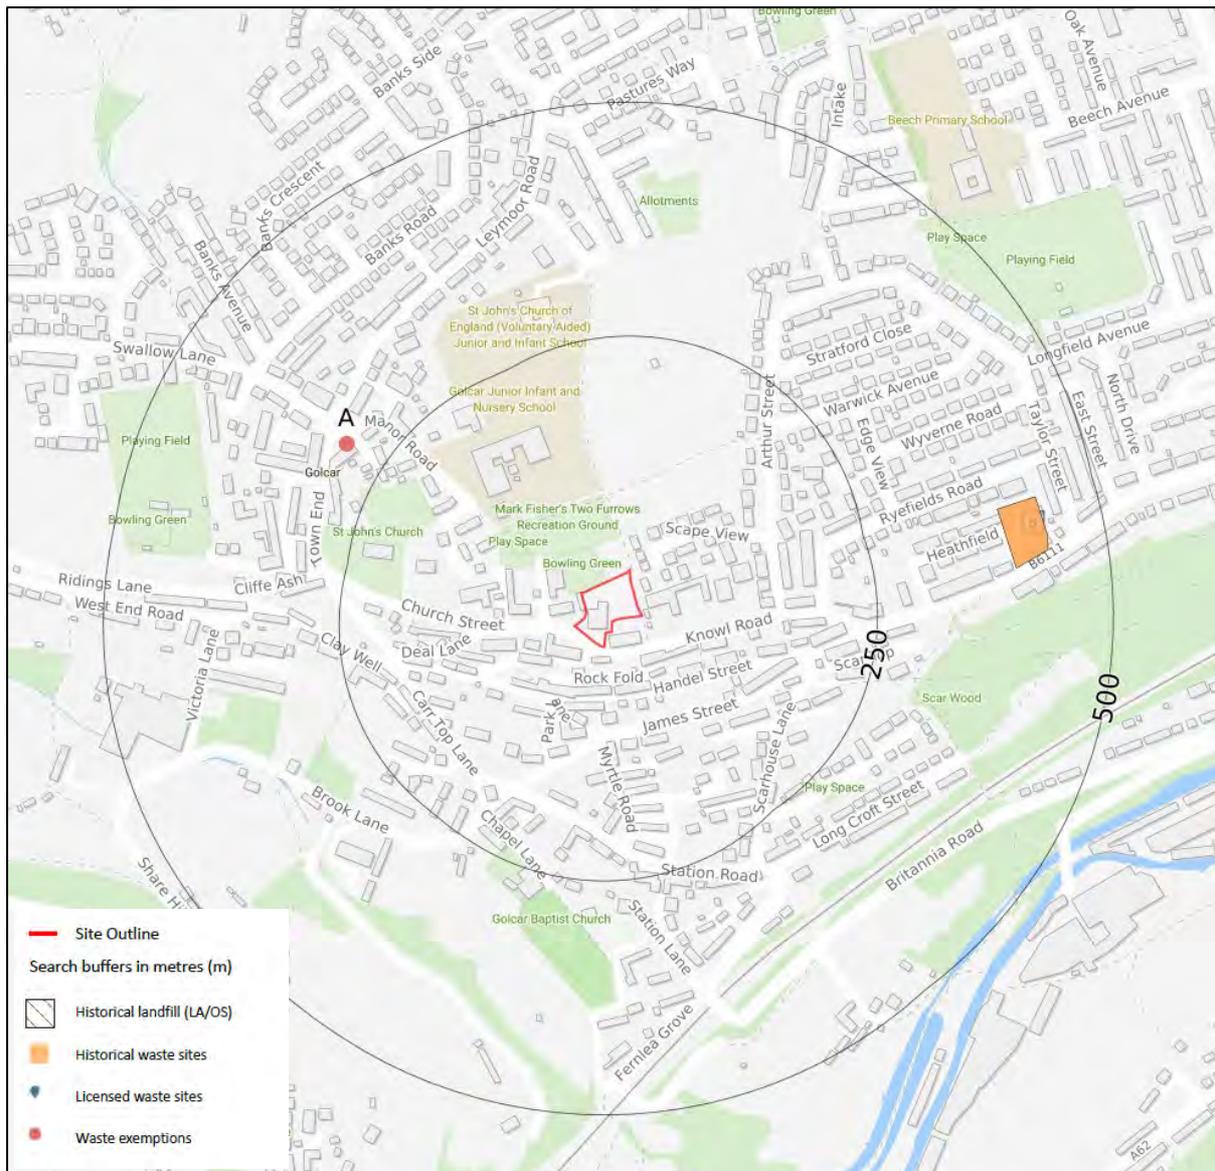
**Figure 4 Waste and Landfill Sites**

There are no active or recent landfill sites within 500m of the site. There existed no historical LA and EA/NRW landfills within 500m of the site area.

There were no historical waste sites within 390m of the site, the closest located 393m to the east noted as waste works. There are no licenced waste sites located within 500m of the site.

There are no waste exemption licences within 250m of the site area. The closest is located 296m to the north west categorised as treating waste exemption, sorting and de-naturing of controlled drugs for disposal.

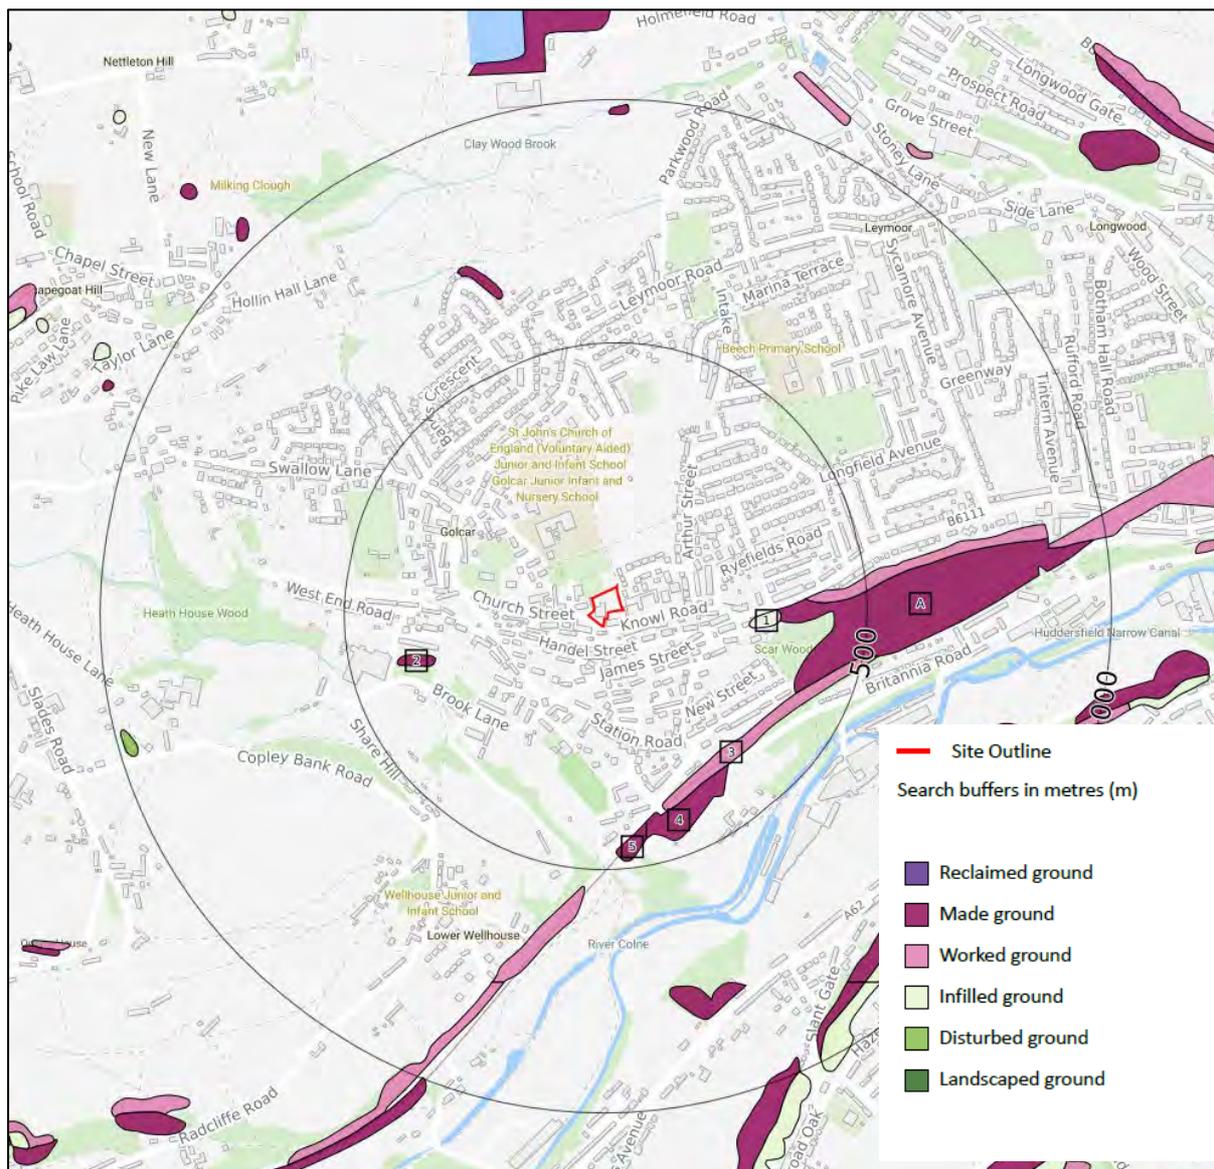
**Figure 5 Artificial and Made Ground**

Infilled ground, made ground, reworked or reclaimed ground is not recorded within 250m of the site. Artificial or made ground is not shown to be within the site area although made ground may be present.

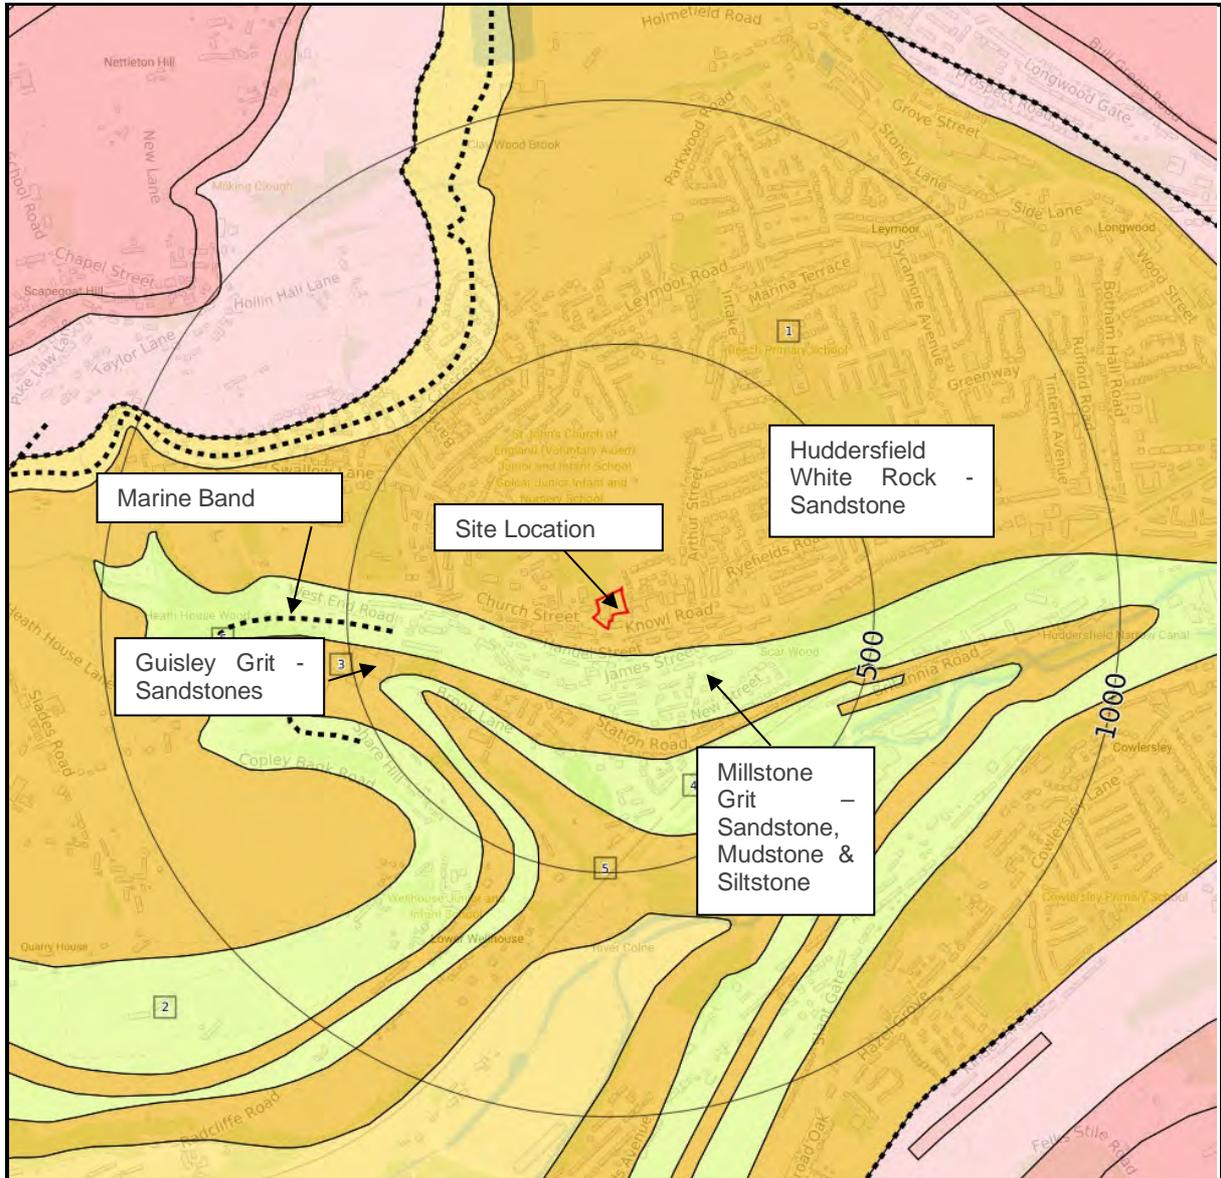
**Figure 7 Geological Faults and Bedrock Geology Plan**

The BGS map does not indicate the presence of any geological faults within 1000m of the site area. It is possible that smaller faults sub parallel to these may exist in the strata causing fissuring and fracturing to the rock. Due to the cessation of tectonic activity in the area, faulting is unlikely to detrimentally affect the site stability.

Made ground may be present on the site. The strata of the Millstone Grit provides good bearing strata where unweathered and unfaulted for carrying the bearing pressures imposed by low rise development without undue settlement.

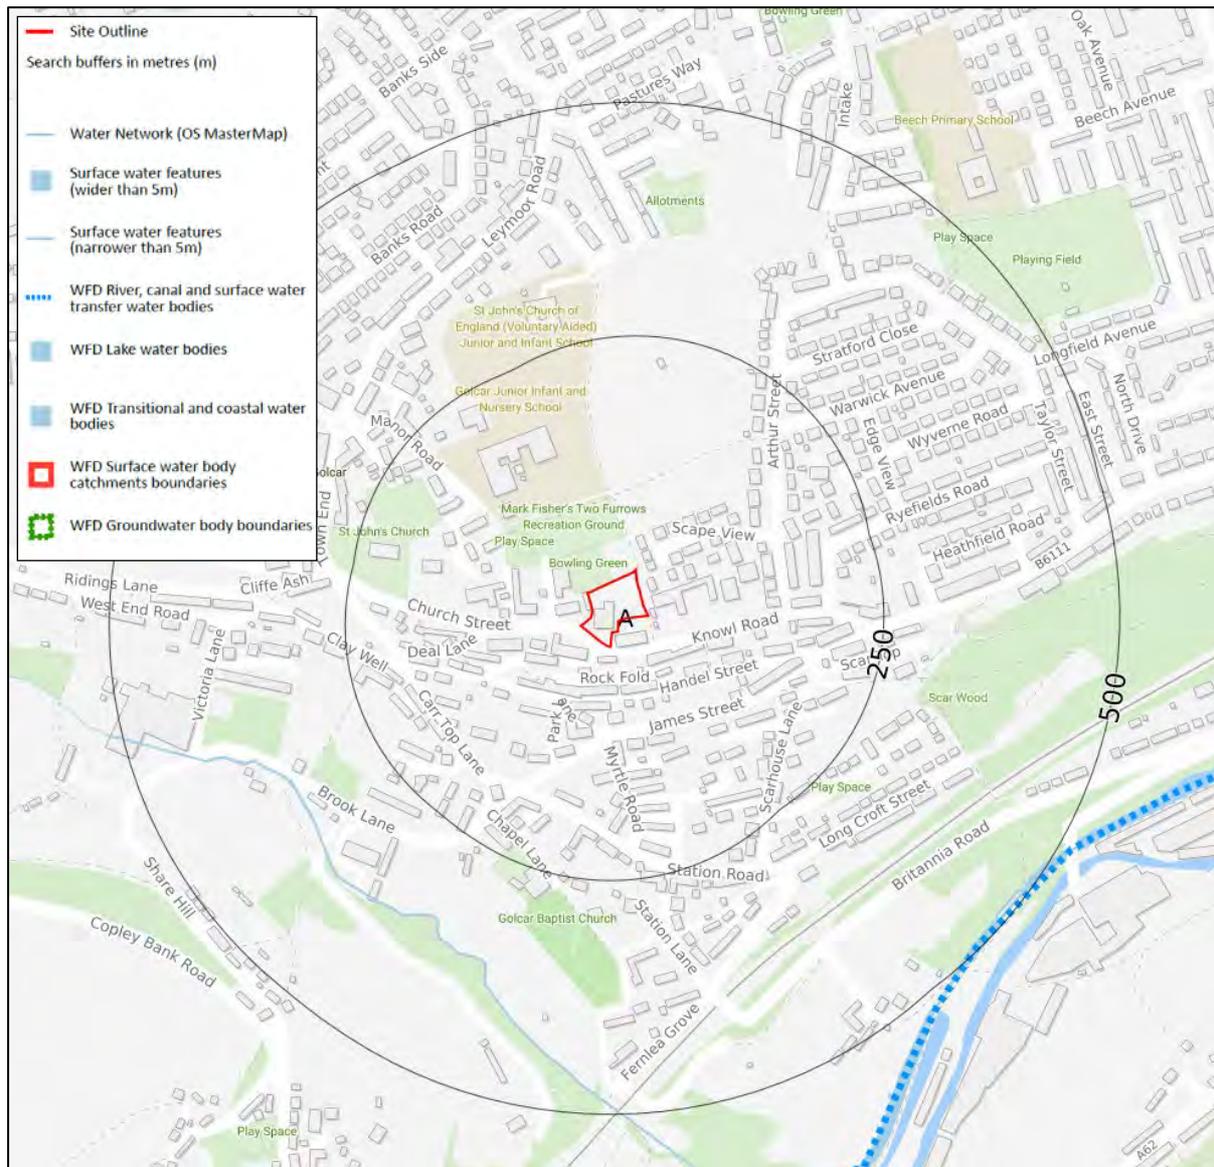
**Figure 8 Hydrology Plan**

There are no recorded surface water abstractions within 500m of the site. The closest is located 654m to the south east of site, currently active, it is used as process water taken from the River Colne. There are a further 27 surface water abstractions from 660 to 2000m distant from site.

It is important that any contamination found on site is not allowed to detrimentally affect any watercourses or ponds. It is unlikely, due to distance, that the site could be detrimentally affecting water courses.

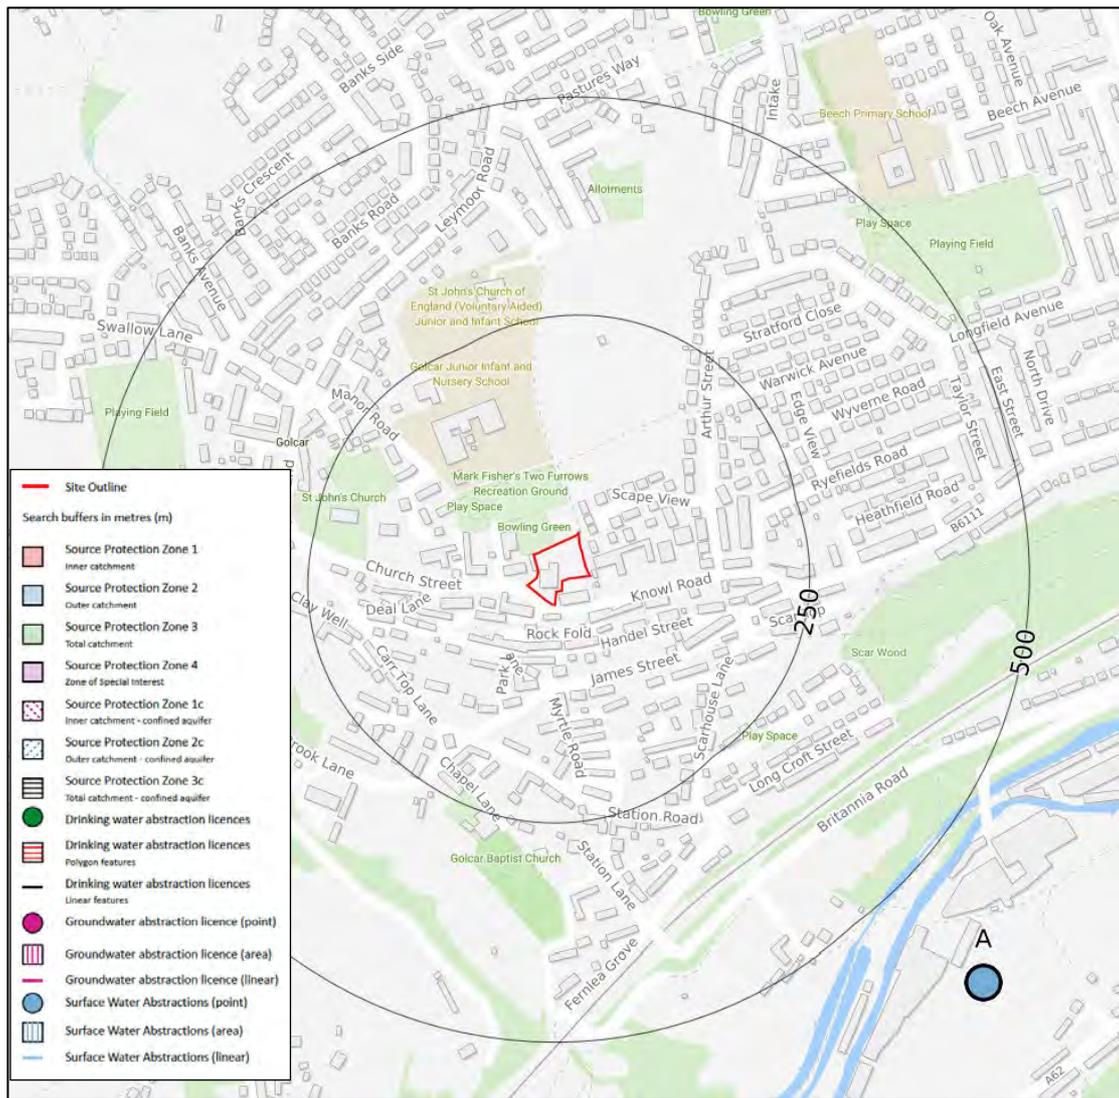
**Figure 10 Source Protection Zones and Abstractions**

The site is shown to not lie within a Source Protection Zone Outer catchment or an Inner Catchment.

Other unrecorded or unlicensed wells may be present close to the site. Historic wells may exist within 500m of the site. As the local groundwater may be utilised for abstraction from old unlicensed wells, it is important that it is protected from pollution. It is an offence to pollute the groundwater, whether or not it is used for abstraction.

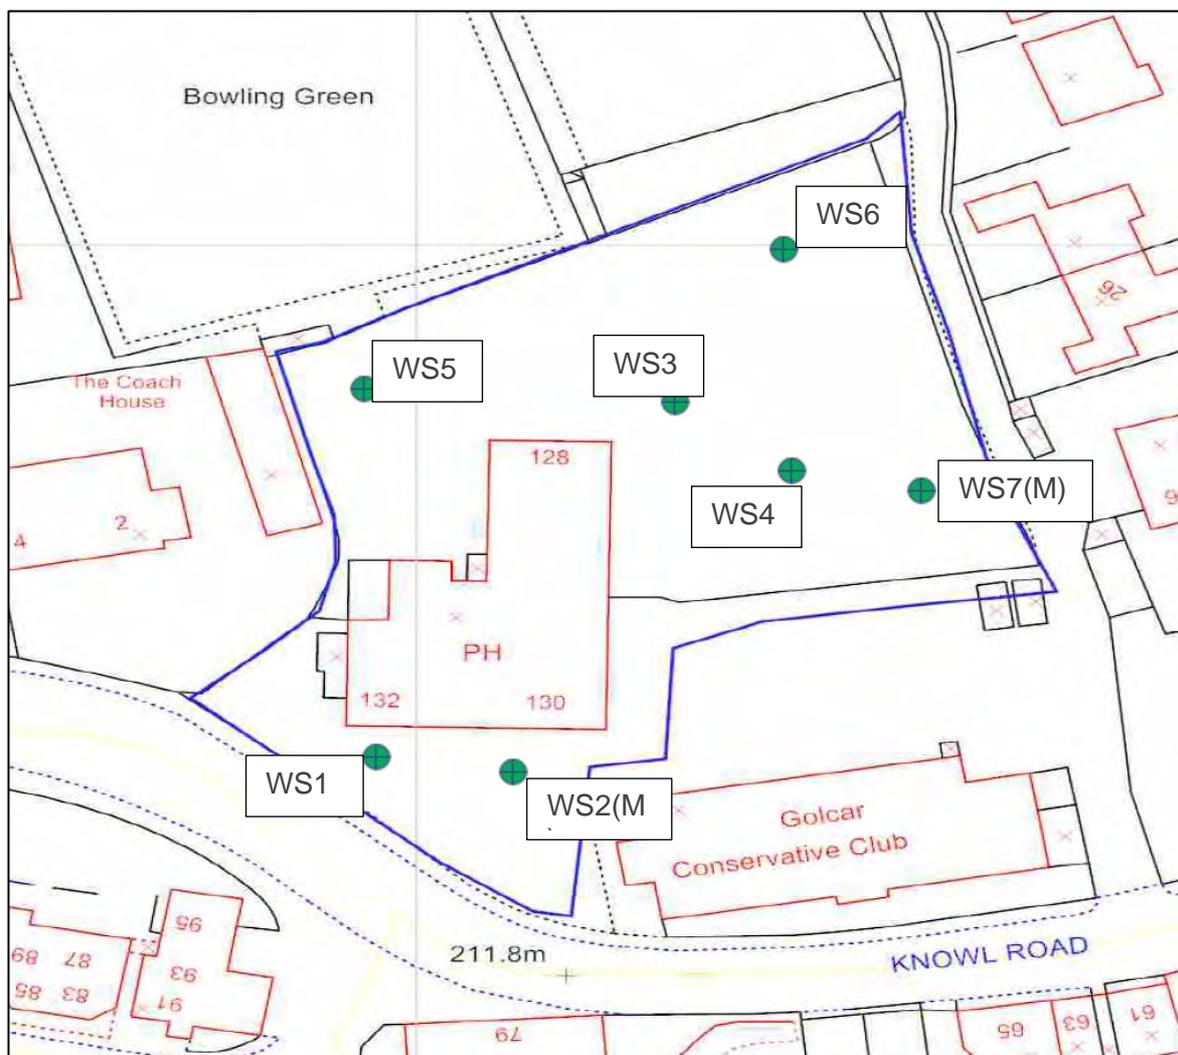
**Figure 11 Window Sampler Borehole Location Plan**

A ground investigation was undertaken by Ashton Bennett on the site, Reference SDG 3534 on January 25<sup>th</sup> 2024 and comprised the drilling of seven percussion boreholes numbered WS1 to WS7 by means of a windowless sampler rig. The boreholes were extended to depths of refusal at the bedrock to assess ground conditions and to collect soil samples for environmental and geotechnical testing. The soil samples were sent to NAMAS and UKAS accredited laboratories for testing for environmental nature and geotechnical properties.

Two boreholes, WS2 and WS7 were fitted with standpipes following drilling to enable measurements of groundwater levels. A borehole location plan is presented as Figure 11.

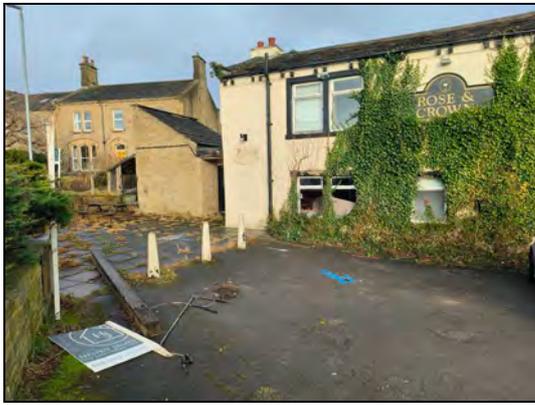
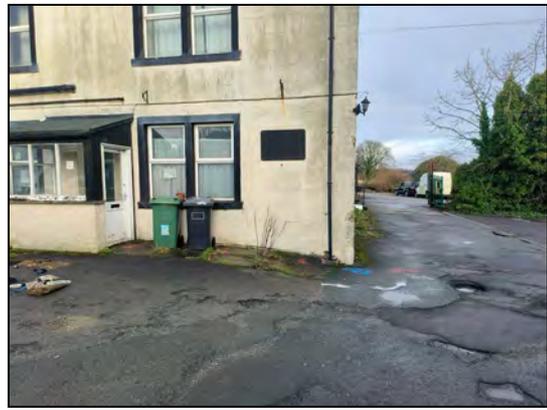
View of Rose n Crown from Knowl Rd & locations of WS1(L) and WS2(R)

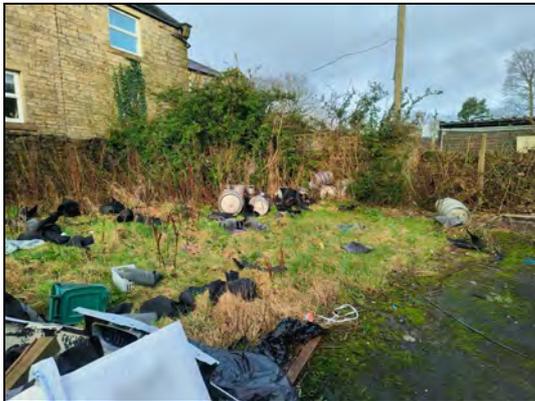
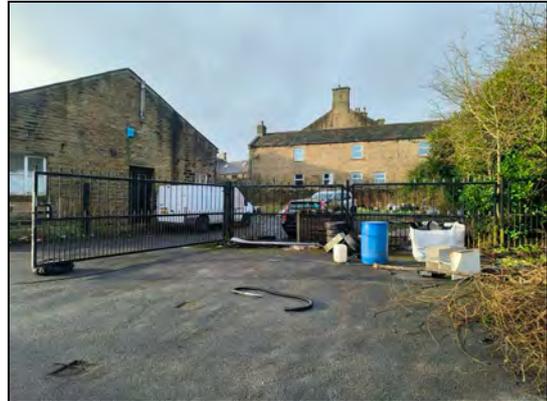
View of north west corner of site & location of WS5 in grass

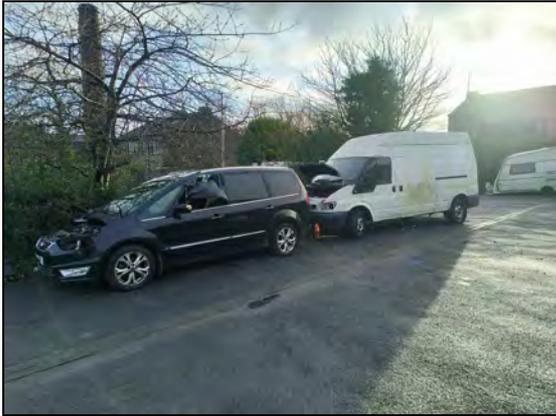
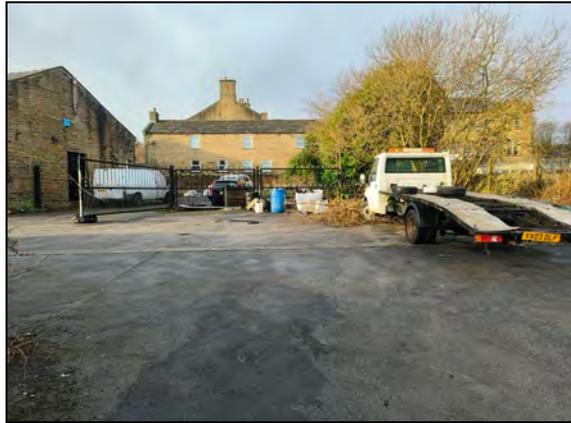
View of centre of site & location of WS3

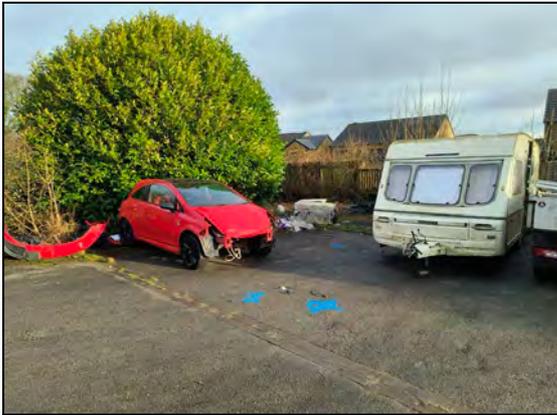
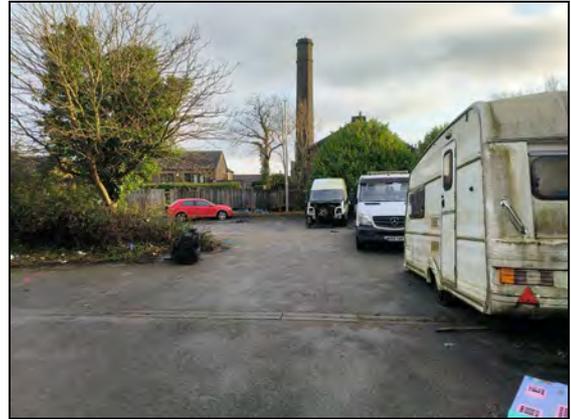
View of north east corner and eastern corner of site & locations of WS6(L) and WS7(R)

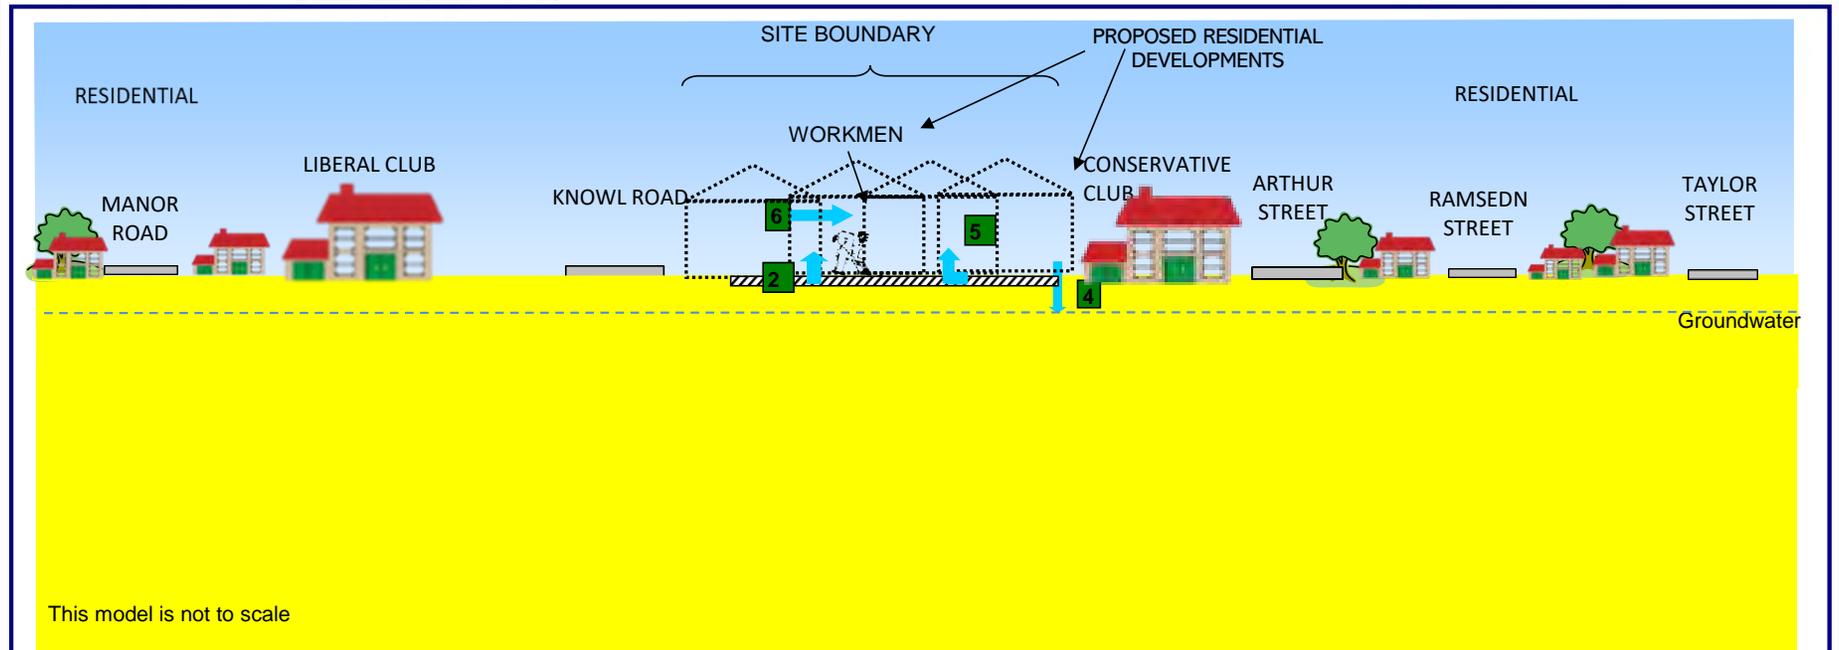
SOURCES	PATHWAYS	RECEPTORS	RISK	GEOLOGY
HISTORICAL USE AS PUBLIC HOUSE BUILDINGS NEIGHBOURING ACTIVITIES LOCAL CLUBS BOWLING GREENS SCHOOL POLICE STATION	1 Inhalation of vapours	Workmen/future occupants	Low. No landfill or mining.
