External Opening Condition Schedule: Kirkby Grange Hall, Flockton, Wakefield, WF4 4AQ

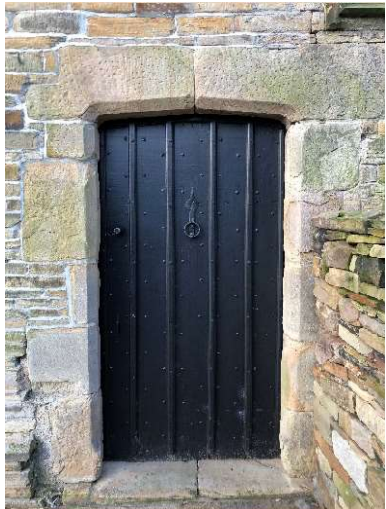
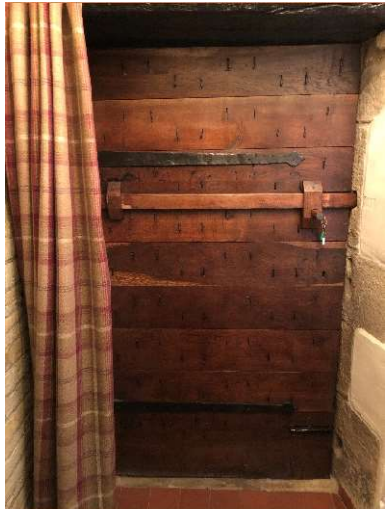
| Item | Location and Window Type | Condition | Repair/ Replace recommendation | Image |
|---|---|---|---|---|
| GF.01 | Entrance Lobby<br><br>Painted timber external door | Not original but depicts a historic style.<br><br>Unit has deteriorated around each edge thus compromising performance (thermal efficiency, security etc)<br><br>Some loss of mortar to stonework around opening.<br><br>Stone surround in good condition. | Remove existing unit completely and replace.<br><br>Inspect surrounding masonry to opening and repair as necessary<br><br>Assume sympathetic intervention with threshold.<br><br>Re-point open joints (where required) with lime mortar. | |

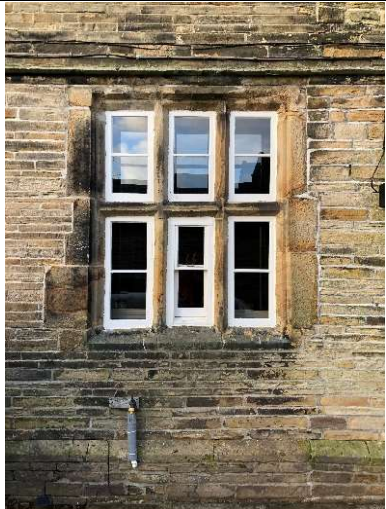
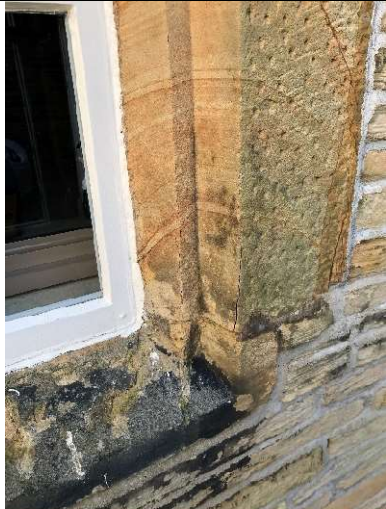
| Item | Location and Window Type | Condition | Repair/ Replace recommendation | Image |
|---|---|---|---|---|
| GF.02 | Kitchen/Dining<br><br>Stone window surround configured to 6no openings each containing a '2 light' single-glazed timber window. Opening unit(s): Bottom row centre | Original design and stonework.<br><br>Numerous points of delamination and deterioration to the stonework.<br><br>Loss of stonework already apparent due to delamination and flaking.<br><br>Window units generally fair but not original. | Carefully remove existing timber window units from within the stone surrounds.<br><br>Carefully defrass the stonework to enable condition assessment.<br><br>Investigate replacement of spilt stonework.<br><br>Carefully replace stonework like for like.<br><br>Re-point open joints (where required) with lime mortar.<br><br>Install new painted timber slimline double glazing window units to match existing layout and configuration. | |

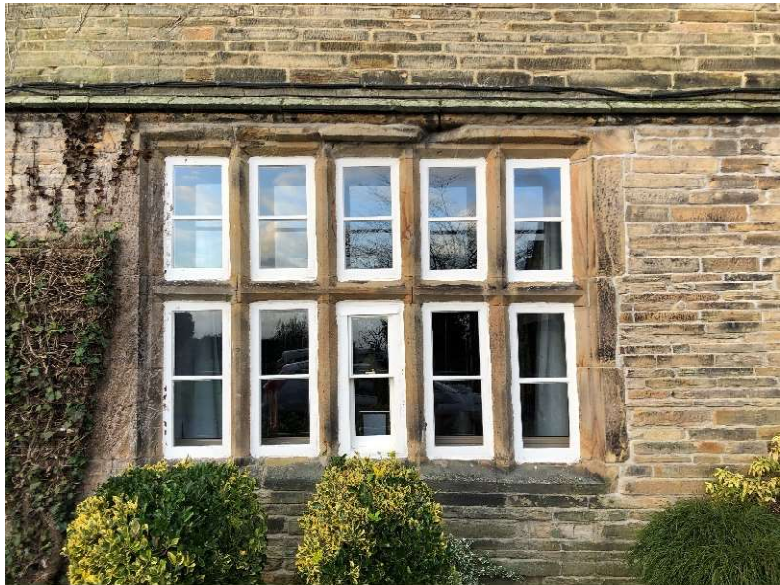
| GF.03 | <p>Sitting Room</p> <p>Stone window surround configured to 10no openings each containing a '2 light' single-glazed timber window. Opening unit(s): Bottom row centre</p> | <p>Original design and stonework.</p> <p>Numerous points of delamination and deterioration to the stonework.</p> <p>Loss of stonework already apparent due to delamination and flaking.</p> <p>Window units generally fair but not original.</p> | <p>Carefully remove existing timber window units from within the stone surrounds.</p> <p>Carefully defrass the stonework to enable condition assessment.</p> <p>Investigate replacement of spilt stonework.</p> <p>Carefully replace stonework like for like.</p> <p>Re-point open joints (where required) with lime mortar.</p> <p>Install new painted timber slimline double glazing window units to match existing layout and configuration.</p> | |

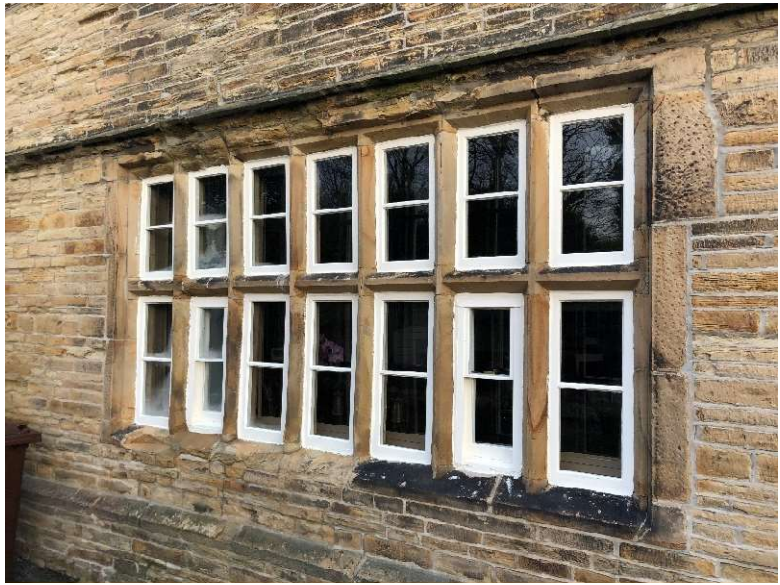
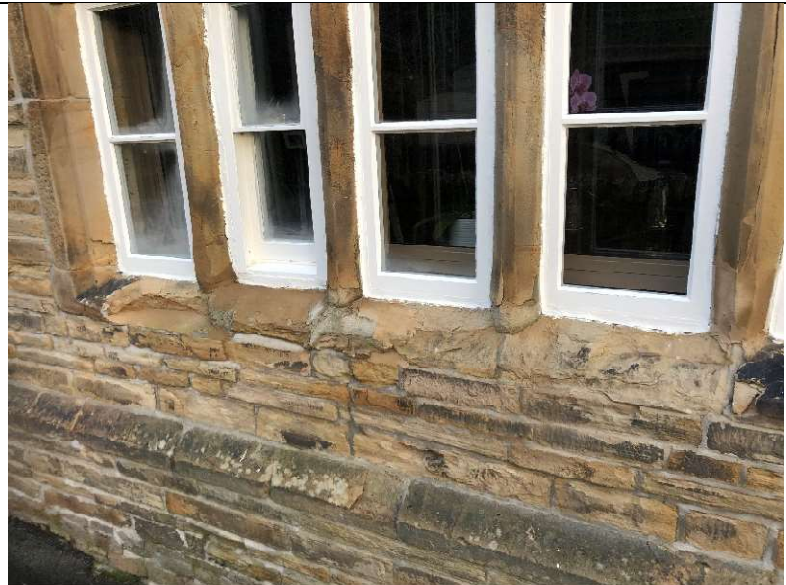
| GF.04 | <p>Sitting Room</p> <p>Stone window surround configured to 14no openings each containing a '2 light' single-glazed timber window. Opening unit(s): Bottom row, second from left &amp; second from right</p> | <p>Original design and stonework.</p> <p>Extensive loss of stonework and points of delamination and deterioration to the stonework, especially to the cill. Numerous open cracks in stonework.</p> <p>Window units generally fair but not original.</p> <p>Modern repairs evident have only served to accelerate decline.</p> | <p>Carefully remove existing timber window units from within the stone surrounds.</p> <p>Carefully defrass the stonework to enable condition assessment.</p> <p>Investigate replacement of spilt stonework.</p> <p>Carefully replace stonework like for like.</p> <p>Re-point open joints (where required) with lime mortar.</p> <p>Install new painted timber slimline double glazing window units to match existing layout and configuration.</p> | |

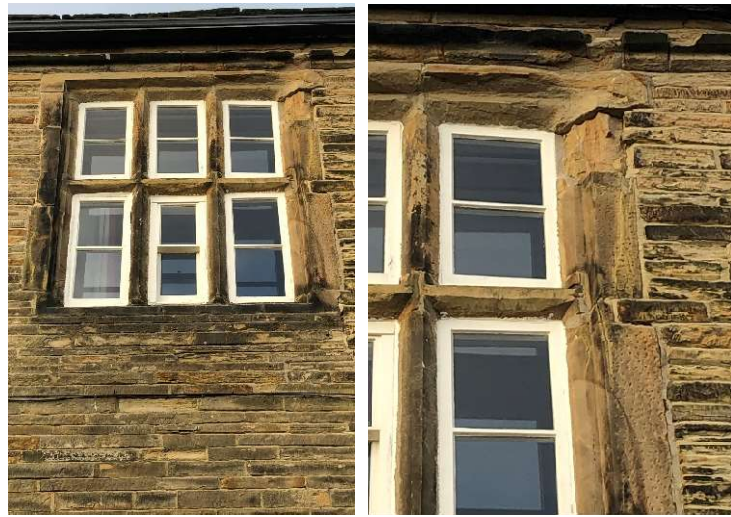
| FF.01 | Bedroom 2<br><br>Stone window surround configured to 6no openings each containing a '2 light' single-glazed timber window. Opening unit(s): Bottom row centre | Original design and stonework.<br><br>Numerous points of delamination and deterioration to the stonework.<br><br>Loss of stonework already apparent due to delamination and flaking.<br><br>Window units generally fair but not original. | Carefully remove existing timber window units from within the stone surrounds.<br><br>Carefully defrass the stonework to enable condition assessment.<br><br>Investigate replacement of spilt stonework.<br><br>Carefully replace stonework like for like.<br><br>Re-point open joints (where required) with lime mortar.<br><br>Install new painted timber slimline double glazing window units to match existing layout and configuration. | |

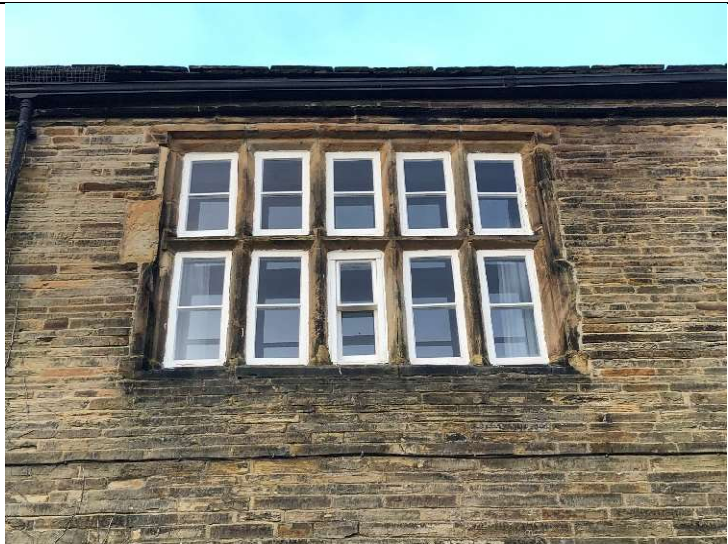
| FF.02 | Bedroom 1<br><br>Stone window surround configured to 10no openings each containing a '2 light' single-glazed timber window. | Original design and stonework.<br><br>Numerous points of delamination and deterioration to the stonework. | Carefully remove existing timber window units from within the stone surrounds.<br><br>Carefully defrass the stonework to enable condition assessment.<br><br>Investigate replacement of spilt stonework. | |

| | Opening unit(s): Bottom row centre | <p>Loss of stonework already apparent due to delamination and flaking.</p> <p>Window units generally fair but not original.</p> | <p>Carefully replace stonework like for like.</p> <p>Re-point open joints (where required) with lime mortar.</p> <p>Install new painted timber slimline double glazing window units to match existing layout and configuration.</p> | |

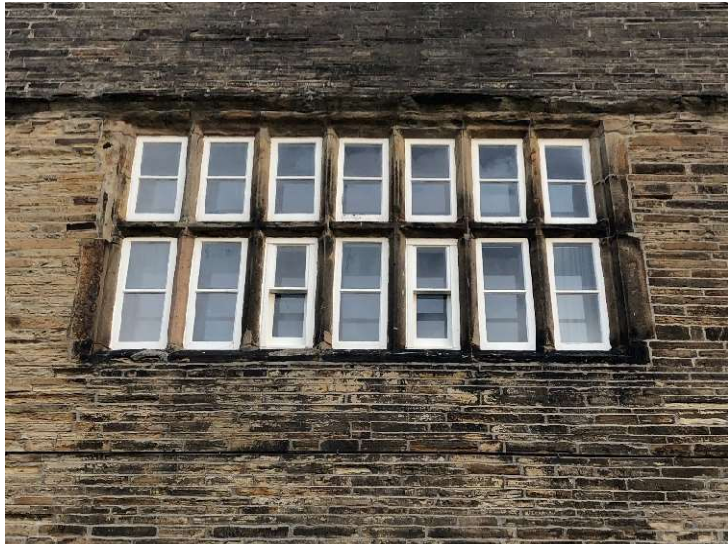
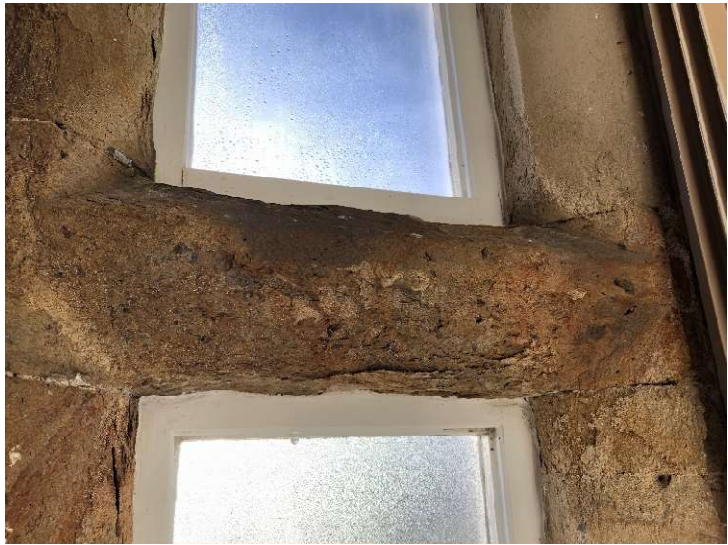
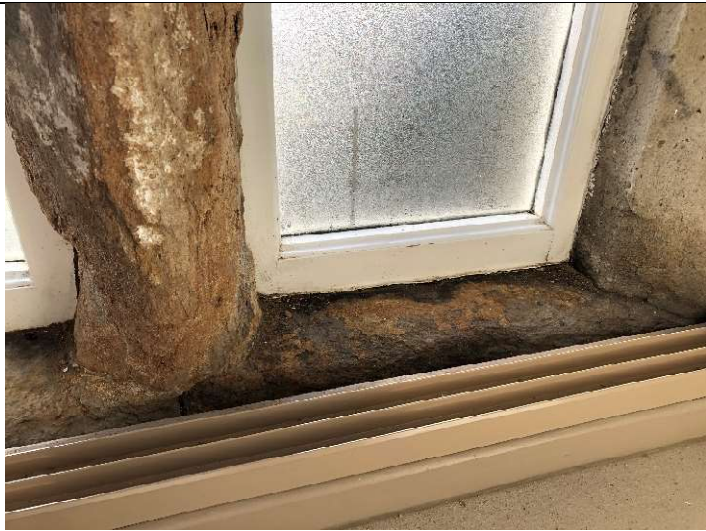
| FF.03 | <p>Bedroom 1</p> <p>Stone window surround configured to 14no openings each containing a '2 light' single-glazed timber window.</p> <p>Opening unit(s): Bottom row, second from left &amp; second from right</p> | <p>Original design and stonework.</p> <p>Extensive loss of stonework and points of delamination and deterioration to the stonework, especially to the cill. Numerous open cracks in stonework.</p> <p>Window units generally fair but not original.</p> <p>Modern repairs evident have only served to accelerate decline.</p> | <p>Carefully remove existing timber window units from within the stone surrounds.</p> <p>Carefully defrass the stonework to enable condition assessment.</p> <p>Investigate replacement of spilt stonework.</p> <p>Carefully replace stonework like for like.</p> <p>Re-point open joints (where required) with lime mortar.</p> <p>Install new painted timber slimline double glazing window units to match existing layout and configuration.</p> | |

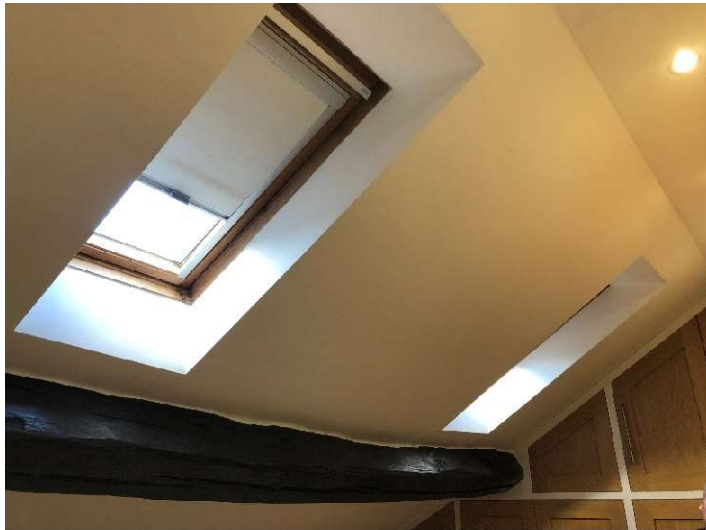
| Skylight<br>FF.01 &<br>FF.02 | Bedroom 3<br><br>2no modern skylights | Existing modern units in good condition.<br><br>No historic significance. | Replace with heritage units as noted in supporting documents. | |

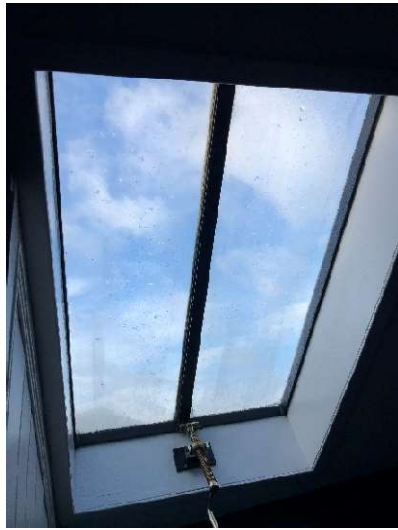
| Skylight<br>SF.01 &<br>SF.02 | Bedroom 4<br><br>2no modern (but obsolete) skylights | Existing modern units in fair condition.<br><br>Some historic significance, but not original. | Replace with heritage units as noted in supporting documents. | |
