Sycamore Grange,
Golcar, HD3 4ST

Preliminary Bat Roost Assessment

January 2024

Report reference	1914a
Revision	2
Prepared by	Morgane Accault ACIEEM
Approved by	Toby Fisher CEnv MCIEEM
Issue date	Rev 1. 23 rd January 2024 Rev 2. 23 rd January 2024

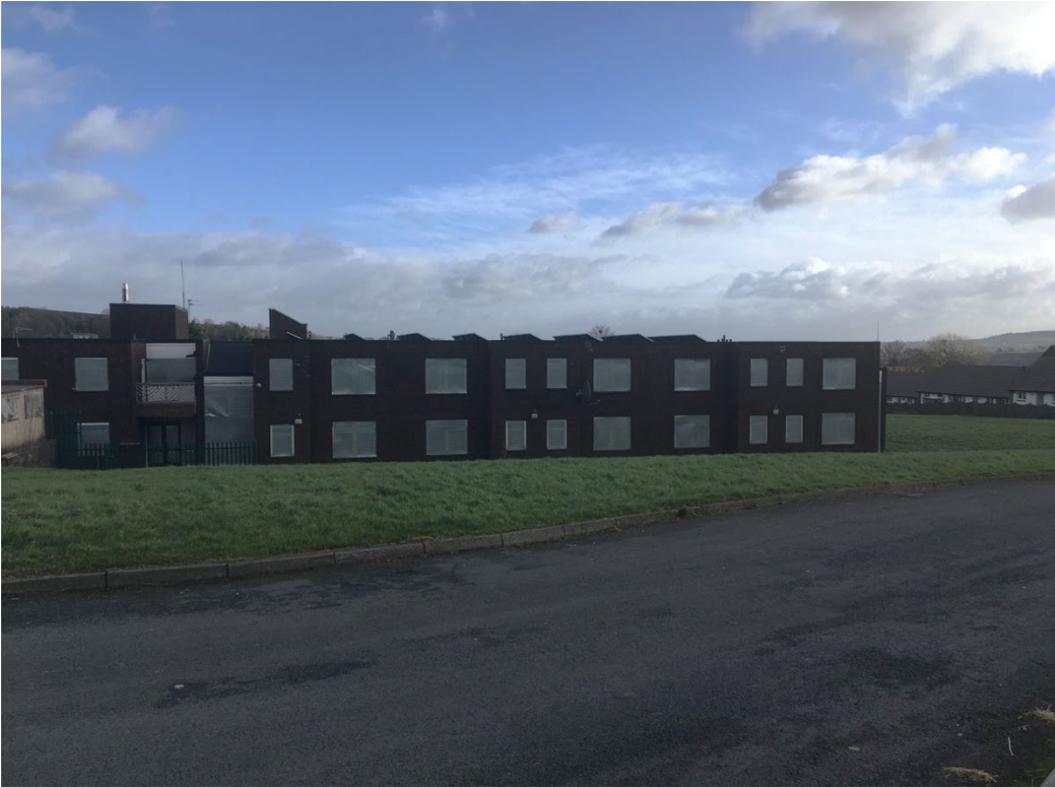
Photo 1. Looking south-east towards the building

3.2.3.1 See photos at Appendix 2. The surveyed building is a two-storey building from the 1970s. The building is of brick construction and the roof flat. The building extends to approximately 75 metres long at its longest axis. The building comprises two main parts each extending to approximately 44 x 15 metres and connecting via a third part extending to approximately 10 x 9 metres.

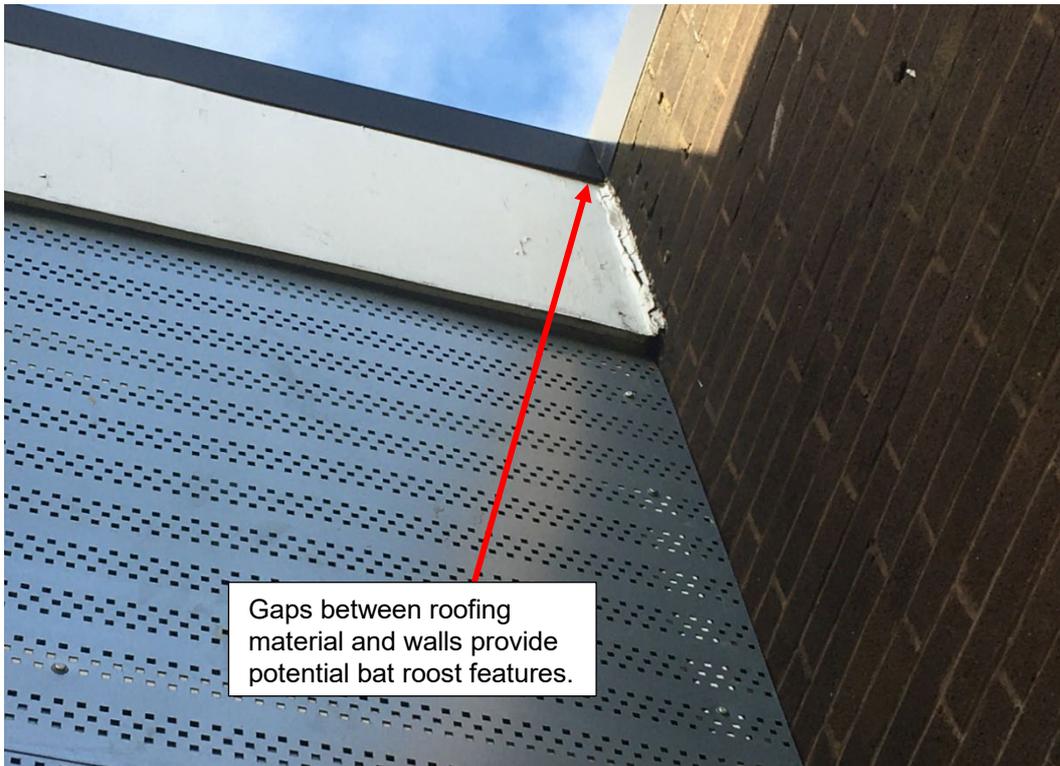
Photo 9. Close-up example of gaps between roofing material and walls, above the eastern entrance

3.2.3.3 The roof is flat with roofing material overlapping the top part of the brick walls. All along the building several gaps between the roofing material and walls are present, providing potential bat roost features. Aside from the roof verges, no other potential bat roost features were identified.

4.1.1.2 Due to the potential presence of bat roosts, prior to any works affecting the building at Sycamore Grange, it is recommended that a minimum of one dusk emergence bat survey should be undertaken during the optimal survey period of May-August. If a bat roost is found to be present, it may be necessary to undertake further survey work and to provide mitigation measures.
