PHASE 1 CONTAMINATED LAND RISK ASSESSMENT ERECTION OF NEW SLURRY STORAGE TANK

Bark House Dairy Farm, Huddersfield Road, Shelley, Huddersfield, HD8 8LJ.

Report Ref: TH/BARK/PHASE1/01/Mar2024

25th March 2024

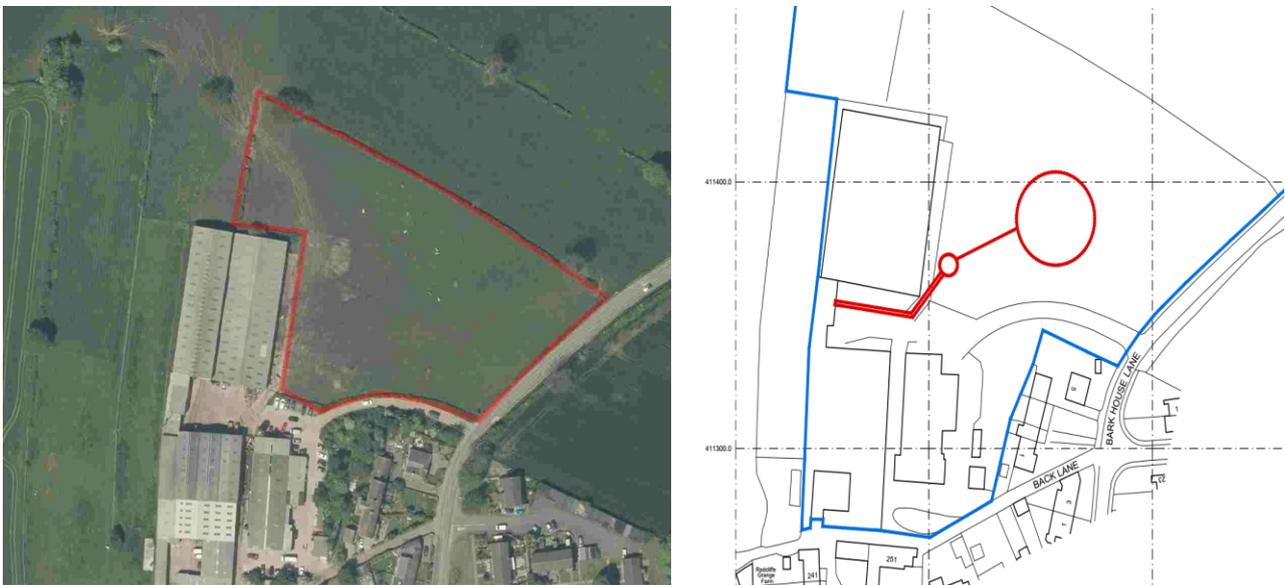
Fig 1 - Aerial photograph & Schematic: Land at Bark House Dairy Farm, Huddersfield Road, Shelley, HD8 8LJ.

The development proposal is to construct a new covered **Slurry Tank** to support the activities of the operational Dairy Farm, and specifically to comply with the requirements of the *Water Resources (Control of Pollution) (Silage, Slurry and Agricultural Fuel Oil) (England) Regulations 2010 (SSAFO)*. The SSAFO Regulations have recently been superseded by *The Reduction and Prevention of Agricultural Diffuse Pollution (England) Regulations 2018*, otherwise known as the *Farming Rules for Water (FRfW)*. Currently the Farm does not have the minimum 6 month storage requirement, and a new structure is required to meet the legal obligations of the FRfW:

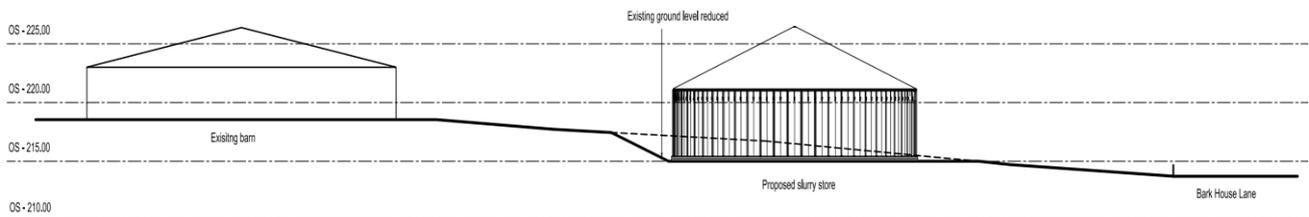
Fig 2 – Site Sectional Drawings showing proposed Slurry Tank at Bark House Dairy Farm, Huddersfield Road, Shelley, HD8 8LJ.

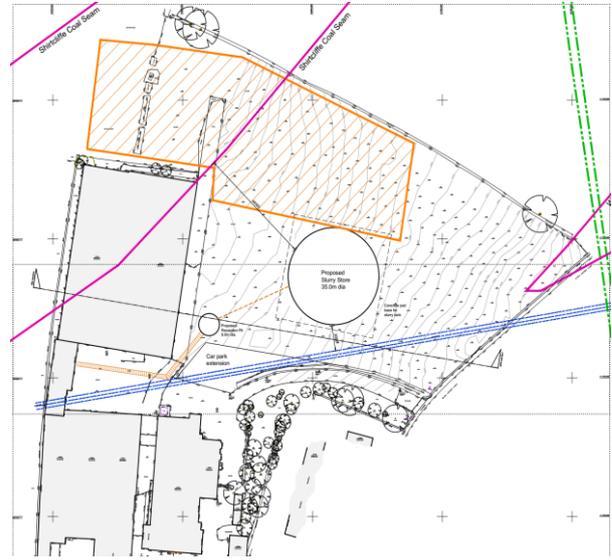
Fig 5 - Development as Proposed - Land at Bark House Dairy Farm, Huddersfield Road, Shelley, HD8 8LJ.

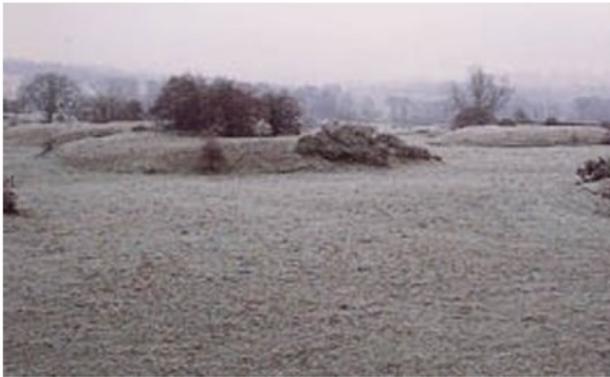
Bell pit mining was the only method then available to reach minerals covered by layers of other rock. After the ore had been extracted it was taken to primitive furnaces called bloomeries, situated near to the bell pit workings and made into wrought iron.

Mining for iron ore became important in this district in the 12th century, when monks came from Fountains, Byland, Roche, and Rievaulx Abbeys. The Tankersley Ironstone Bed lies within the Coal Measure shales and is 35 cm thick. The monks worked this iron ore along its outcrop towards the north and east, from Bentley Grange, near Emley, which was the main centre of the iron ore industry. Old pit mounds show evidence of iron mining at Bentley Springs. In the early years of mining the monks used to dig either long trenches or bell pits depending on the depth of the ore. A series of holes or shafts was dug to the depth of the mineral layer and then the ore was extracted in all directions, forming a bell shape beneath the surface. When the likelihood of roof collapse was imminent the pit would be abandoned. The excavation of a new shaft would then begin a short distance away.

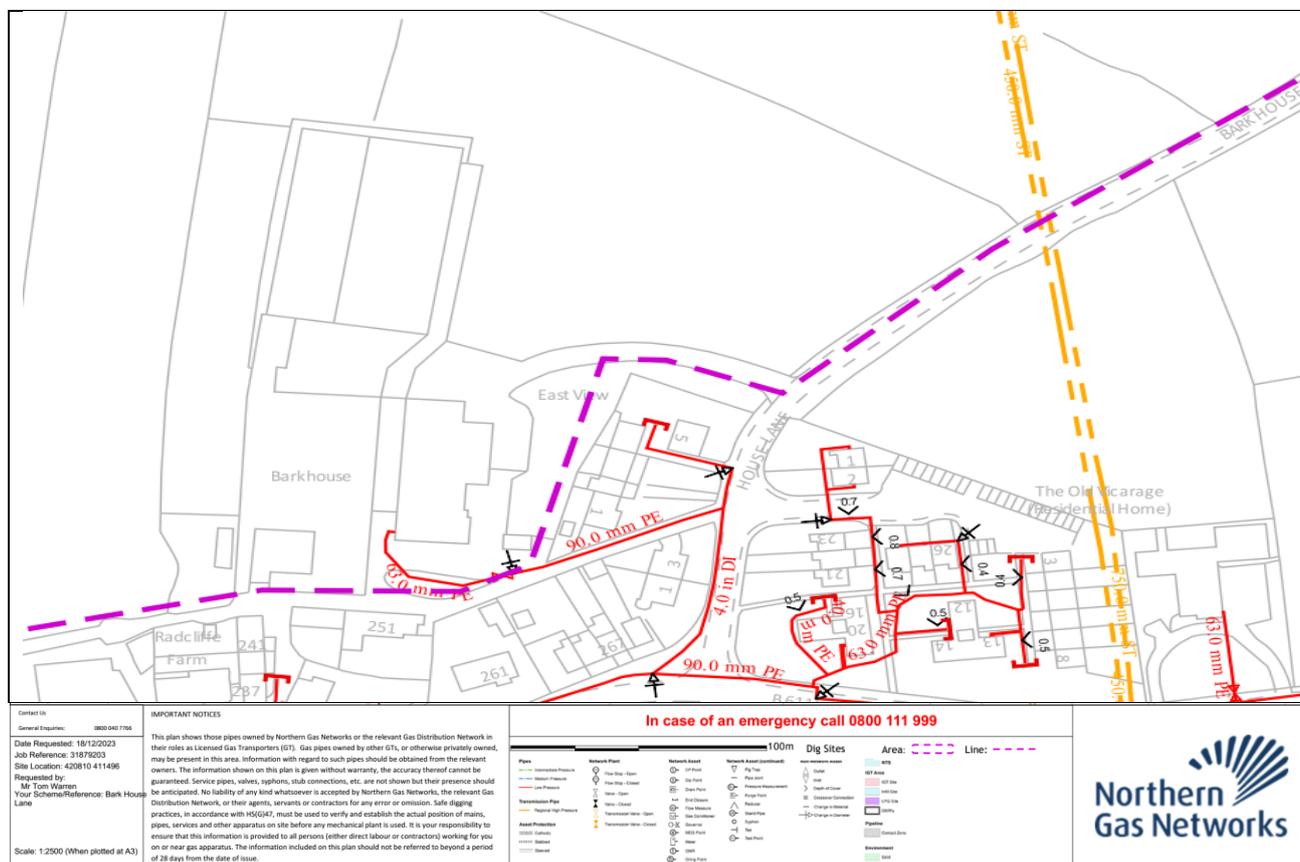
A twin 750mm & 150mm diameter HP Gas Pipeline is located in close proximity (Plot 487) to the site as shown below:

Working in proximity to HP Gas Pipelines presents a variety of challenges, and considerable steps need to be taken if the proposed Slurry Tank is situated within 15m of the asset. The developer MUST follow the guidance contained within the following publications:

As such, the near field plot (488) should be considered as the **optimum location** for the Slurry Tank – a safe distance away from the *High Risk* pressurised gas infrastructure. This would render the preferred site location to the West of the HP Gas Pipeline as a **LOW HAZARD POTENTIAL** for the purposes of **Construction**.

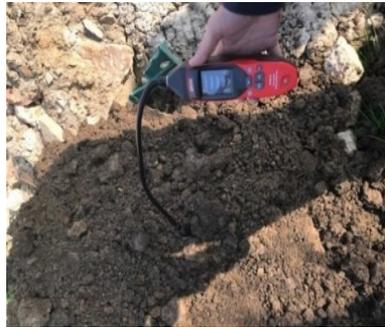
Very basic in-situ methane gas tests (by soil spiking) were carried out in probe holes made in the sides of the natural ground slopes using a portable RS-Pro gas detector (shown below) which measures the methane content as its percentage volume in air.

Fig 9 - Portable RS-Pro methane detector (above) & (right) in use during survey at Bark House Farm on 06.02.2024

RS-PRO PORTABLE GROUND GAS MONITOR							
GAS DETECTOR FEEDBACK FOR METHANE CONCENTRATION LEVELS							
Low Sensitivity White Light ON = 0 ppm	High Sensitivity Yellow Light ON = 0 ppm	Level Lights					Audible Alert Beeping OFF
		L1	L2	L3	L4	L5	
1... 100ppm	1... 1000ppm	ON	OFF	OFF	OFF	OFF	1 cyc/sec
100... 400ppm	1000... 4000ppm	ON	ON	OFF	OFF	OFF	1.2 cyc/sec
400... 700ppm	4000... 7000ppm	ON	ON	ON	OFF	OFF	1.65 cyc/sec
700... 1000ppm	7000... 10000ppm	ON	ON	ON	ON	OFF	3.25 cyc/sec
> 1000ppm	> 10000ppm	ON	ON	ON	ON	ON	6.25 cyc/sec

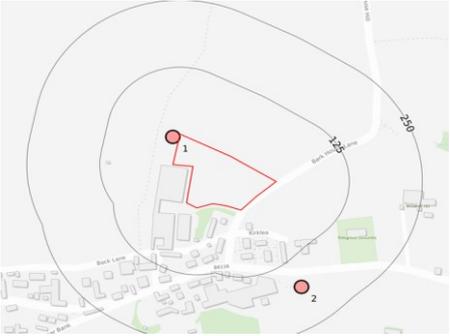
ID	Location	Grid reference	Name	Length	Confidential	Web link	1	11m NW	420880 411480	BARK HOUSE FARM SHELLEY	154.0	N	57135	2	177m SE	421100 411200	PENNINE GARDEN CENTRE HUDDERSFIELD ROAD SHELLEY	137.0	N	18526322
ID	Location	Grid reference	Name	Length	Confidential	Web link																
1	11m NW	420880 411480	BARK HOUSE FARM SHELLEY	154.0	N	57135																
2	177m SE	421100 411200	PENNINE GARDEN CENTRE HUDDERSFIELD ROAD SHELLEY	137.0	N	18526322																
Other Records	<p>A Site Investigation for the purposes of a similar Planning Permission application was carried out in 2014 for the late Mr G Dearnley. The Site Investigation was carried out by Structural Soils Ltd (Report Ref: 763096) - but was not undertaken after a proper Phase I Desk Study, and as such BHs were located arbitrarily.</p>

<table><tr style="background-color: #e0e0e0;"> <th>ID</th> <th>Location</th> <th>Grid reference</th> <th>Name</th> <th>Length</th> <th>Confidential</th> <th>Web link</th> </tr><tr> <td>1</td> <td>11m NW</td> <td>420880 411480</td> <td>BARK HOUSE FARM SHELLEY</td> <td>154.0</td> <td>N</td> <td>57135</td> </tr><tr> <td>2</td> <td>177m SE</td> <td>421100 411200</td> <td>PENNINE GARDEN CENTRE HUDDERSFIELD ROAD SHELLEY</td> <td>137.0</td> <td>N</td> <td>18526322</td> </tr></table>

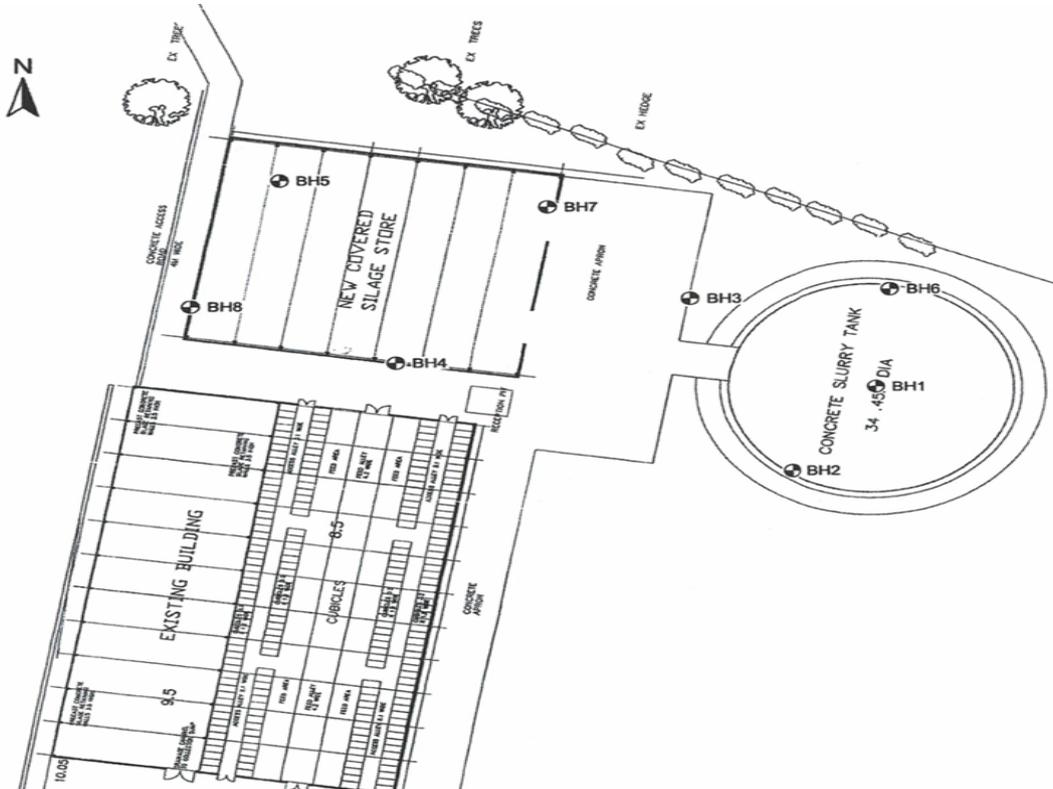
The Structural Soils Ltd Site Investigations dated 2014 (carried out for the late Mr G Dearnley) identified various shallow voids that are likely associated with shallow coal mining:

Fig 10 – Boreholes Drilled as part of the Structural Soils Survey – 2014 with Slurry Tank shown in the Northern part of the site.

The Site Investigation identified various geo-hazard features in the BHs and concluded that **Shallow Mine Workings** had been encountered, with voids ranging from **300mm to 700mm** with up to 1.80m of stowed material or backfill left in the workings. This was an assumption as backfilled material was not recovered during the site investigation, but observations / comments were made by the drillers, who reported ‘soft consistency’ materials in proximity. A thin lay of coal was also observed in each BH, varying in quality and approximately 500m thick, indicating the base of the historic workings.

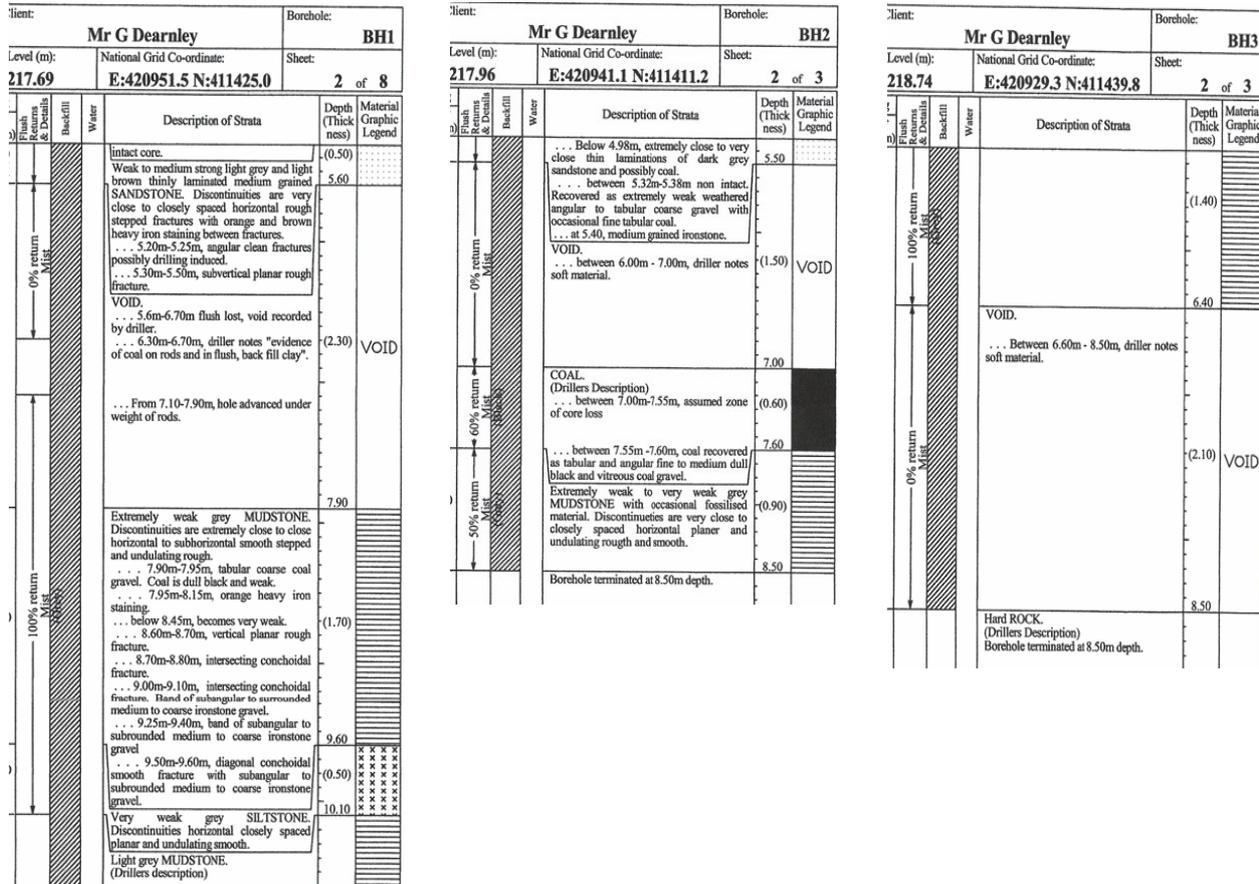
An example of the Geo-hazard data (voids / loss of flush) provided by the previous SI is shown below:

NOTE (4) - What does this mean?

This means that there are **potential underground mining hazards** indicated in the vicinity of the site:

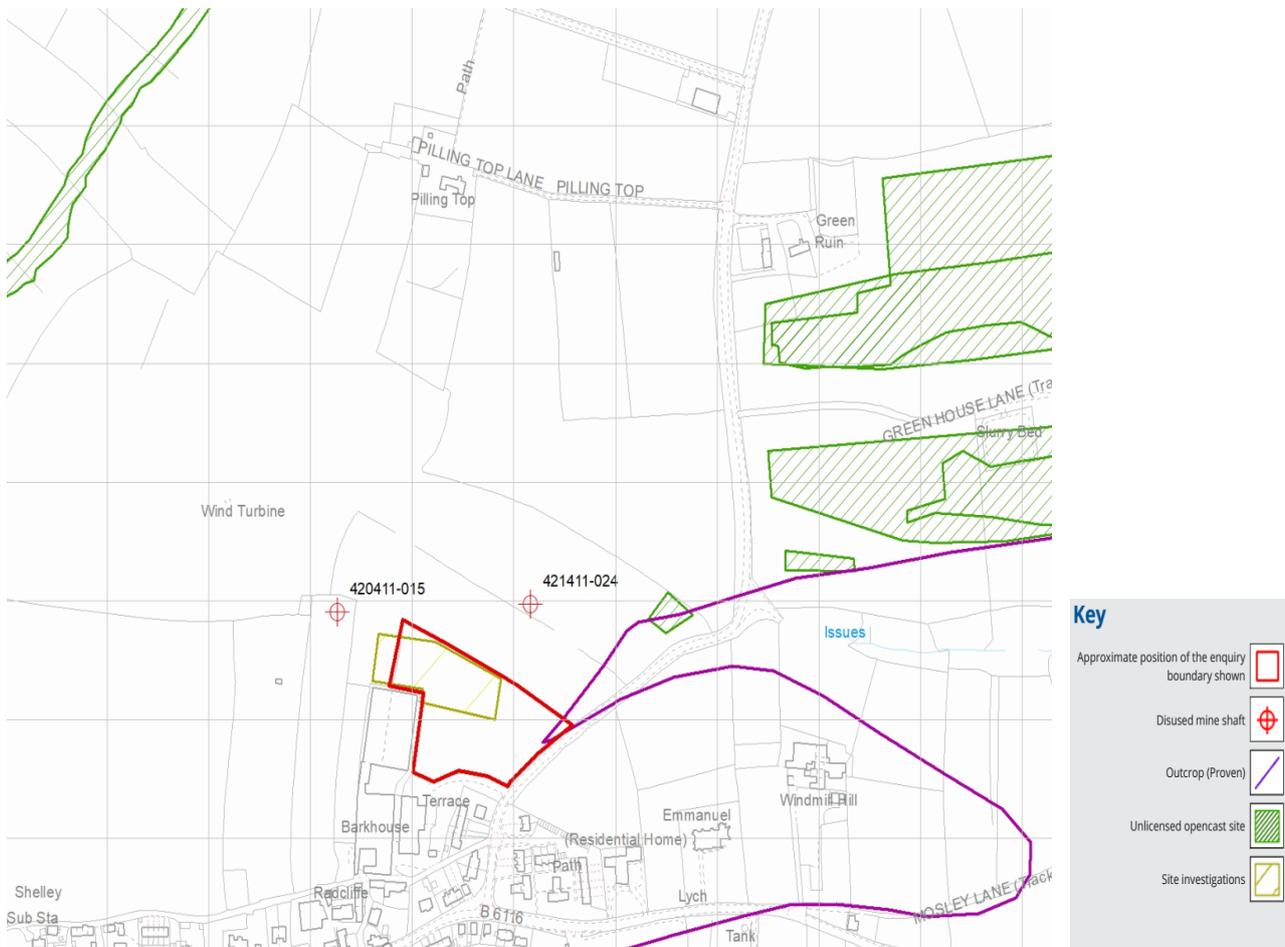
The map highlights any specific surface or subsurface features within or near to the boundary of the site.

NOTE (5) - What does this mean?

This means that there are **significant Coal Mining hazards** indicated in the vicinity of the site:

The site is considered a **HIGH HAZARD POTENTIAL** for the purposes of *Construction* and *Shallow Workings*.
