STAGE 2 GEO-ENVIRONMENTAL REPORT

**THORNHILL WORKS
CALDER ROAD
DEWSBURY**

NEWLAY READYMIX LTD

REPORT REFERENCE: NRL/01r1

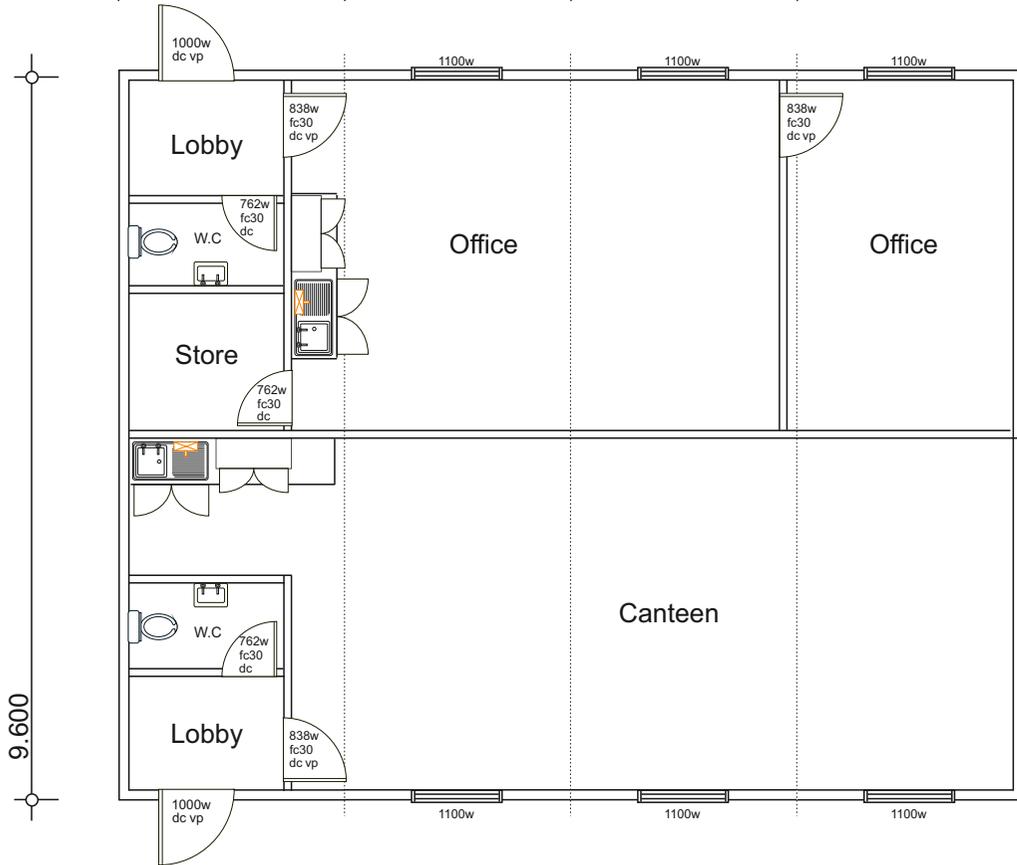
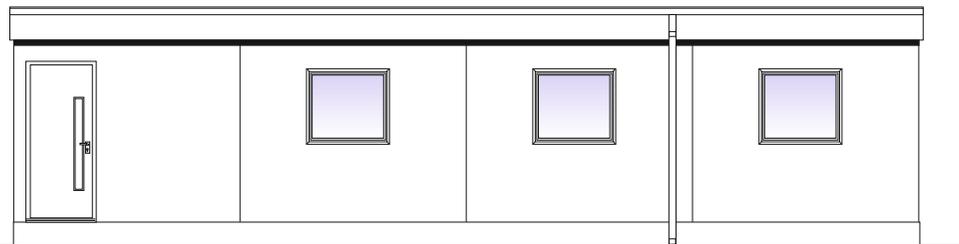
Front Elevation

12.0 Metres Overall

9.600

- 9.4 For the proposed single storey office in the northeast of the site, this is to be a modular structure and it is assumed that the foundation and load requirements will be dictated by the supplier. If the founding stratum is to be the natural clay encountered at 1m depth in this area, an allowable bearing pressure of 100kN/m² is considered applicable. A higher allowable bearing pressure would be applicable if founded on intact mudstone or any other bedrock.
- 9.5 There are no existing trees within 30m of the proposed building, but in the event any trees are proposed within 30m, any potential impact on proposed foundations will need to be considered.

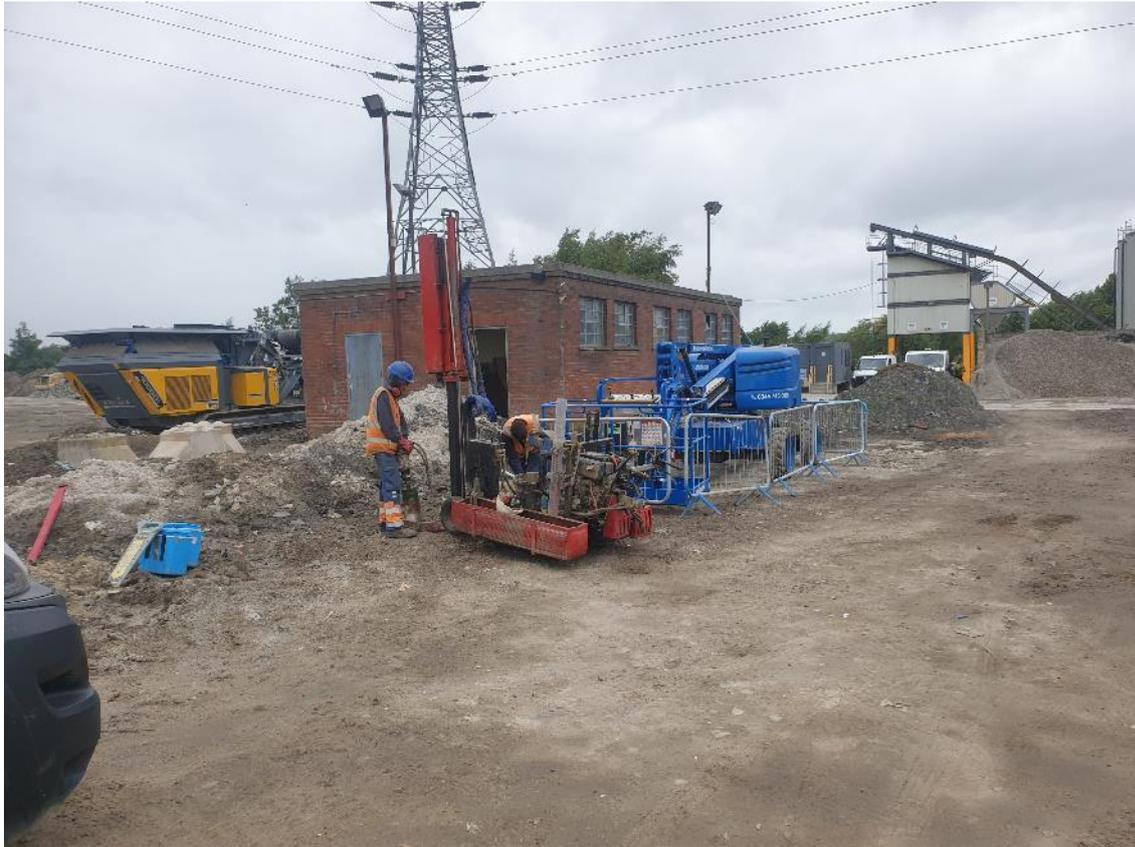
Photograph 1: Drilling WS01 towards western boundary of the site, facing northwest.

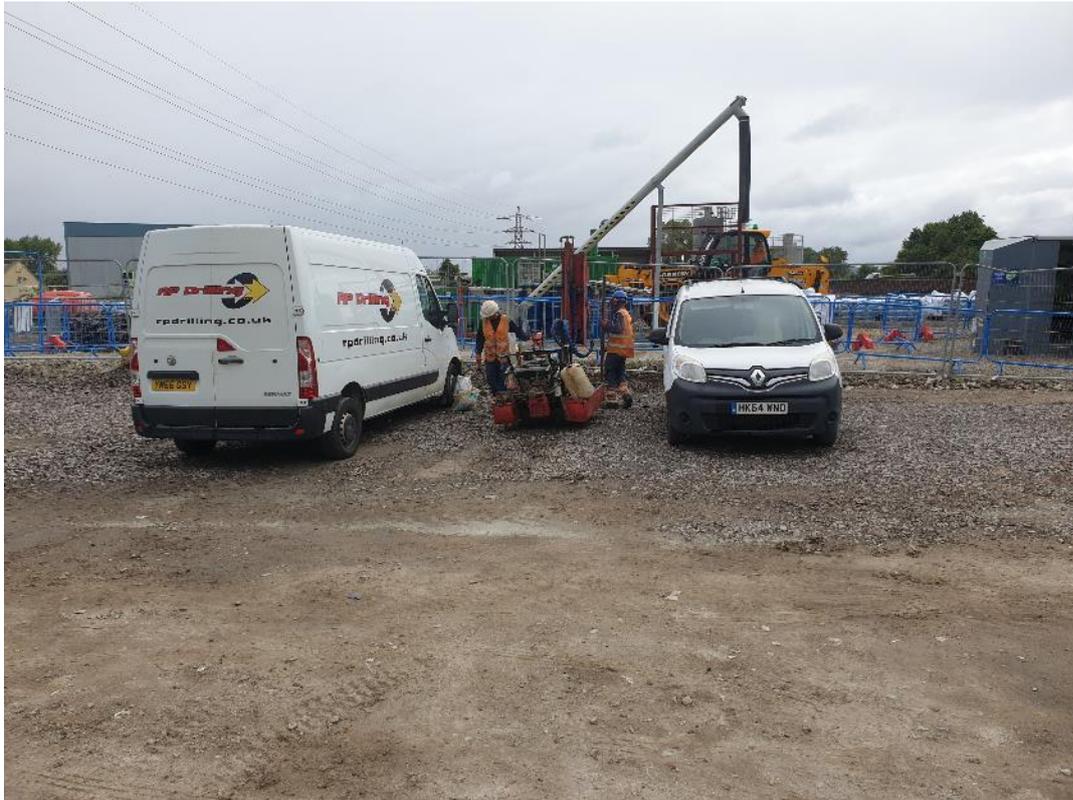
Photograph 5: Drilling of WS02 towards the western end of the site, facing east. A compound for a development along the railway track is present in the background.

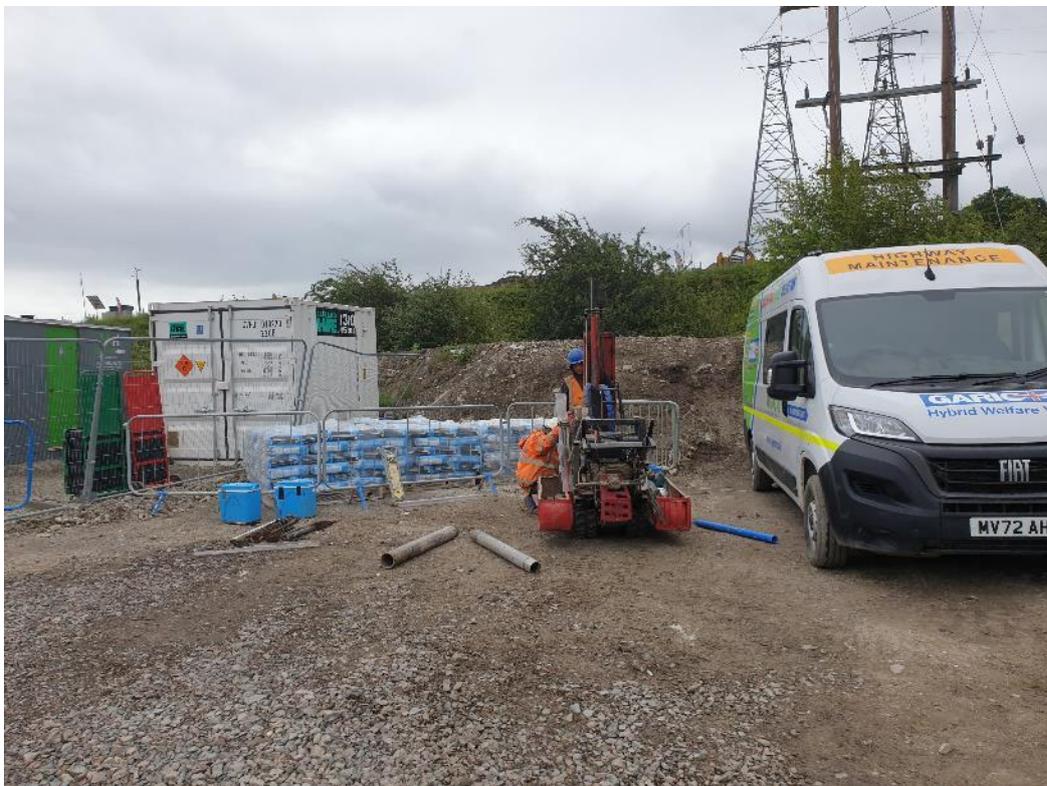
Photograph 6: Drilling of WS03 at the southwestern boundary of the site.

- 9.2 Insufficient rock cover is concluded to be present at WS3 in the southwestern corner of the site. As no structures or infrastructure are currently proposed in this location, no grout treatment should be required. However, if any structures or infrastructure are proposed in this location in the future, further rotary investigation would be recommended to determine any need for grout treatment.

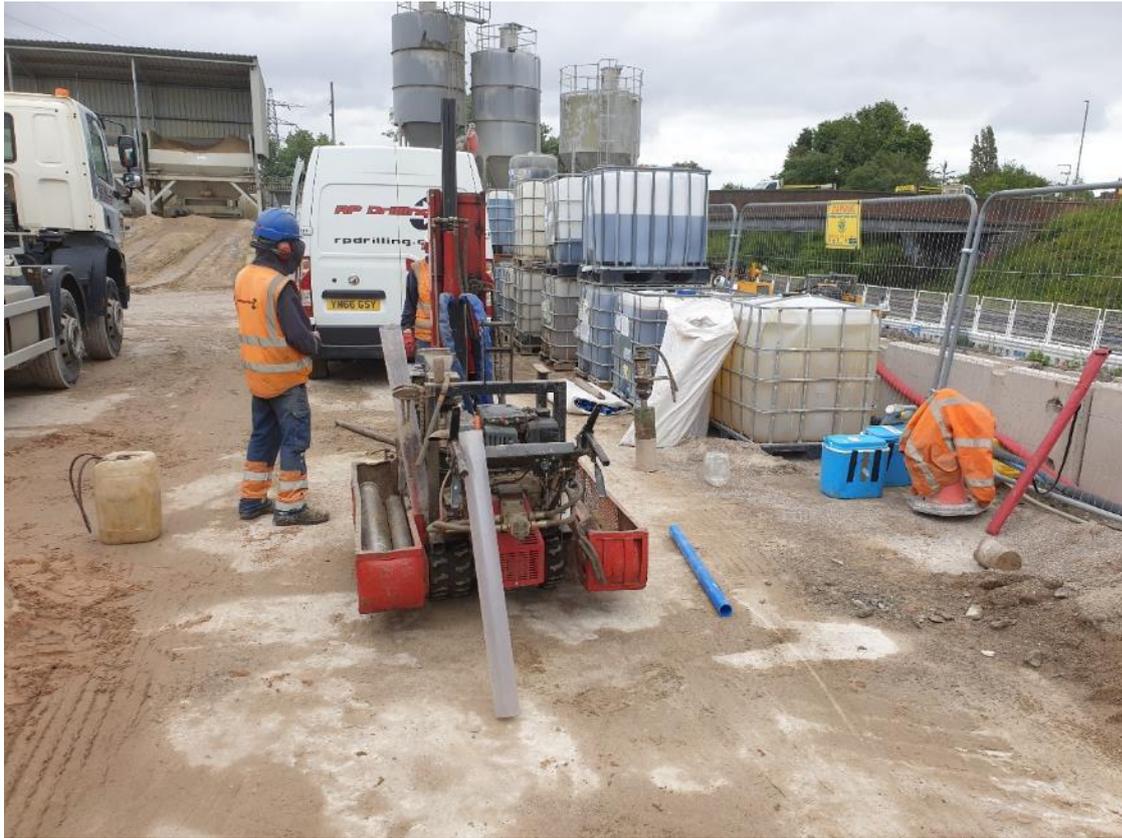
Photograph 7: Drilling of WS04 at the centre south boundary of the site.

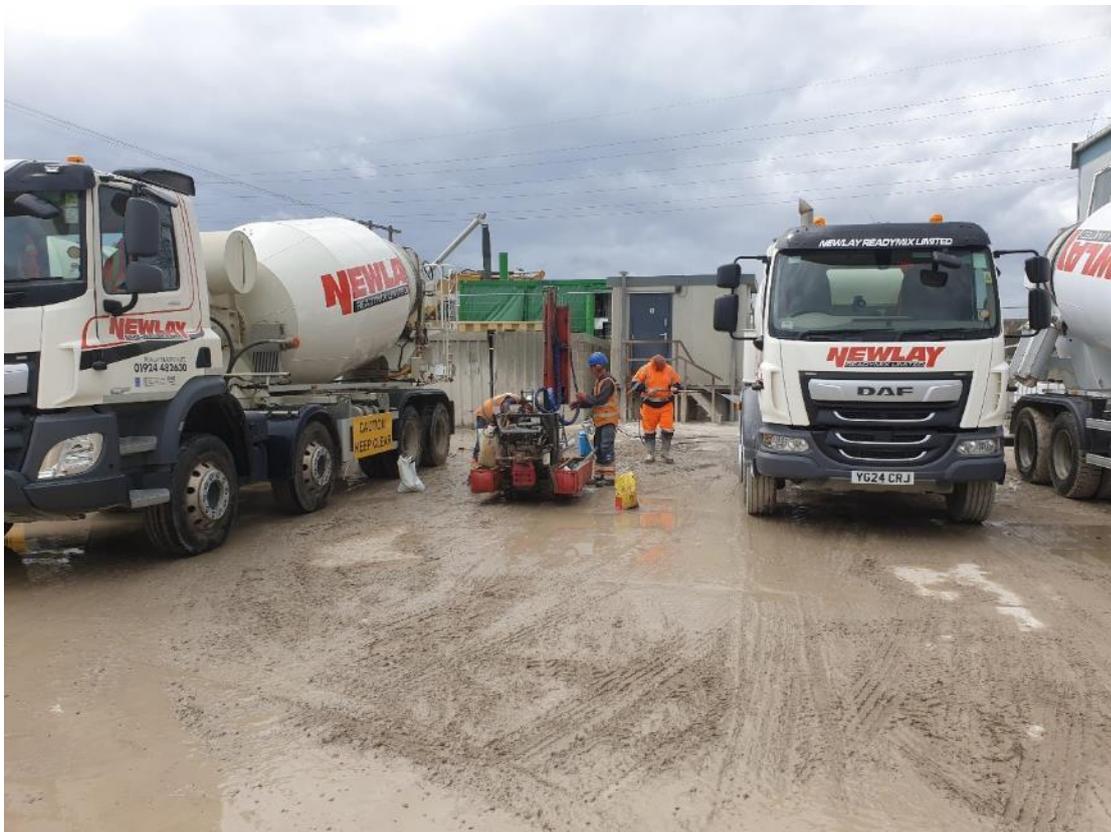
Photograph 8: Drilling of WS05 towards the centre of the site, facing west.

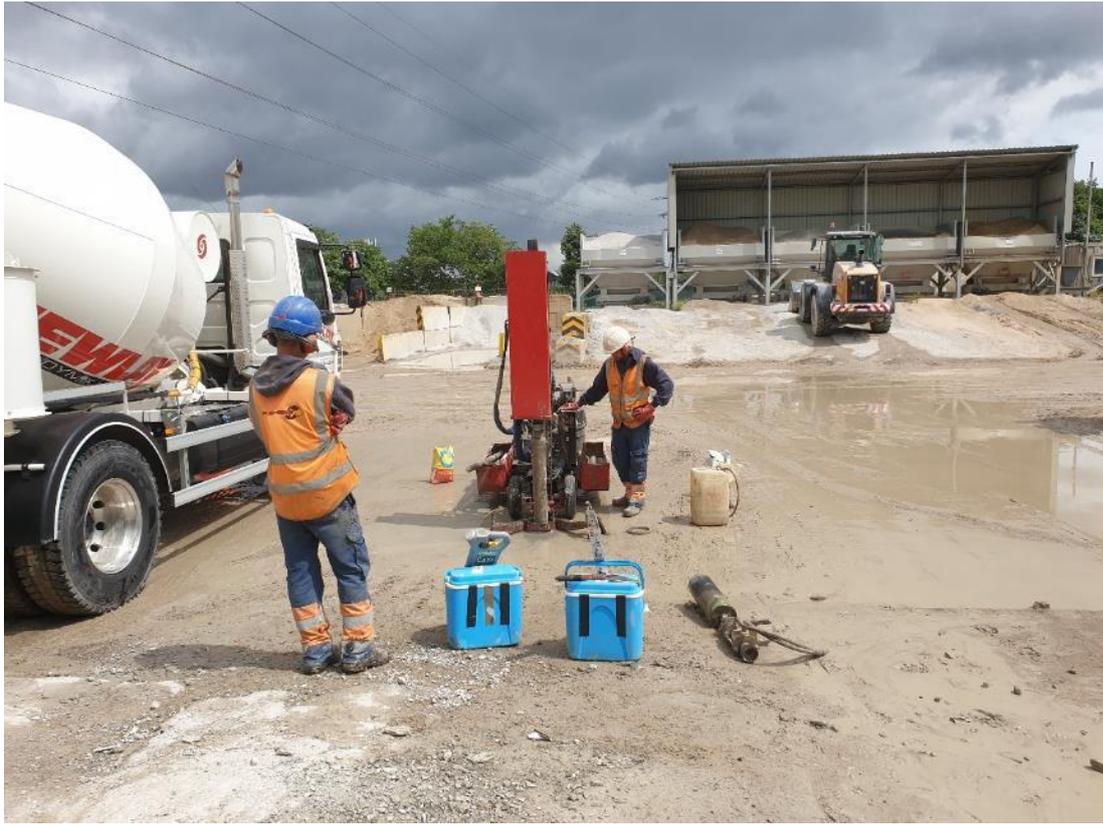
Photograph 9: Drilling of WS05 towards the centre of the site, facing east.

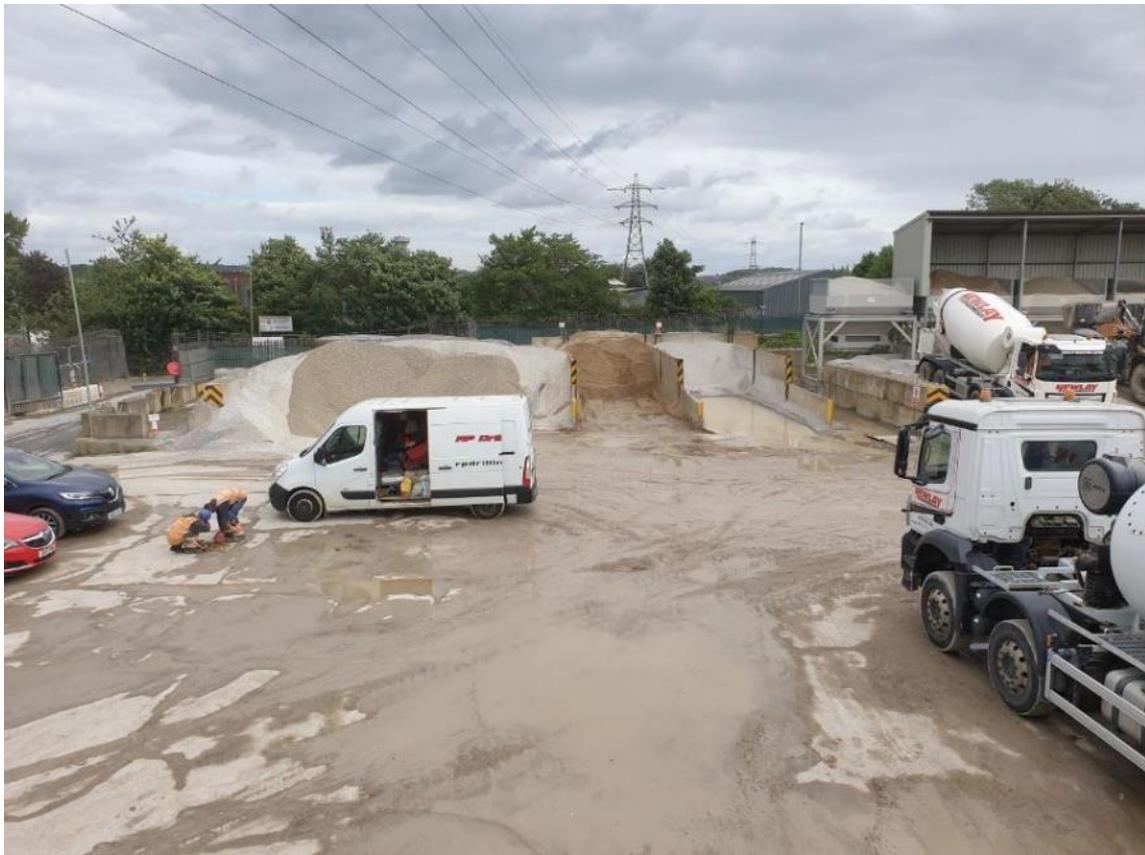
Photograph 10: Location of WS06 towards the northeastern end of the site, facing northeast.

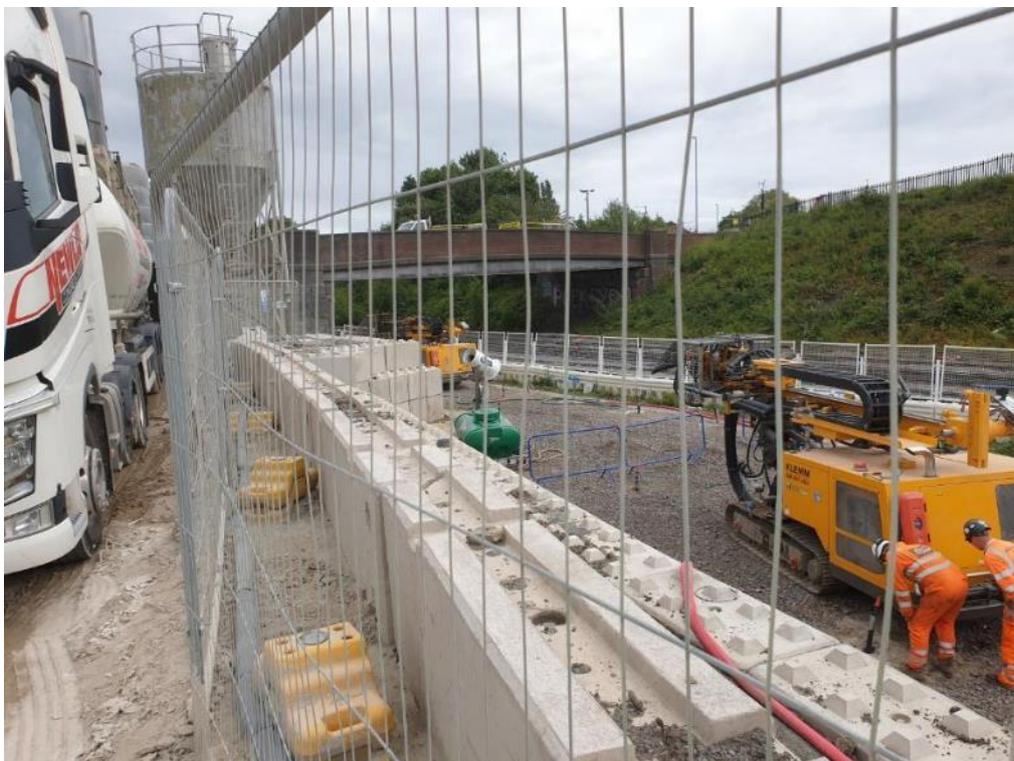
Photograph 16: Drilling works underway beyond the southern boundary of the site parallel with the railway tracks.
