INITIAL INSURANCE REPORT
Retained

DATE OF ISSUE:	11 th November 2021
OUR REFERENCE NO:	72126981
YOUR REFERENCE NO:	74851548913
Eaton Gate Household Davies Group Ltd (Stoke) 2nd Floor, East Court Riverside Park Stoke-on-Trent Staffordshire ST4 4EY	46 West Park Street Drewsbury WF13 4LD

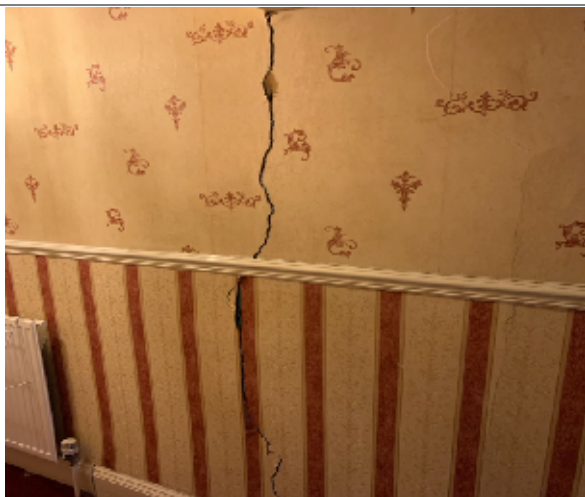
Photograph 3 – Cracking on the landing along the party wall

Internally, the party wall at the top of the stairs on the landing, exhibits a vertical crack from floor to ceiling that measures up to 8mm in width. On an internal wall on the other side of the landing, there is a similar crack about 4mm wide.

We now recommend that site investigations are undertaken to confirm our initial opinion as to the cause of the damage; with the required investigations consisting of:

- One Trial hole / bore hole to the rear elevation of the property to confirm the depth of the foundations and condition of the bearing soils beneath the foundations.
- A CCTV survey of the drainage runs within proximity of the area of concern.

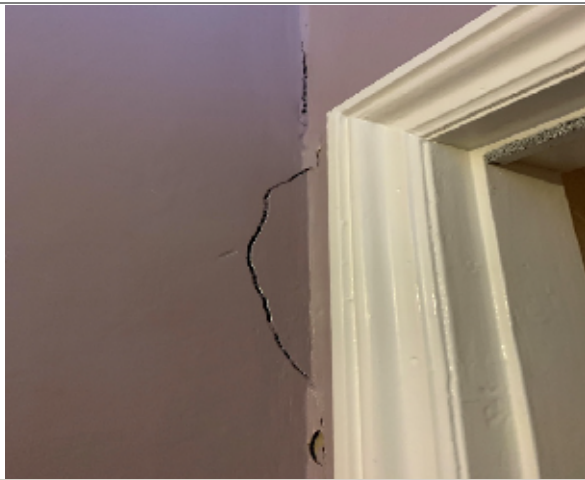
Photograph 5 – Cracking in the office – first floor adjacent to the landing

Inside the office, adjacent to the internal landing wall, there is a crack next to the door that goes through to the landing and is about 2-3mm wide.

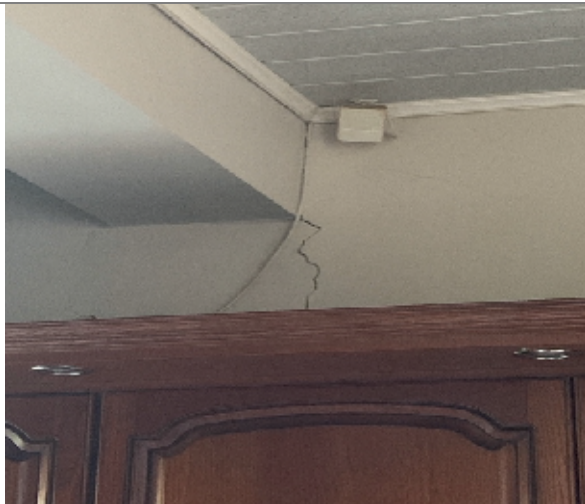
Photograph 6 – Cracking in the kitchen on the party wall

In the kitchen, there is a crack on the party wall above a wall unit that may extend down behind the wall unit that is about 3-4mm wide. Above the exit door from the kitchen to the rear garden, there is a crack about 1mm wide that may be due to lintel deflection.
