Monitoring Details:

Crack and Level Monitoring

| Address: 46 West Park Street, Drewsbury, WF13 4LD |

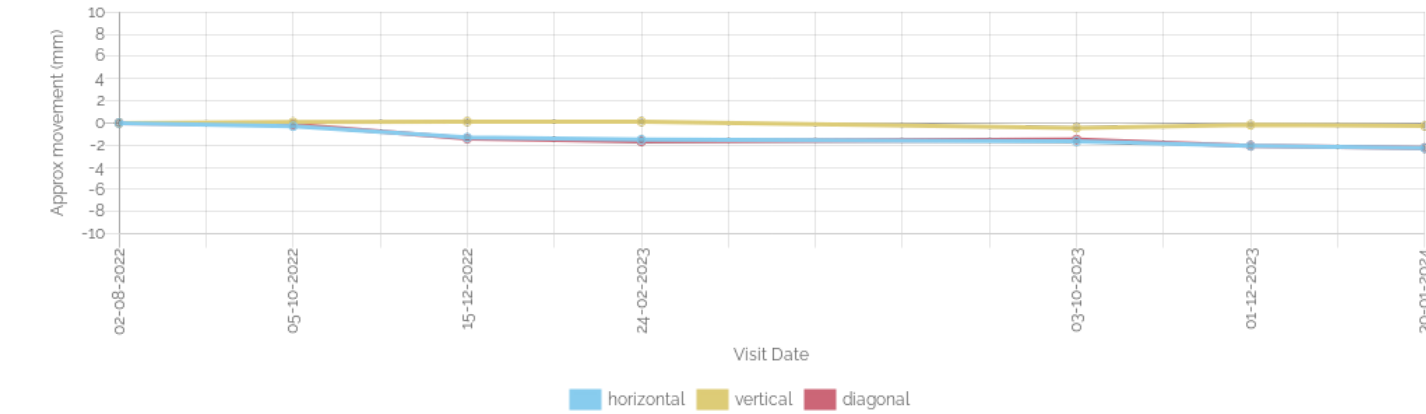
Kitchen above unit - Crack Readings Differences (Displayed in Millimetres)

| | Visit 1 | Visit 2 | Visit 3 | Visit 4 | Visit 5 | Visit 6 | Visit 7 | Visit 8 |
|---|---|---|---|---|---|---|---|---|
| H | 0 | -0.3 | -1.32 | -1.51 | -1.66 | -2.06 | -2.26 | |
| V | 0 | 0.07 | 0.12 | 0.12 | -0.44 | -0.17 | -0.27 | |
| D | 0 | -0.14 | -1.41 | -1.66 | -1.49 | -2.06 | -2.25 | |

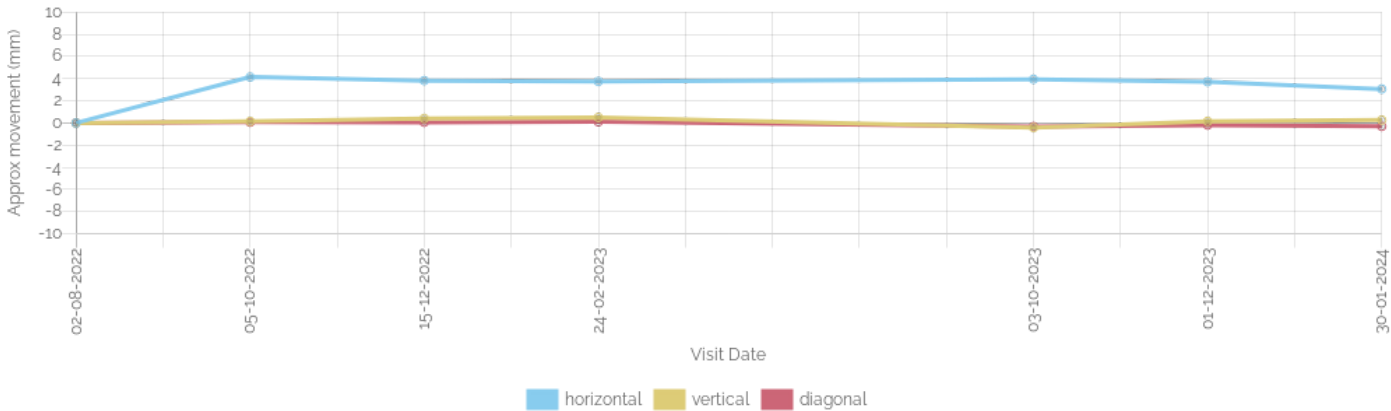
## Landing left wall - Crack Readings Differences (Displayed in Millimetres)

| | Visit 1 | Visit 2 | Visit 3 | Visit 4 | Visit 5 | Visit 6 | Visit 7 | Visit 8 |
|---|---|---|---|---|---|---|---|---|
| H | 0 | 4.14 | 3.82 | 3.74 | 3.94 | 3.71 | 3.06 | |
| V | 0 | 0.13 | 0.4 | 0.5 | -0.41 | 0.14 | 0.26 | |
| D | 0 | 0.07 | 0.06 | 0.1 | -0.33 | -0.19 | -0.31 | |

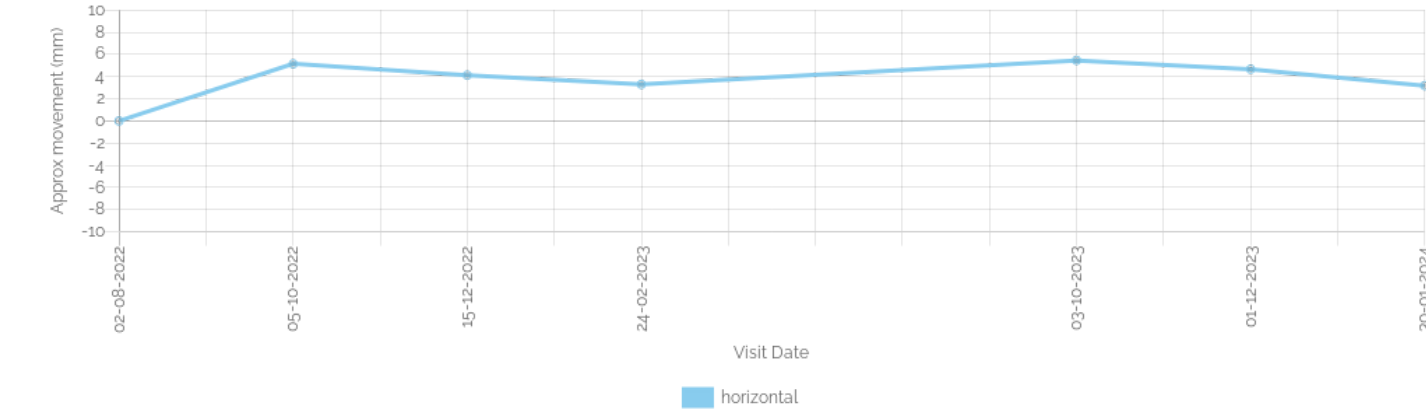
## Landing right wall - Crack Readings Differences (Displayed in Millimetres)

| | Visit 1 | Visit 2 | Visit 3 | Visit 4 | Visit 5 | Visit 6 | Visit 7 | Visit 8 |
|---|---|---|---|---|---|---|---|---|
| H | 0 | 515 | 413 | 33 | 546 | 467 | 319 | |

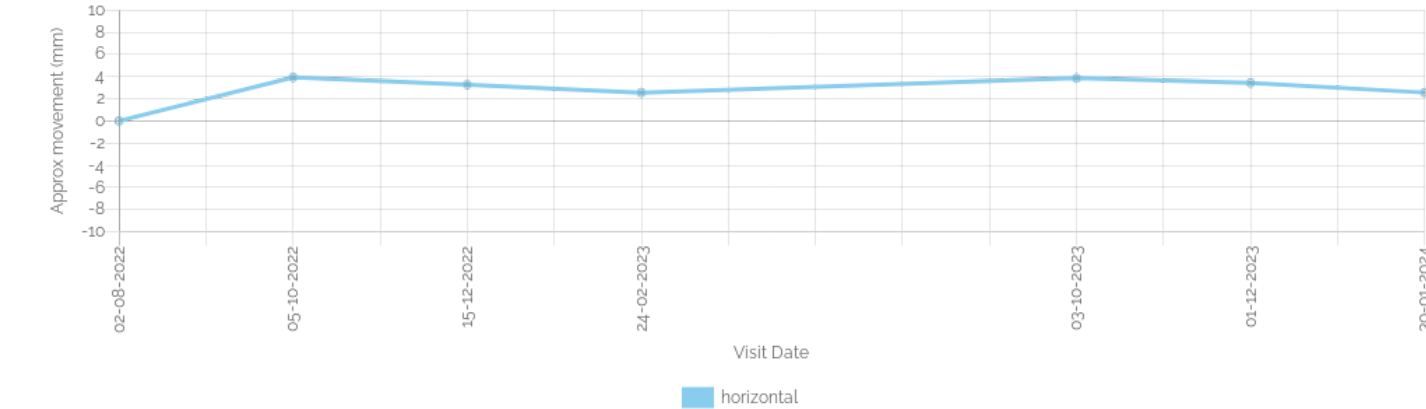
Bedroom - Crack Readings Differences (Displayed in Millimetres)

| | Visit 1 | Visit 2 | Visit 3 | Visit 4 | Visit 5 | Visit 6 | Visit 7 | Visit 8 |
|---|---|---|---|---|---|---|---|---|
| H | 0 | 393 | 328 | 256 | 386 | 342 | 256 | |
