Prince Royd Car Park, A629 Halifax Road, Huddersfield

Ground Investigation Report

Our Scheme Ref: 446368

Date: December 2019

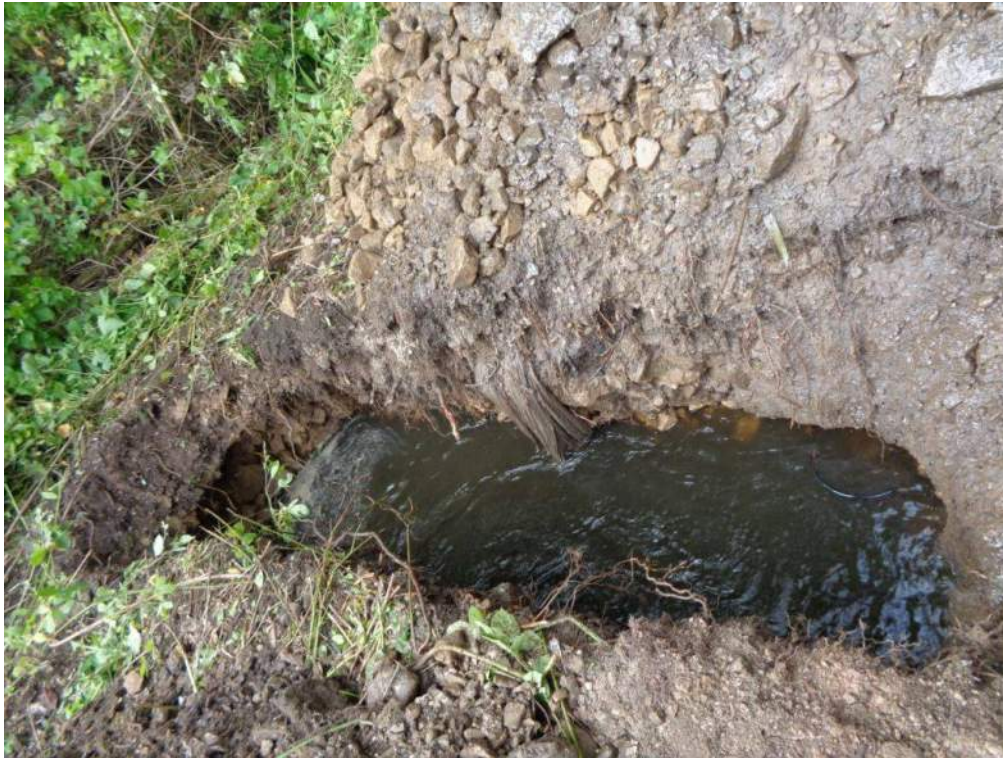
Figure TP010.1
TP010

GROUNDWATER
Water strike at 1.30m BGL - sheen noted (no odour).

STABILITY
Pit sides and base very unstable throughout excavation.

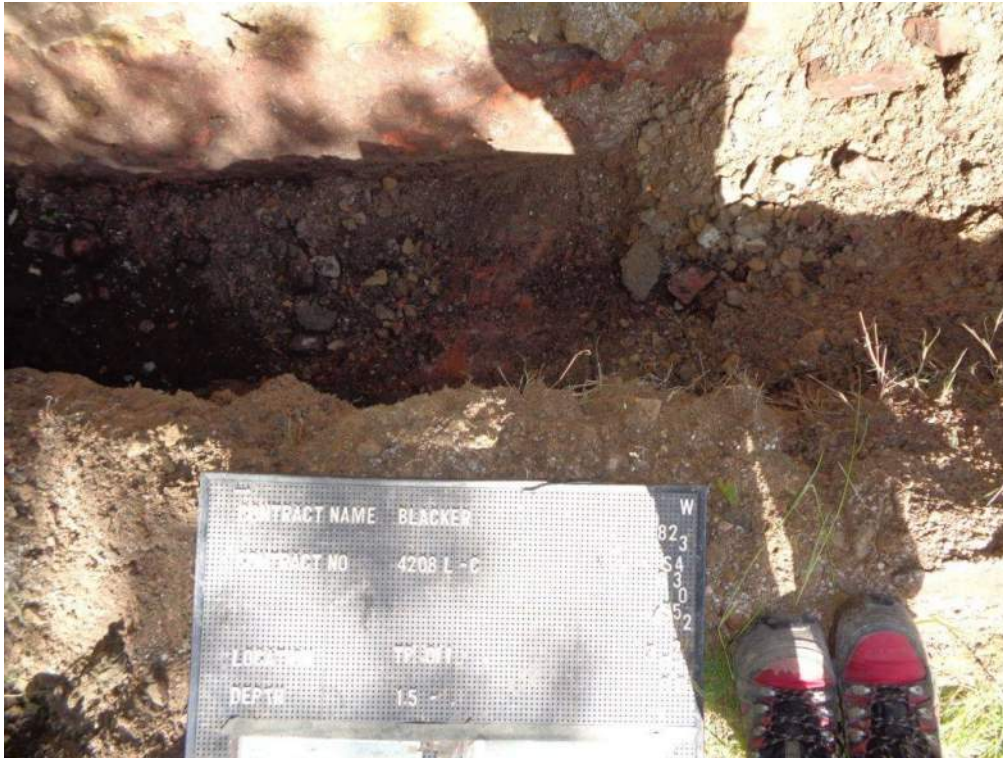
Figure TP011.1
TP011

Trial pit TP011 encountered a suspected brick culvert below 0.50m bgl. Further excavation was abandoned to avoid damaging this potentially unstable structure. No drainage features are shown on the Yorkshire Water plans in this area.

GROUNDWATER
 Water strike at 1.30m BGL.

Trial pit TP011 encountered a suspected brick culvert below 0.50m bgl. There are likely to be further obstructions or relict structures encountered during construction. If found, relict drainage features should be protected and existing drainage pathways maintained where possible. Relict structures (cellar walls, floor slabs etc) should be excavated and replaced with granular fill to avoid forming hard spots beneath the proposed car park construction.

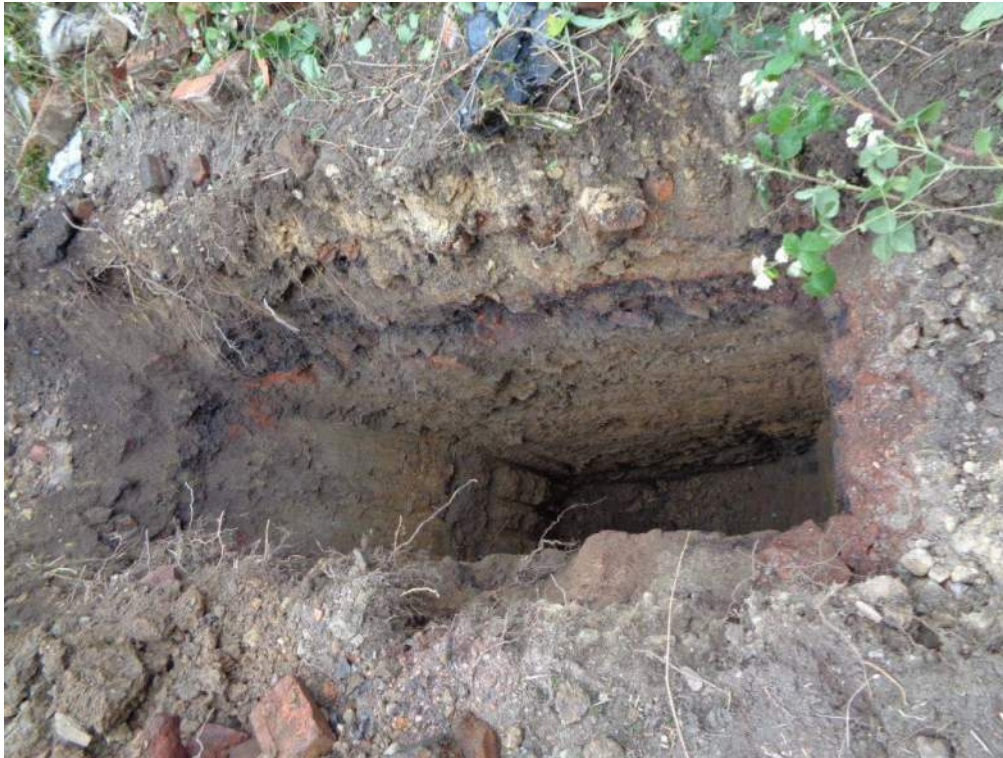
Figure TP012.1
TP012

GROUNDWATER
 No groundwater inflow observed.

STABILITY
 Pit sides and base stable throughout excavation.
