Ainley Top Highway Improvements, A629 Halifax Road, Huddersfield

Ground Investigation Report, Rev 1

Our Scheme Ref: 446367

Date: December 2021

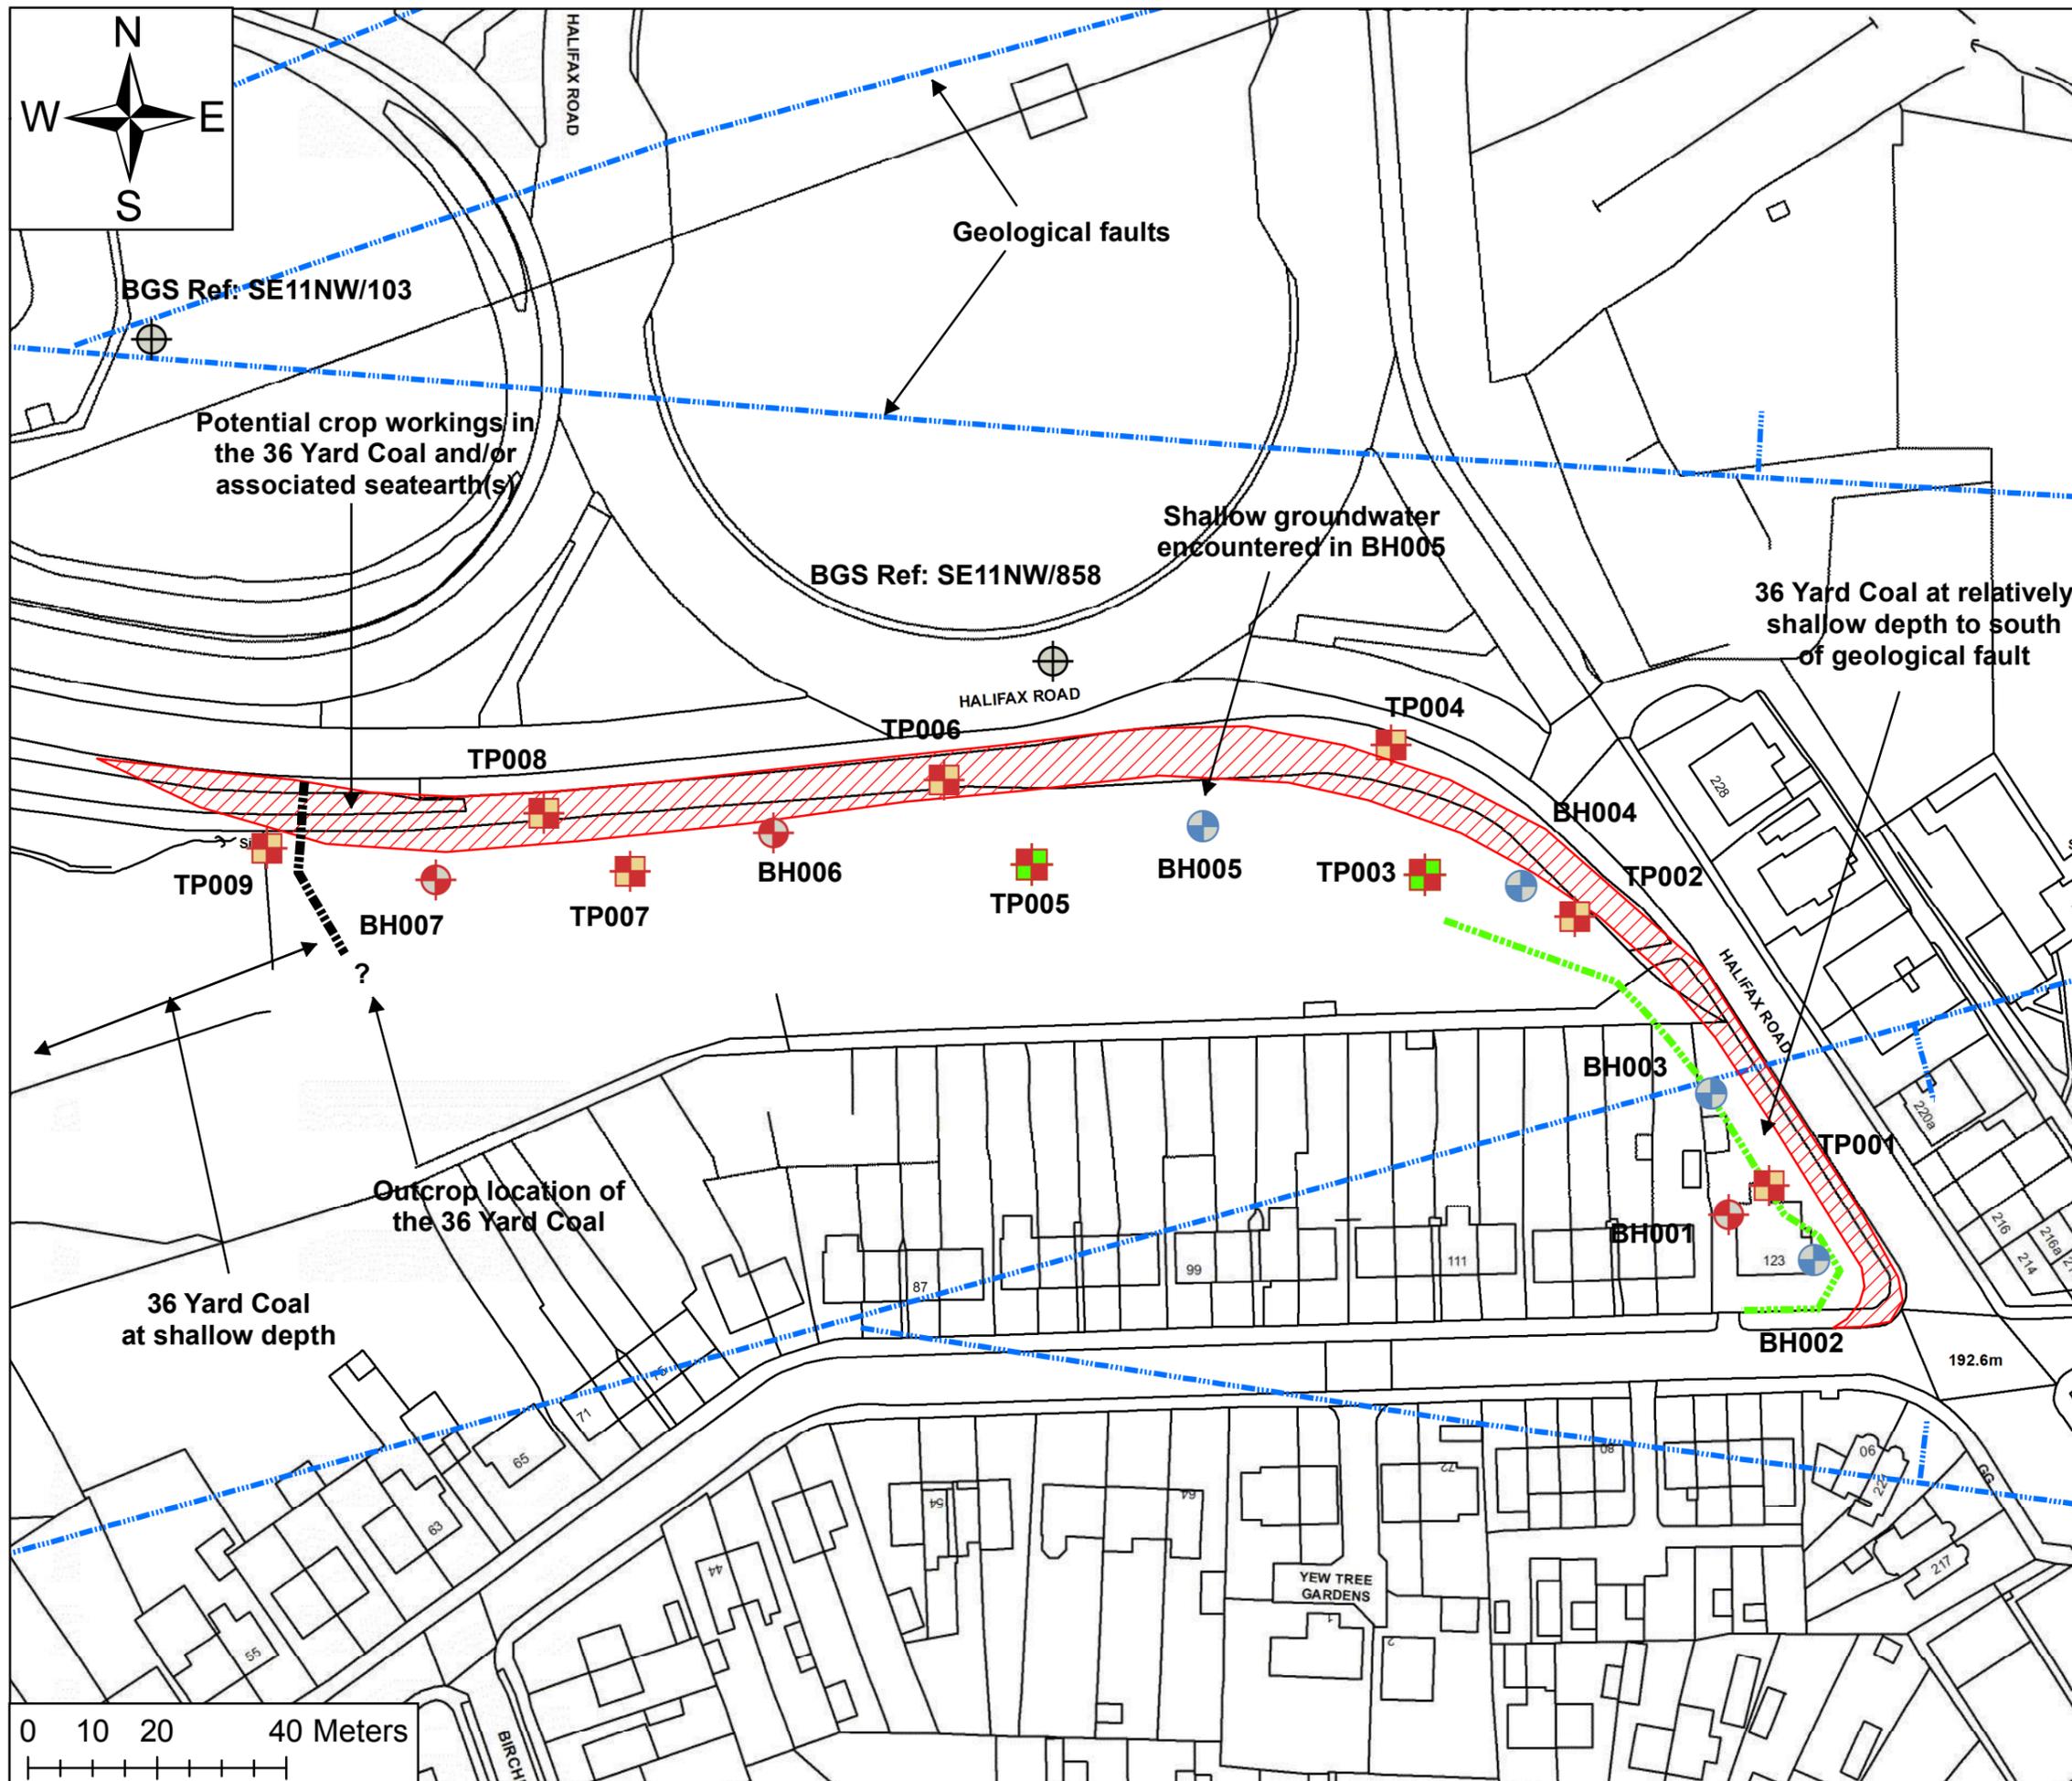
Site Layout Plan

The weathered bedrock was found to consist of sandstone, siltstone, mudstone and coal. An interpretative section has been produced; Geological Section A (see Figure 3). The line of section follows approximately the south and south-west edge of the proposed new highway (see Figure 2).

The foundation excavation for the retaining wall should be checked by an experienced geotechnical engineer for evidence of mine workings and in the location of the geological fault (see Figure 2) to confirm if any additional treatment or strengthening works are required.

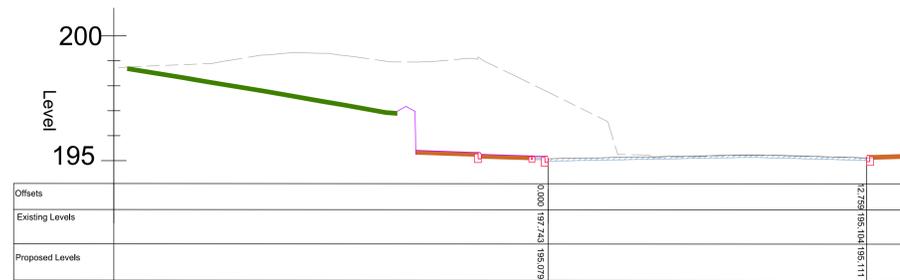
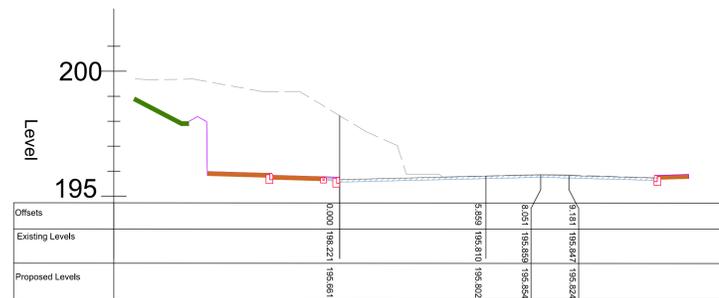
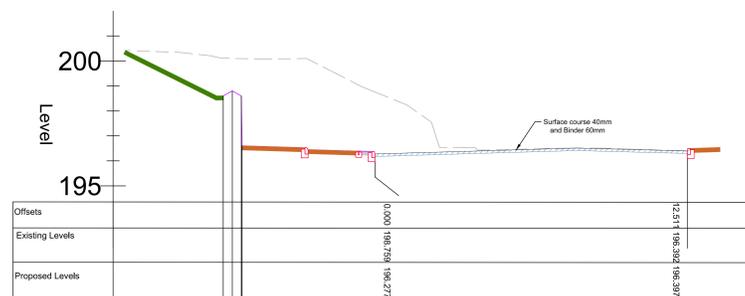
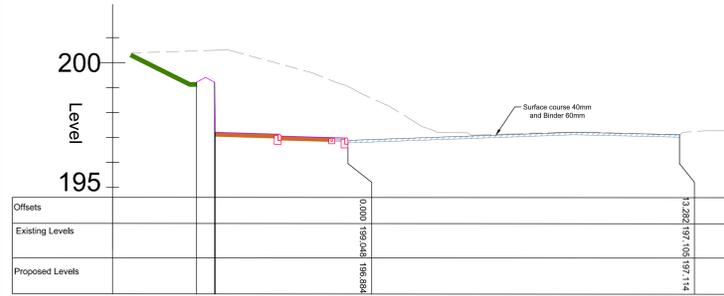
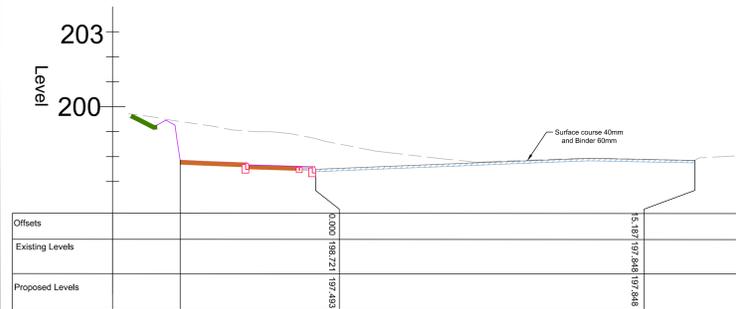
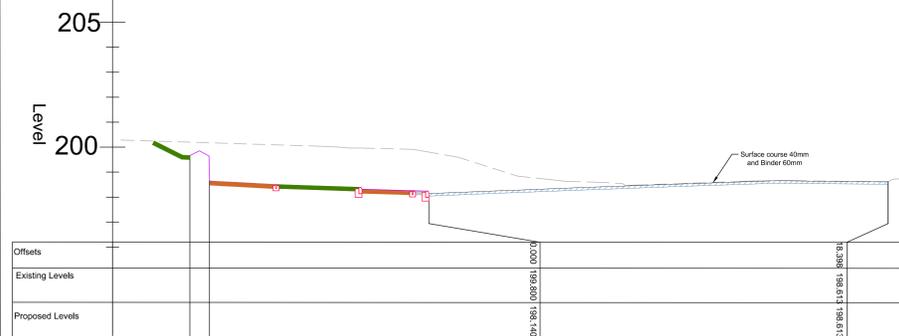
CROSS SECTION 0.0-130.0
SCALE 1:200

The proposed cross-sections (see Appendix 1) appear to show the retaining wall to attain a maximum height of 2m between Ch 80m and 100m with a slope above. The proposed retaining wall will be founded on weathered bedrock for the majority of its length. A conventional mass gravity reinforced foundation is appropriate and there should be adequate bearing capacity available on the weathered bedrock.

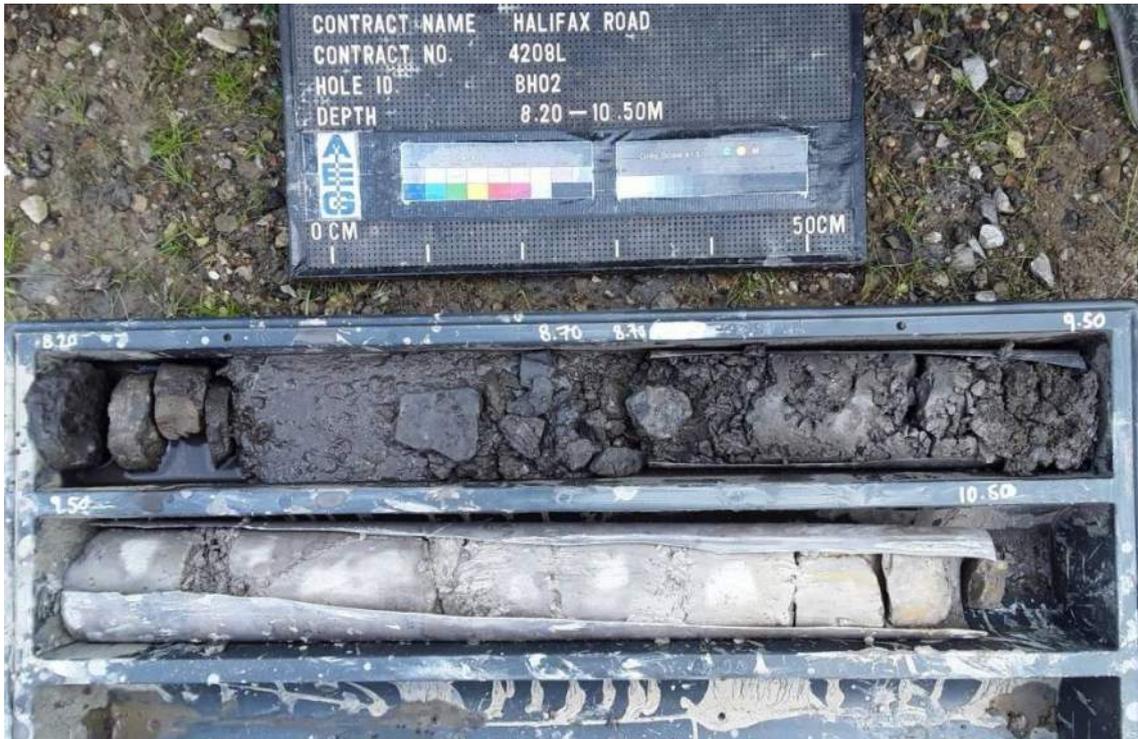
Figure BH002 R.3
BH002 8.20-10.50m BGL

The 36 Yard Coal and/or the Hard Bed Band Coal were also identified at relatively shallow depth in the south-eastern part of the site, in boreholes BH002R and BH003R, at depths of between 8.20m and 9.10m bgl. No evidence of mine workings was found in boreholes BH002R and BH003R beneath the proposed retaining wall.

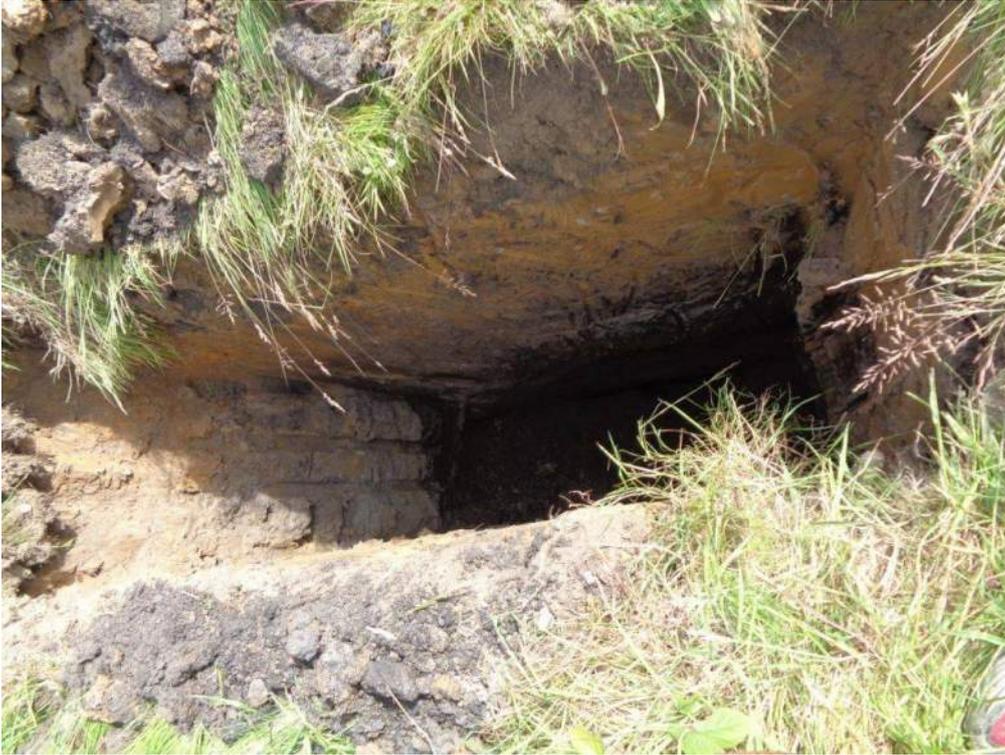
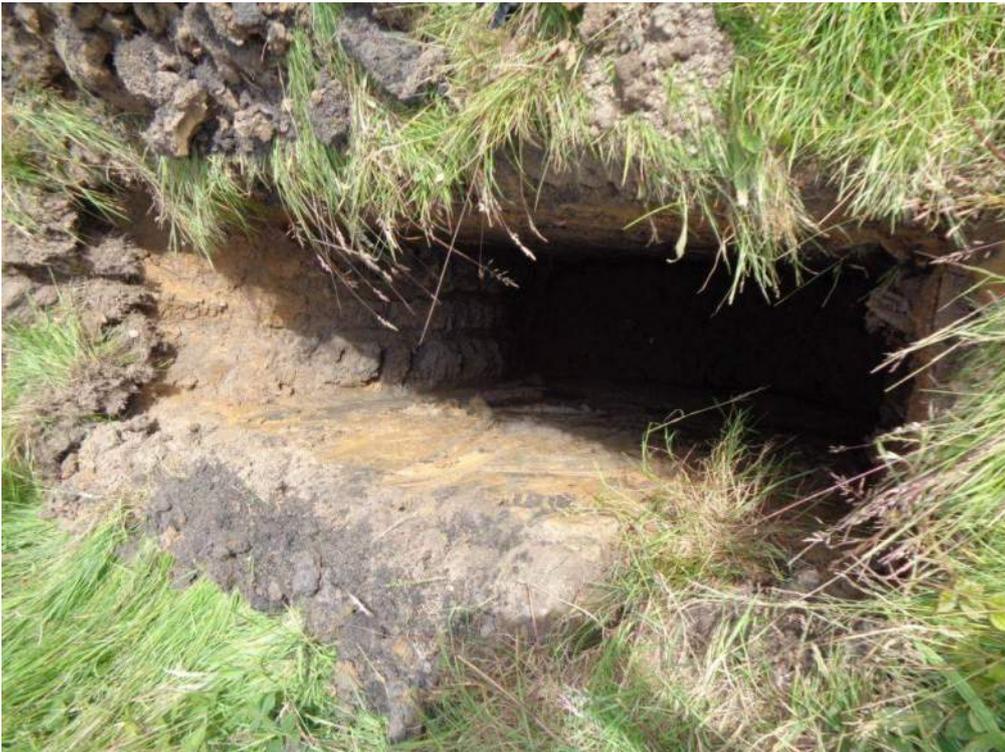
Figure TP009.1
TP009

The outcrop of the suspected 36 Yard Coal was found in the western corner of the site in TP009. The adjacent borehole BH007 reports possible made ground to 3.20m bgl, comprising a variable sequence of very soft to very stiff clay with coal fragments. GS suspect these soils are made ground and represent crop workings into the 36 Yard Coal and associated fireclay(s).

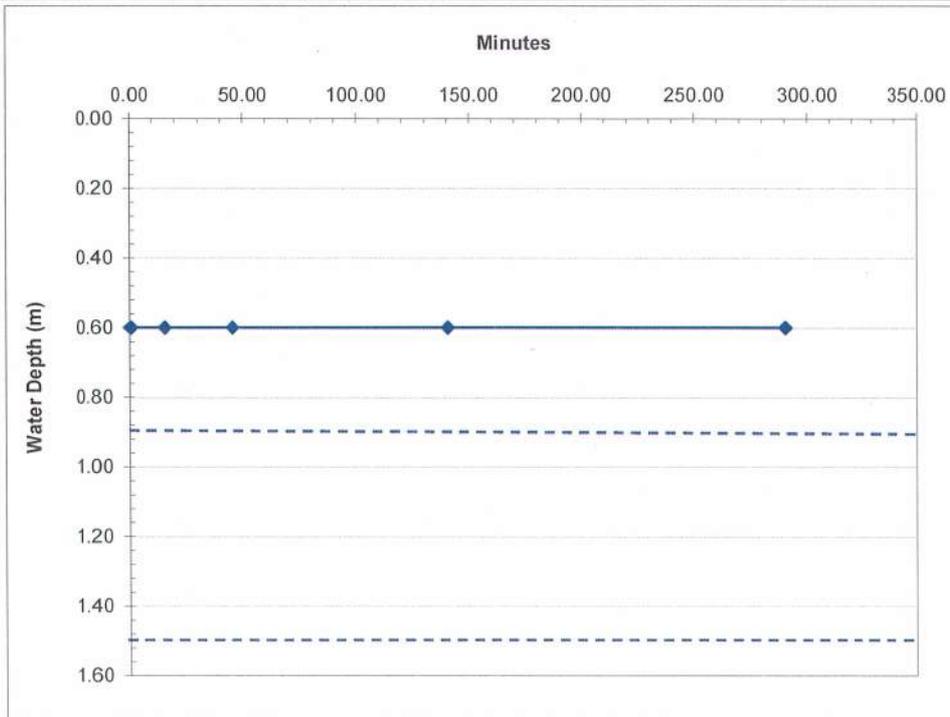
Minutes	Water Depth (m)	Remarks
0.00	0.60	Test Start
15.00	0.60	
45.00	0.60	
140.00	0.60	
290.00	0.60	Test Finish

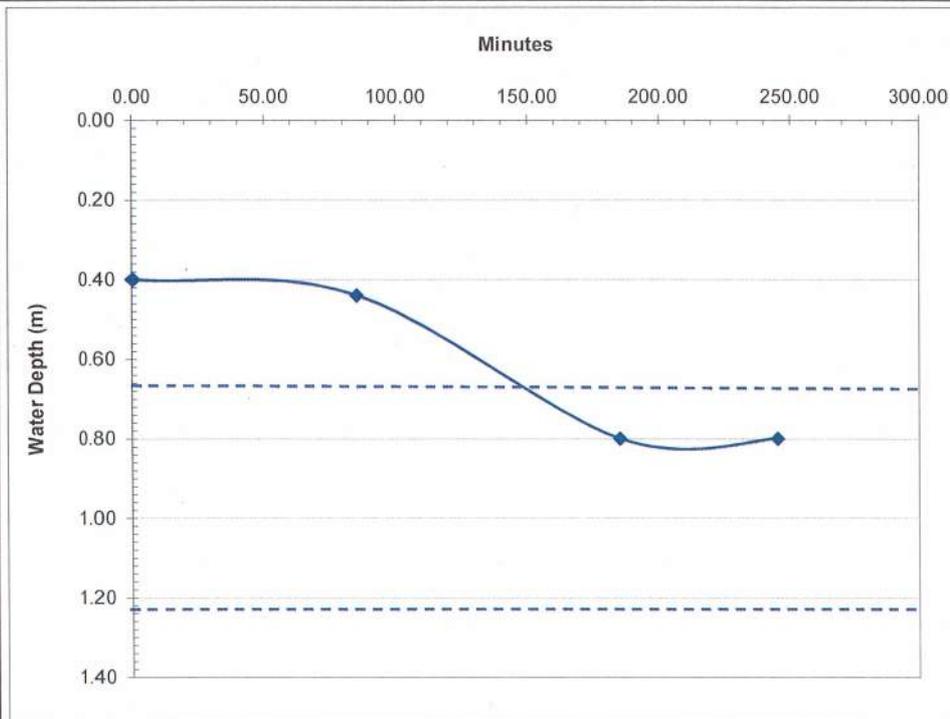
Minutes	Water Depth (m)	Remarks
0.00	0.40	Test Start
85.00	0.44	
185.00	0.80	
245.00	0.80	Test Finish

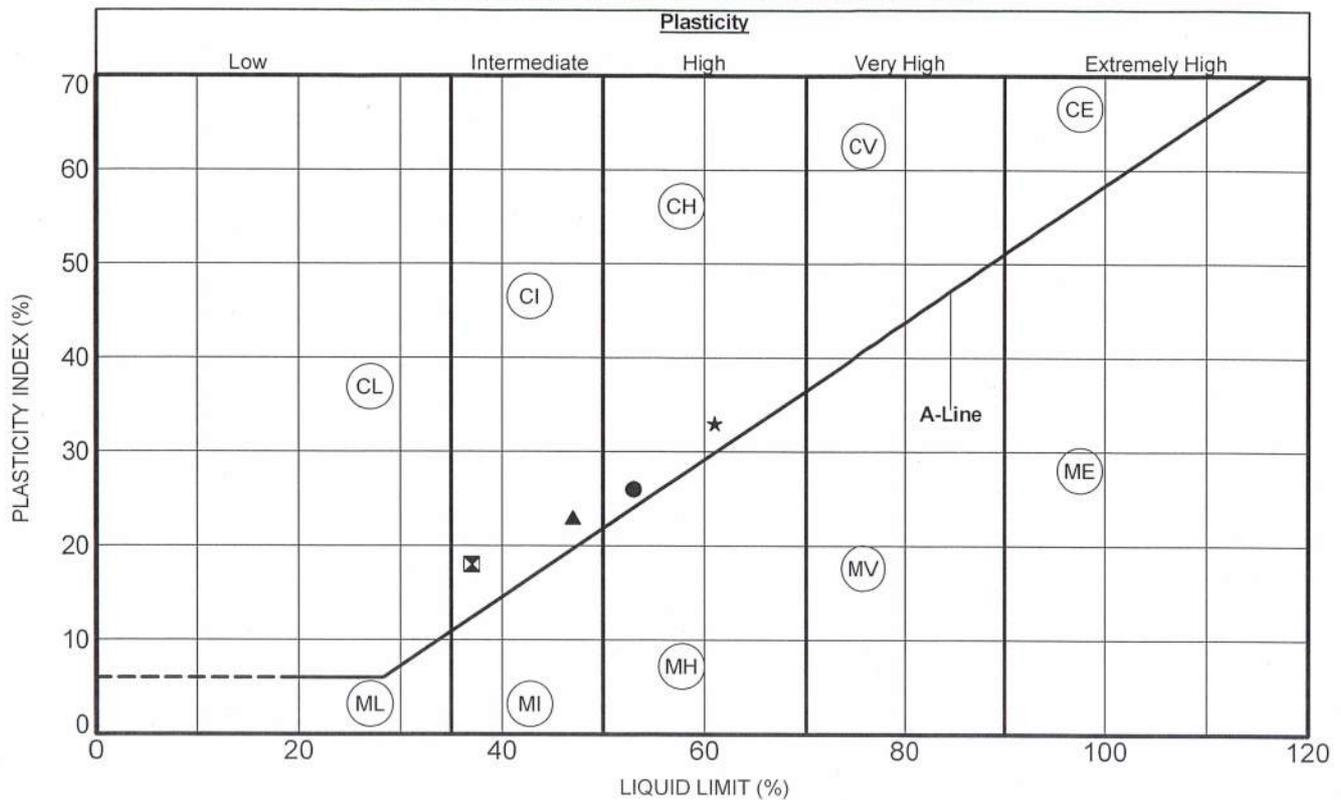
Test Method :- BS 1377 : Part 2 : Clause 3.2, 4.1 to 4.4 & 5 : 1990

Four plasticity tests were carried out on the cohesive residual soils and report modified plastic indices between 15% and 32% (low to medium volume change potential). Moisture contents are reported between 15% and 34%.

Exploratory Hole No.	Depth (m)	Sample Type/Ref.	Specific Depth (m)	LL	PL	PI	I_c	Preparation Method	<0.425mm (%)	m/c (%)	Date Tested	
● TP001	0.50	B5	0.50	53	27	26	-0.14	Air Dried	58.0	23.4	04/09/2019	#
⊠ TP003	0.50	B3	0.50	37	19	18	0.09	Natural	84.0	20.6	04/09/2019	
▲ TP005	1.00	B7	1.00	47	24	23	0.30	Natural	76.0	30.8	05/09/2019	
★ TP009	0.60	B5	0.60	61	28	33	0.18	Natural	98.0	34.0	05/09/2019
