Leeds
CITY COUNCIL

Cavalry Arms Junction, Huddersfield

Ground Investigation Report

Our Scheme Ref: 446368

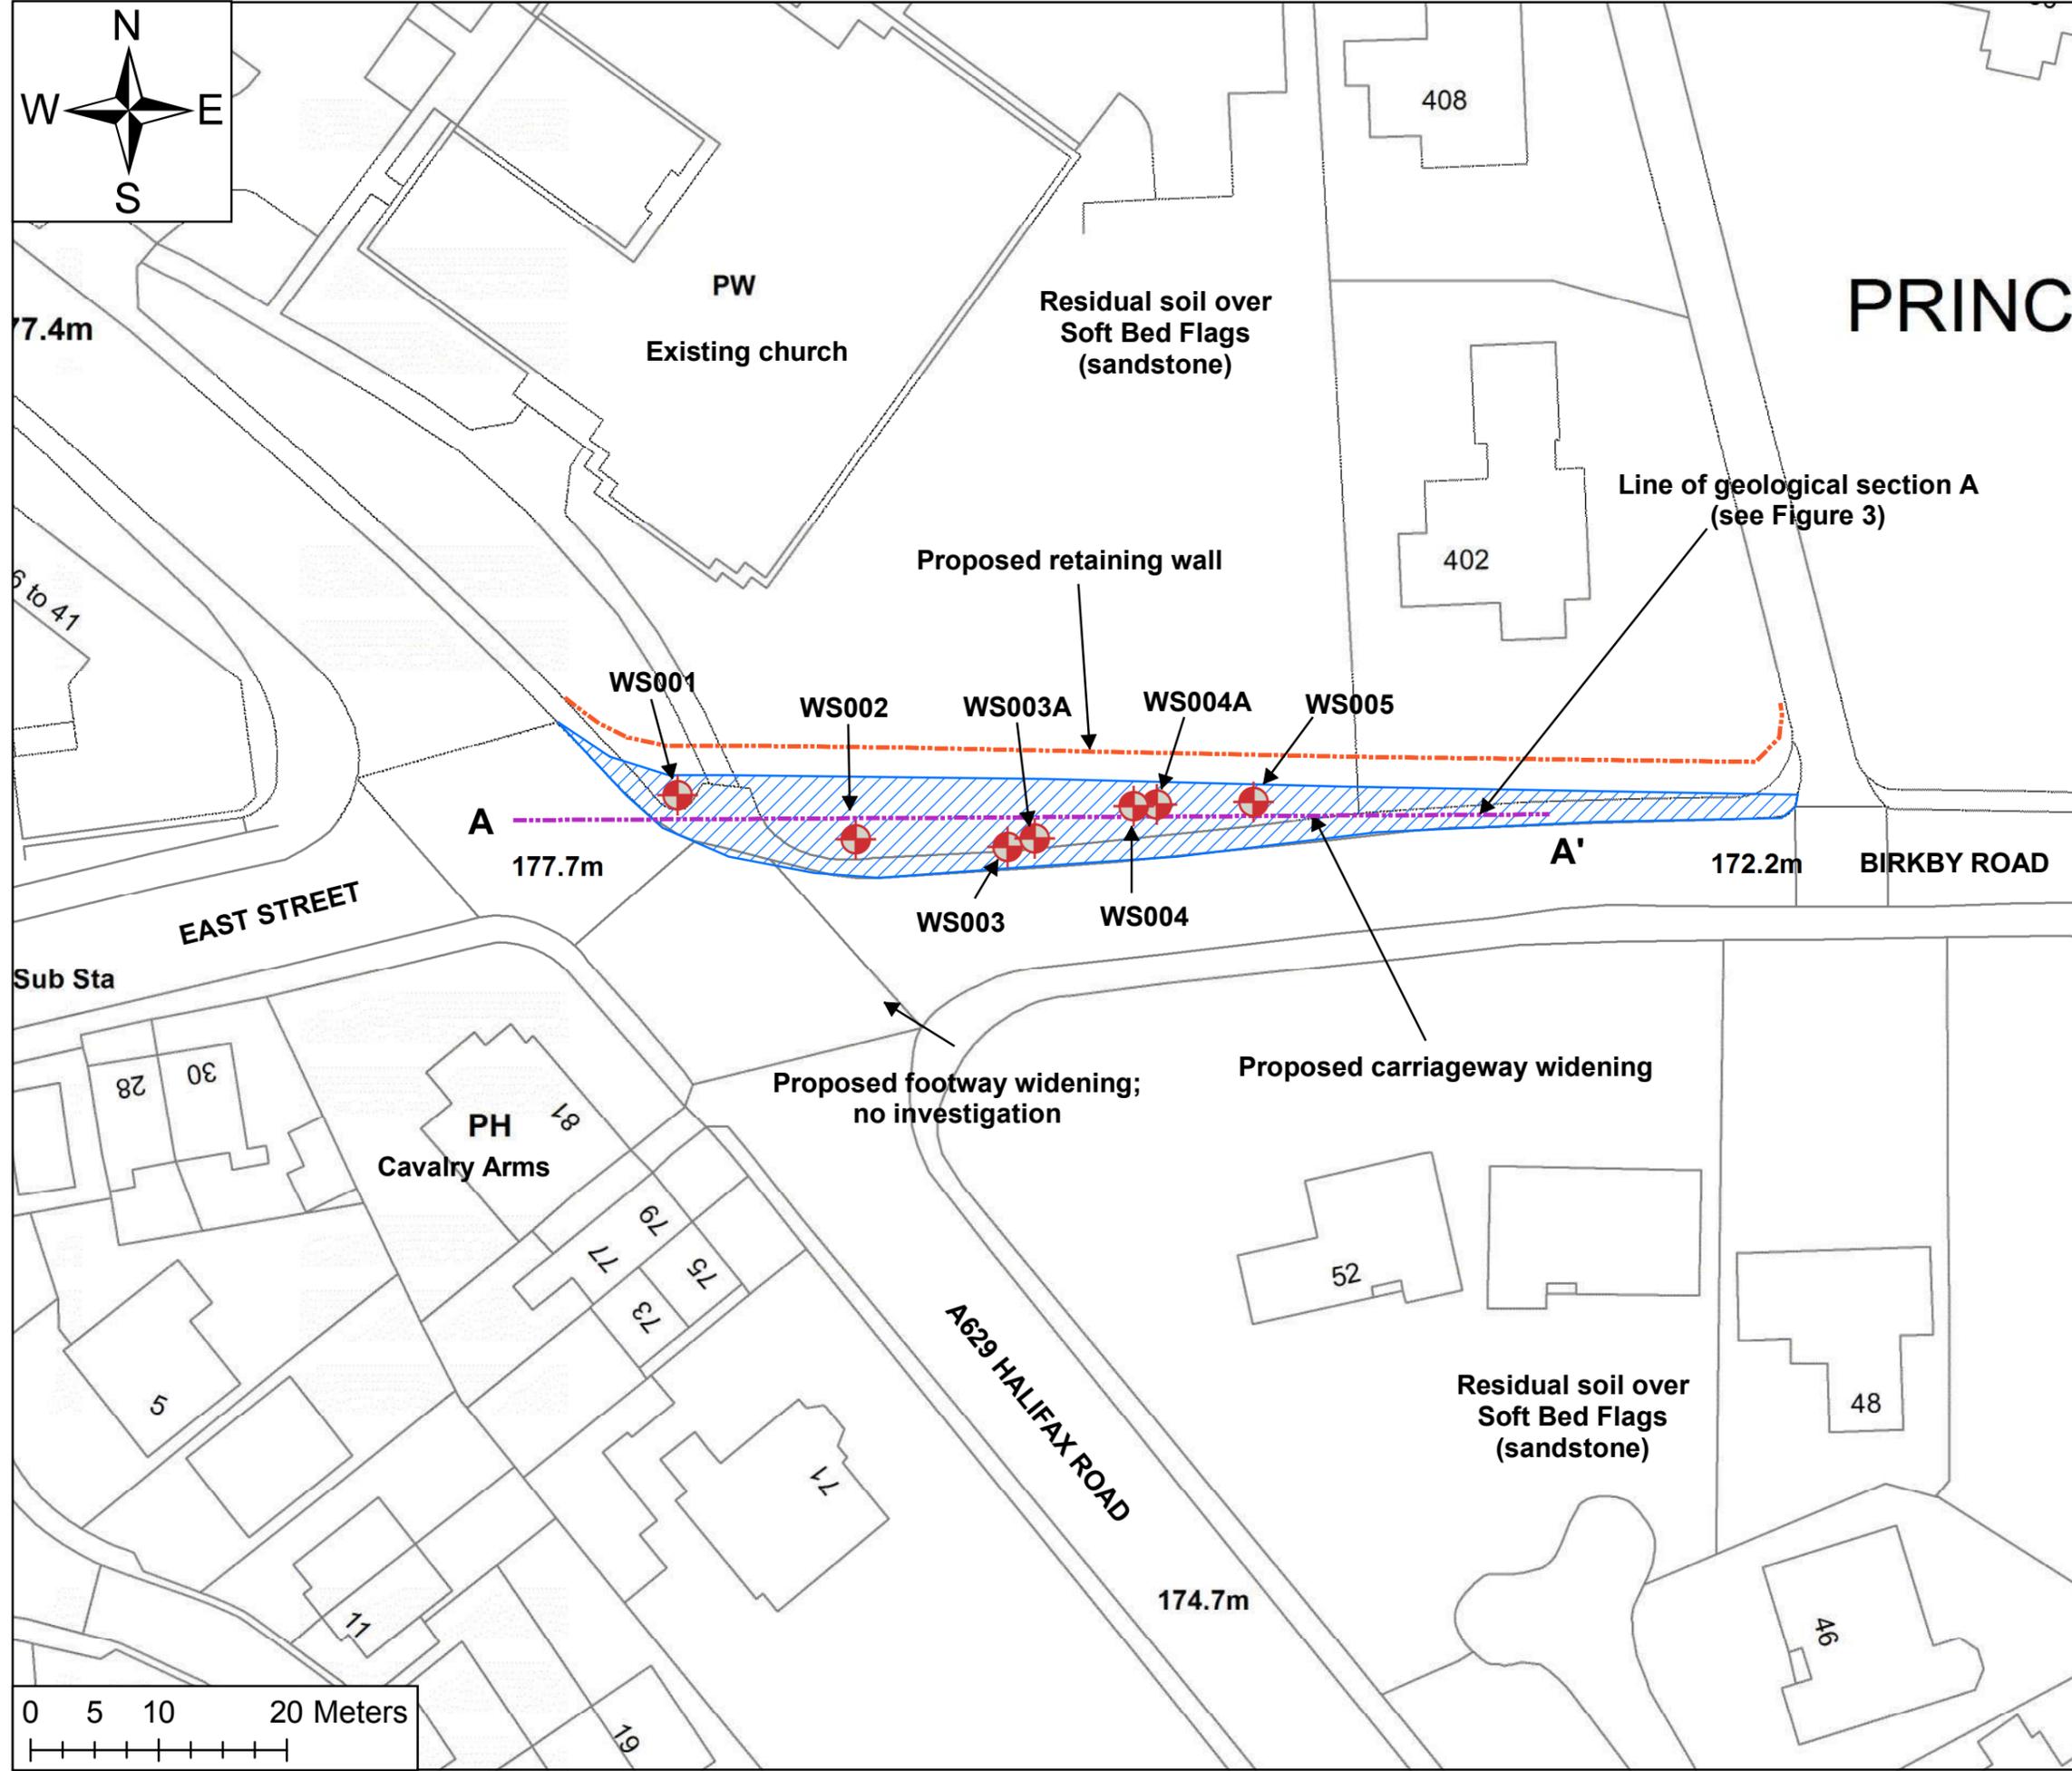
FIGURE: 2

Figure 2 Site Layout Plan

- = Proposed retaining wall (approximate)
- = Proposed new carriageway widening (approximate)
- = Window samples
- = Line of geological section (see Figure 3)

The locations of the exploratory holes are shown on the site layout plan, see Figure 2.

The ground investigation generally confirmed the expected ground conditions on site comprising made ground over cohesive (clay) residual soils over weathered bedrock. The weathered bedrock was found to consist of sandstone and siltstone. An interpretative section have been produced; Geological Section A (see Figure 3). The approximate line of section is shown on Figure 2.

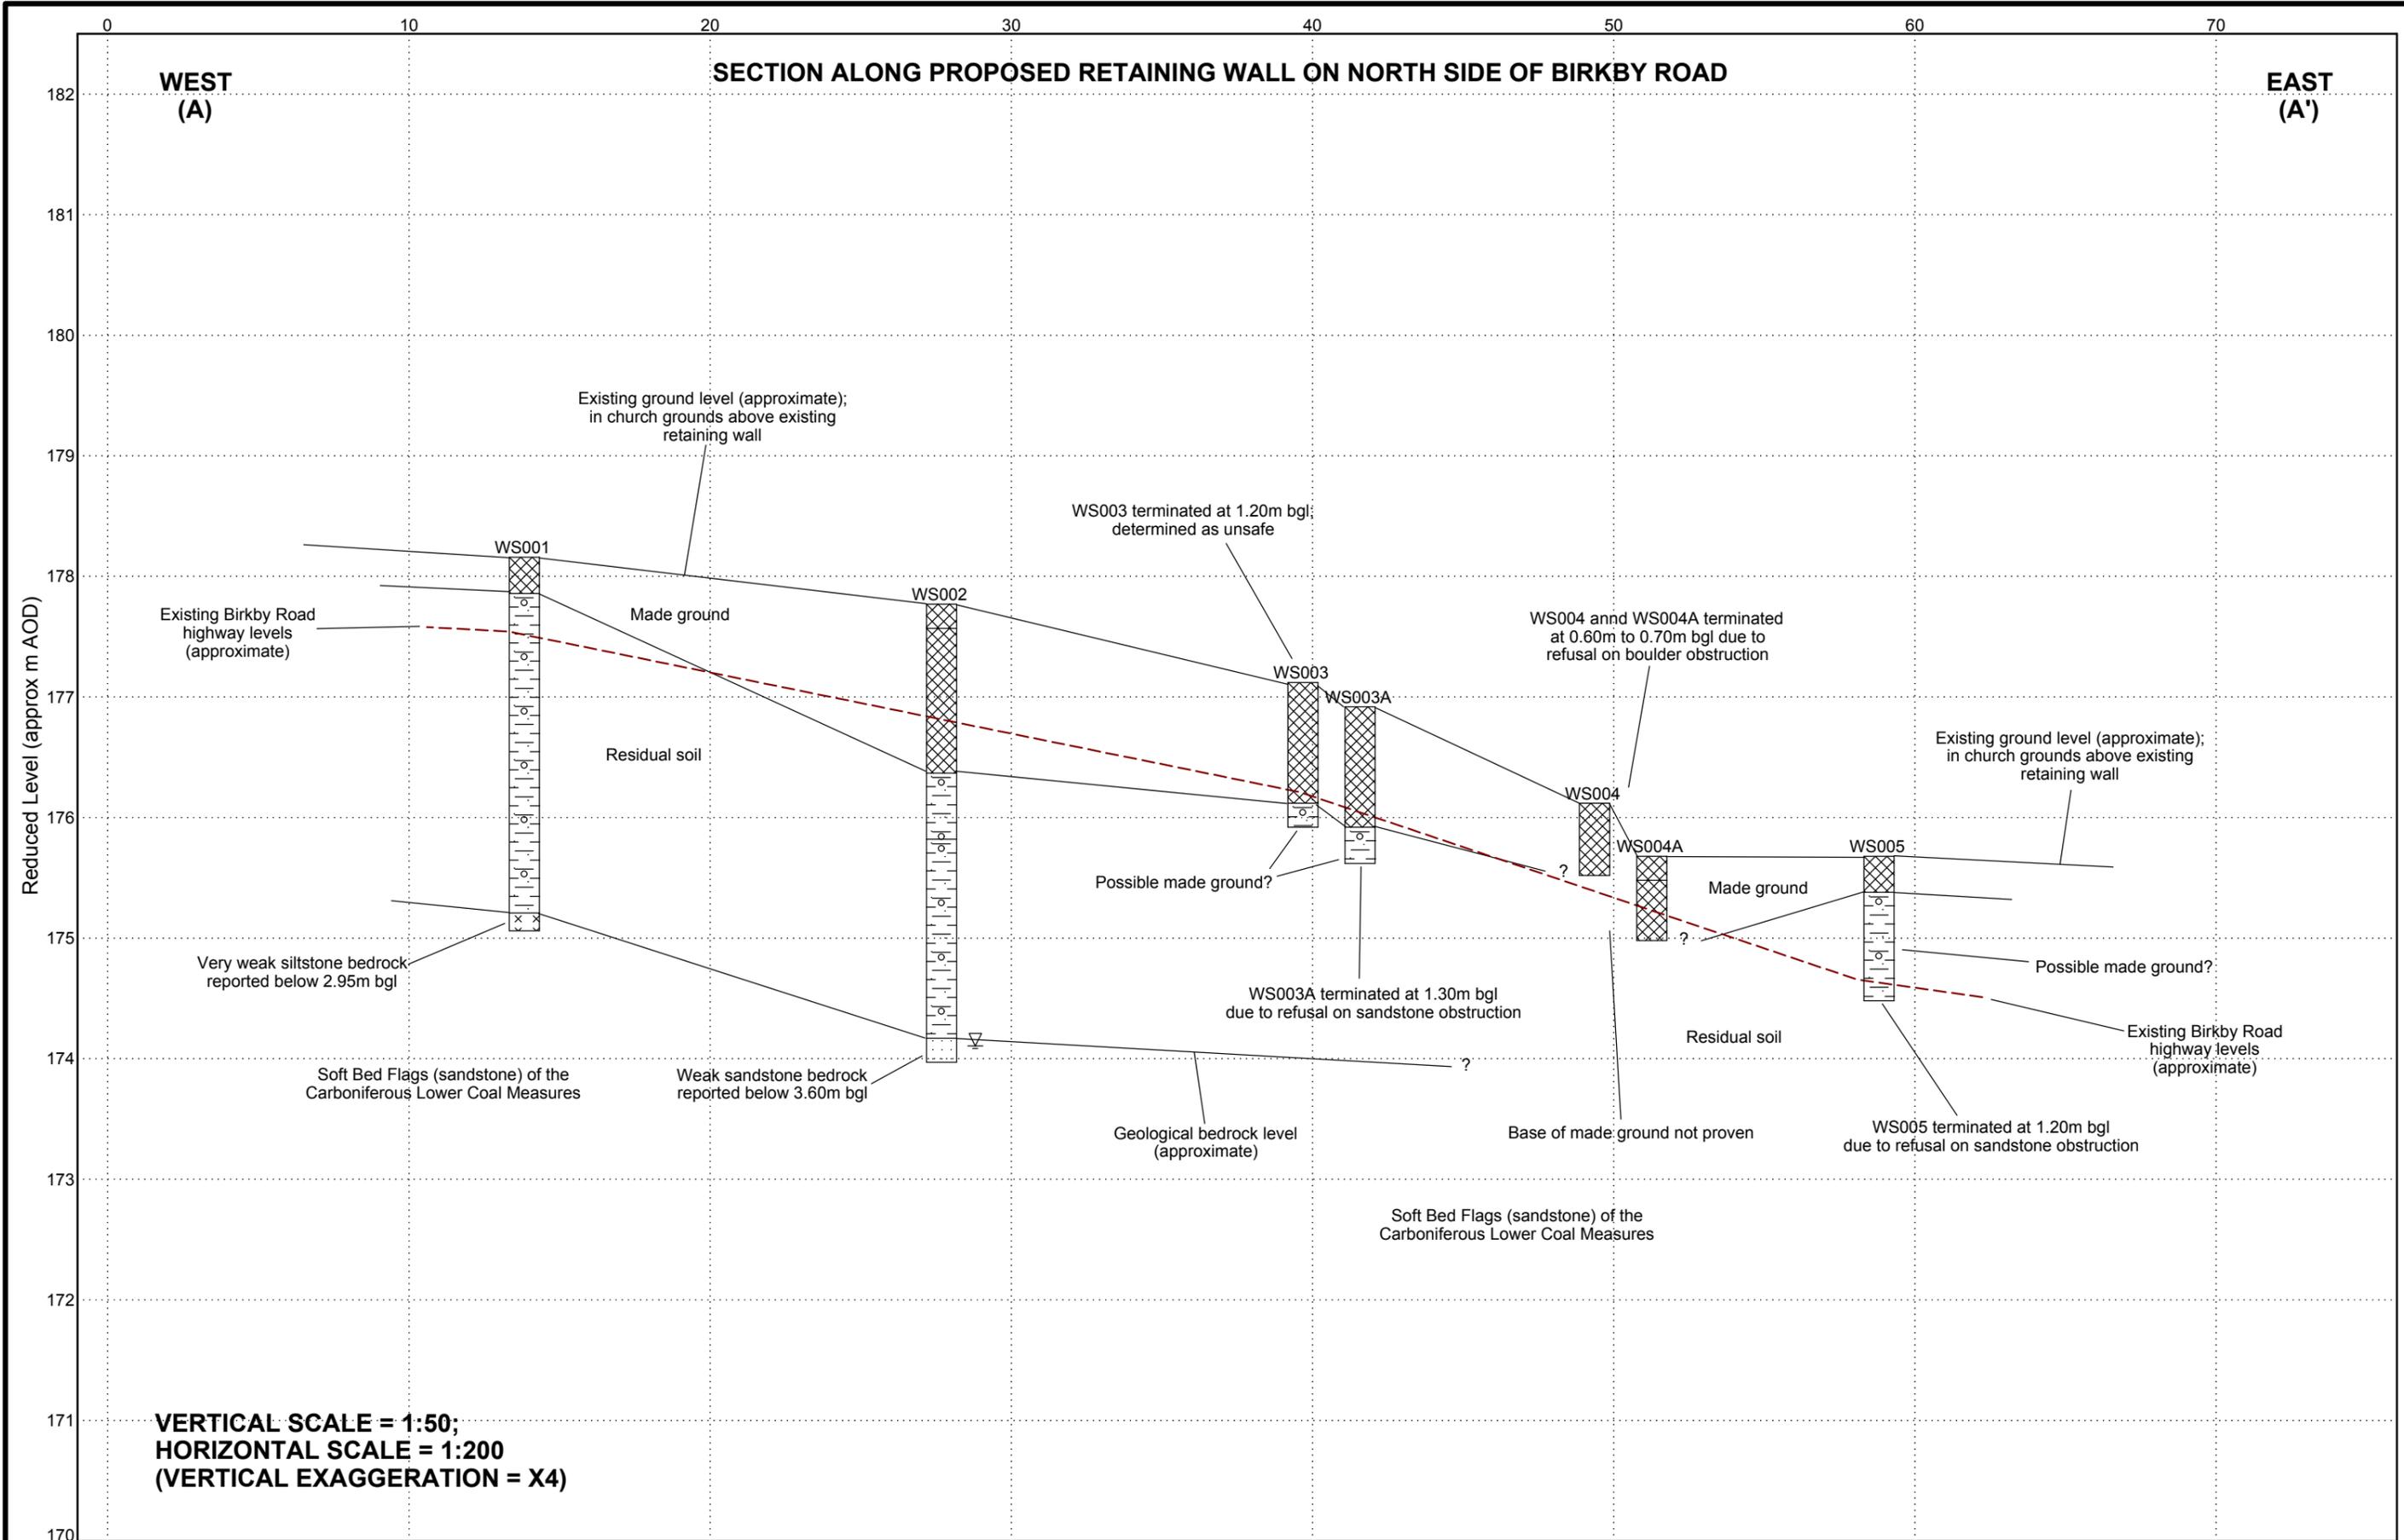
FIGURE 3 / GEOLOGICAL SECTION A

Figure 3 Geological Section A

N= Standard penetration test, blow count for 300mm test zone

50/100 Standard penetration test refusal (blow count/mm penetration) (Also see Key Sheet in Appendix 1)

Natural residual soils were found beneath the surface made ground in the majority of the exploratory holes. The exceptions were at the locations of WS004 and WS004A where the window samples refused on obstructions within the surface made ground. It is also unclear whether WS005, at the eastern end of the site, has positively identified natural residual soils below 0.30m bgl (see Figure 3).

The proposed highway widening will remove the surface made ground (see Figure 3) and the proposed retaining wall will be founded on natural residual soils. Although there are some large trees within the site area, the modified plastic index of the soil is <10% and there are less than 35% fines reported by the laboratory tests, therefore volume change potential is not of concern.

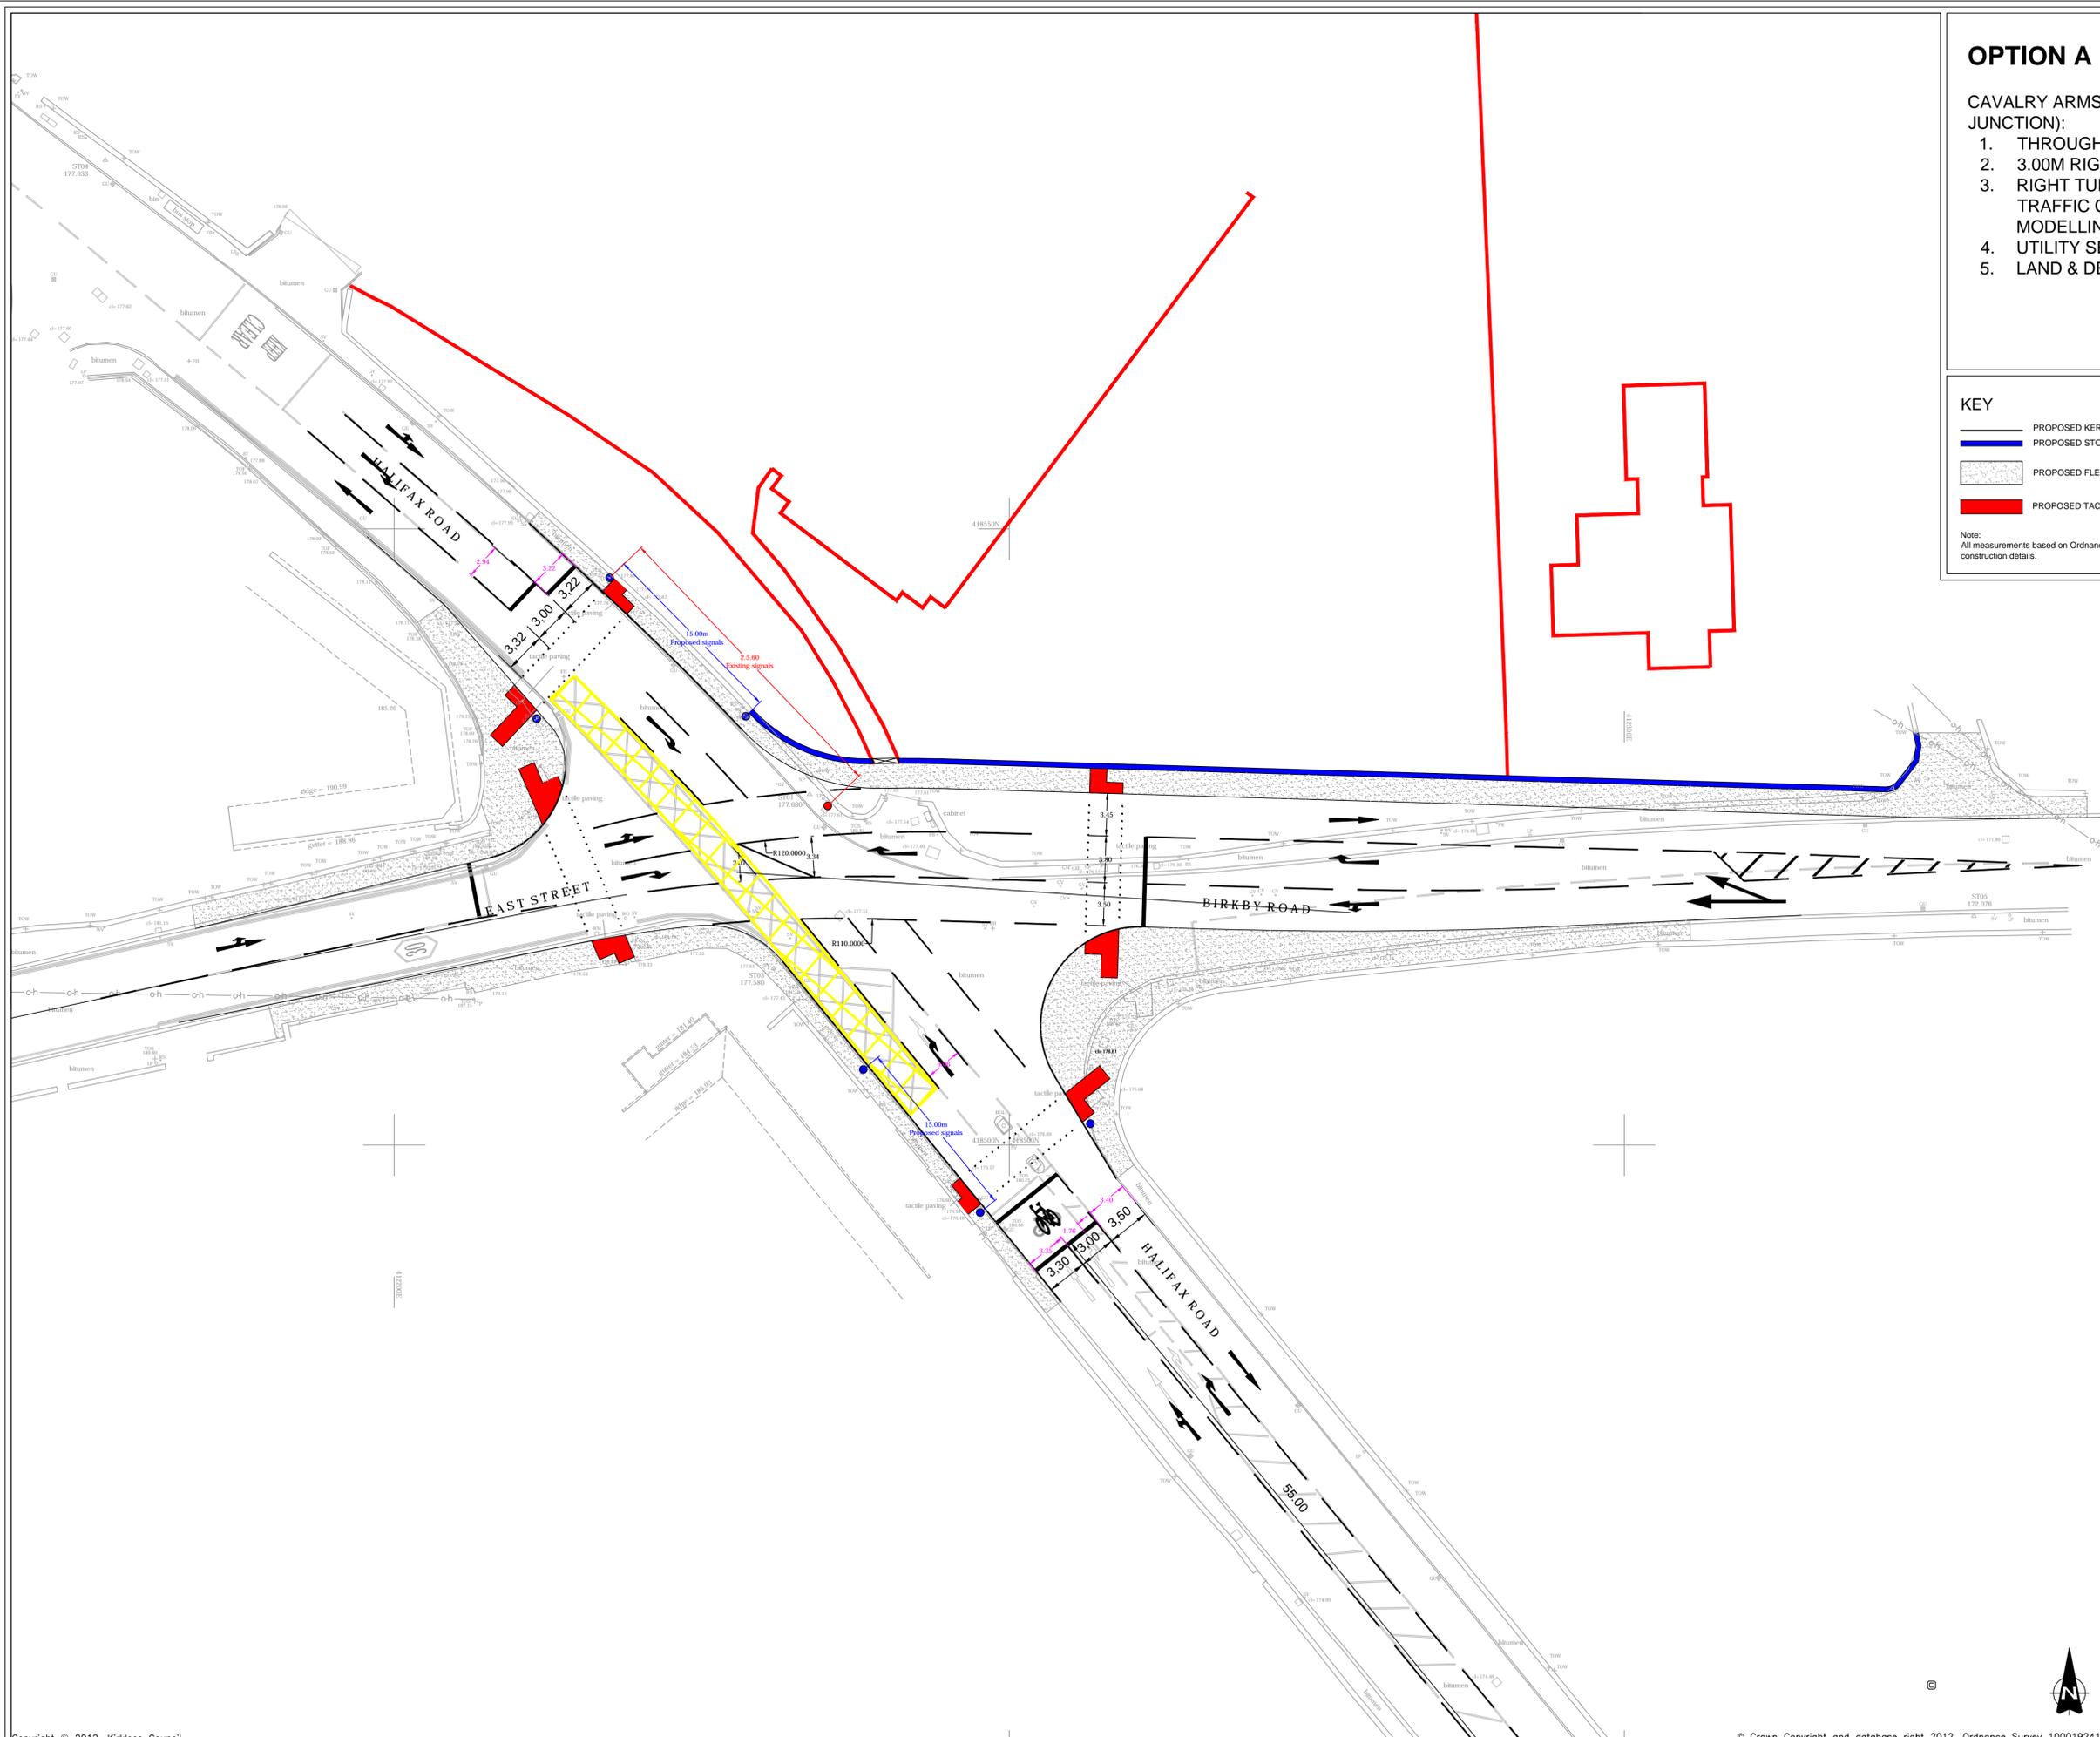
DRAWING No. TF5/WP1/2/A/RSA1-2A
CAD No.

1. THROUGH LANE WIDTH VARIES.
2. 3.00M RIGHT TURNING LANE WIDTH.
3. RIGHT TURN QUEUING LENGTH SUBJECT TO TRAFFIC CAPACITY CALCULATION OR MODELLING.
4. UTILITY SERVICE DIVERSION REQUIRED.
5. LAND & DEMOLITION WORKS REQUIRED

TITLE
CAVALRY ARMS JUNCTION
OPTION A
DRAFT LAYOUT

Appendix 1 Proposed Development

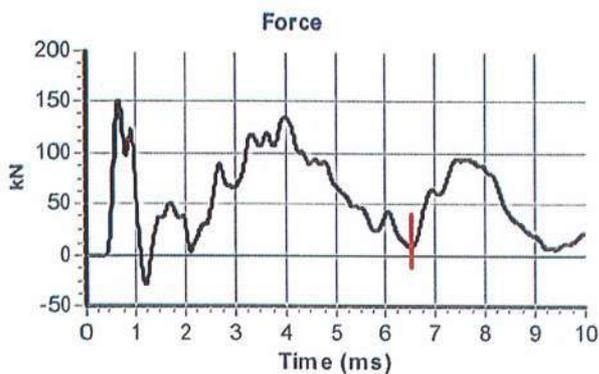
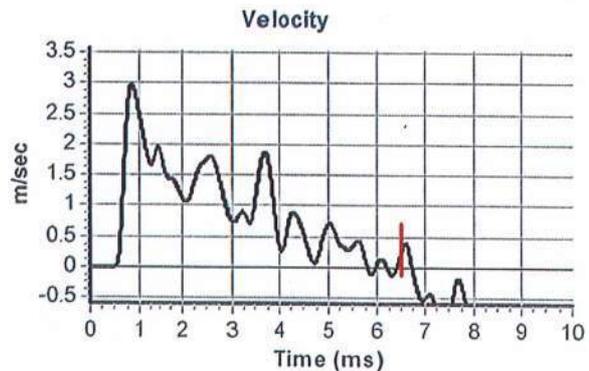
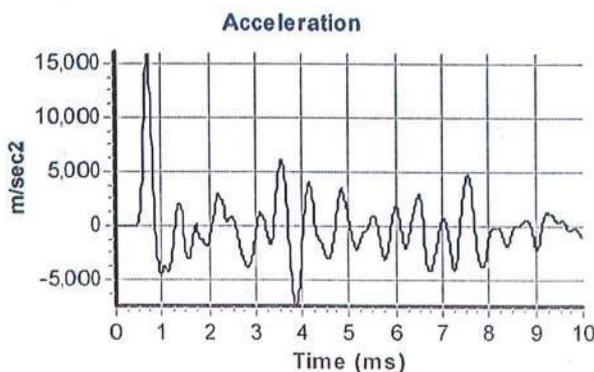
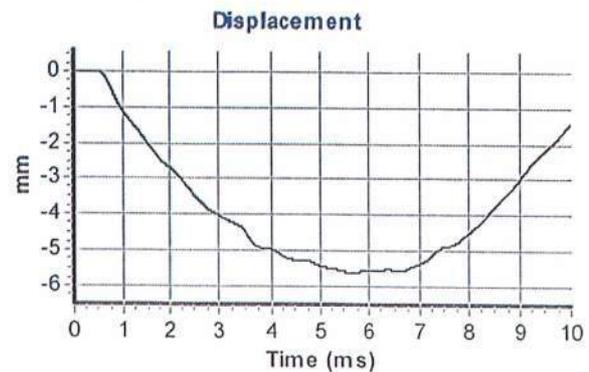
Diameter d_r (mm): 54
Wall Thickness t_r (mm): 6.3
Assumed Modulus E_a (GPa): 208
Accelerometer No.1: 5991
Accelerometer No.2: 5990

Hammer Mass m (kg): 63.5
Falling Height h (mm): 760
SPT String Length L (m): 14.1

Area of Rod A (mm²): 944
Theoretical Energy E_{theor} (J): 473
Measured Energy E_{meas} (J): 375

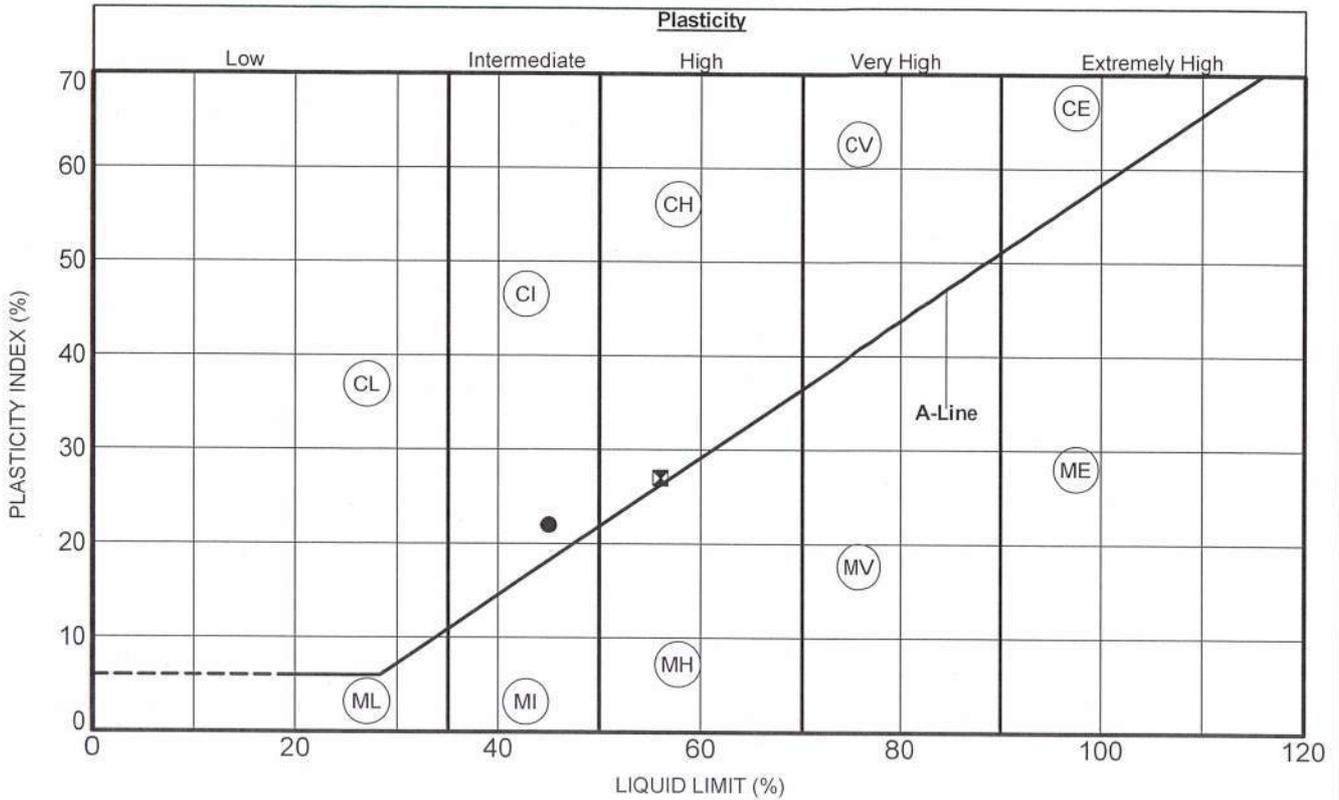
ATTERBERG LIMITS & NATURAL MOISTURE CONTENT

Test Method :- BS 1377 : Part 2 : Clause 3.2, 4.1 to 4.4 & 5 : 1990

Exploratory Hole No.	Depth (m)	Sample Type/Ref.	Specific Depth (m)	LL	PL	PI	I_c	Preparation Method	<0.425mm (%)	m/c (%)	Date Tested
● WS001	0.40	B2	0.40	45	23	22	0.24	Natural	39.0	28.3	03/09/2019
☒ WS004A	0.60	B3	0.60	56	29	27	-0.02	Natural	50.0	28.4	03/09/2019

A single particle size distribution test was carried out on a sample of the made ground soil at 0.60m bgl. The test reports 14% fines (clay and silt), 61% sand and 25% gravel sized fragments. A single plasticity test was carried out on the fine fraction of the same sample of and the reports modified plasticity index of 13.5% (low volume change potential). The moisture content of the sample was reported to be 28% with a respective plastic limit of 29%.

A single particle size distribution test was carried out on a sample of the residual soil at 0.40m bgl. The test reports 16% fines (clay and silt), 36% sand, 38% gravel and 10% cobble sized fragments. A single plasticity test was carried out on the natural soil and reports a modified plastic index of 8.6% (very low volume change potential). A moisture content of 28% is reported; 5.3% above (wet of) the plastic limit.
