**Job name:** KMCPRP-139-010-049 A629 Halifax Road

**Job No:** S12427

**Note No:** S12427-JNP-XX-XX-TN-G-1006-P02

**Subject:** Updated Conceptual Site Model – Area B (Cavalry Arms)

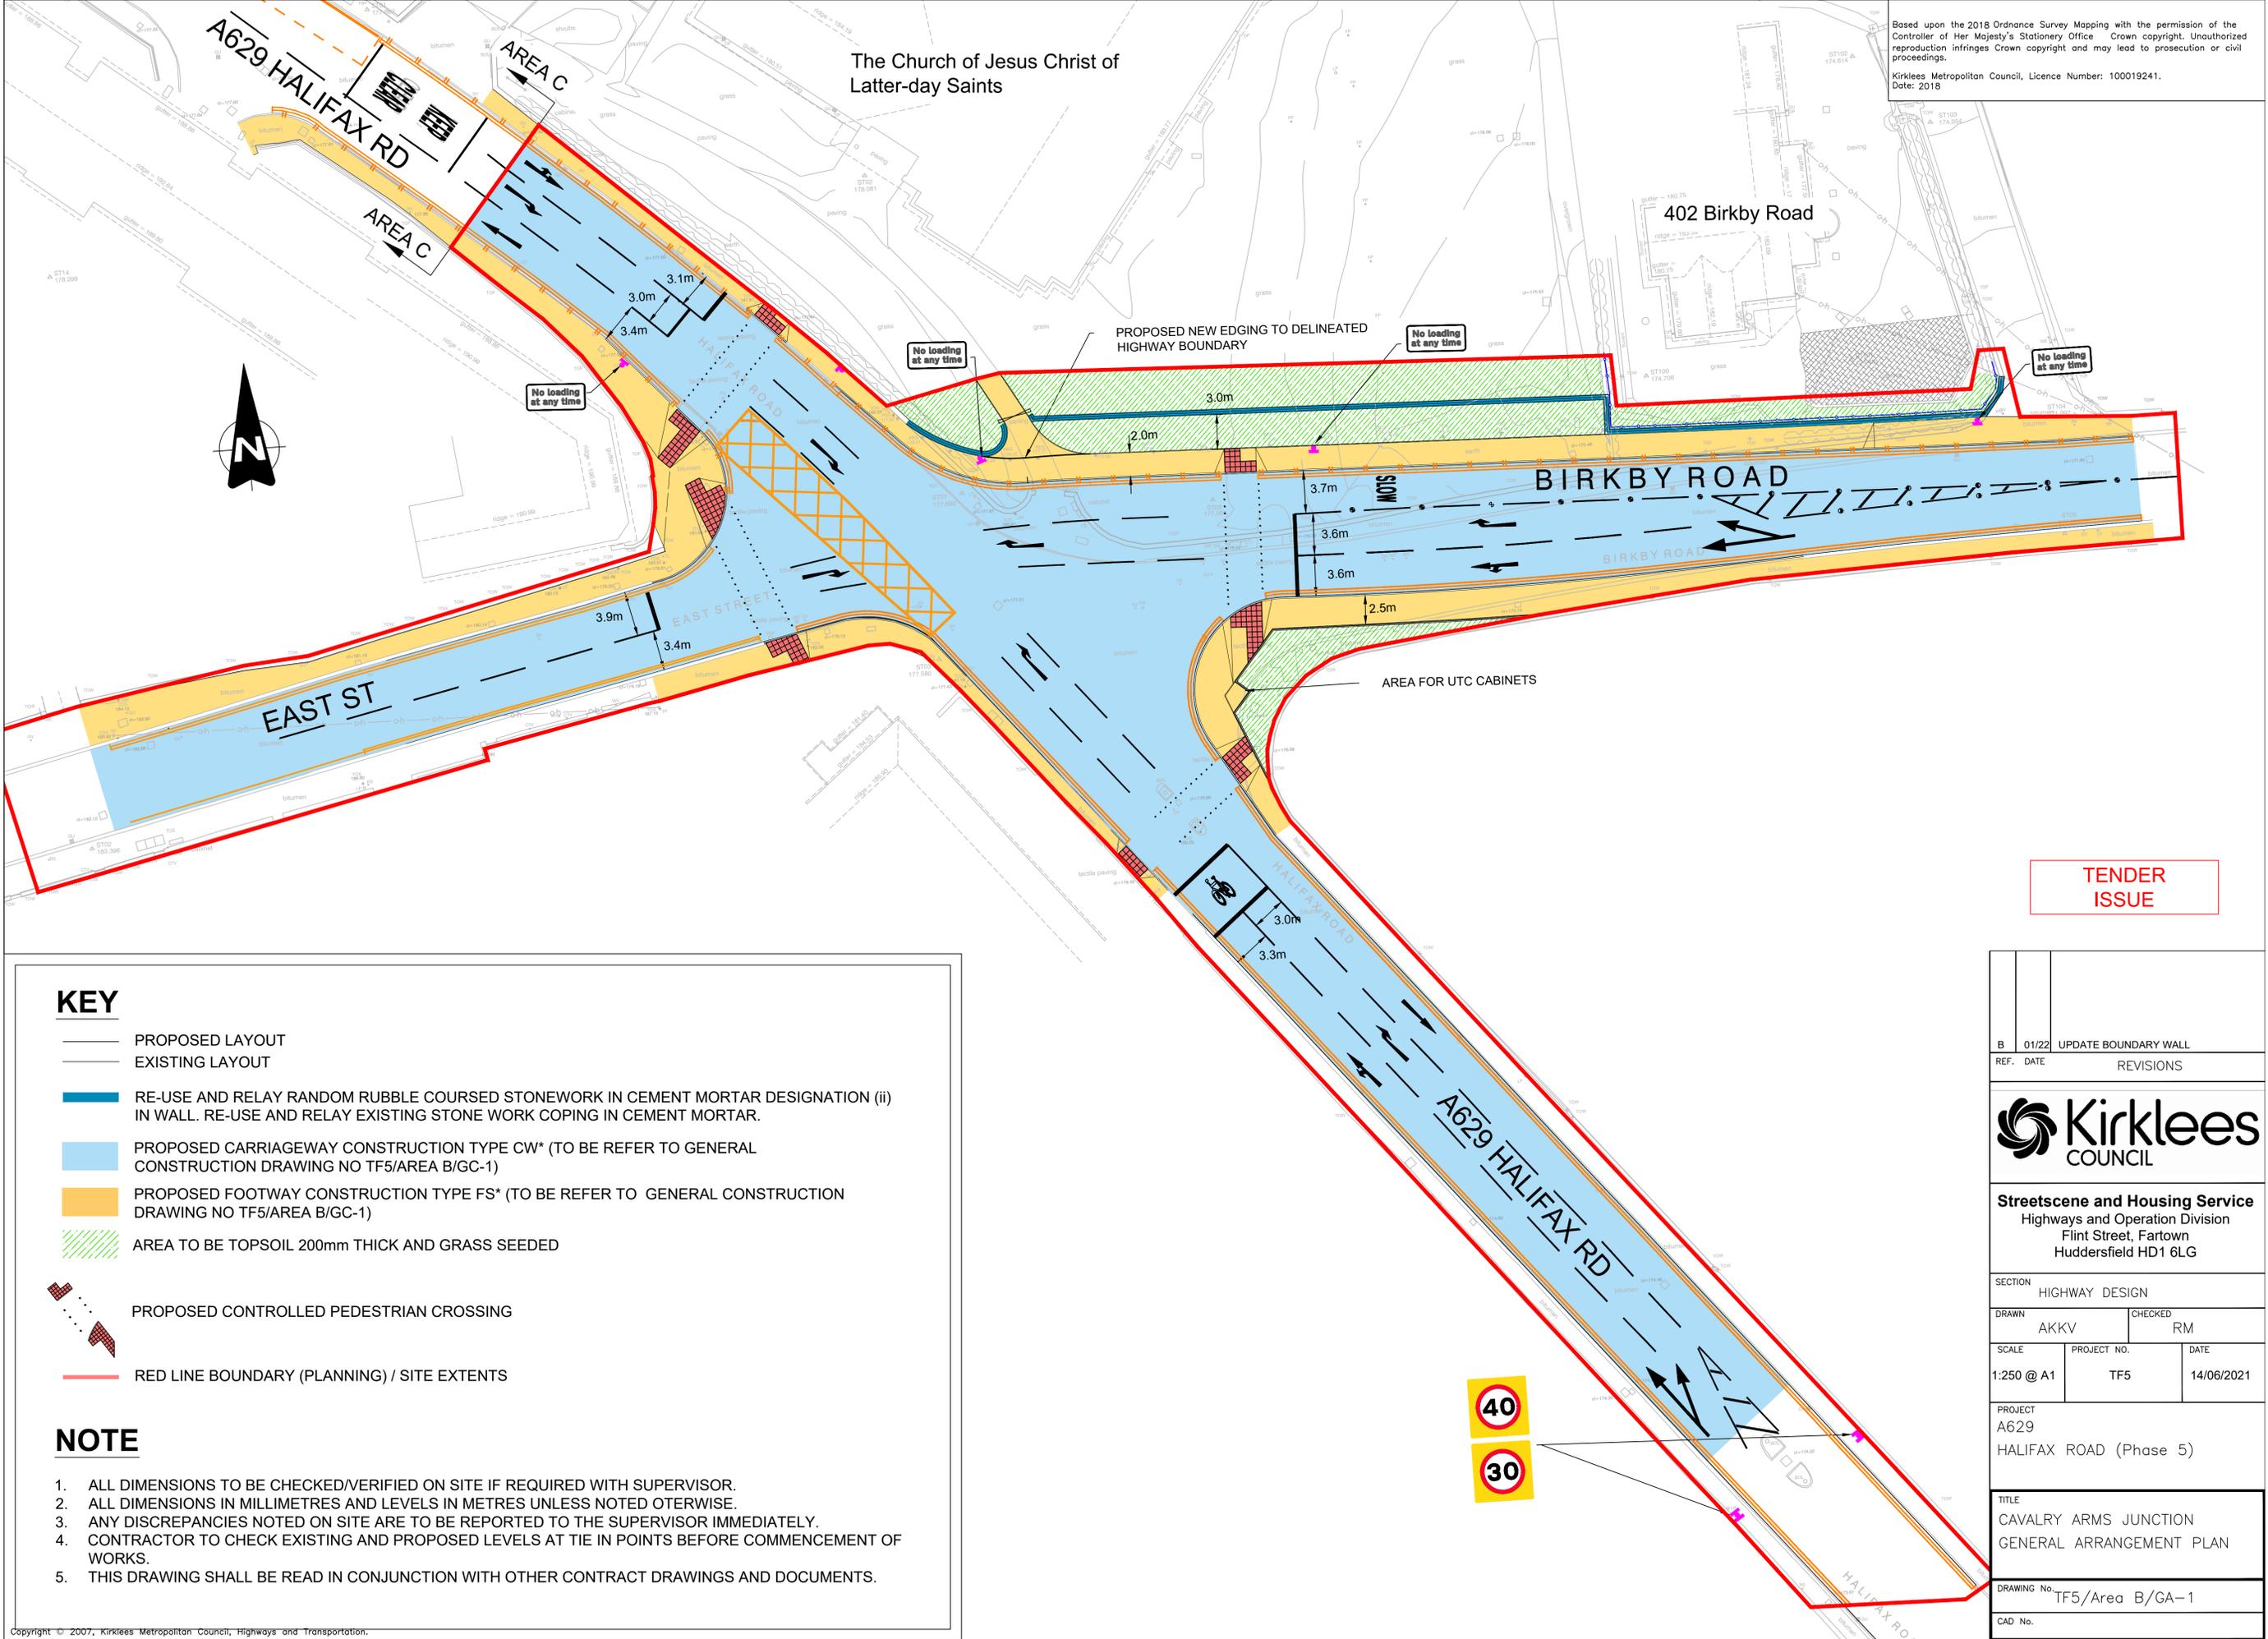
- 2.2 Alterations to the highway junction on the A629 Halifax Road between Birkby Road and East Street are proposed, as shown in the GA Plan (TF5/Area B/GA-1, REV B, dated 01/22, Appendix A). These comprise widening of Birkby Road to the north east of the junction, works to the existing carriageway and pavements and new grassed areas to the north and south of Birky Road, on the eastern side of the junction.
