Proposed Redevelopment at Whitley Lower

Phase II Interpretative Report

March 2024

Project: Proposed Development at Whitley Lower Phase II Intrusive Investigation

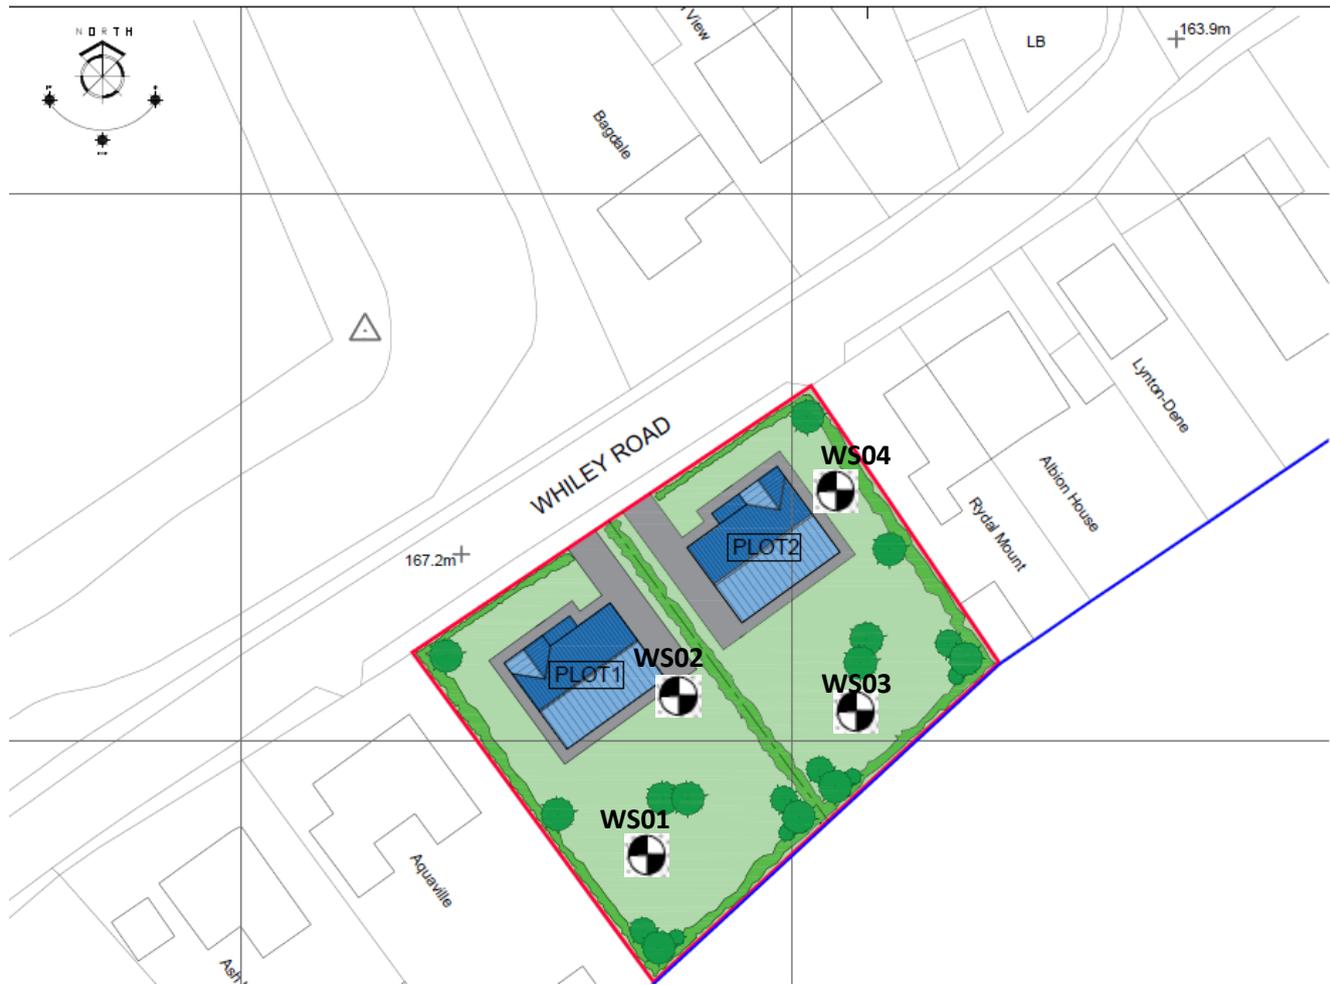
Boreholes

An exploratory hole location plan is shown in Appendix A.

The exploratory hole location plan is shown in Appendix A and full exploratory hole logs are included as Appendix B.
