COAL MINING INVESTIGATION REPORT

Report on Rotary Probing

Location: **Whitley Road**
Lower Whitley, Dewsbury, WF12 0NB

Report No. C3619/23/E/5493

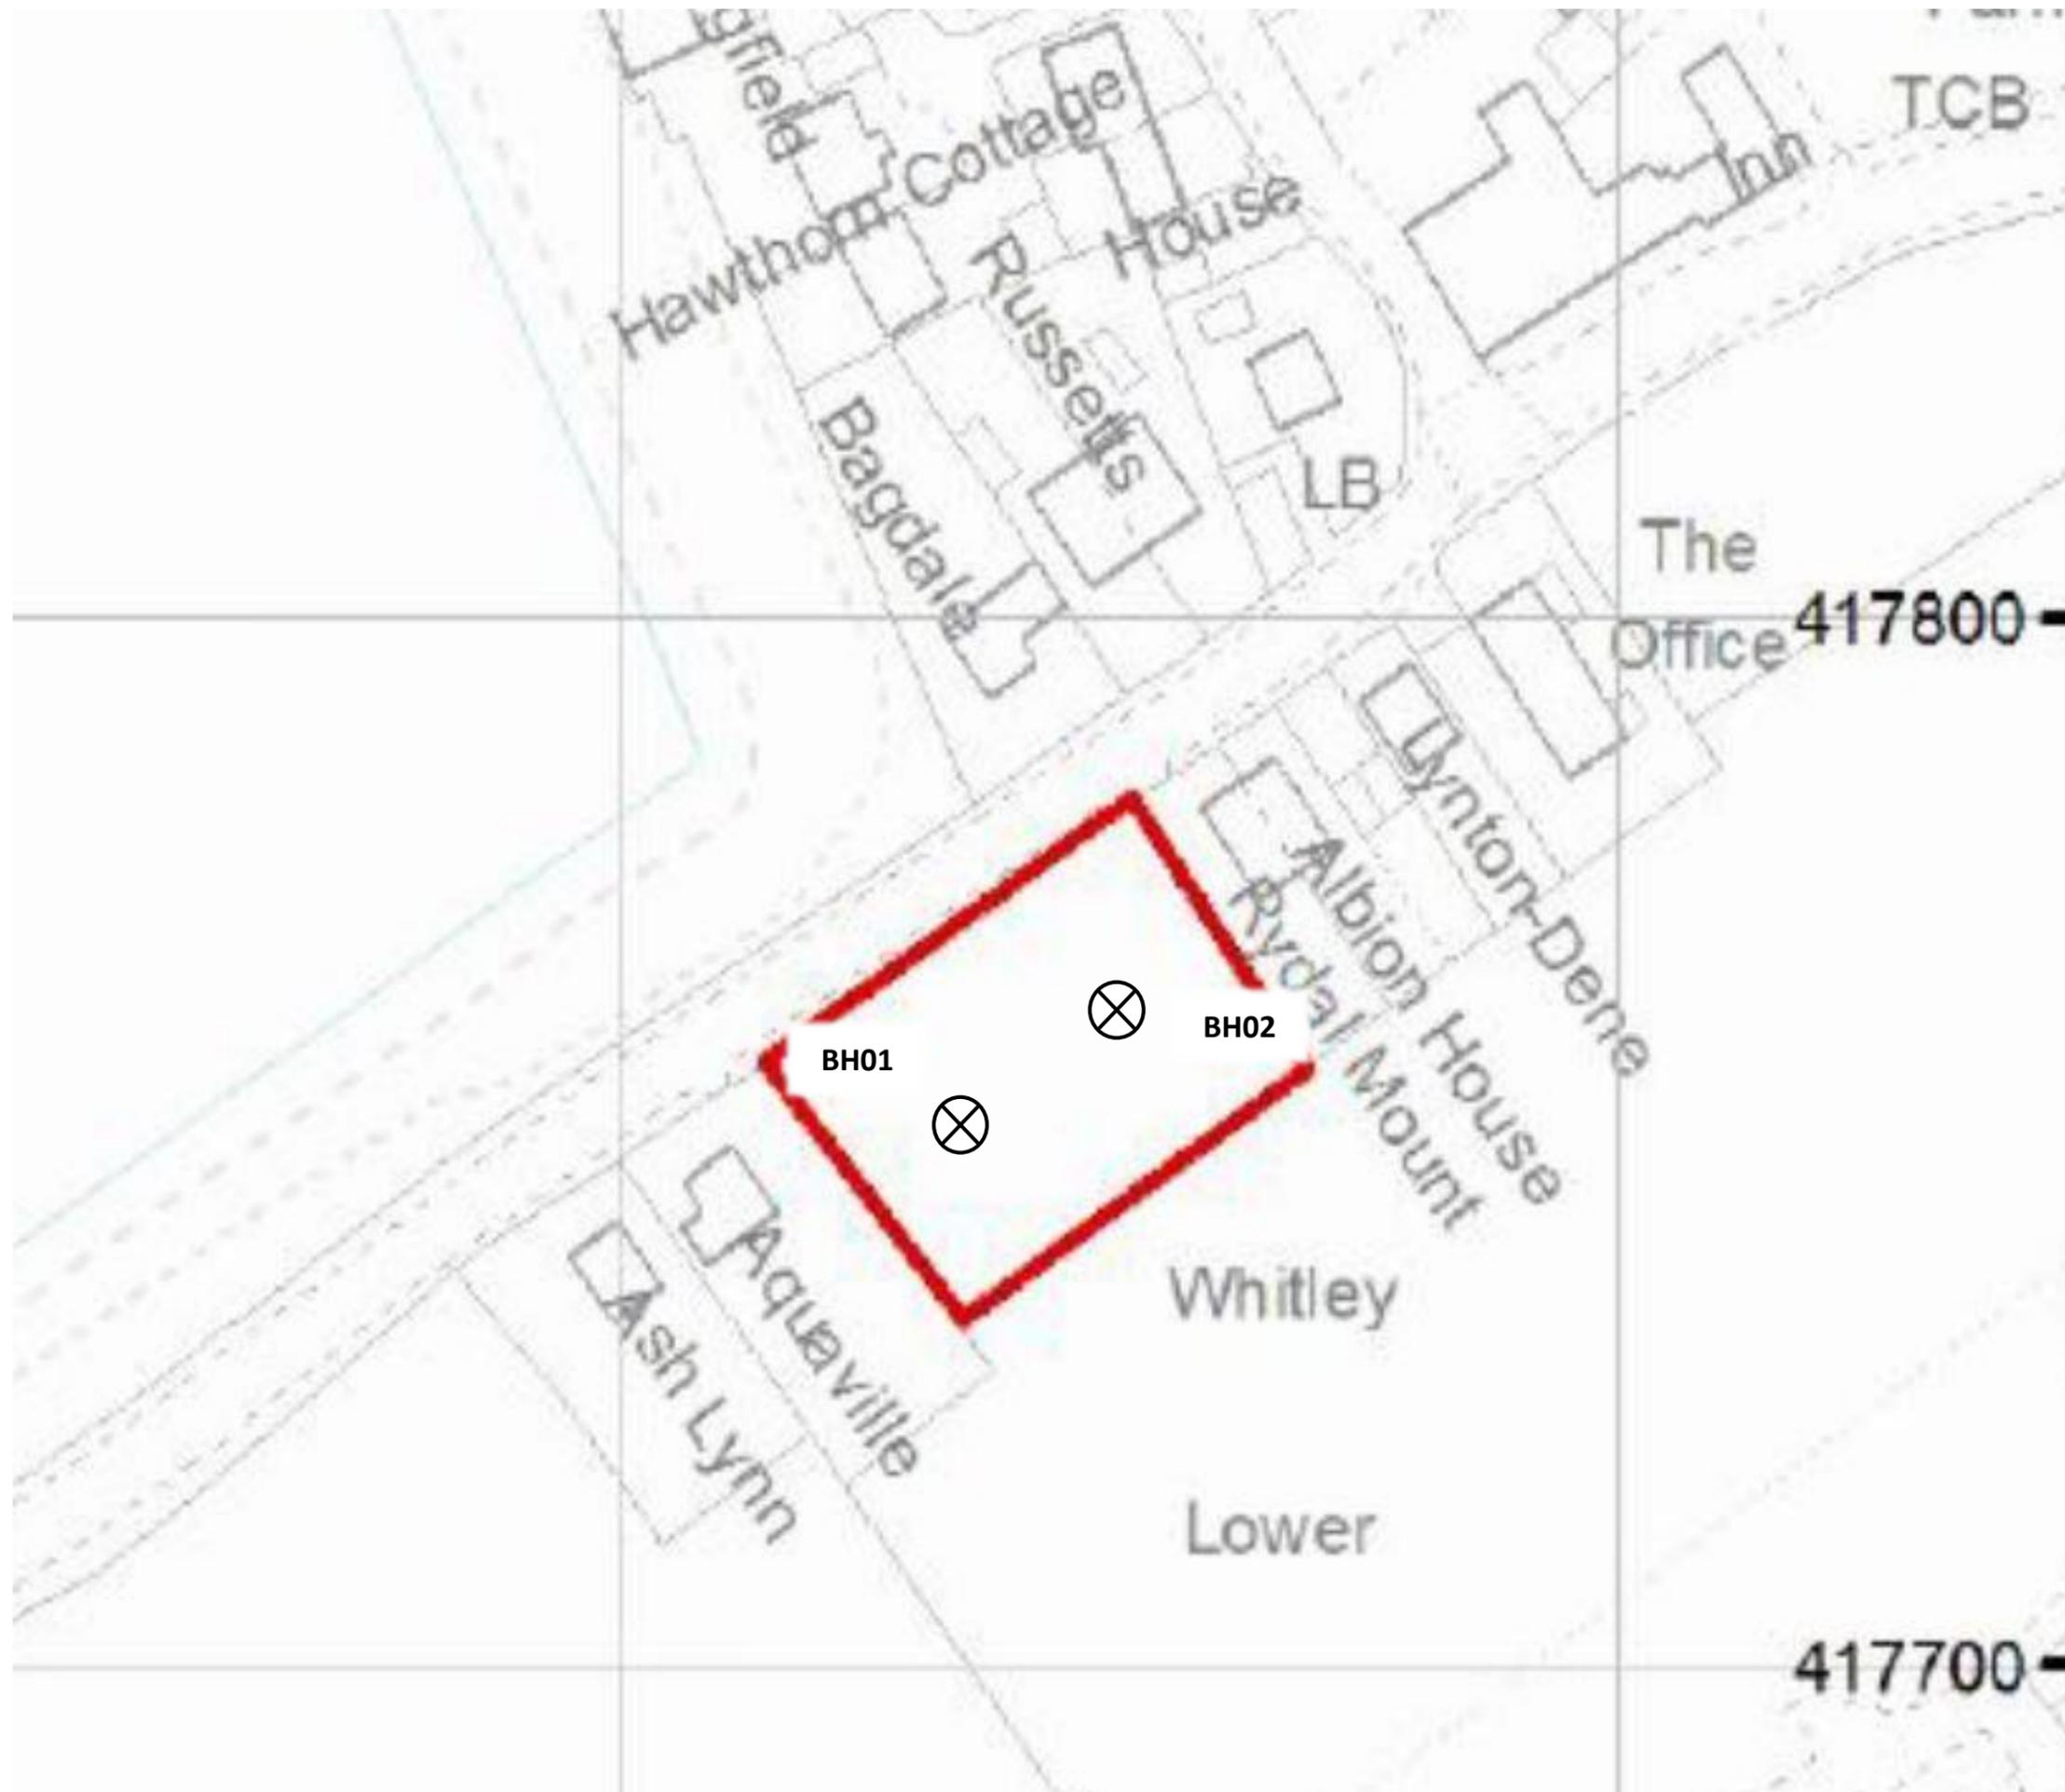
Site Plan

Investigation positions approximated from site operative's notes.

The boreholes were sunk using a Comacchio 205 rotary drilling rig using rotary open-hole drilling techniques and employing 130mm diameter drag and tricone roller bits. Where necessary, 140mm diameter casing was temporarily installed through the overburden to support the bore. The investigation was undertaken using water flush drilling techniques in accordance with the Coal Authority and Health and Safety Executive positioning statement. Drill chippings brought to surface in the flush returns were inspected by the driller on a screen, which forms part of the re-circulation tanks. In addition, representative disturbed samples of the arisings were taken at regular depth intervals and sealed in plastic containers. The borehole positions are shown on the site plan, which is presented in Appendix 2 and the strata conditions are presented on the borehole records in Appendix 3.
