5.0 OUTLINE CONCEPTUAL MODEL

CLOUGH HOUSE, LEEDS ROAD, BIRSTALL

SITE PHOTOGRAPHS

E+P
Eastwood & Partners
 CONSULTING ENGINEERS

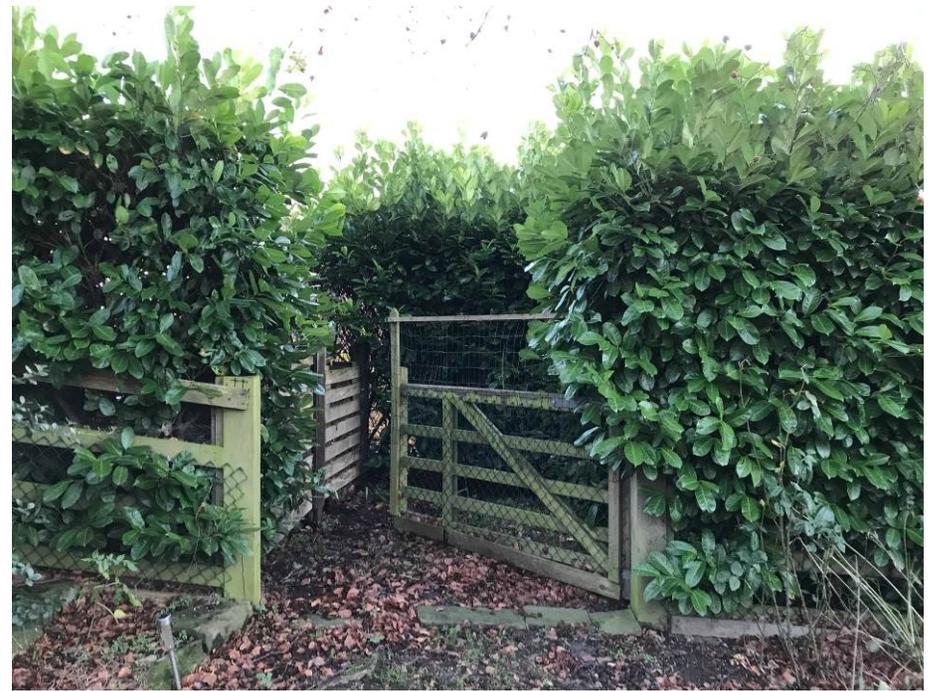
Prepared	NG	Checked	CAT	Date	09.12.19	Photograph No	3 & 4
----------	----	---------	-----	------	----------	---------------	-------

Hardstanding is present across a large portion of the western half of the site which will need broken out as part of any investigation. A walled / fenced garden directly east of Clough House is currently inaccessible for large machinery, only pedestrian access is possible.

Pedestrian access to the enclosed garden located to the east of Clough House

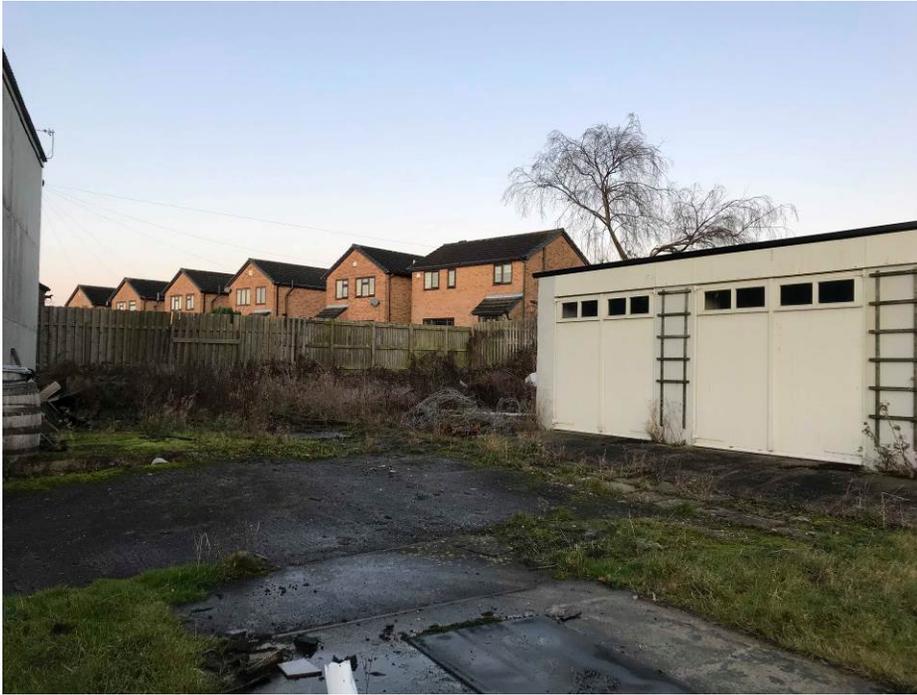
Prepared	NG	Checked	CAT	Date	09.12.19	Photograph No	7 & 8
-----------------	----	----------------	-----	-------------	----------	----------------------	-------

The site slopes down to Leeds Road on the southern boundary at an approximate gradient of around 1 in 24. The ground level of site was noted to be around 0.5 m lower than Moat Hill Farm Drive located directly west of the boundary and where an access road is expected to be built. Site levels may therefore require re-grading.

View looking west between outbuildings towards the entrance to Moat Hill Farm Drive beyond the site boundary

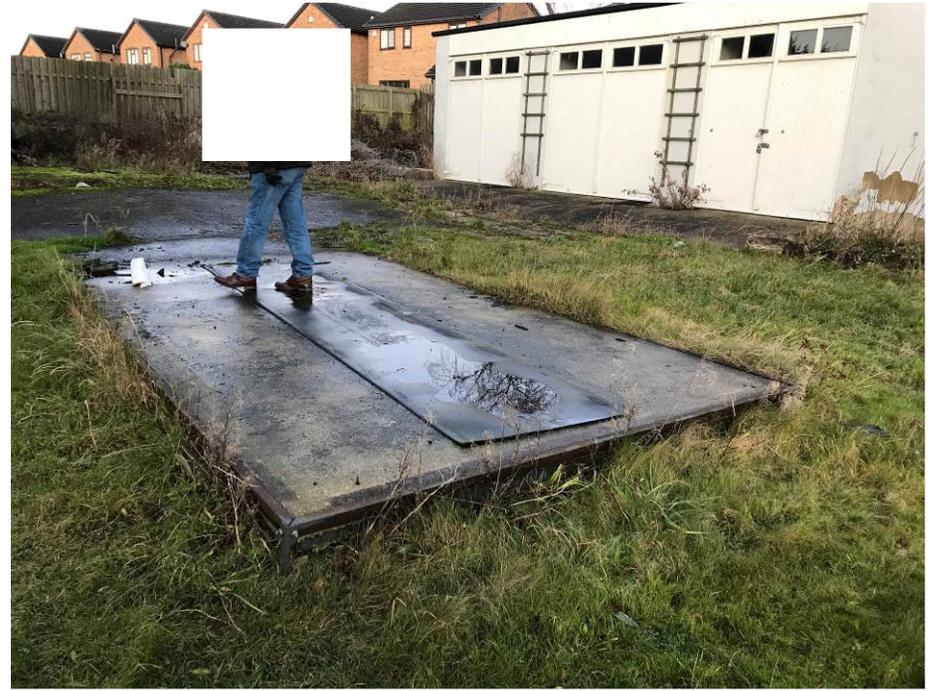
Prepared	NG	Checked	CAT	Date	09.12.19	Photograph No	9 & 10
----------	----	---------	-----	------	----------	---------------	--------

A remnant rectangular concrete base was observed to the north of Clough House during the site walkover, its purpose is unknown and further similar features or slabs cannot be discounted.

Remnant rectangular concrete base located between the outbuildings
