GEO-ENVIRONMENTAL REPORT

| site address | Cummins Turbo Proposed Footbridge, Saint Andrew's Road, Huddersfield, HD1 6RA. | | |

Report on a Phase 2 Geo-environmental Investigation

Location: Cummins Turbo Proposed Footbridge
Saint Andrew's Road, Huddersfield, West Yorkshire, HD1 6RA

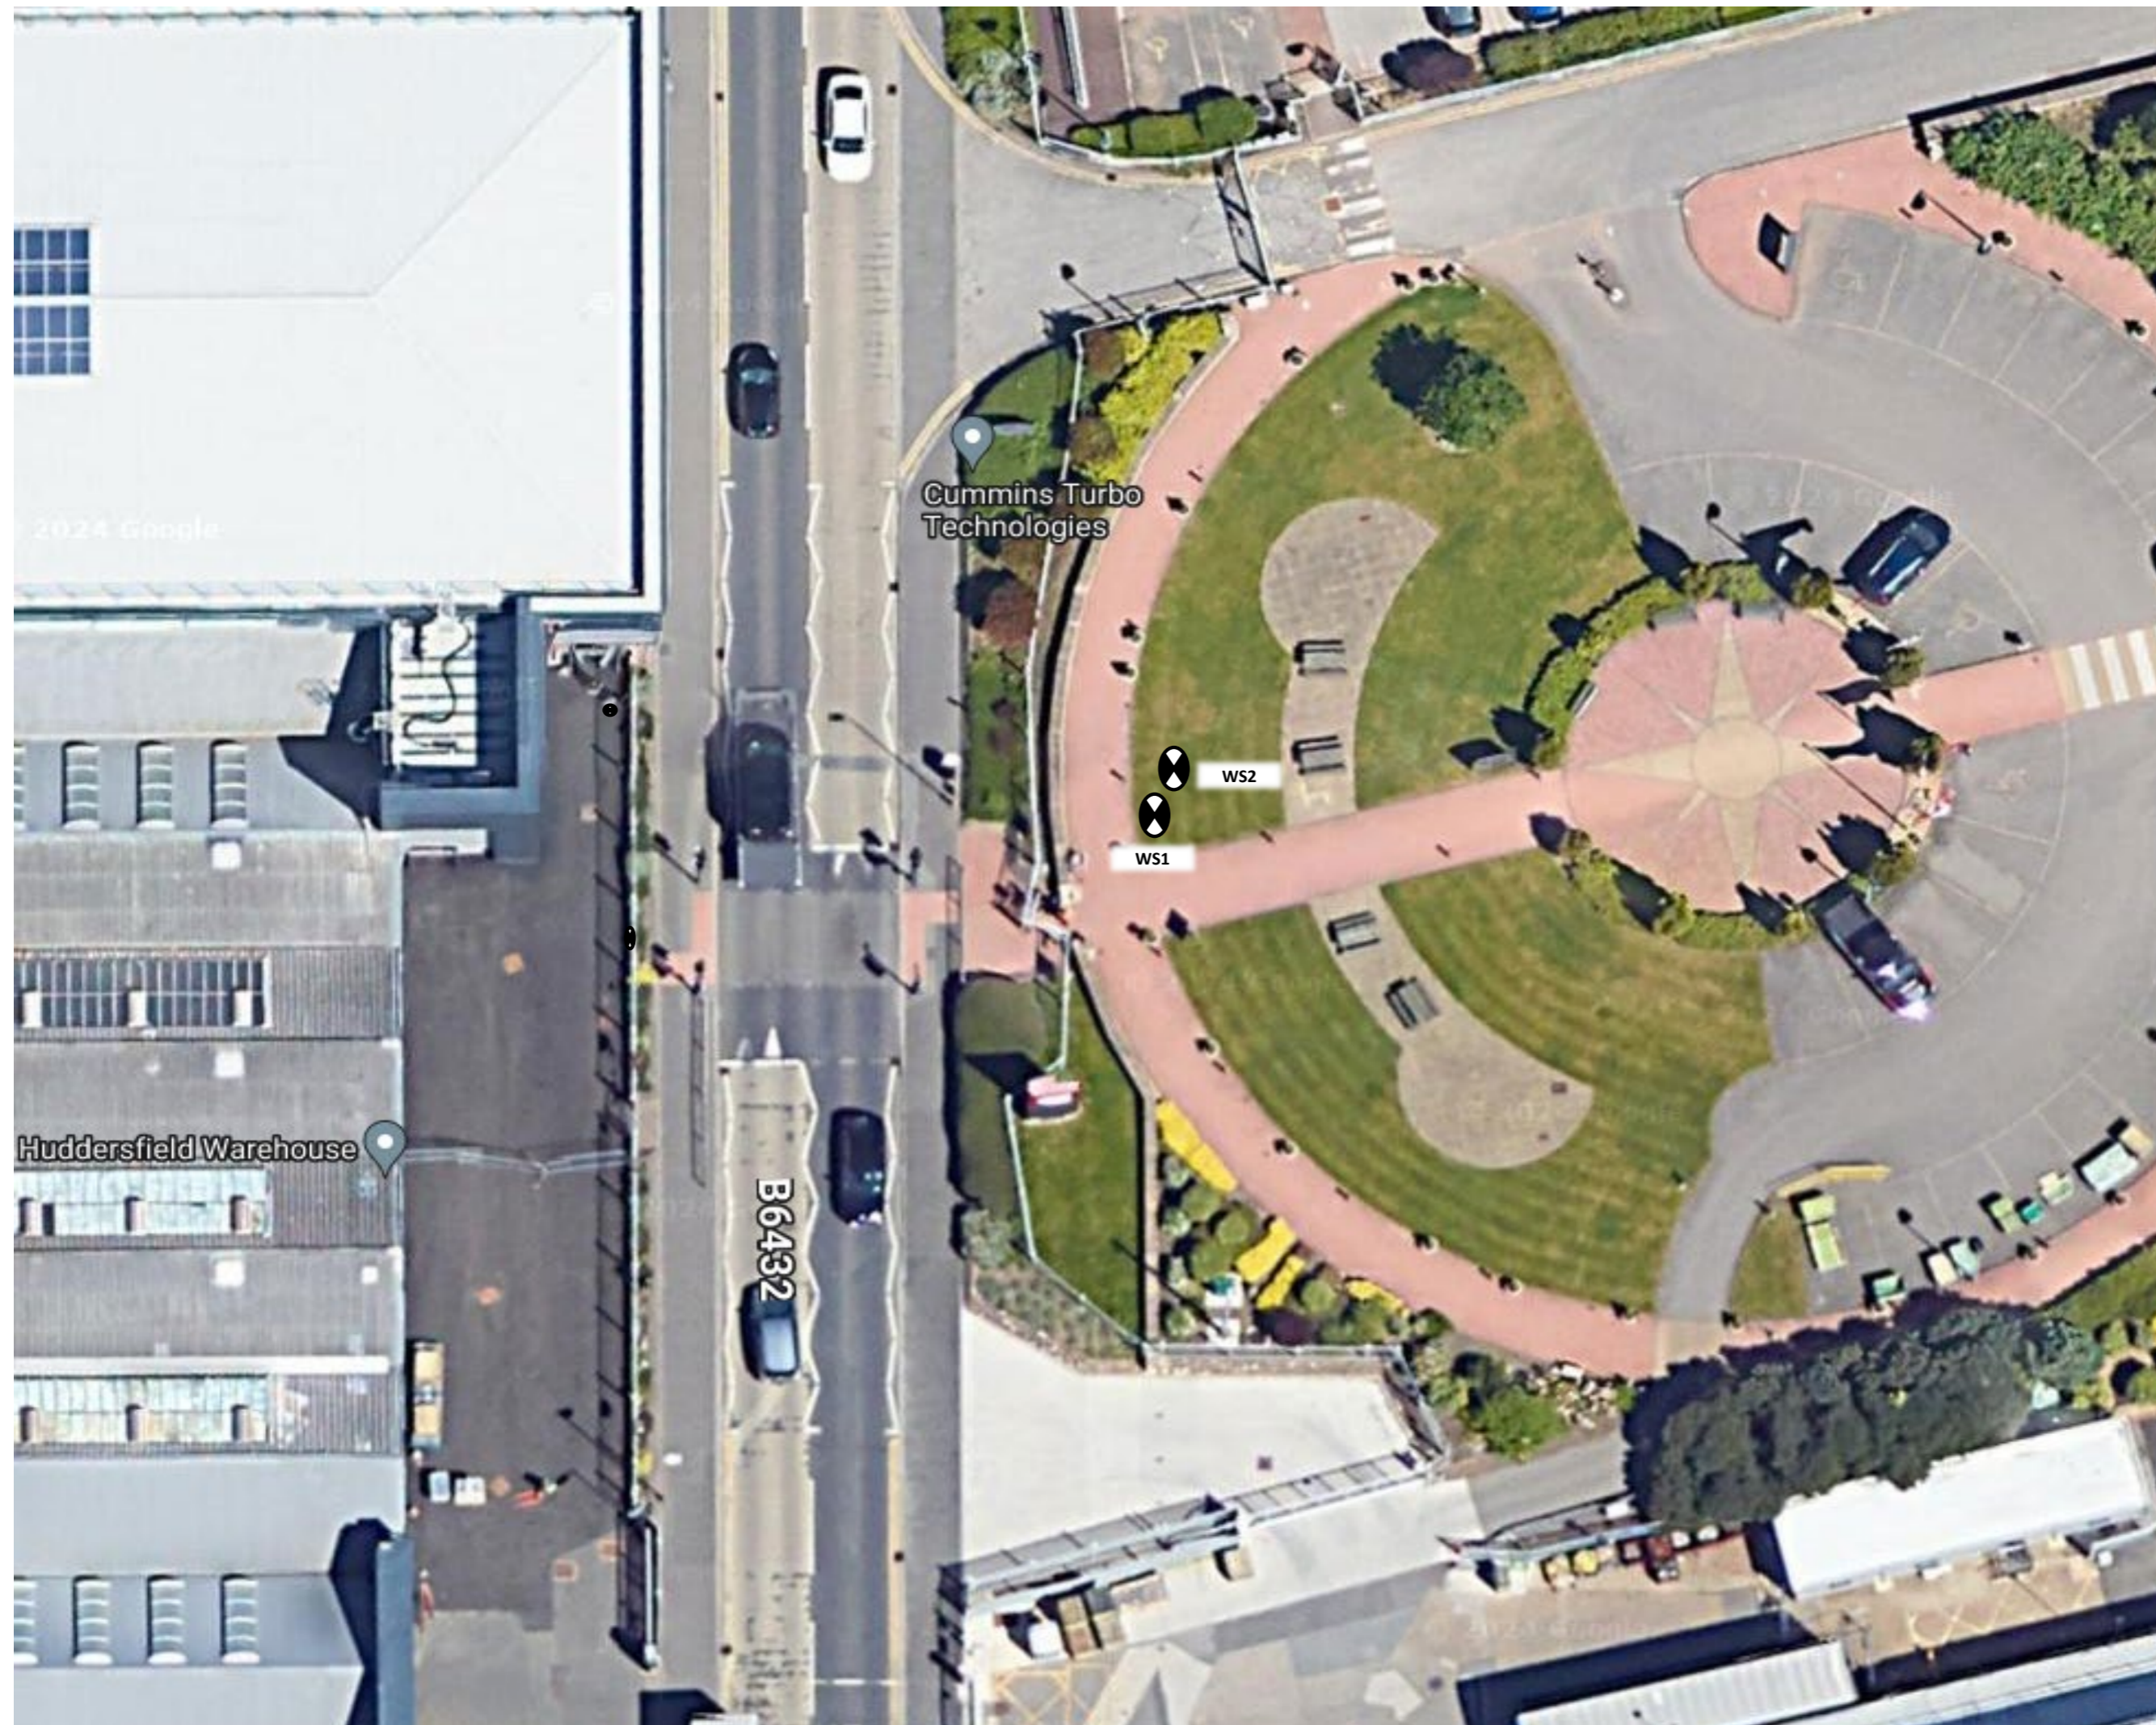
Site Plan

Notes:
Investigation positions approximated from site operative's notes.

The investigatory locations are shown on the site plan which is presented in Appendix 1 to this report.
