# Geoenvironmental Appraisal

## Land at Long Lane, Earlsheaton For Britology Ltd

Report no: 2986/1B

Date: June 2020

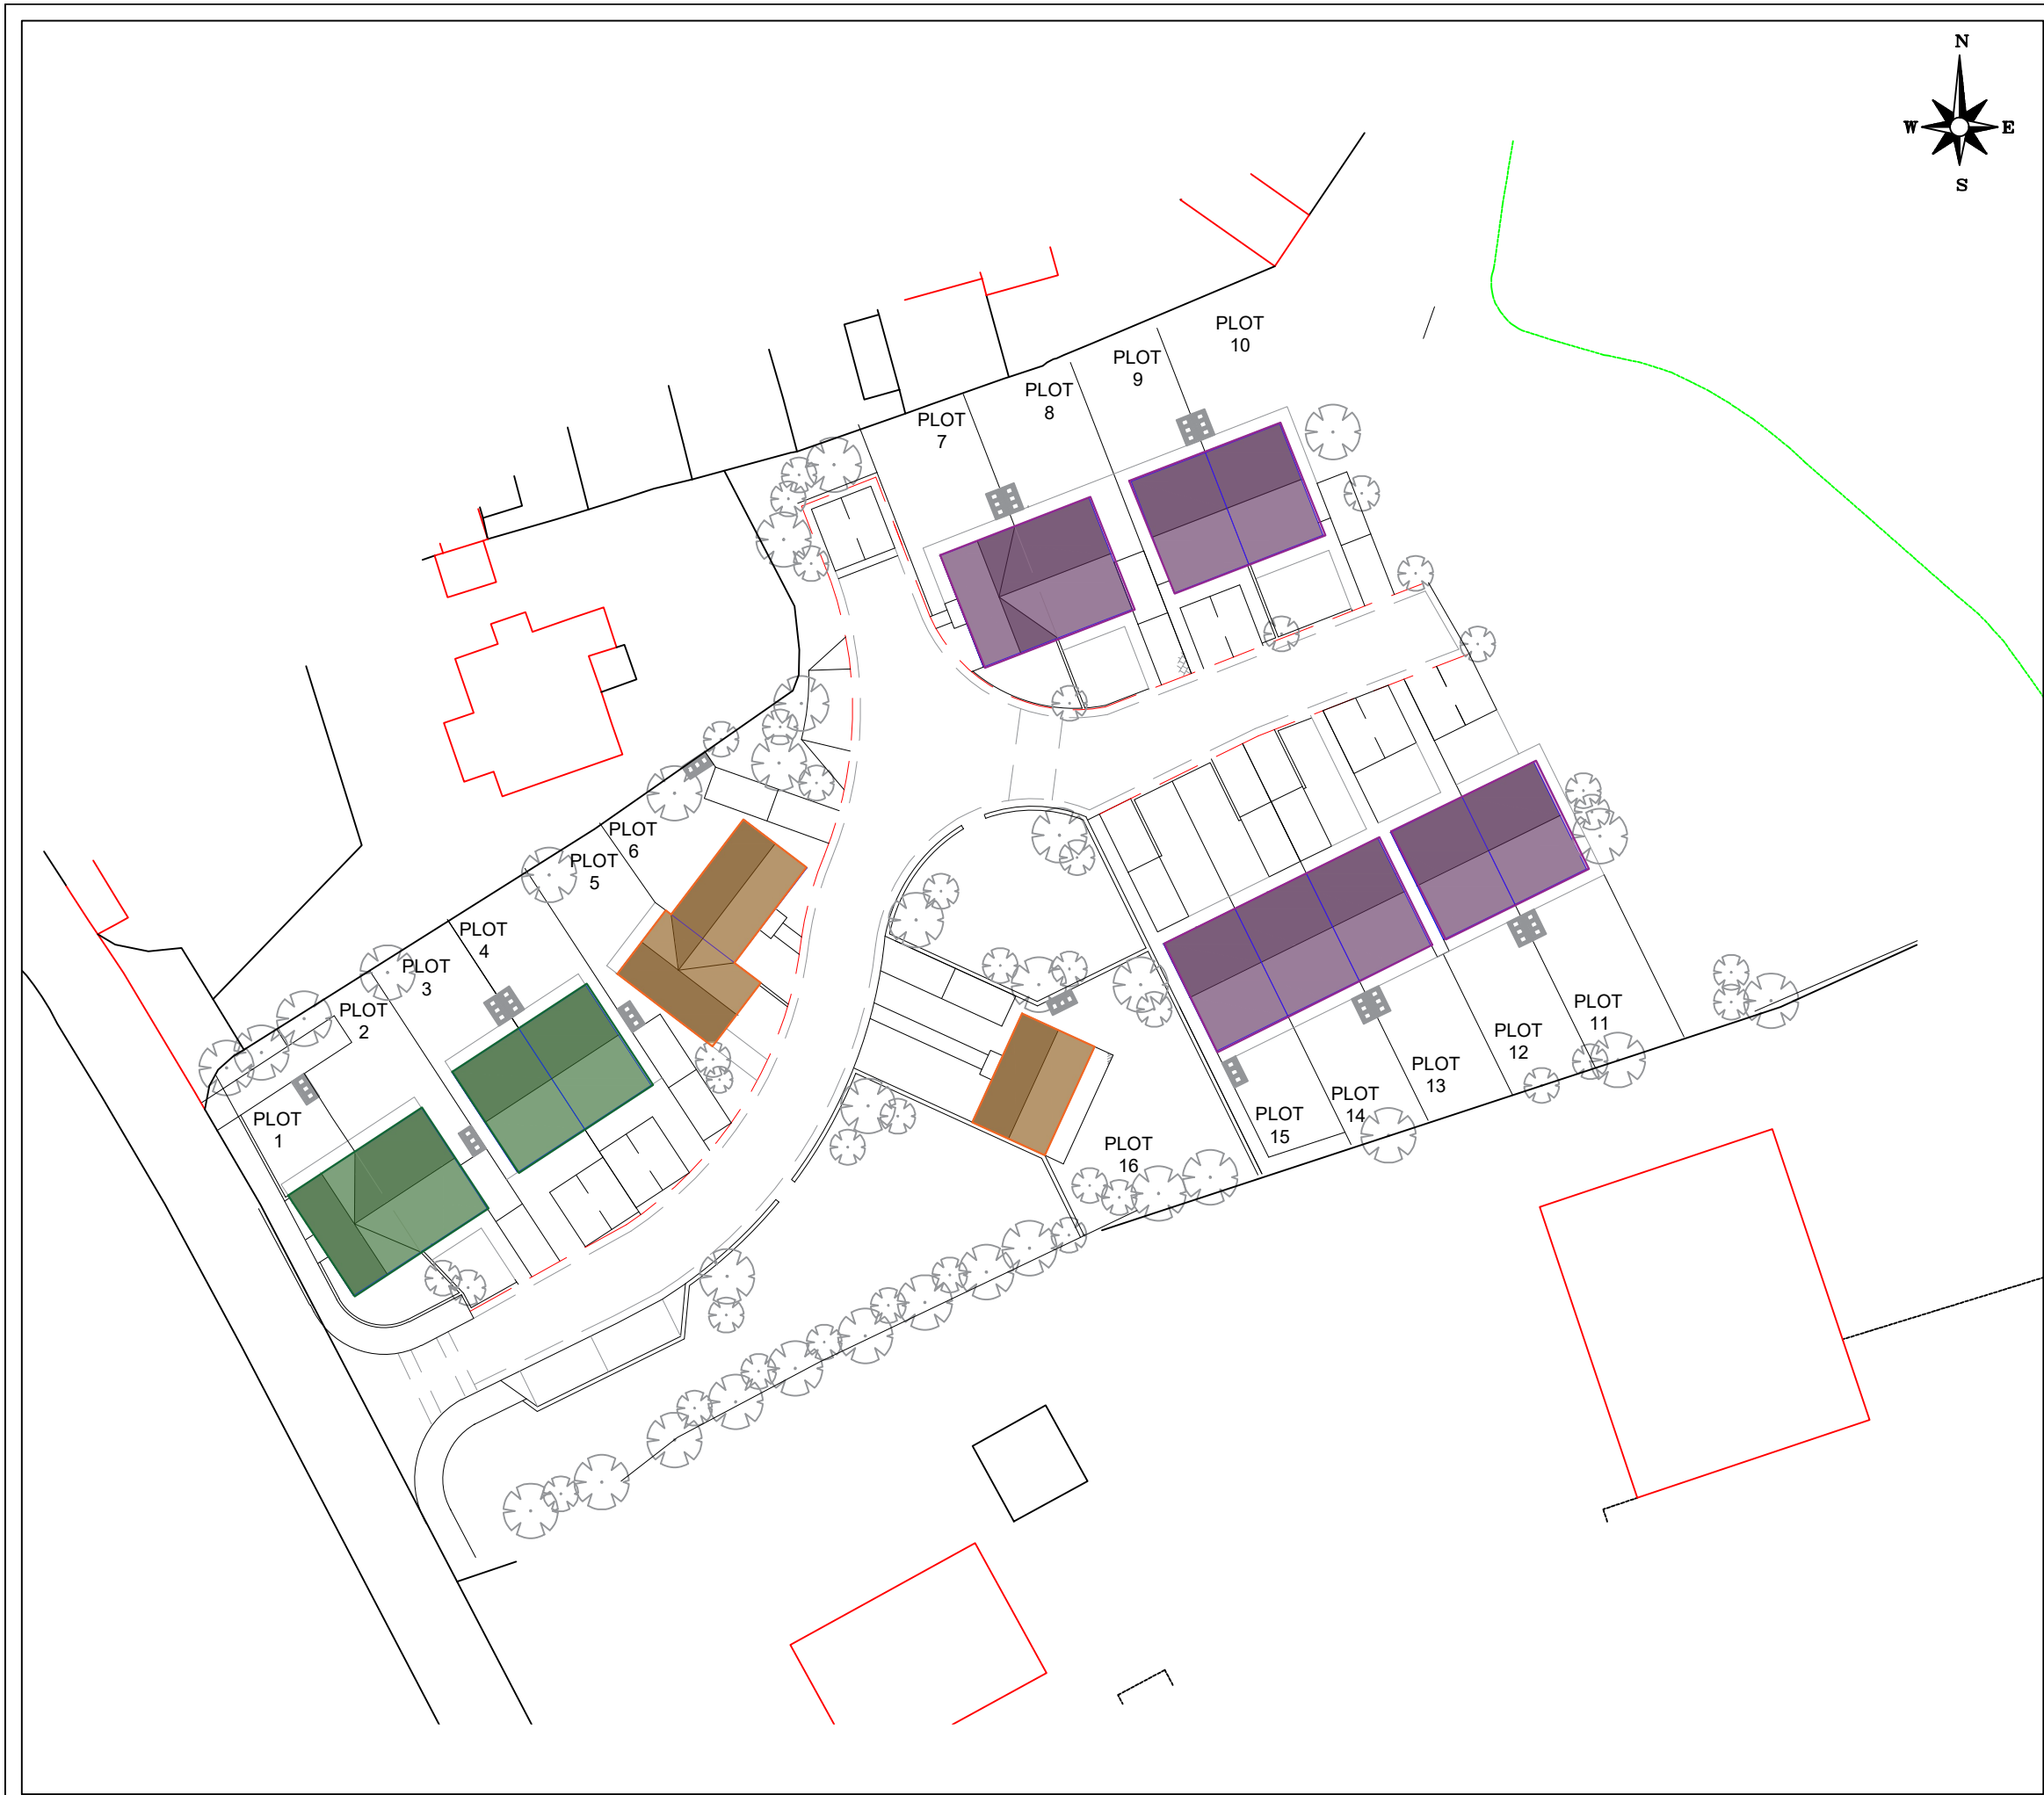
- BUILDING WITH ANTICIPATED FOUNDATION DEPTH OF 600mm
- BUILDING WITH ANTICIPATED FOUNDATION DEPTH OF 600mm TO 1,000mm
- BUILDING WITH ANTICIPATED FOUNDATION DEPTH OF >1,000mm
- APPROXIMATE SITE BOUNDARY

| Issue | Remarks |
|---|---|
| Foundations | Strip/trenchfill footings are considered the most suitable means of foundations for all buildings at this site. Foundations will require deepening where deep made ground is encountered to found in natural residual soils of adequate bearing capacity. |

| Drawing | Revision | Title |
|---|---|---|
| 2986/10 | B | Indicative Foundations Zoning Plan |
