## Phase 1 Desk Study Site Investigation Report

| <b>LOCATION</b> | Bell Cabin, Long Lane, Earlsheaton, Dewsbury, WF12 8LG |
| <b>OUR REF.</b> | G23326 |

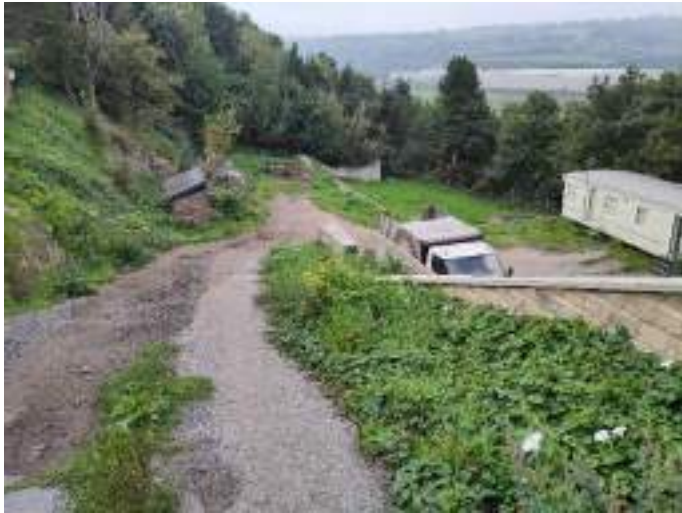
**Photograph 1:** Site access road leading south.

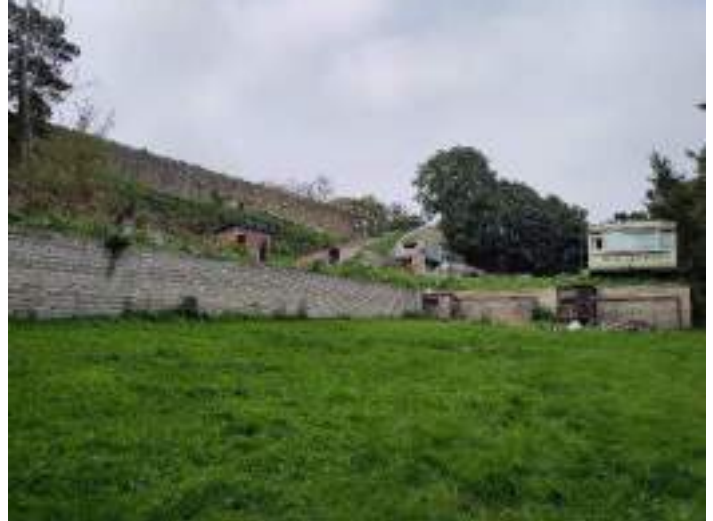
**Photograph 3:** Vegetation center north, side of site with brick outhouse.

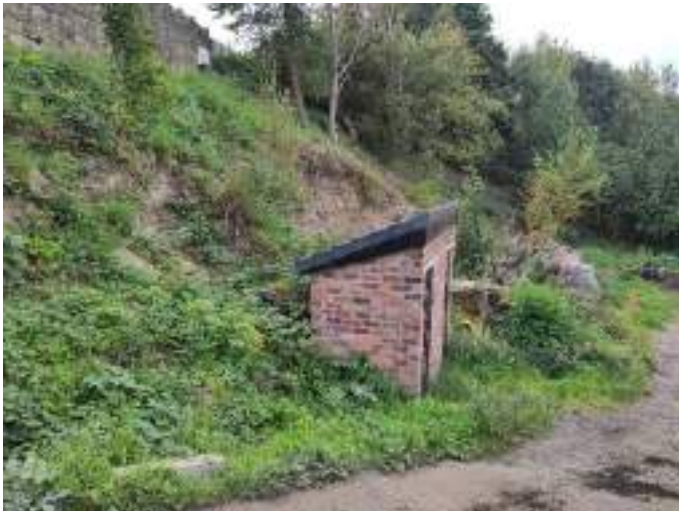
**Photograph 4:** Southwest plateau with, groundworks.

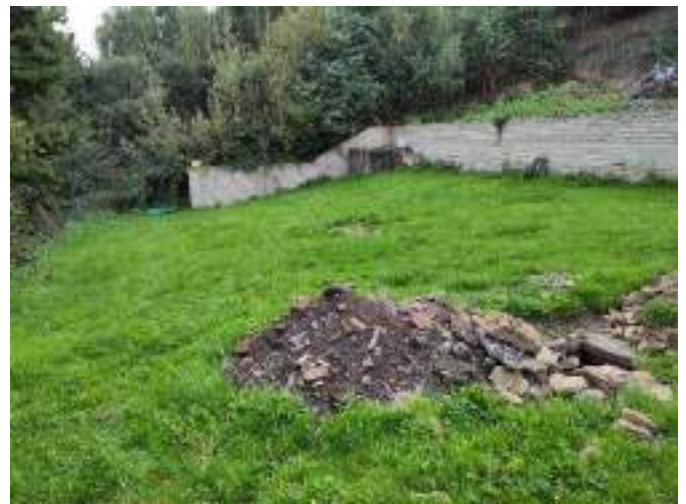
**Photograph 5:** Retaining wall northeast, of the site.

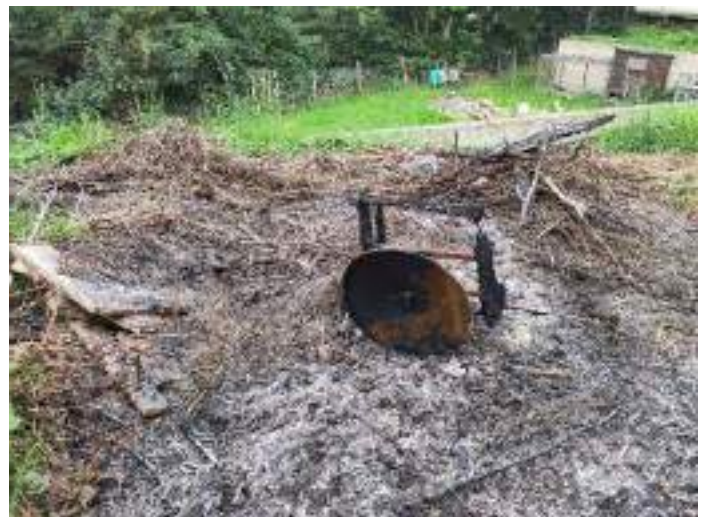
**Photograph 6:** Ash pile with burnt materials.

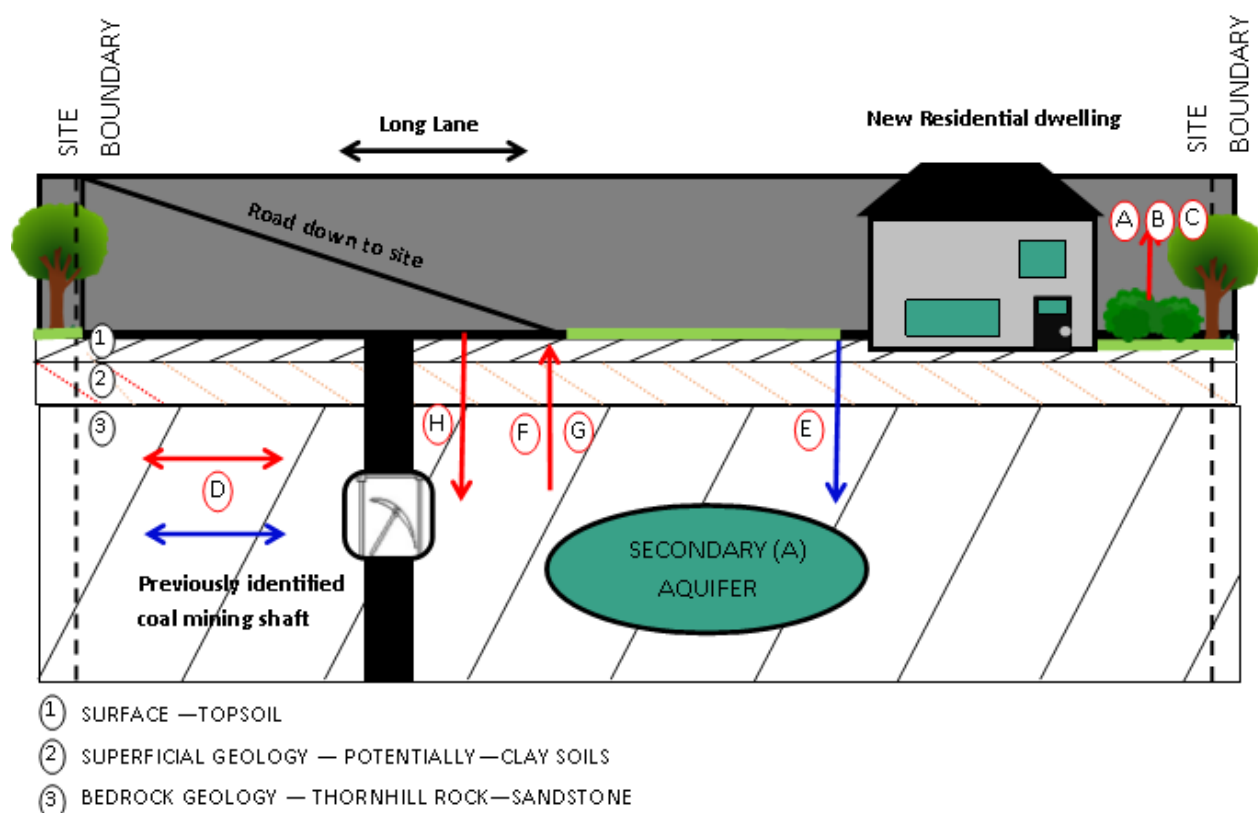
**Figure 1 – Conceptual Ground Hazard Model of site including a Source, Pathway and Receptor Model**

- Construction (materials) from previous land use.
- Contamination from traffic on nearby Long Lane.
- Potential hazardous gases sourced from mine workings and/or made ground on site.

Identified potential sources of hazard or contamination, vulnerable receptors, and possible pathways by which they may be exposed are presented in the Conceptual Ground Hazard Model (CGHM) presented in Figure 1, see Section 4.2.

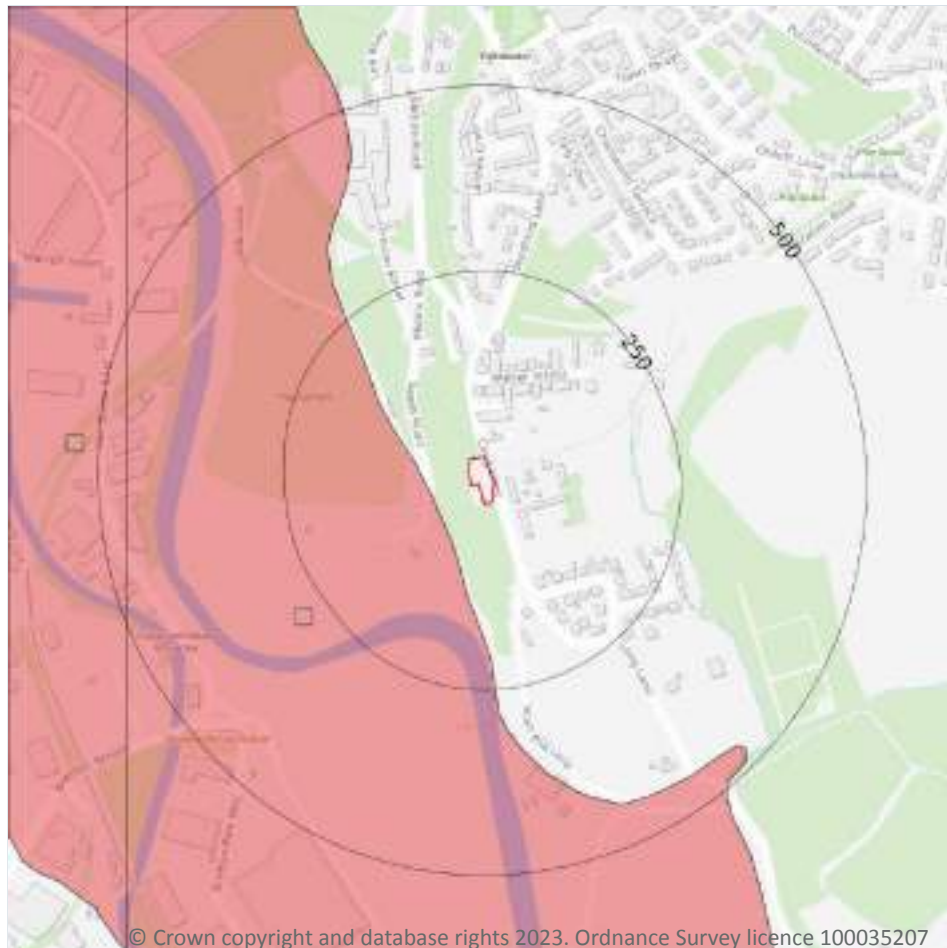
## 5 Hydrogeology - Superficial aquifer

- Site Outline
- Search buffers in metres (m)
- Principal
  - Secondary A
  - Secondary B
  - Secondary Undifferentiated
  - Unproductive
  - Unknown

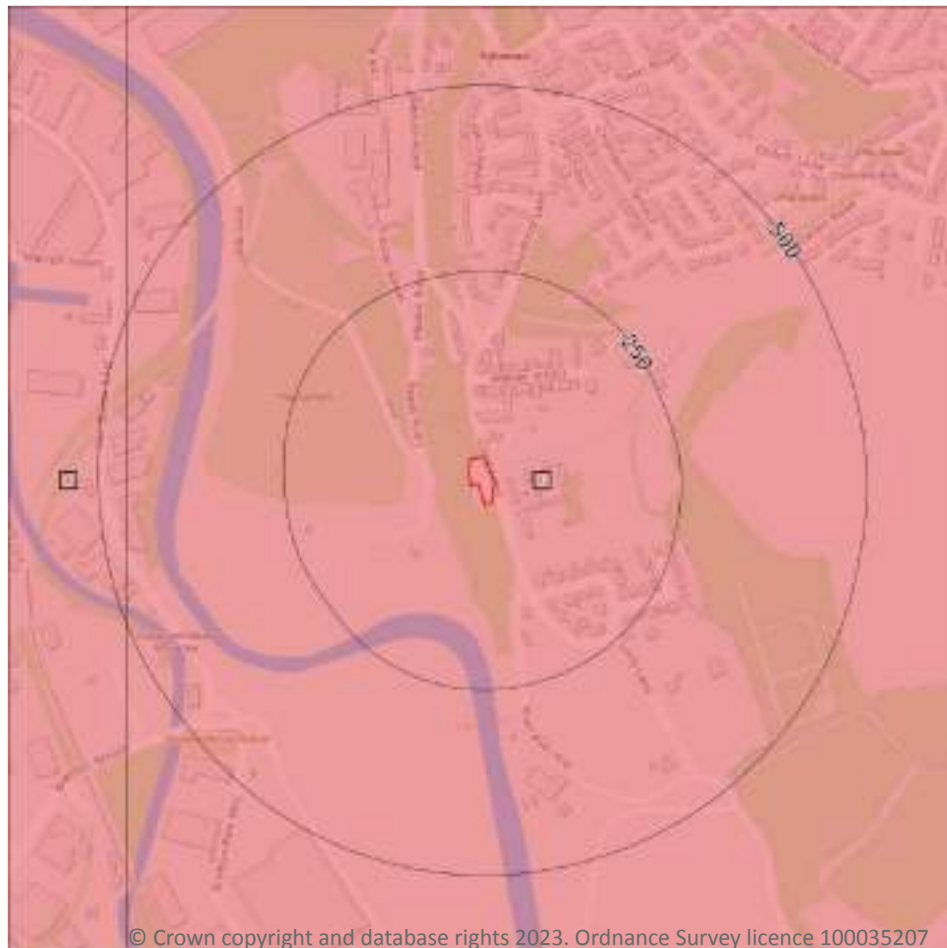
## Bedrock aquifer

- Site Outline
- Search buffers in metres (m)
- Principal
  - Secondary A
  - Secondary B
  - Secondary Undifferentiated
  - Unproductive

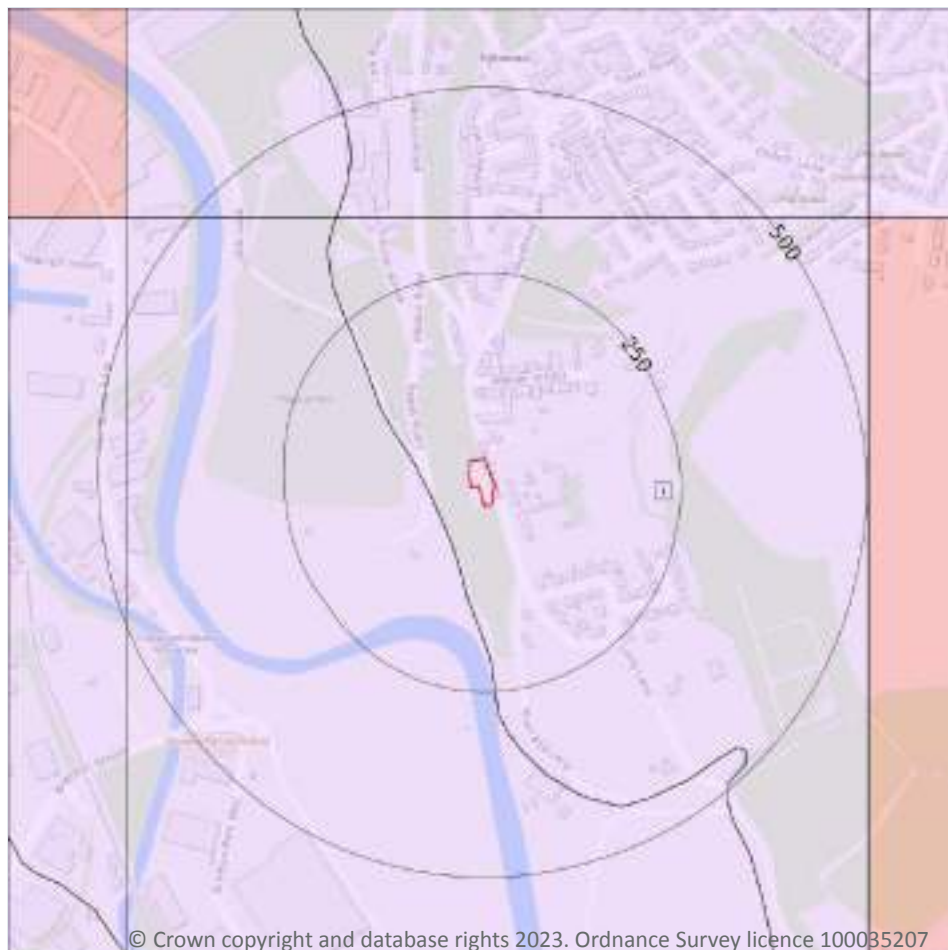
## Groundwater vulnerability

| ID | Location | Summary | Soil / surface | Superficial geology | Bedrock geology |
|---|---|---|---|---|---|
| 1 | On site | <b>Summary Classification:</b><br>Secondary bedrock aquifer -<br>Medium Vulnerability<br><b>Combined classification:</b><br>Productive Bedrock Aquifer,<br>No Superficial Aquifer | <b>Leaching class:</b> Low<br><b>Infiltration value:</b><br><40%<br><b>Dilution value:</b> 300-<br>550mm/year | <b>Vulnerability:</b> -<br><b>Aquifer type:</b> -<br><b>Thickness:</b> 3-10m<br><b>Patchiness value:</b> <90%<br><b>Recharge potential:</b> High | <b>Vulnerability:</b> Medium<br><b>Aquifer type:</b> Secondary<br><b>Flow mechanism:</b> Well<br>connected fractures |

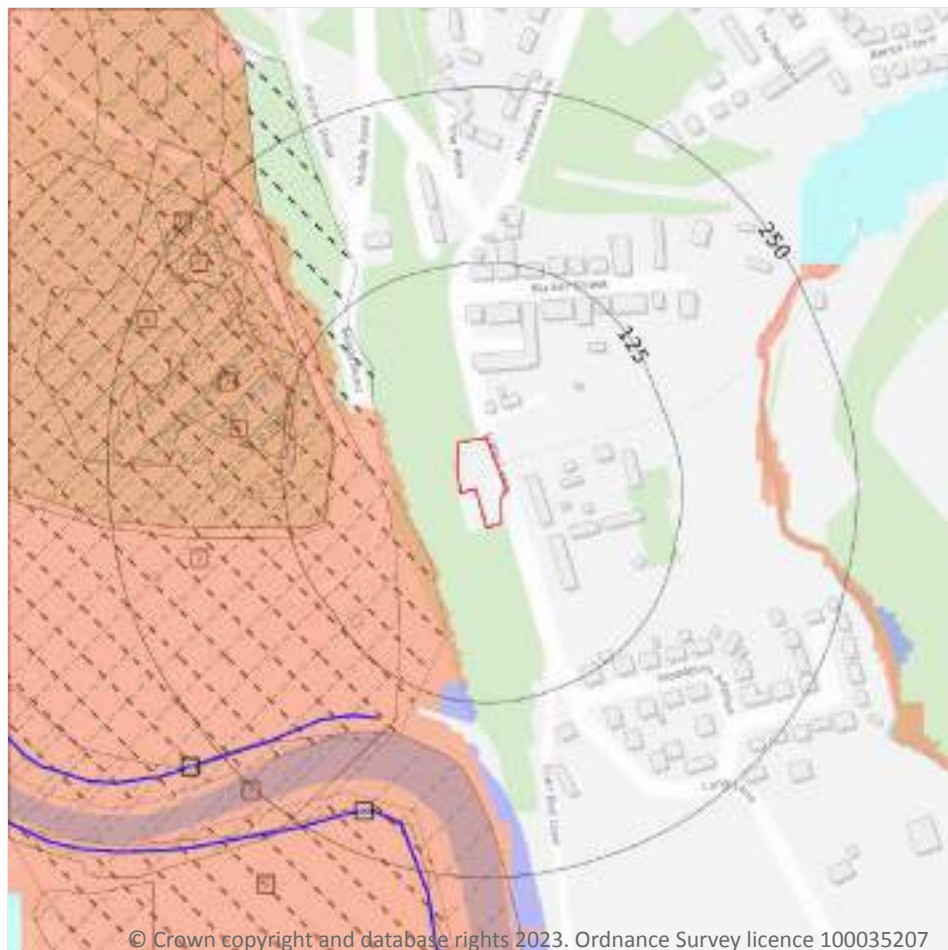
## 7 River and coastal flooding

- Site Outline
- Search buffers in metres (m)
- River and coastal flooding:
- High
- Medium
- Low
- Very Low
- Historical Flood Events
- Areas Used for Flood Storage
- Areas Benefiting from Flood Defences
- Flood Defences

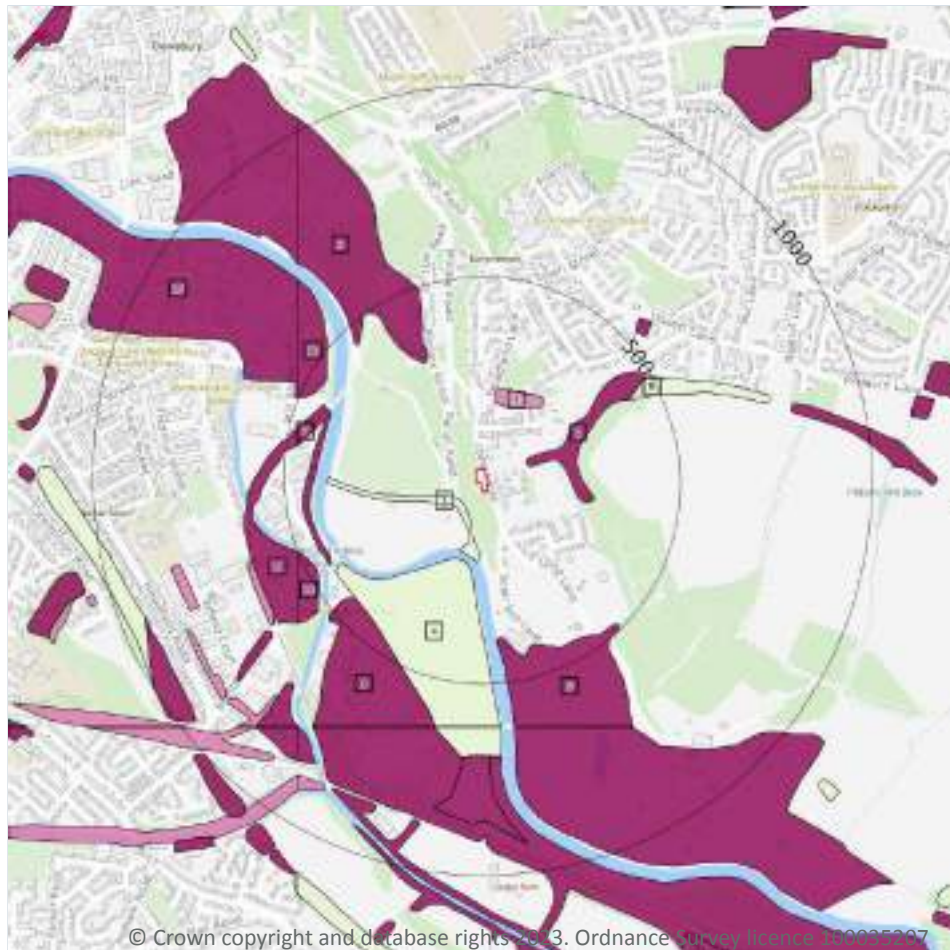
## Geology 1:10,000 scale - Artificial and made ground

- Site Outline
- Search buffers in metres (m)
- Reclaimed ground
  - Made ground
  - Worked ground
  - Infilled ground
  - Disturbed ground
  - Landscaped ground

Details of made, worked, infilled, disturbed and landscaped ground at 1:10,000 scale. Artificial ground can be associated with potentially contaminated material, unpredictable engineering conditions and instability.

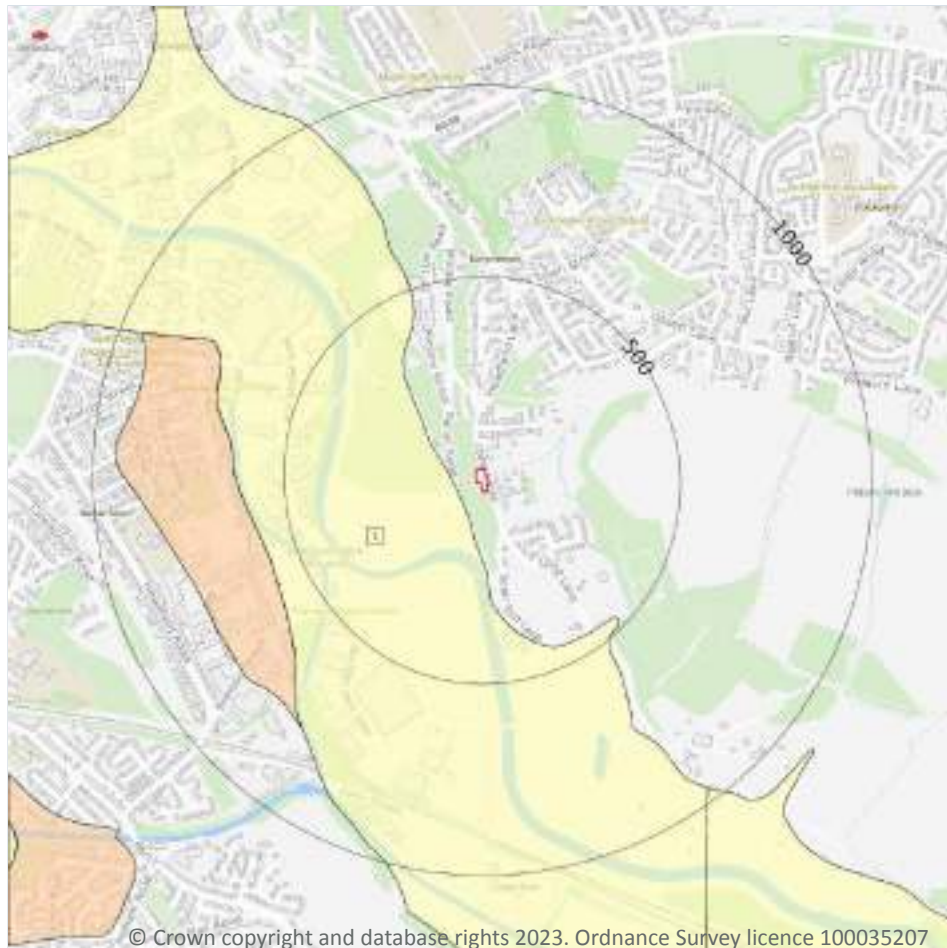
## Geology 1:50,000 scale - Superficial

- Site Outline
- Search buffers in metres (m)
- Landslip (50k)
- Superficial geology (50k)  
Please see table for more details.

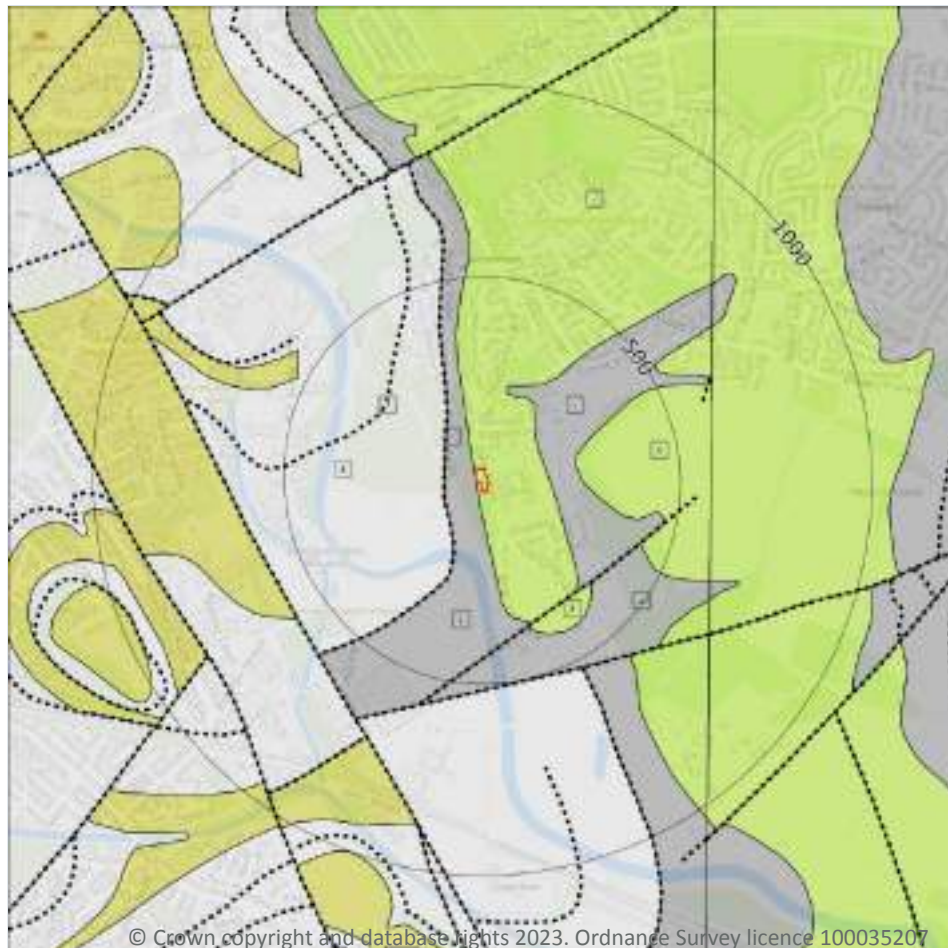
## Geology 1:50,000 scale - Bedrock

| Location | Flow type | Maximum permeability | Minimum permeability |
|---|---|---|---|
| On site | Fracture | High | Moderate |
| On site | Fracture | Moderate | Low |

Linear features at the ground or bedrock surface at 1:50,000 scale of six main types; rock, fault, fold axis, mineral vein, alteration area or landform. Features are either observed or inferred, and relate primarily to bedrock.

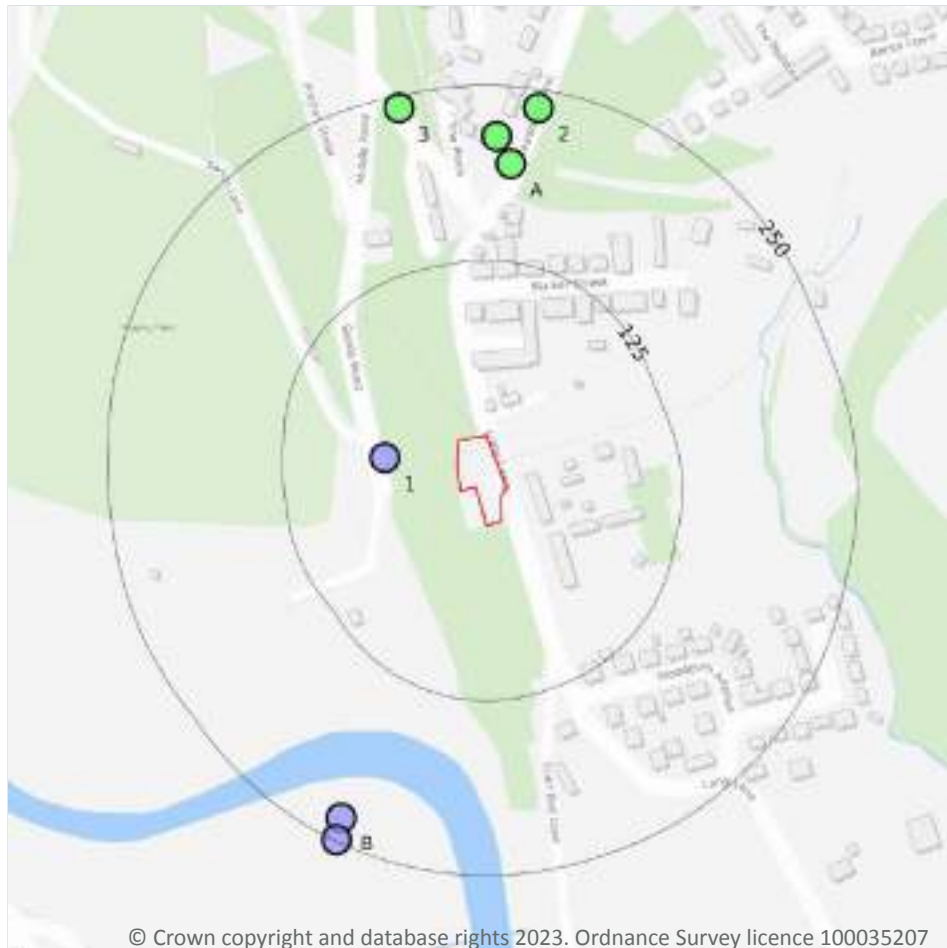
## 16 Boreholes

- Confidential
- 0 - 10m
- 10 - 30m
- 30m+
- Unknown

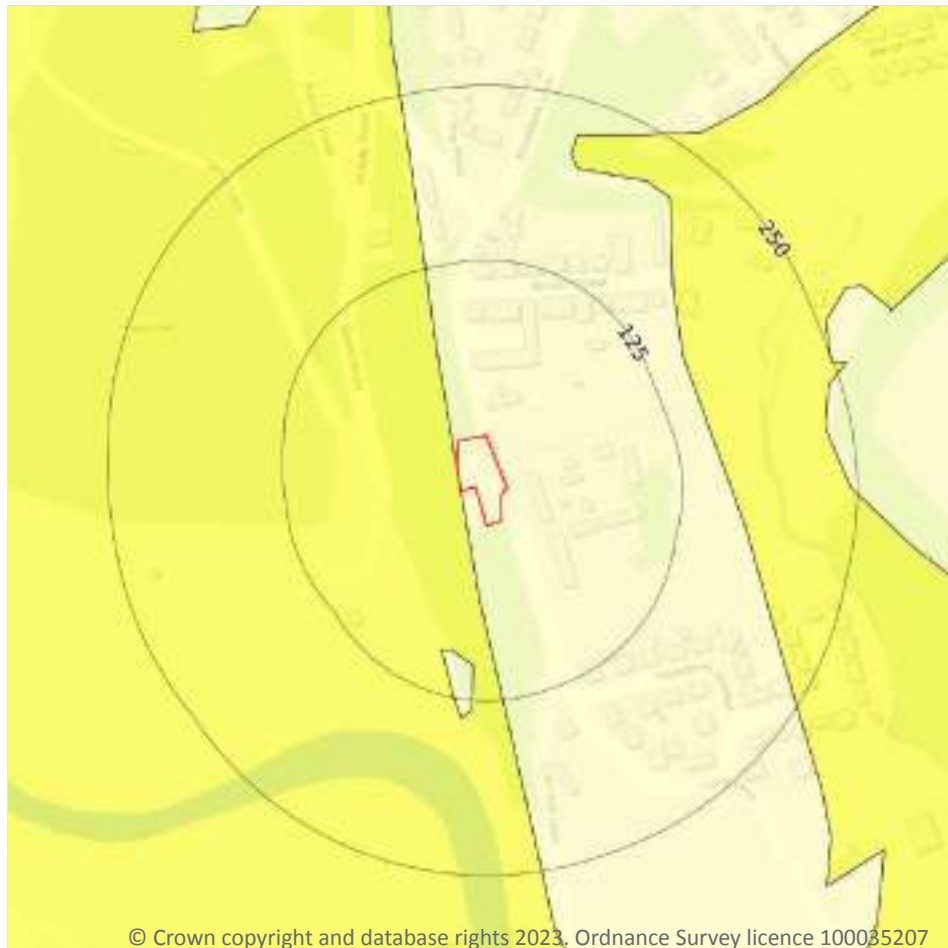
## 17 Natural ground subsidence - Shrink swell clays

The potential hazard presented by soils that absorb water when wet (making them swell), and lose water as they dry (making them shrink). This shrink-swell behaviour is controlled by the type and amount of clay in the soil, and by seasonal changes in the soil moisture content (related to rainfall and local drainage).

| Location | Hazard rating | Details |
|---|---|---|
| On site | Negligible | Ground conditions predominantly non-plastic. |
| On site | Very low | Ground conditions predominantly low plasticity. |

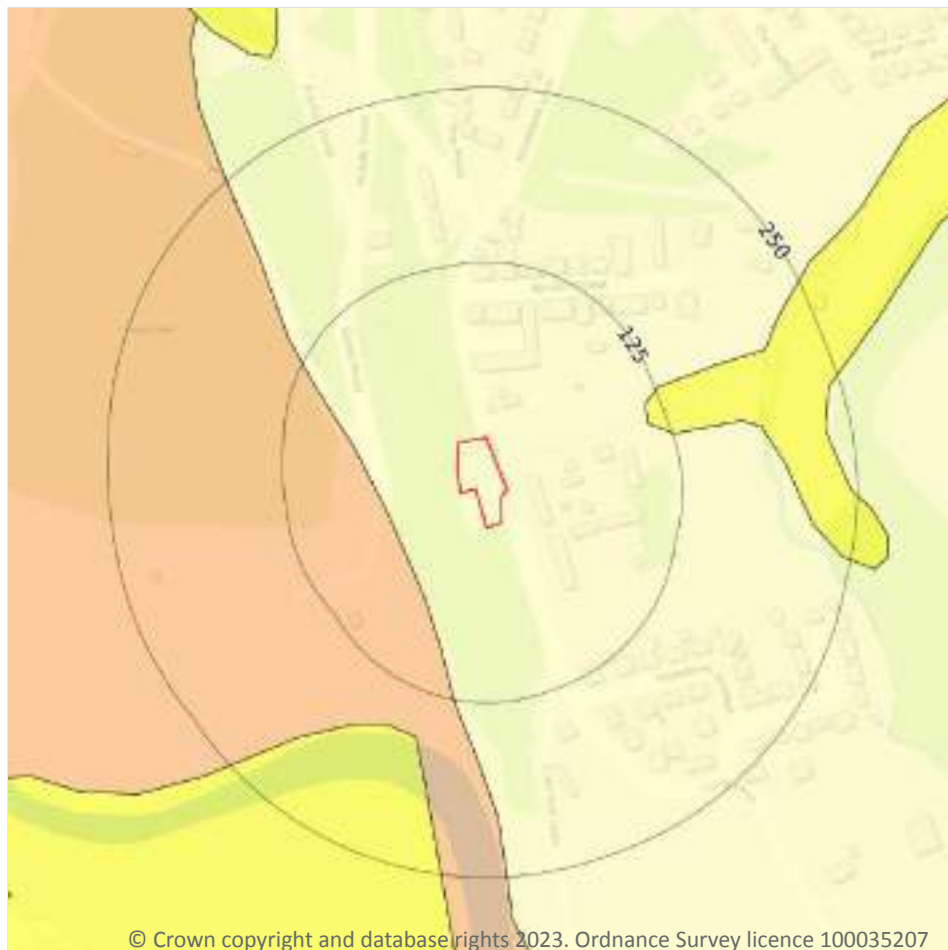
## Natural ground subsidence - Running sands

The potential hazard presented by rocks that can contain loosely-packed sandy layers that can become fluidised by water flowing through them. Such sands can 'run', removing support from overlying buildings and causing potential damage.

| Location | Hazard rating | Details |
|---|---|---|
| On site | Negligible | Running sand conditions are not thought to occur whatever the position of the water table. No identified constraints on lands use due to running conditions. |

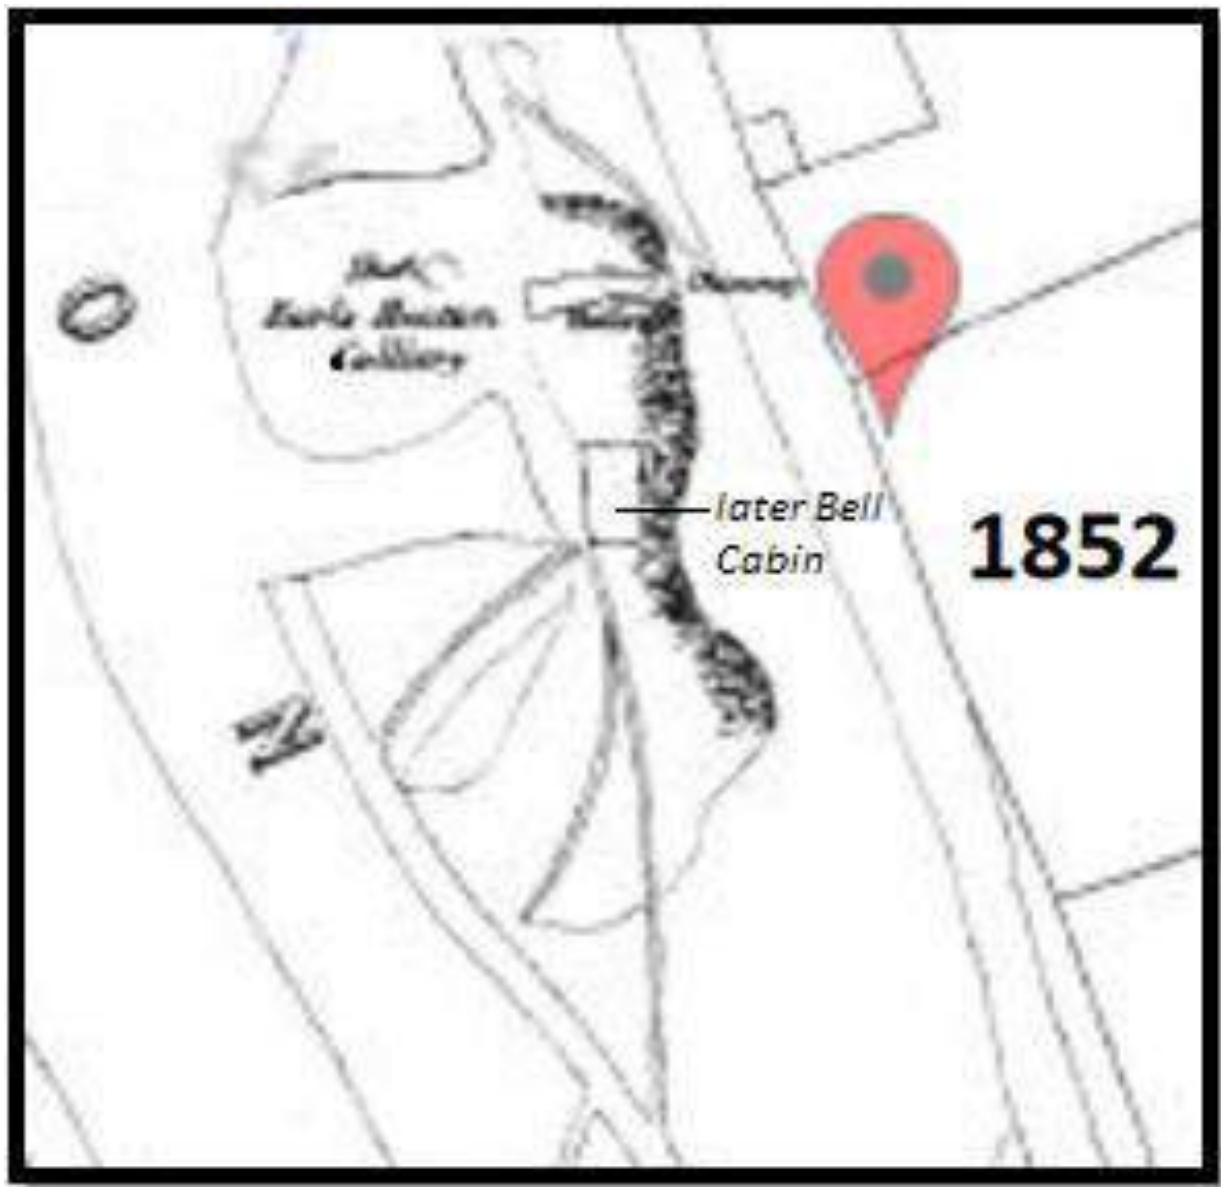
It is believed the original site platform on this steep slope on which the mobile home stands today was formed by cut and fill pre 1850 to provide space for a Earlsheaton Colliery mine shaft, engine house and chimney. The outline of Bell Cabin (named so by the previous site owner Alan Yates) is shown on the earliest OS map of 1852. The remnants of Bell Cabin can still be seen at site today. This building proved a useful reference feature for locating the shaft using old maps.

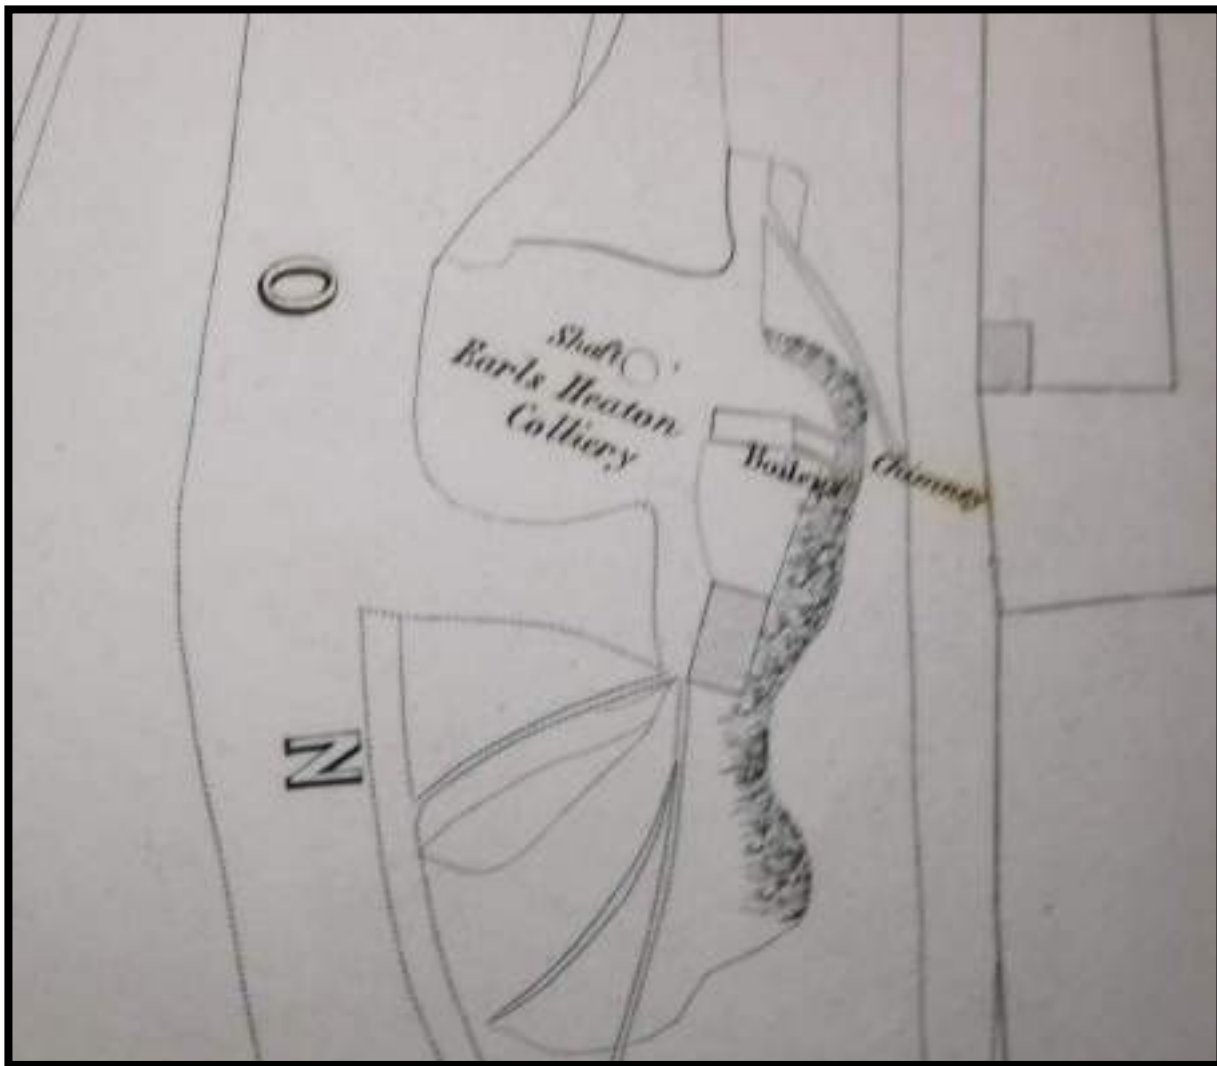
Subsequently Lucy Buckley provided a clearer image of this early map obtained from a local contact. Unexpectedly, it is understood that this map was also provided to Alan Yates the previous site owner many years ago by Lucy's recent contact.

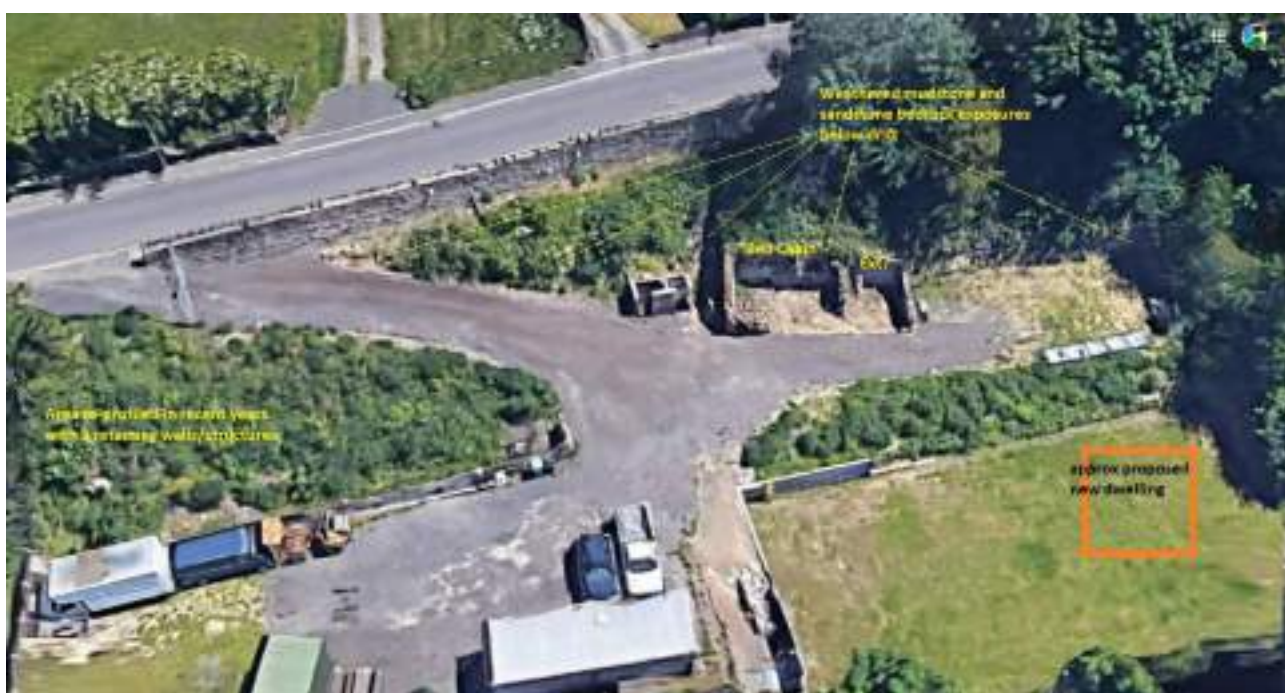
Several years ago, during Mr Yates tenure the site looked different as shown by the image below.

It is understood that subsequently, the previous property owner Mr Alan Yates carried out significant alterations to the site, which included installing three major RTWs on the left side of the image and creating a lower platform on the right, supported on three sides by a 4<sup>th</sup> RTW.

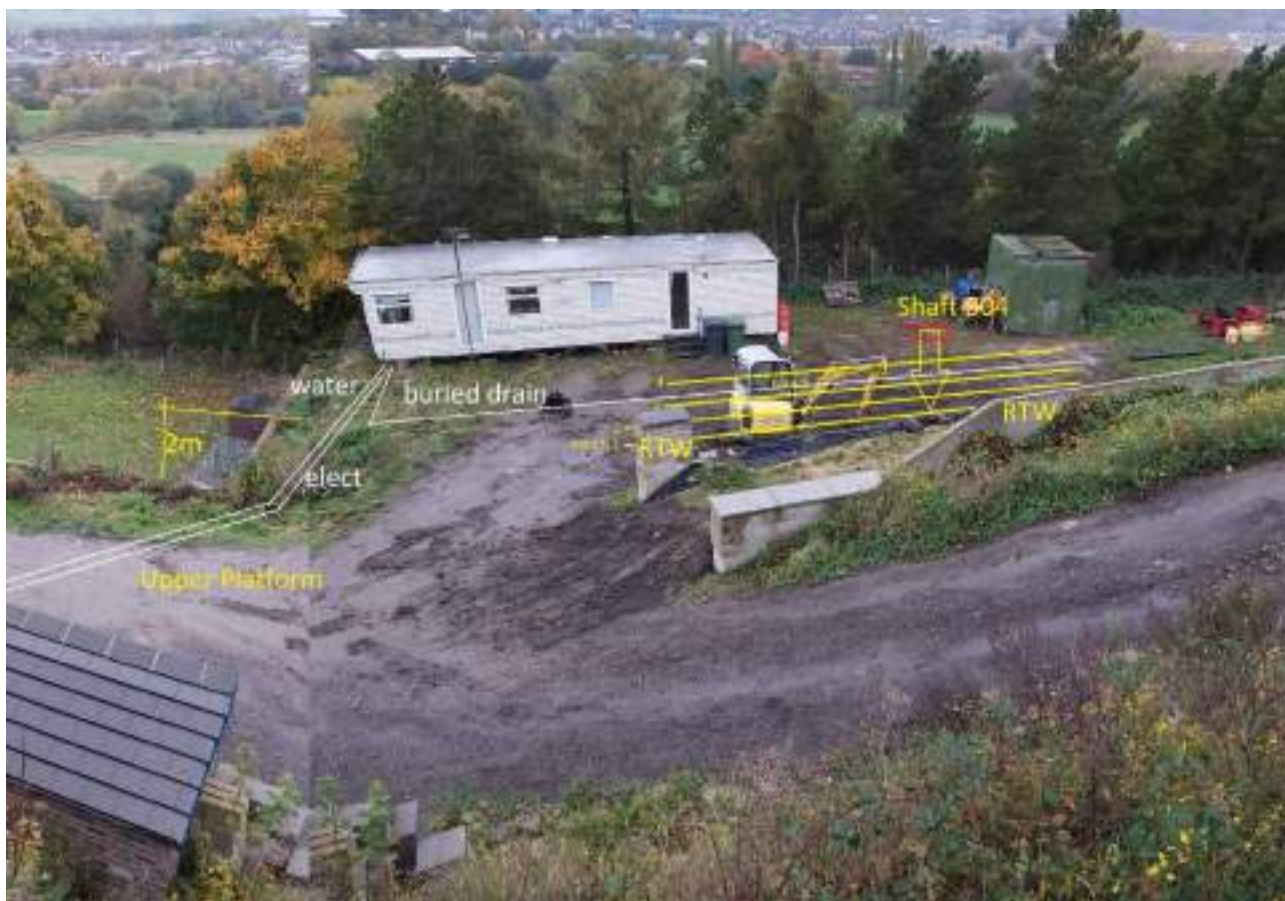
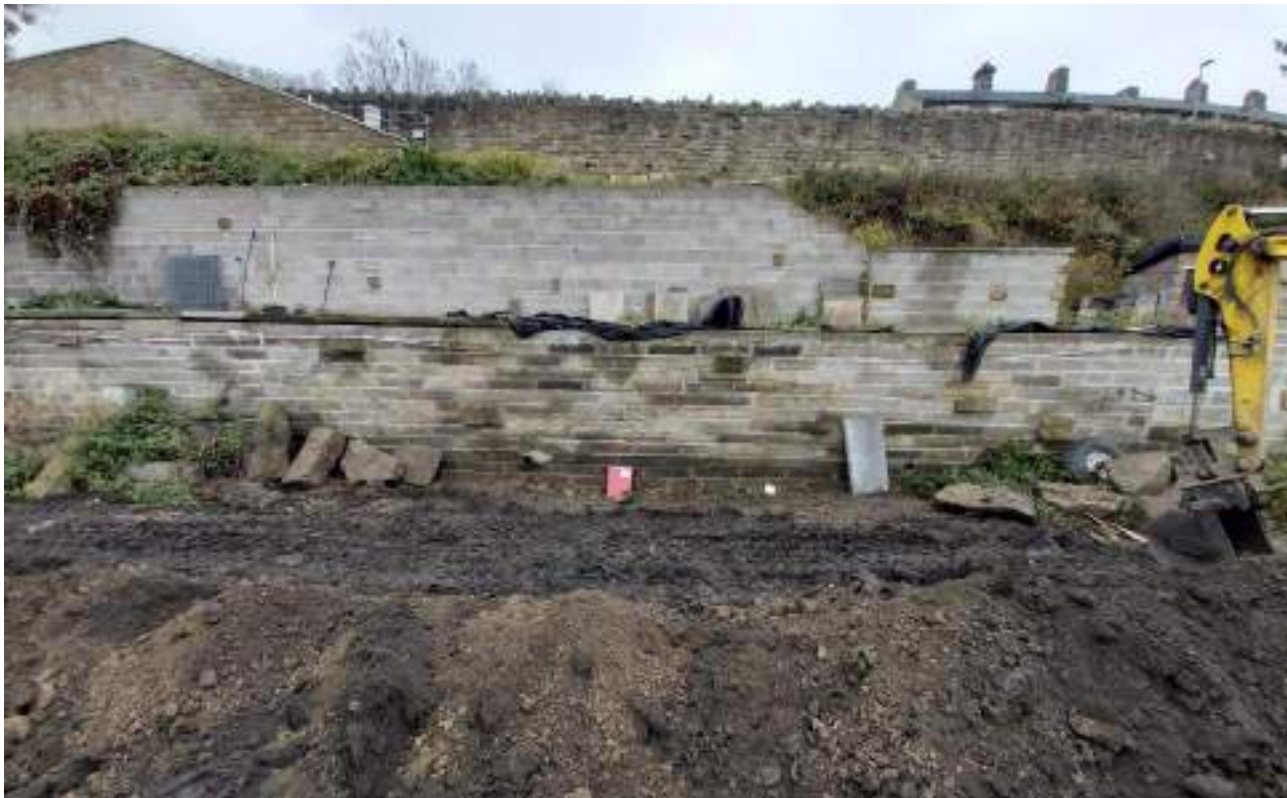
According to the CAs earlier plotted position, the mine shaft lay somewhere between the lower wall and the mobile home. On 27<sup>th</sup> October 2020 Geoinvestigate found what appeared to be this mine shaft by trenching at the approximate position indicated by the RED clip board propped against the RTW wall on the 2<sup>nd</sup> image below. The shaft lies very close to and perhaps even extending a little way under the wall.

In some respects, Geoinvestigate were surprised to find the shaft so quickly, almost right from the start of the trenching exercise though it was found more or less, where expected using off-set measurements from Bell Cabin. Because of this uncertainty and because of concerns about de-stabilising the adjacent wall, slope drilling was considered necessary to locate the shaft with certainty and to investigate its condition at depth.

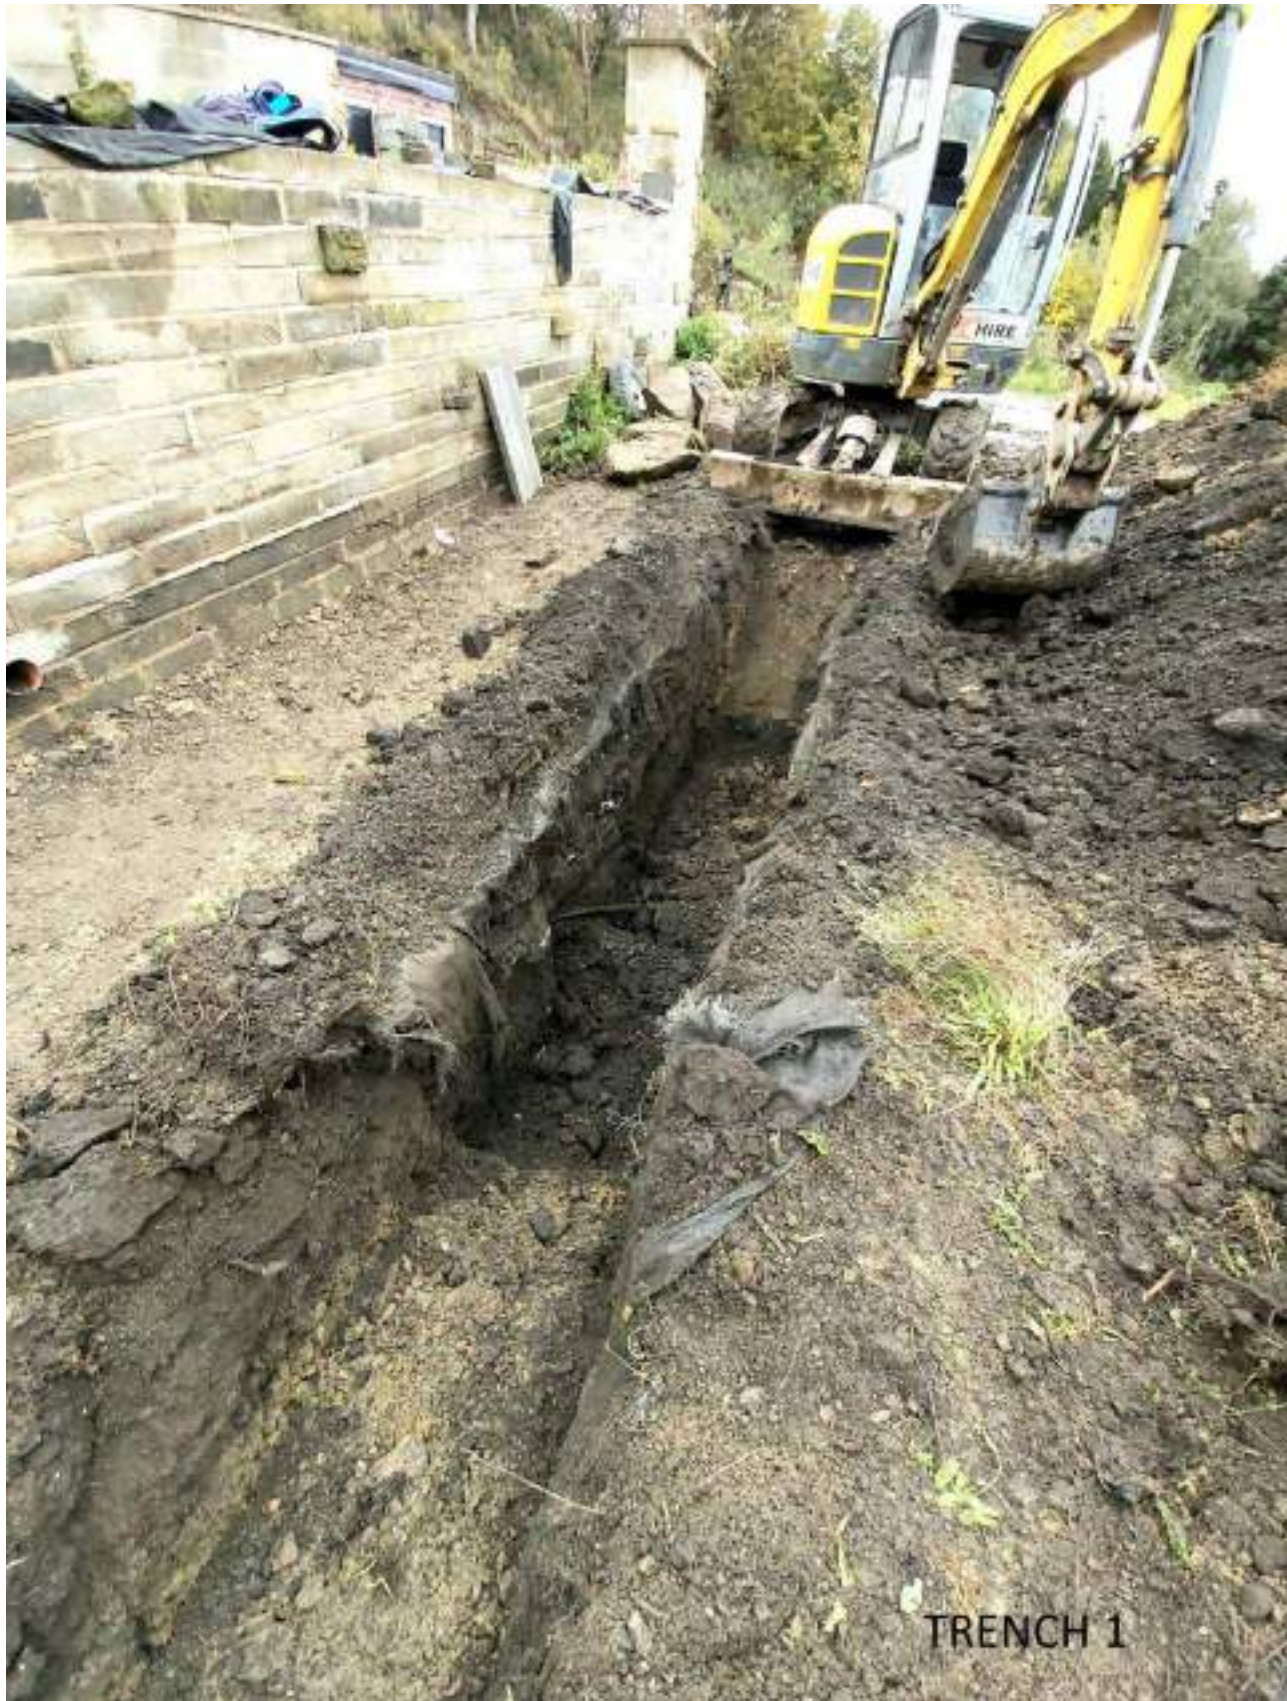
Shaft 004 was tentatively found in Trench 1 on 27<sup>th</sup> October 2020 at the position indicated in the following images.

Between 5.80m and 7.80m distance along the tape (measured from the wall pillar/pier on the right) the trench conditions changed markedly and deep loose/unstable blackish grey coaly mine waste including occasional iron pipe, wire, bricks, and pottery was encountered. The fill extended below 2.50m depth and beyond the maximum reach of the mini-excavator. Because of this and because of concerns about the stability of the adjacent retaining wall and the slope in general, further shaft excavation was limited to a 2<sup>nd</sup> short pit, cut perpendicular to the wall.

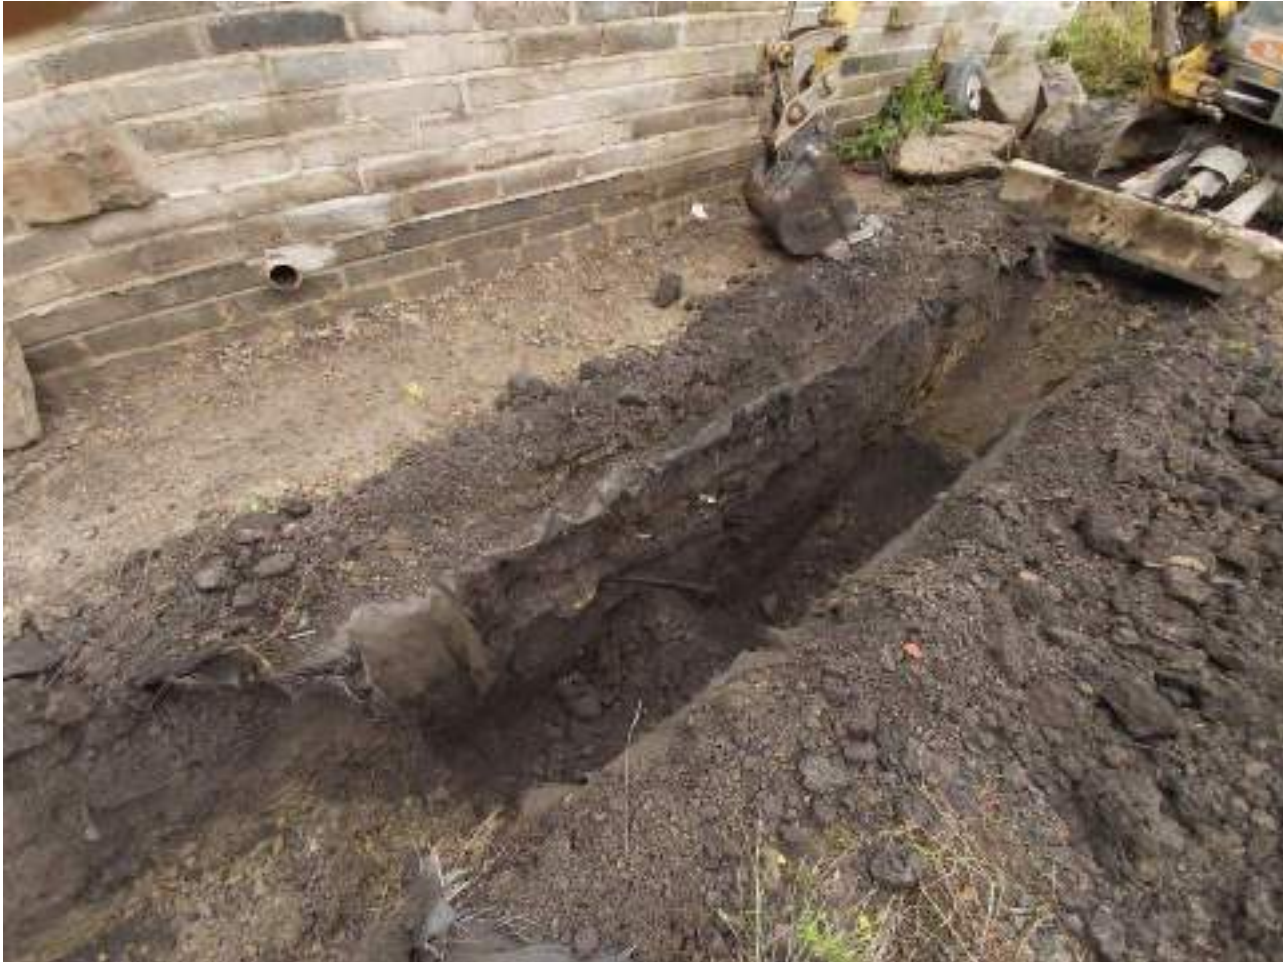
Interestingly, a geofabric layer was found near surface between fill layers.
