## Phase 1 Desk Study Site Investigation Report

| <b>LOCATION</b> | Bell Cabin, Long Lane, Earlsheaton, Dewsbury, WF12 8LG |
| <b>OUR REF.</b> | G23326 |

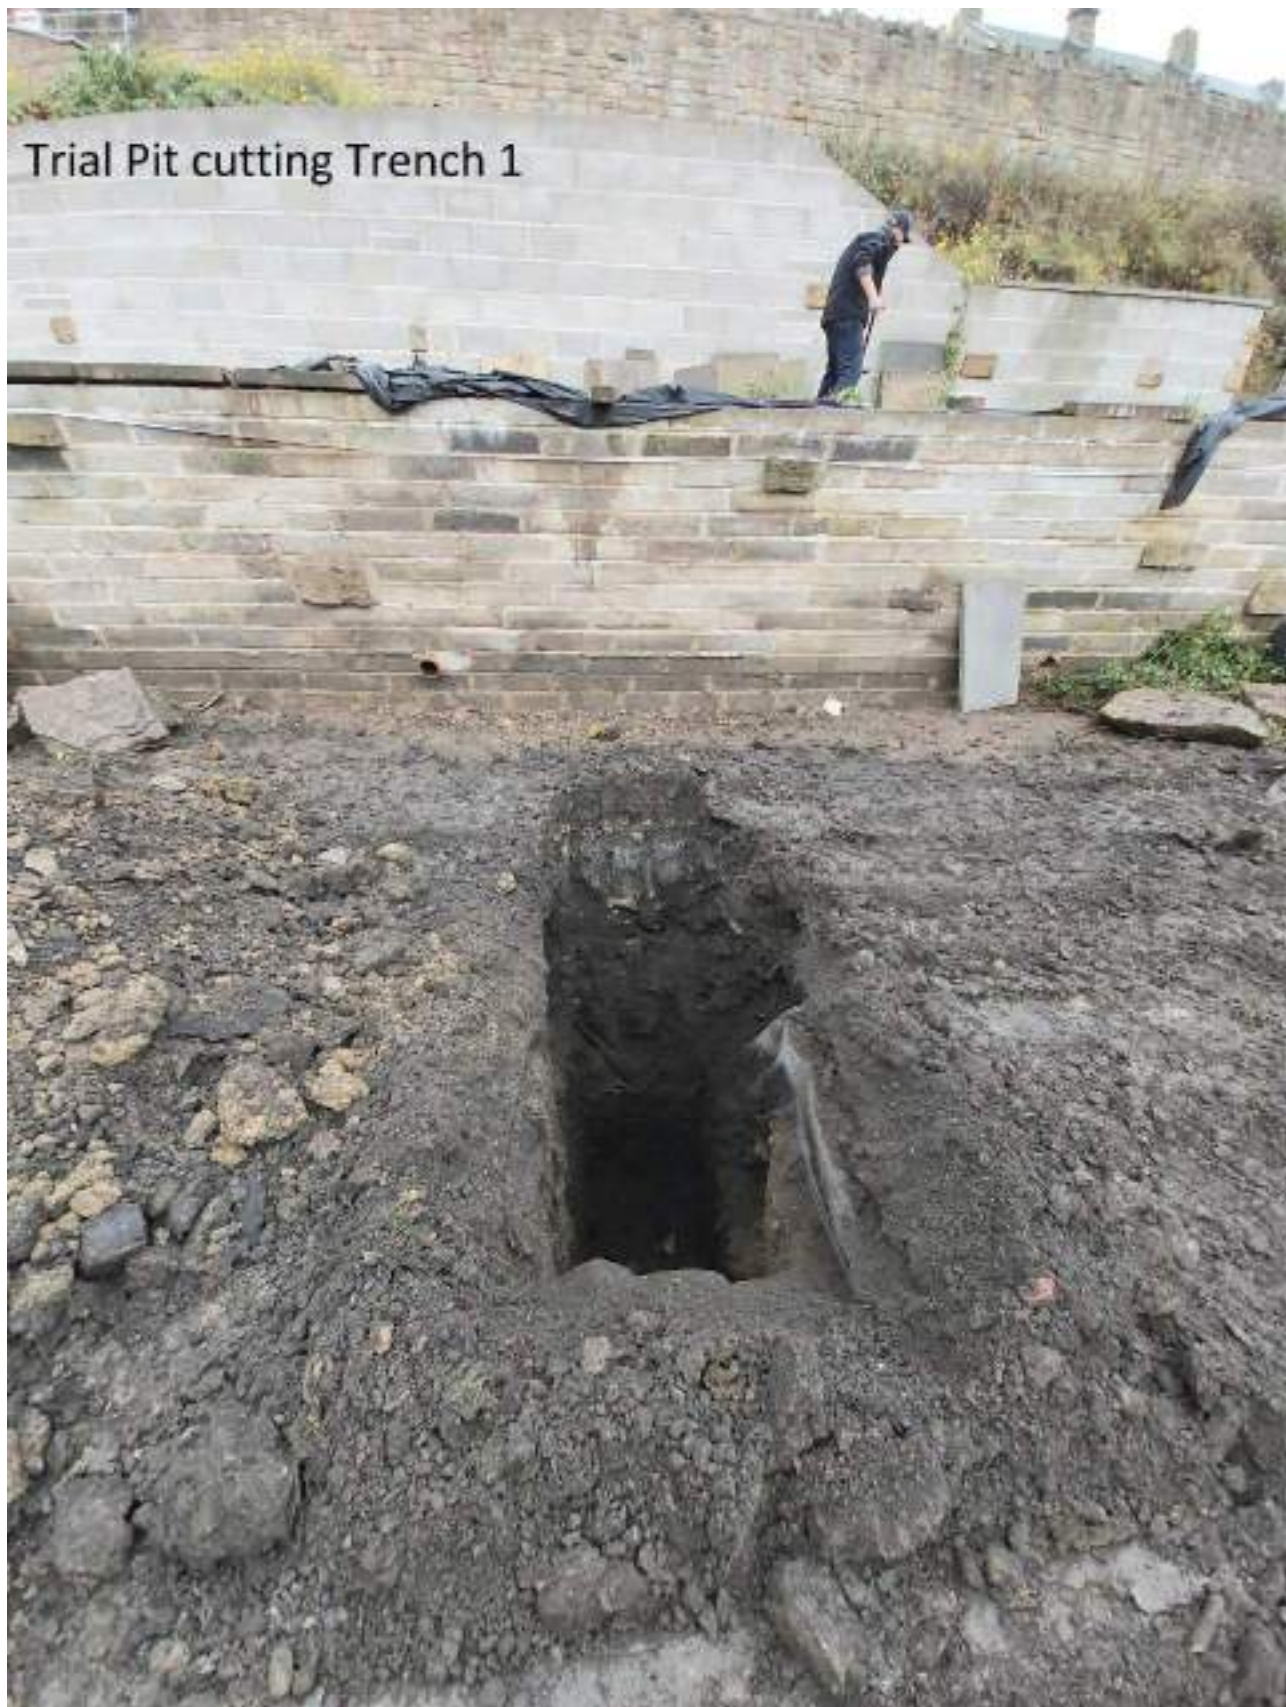
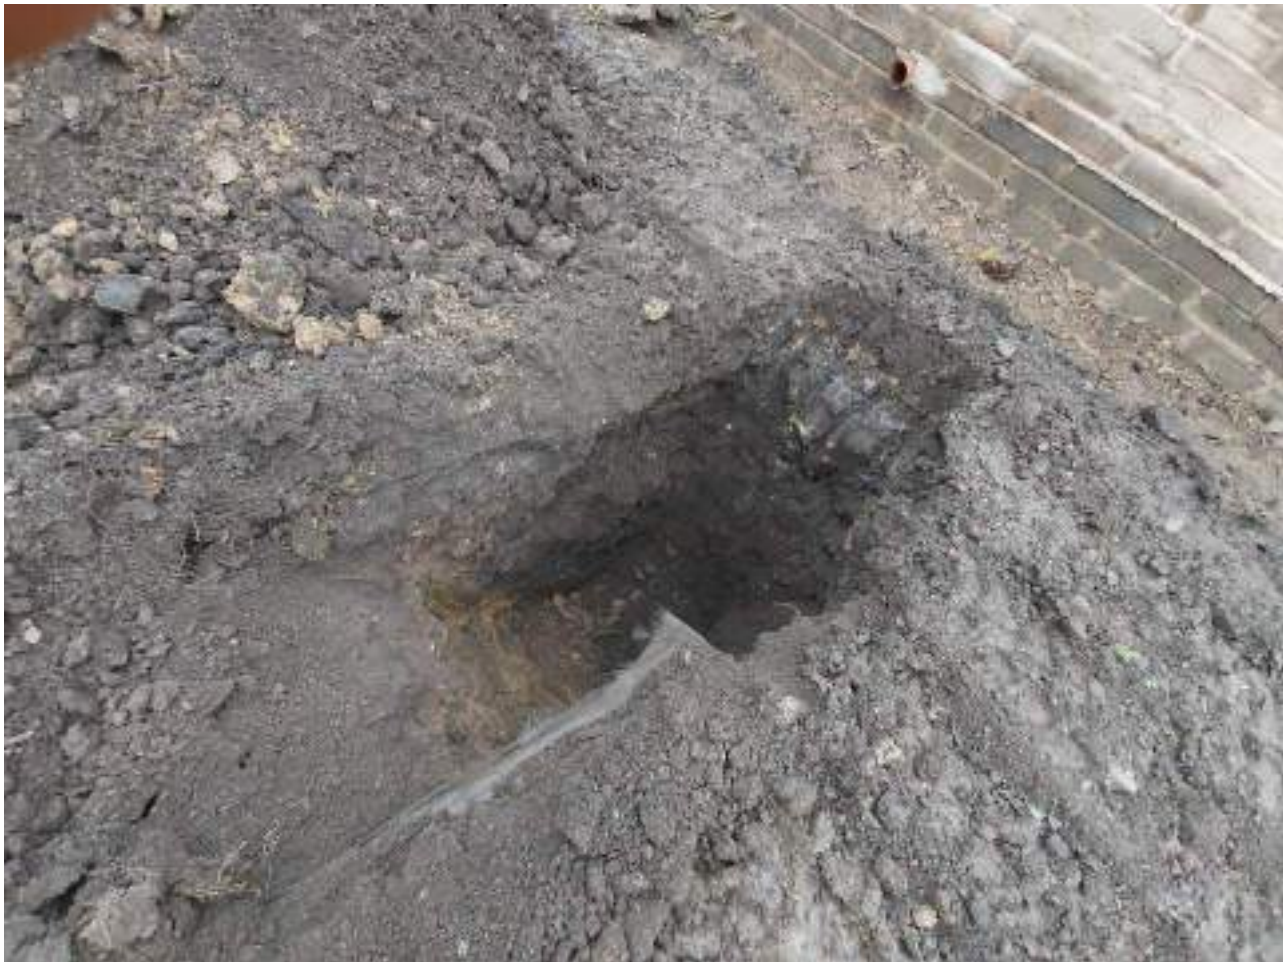
A trial pit was cut perpendicular to the wall at 6.50m distance along Trench 1 to further investigate the suspected shaft fill found at this position. It encountered dark coaly mine waste with some pipe bricks and clay fill extending below 2.50m.

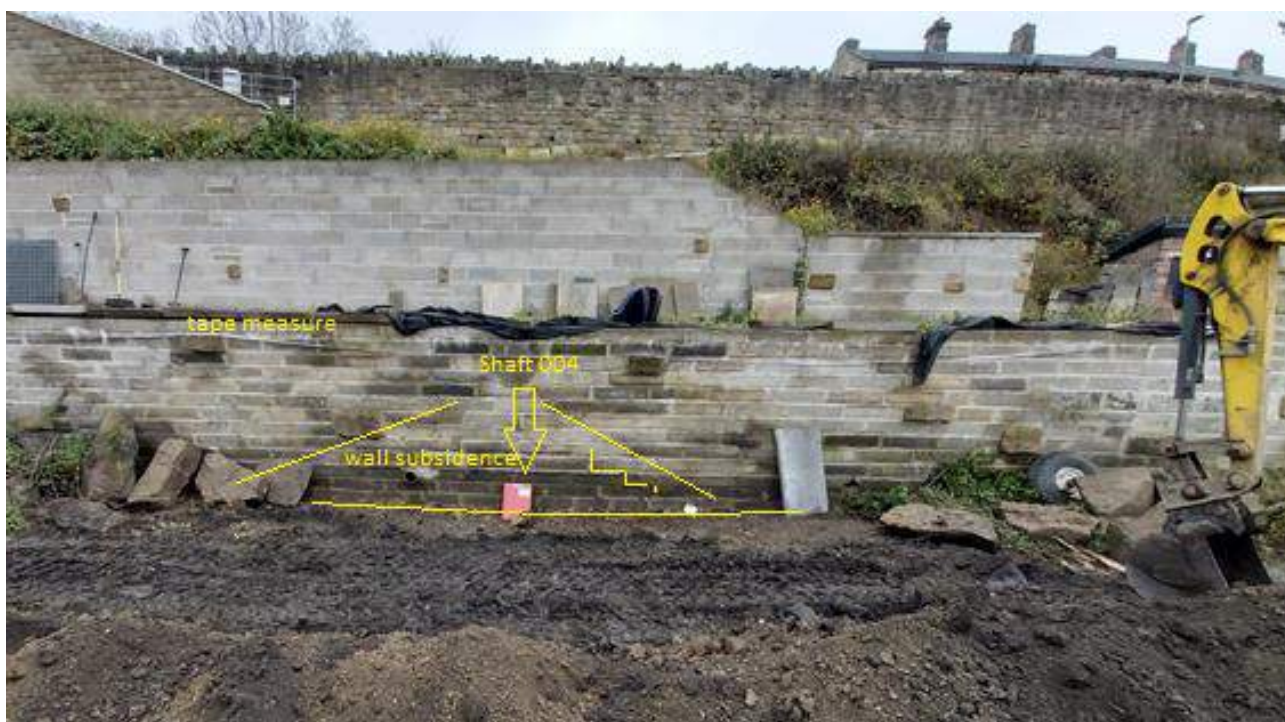
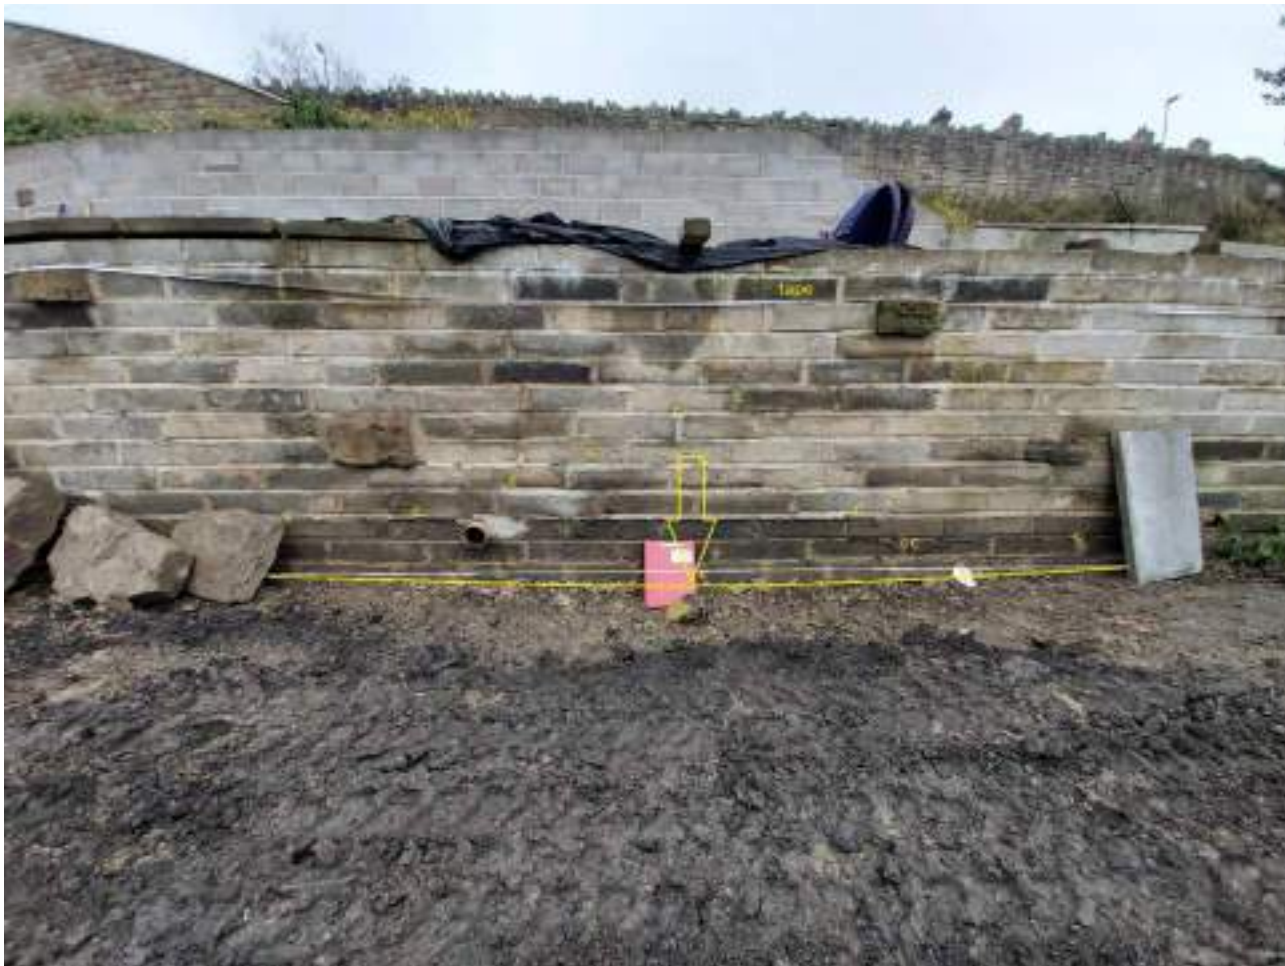
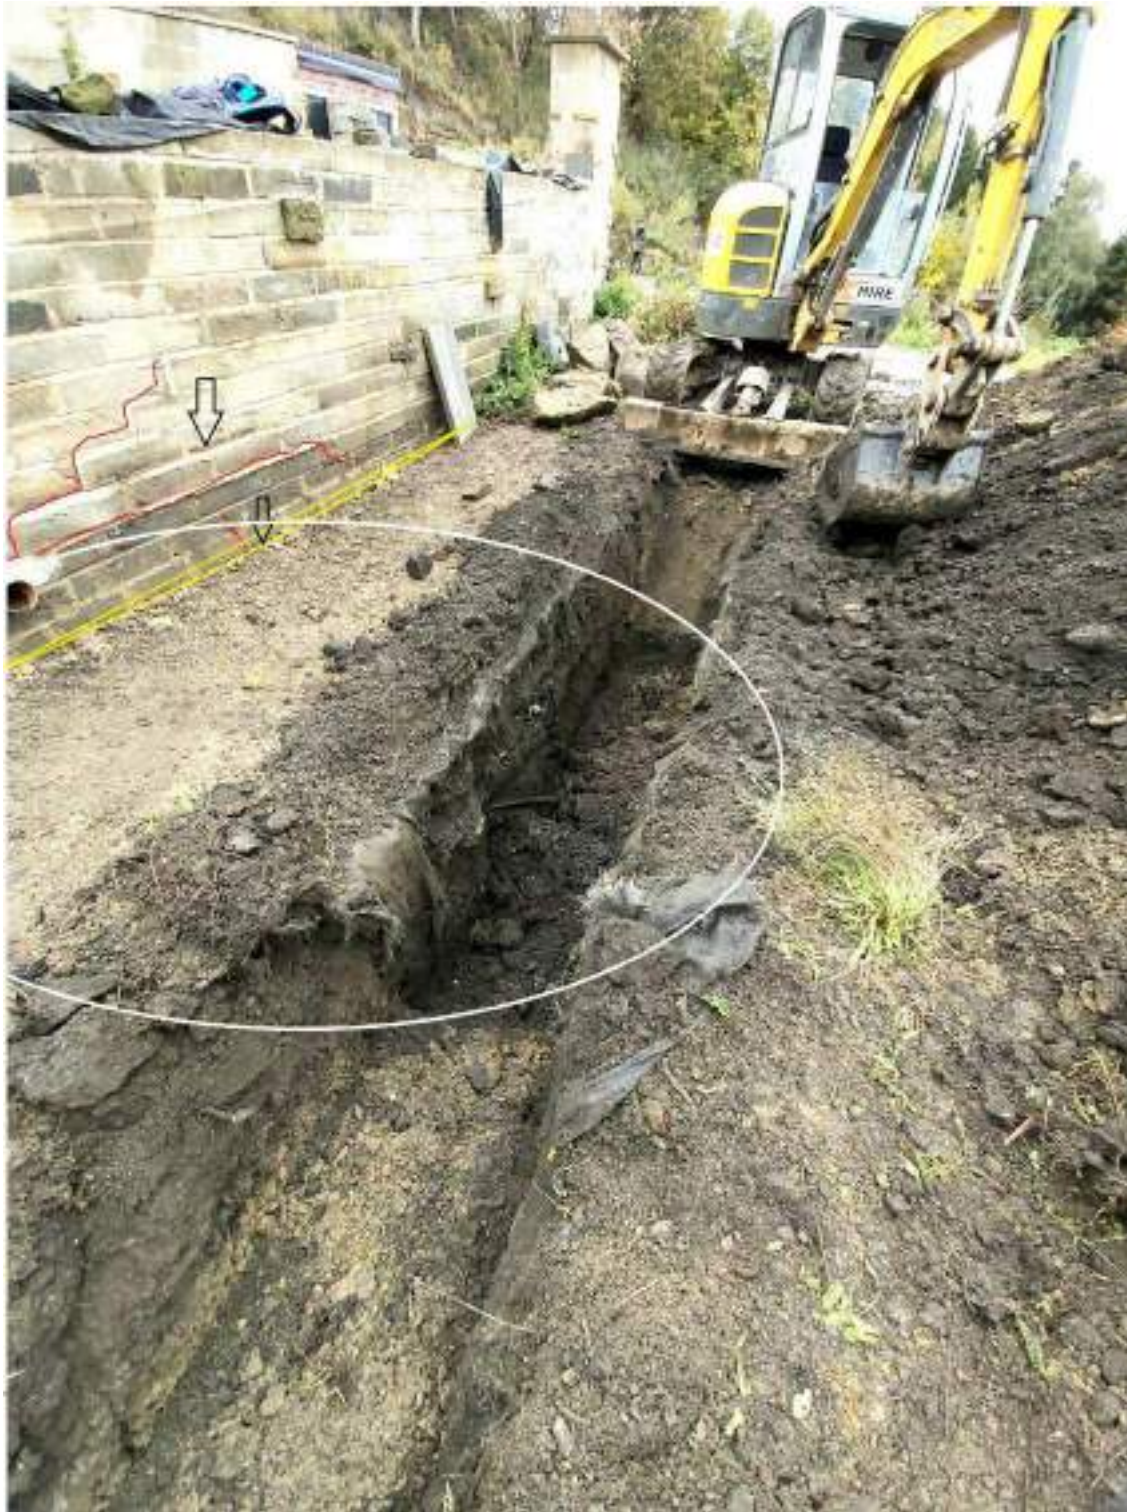
The images below taken on 27<sup>th</sup> October show minor crack damage to the wall and sagging of the ground surface adjacent to it. These features were present before the trenching exercise commenced and in Geoinvestigate's opinion are caused by subsidence of the mine shaft infill beneath this section of wall.

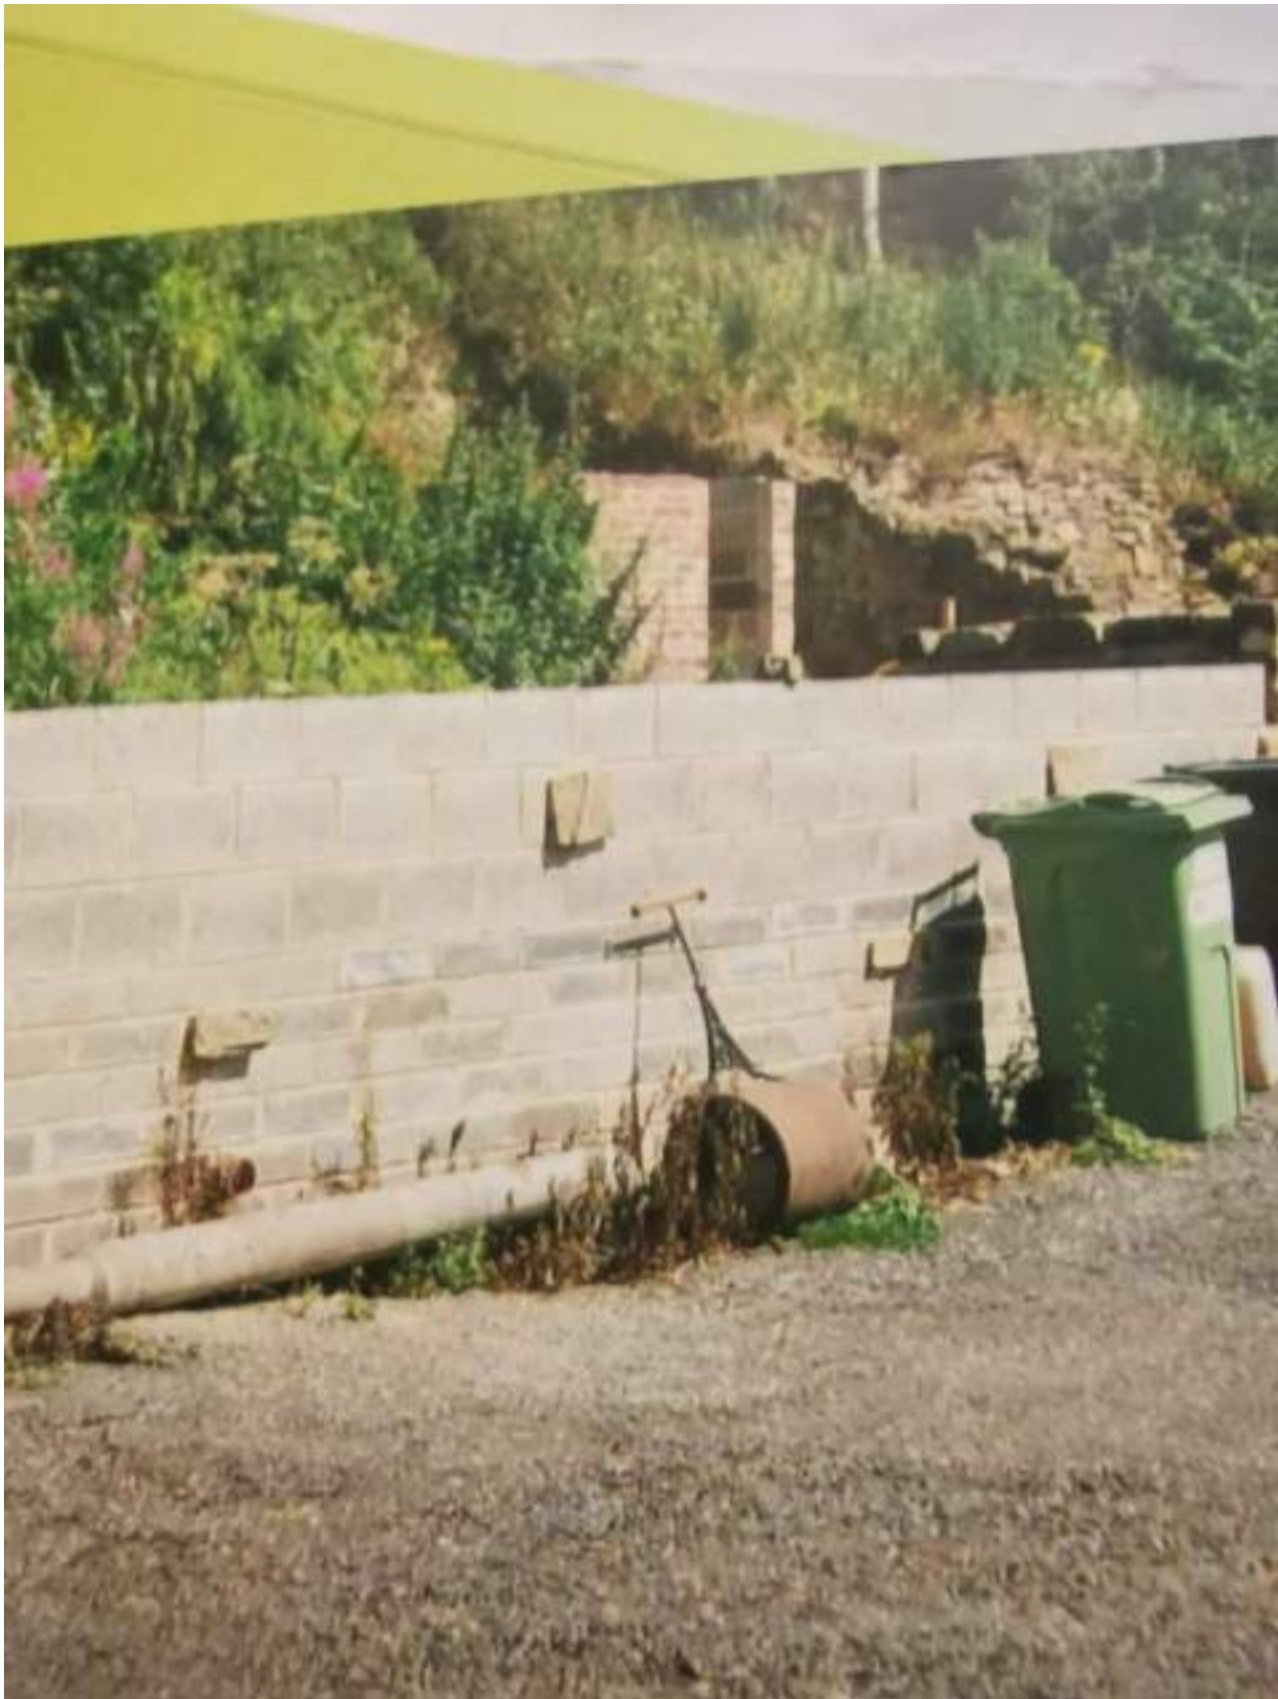
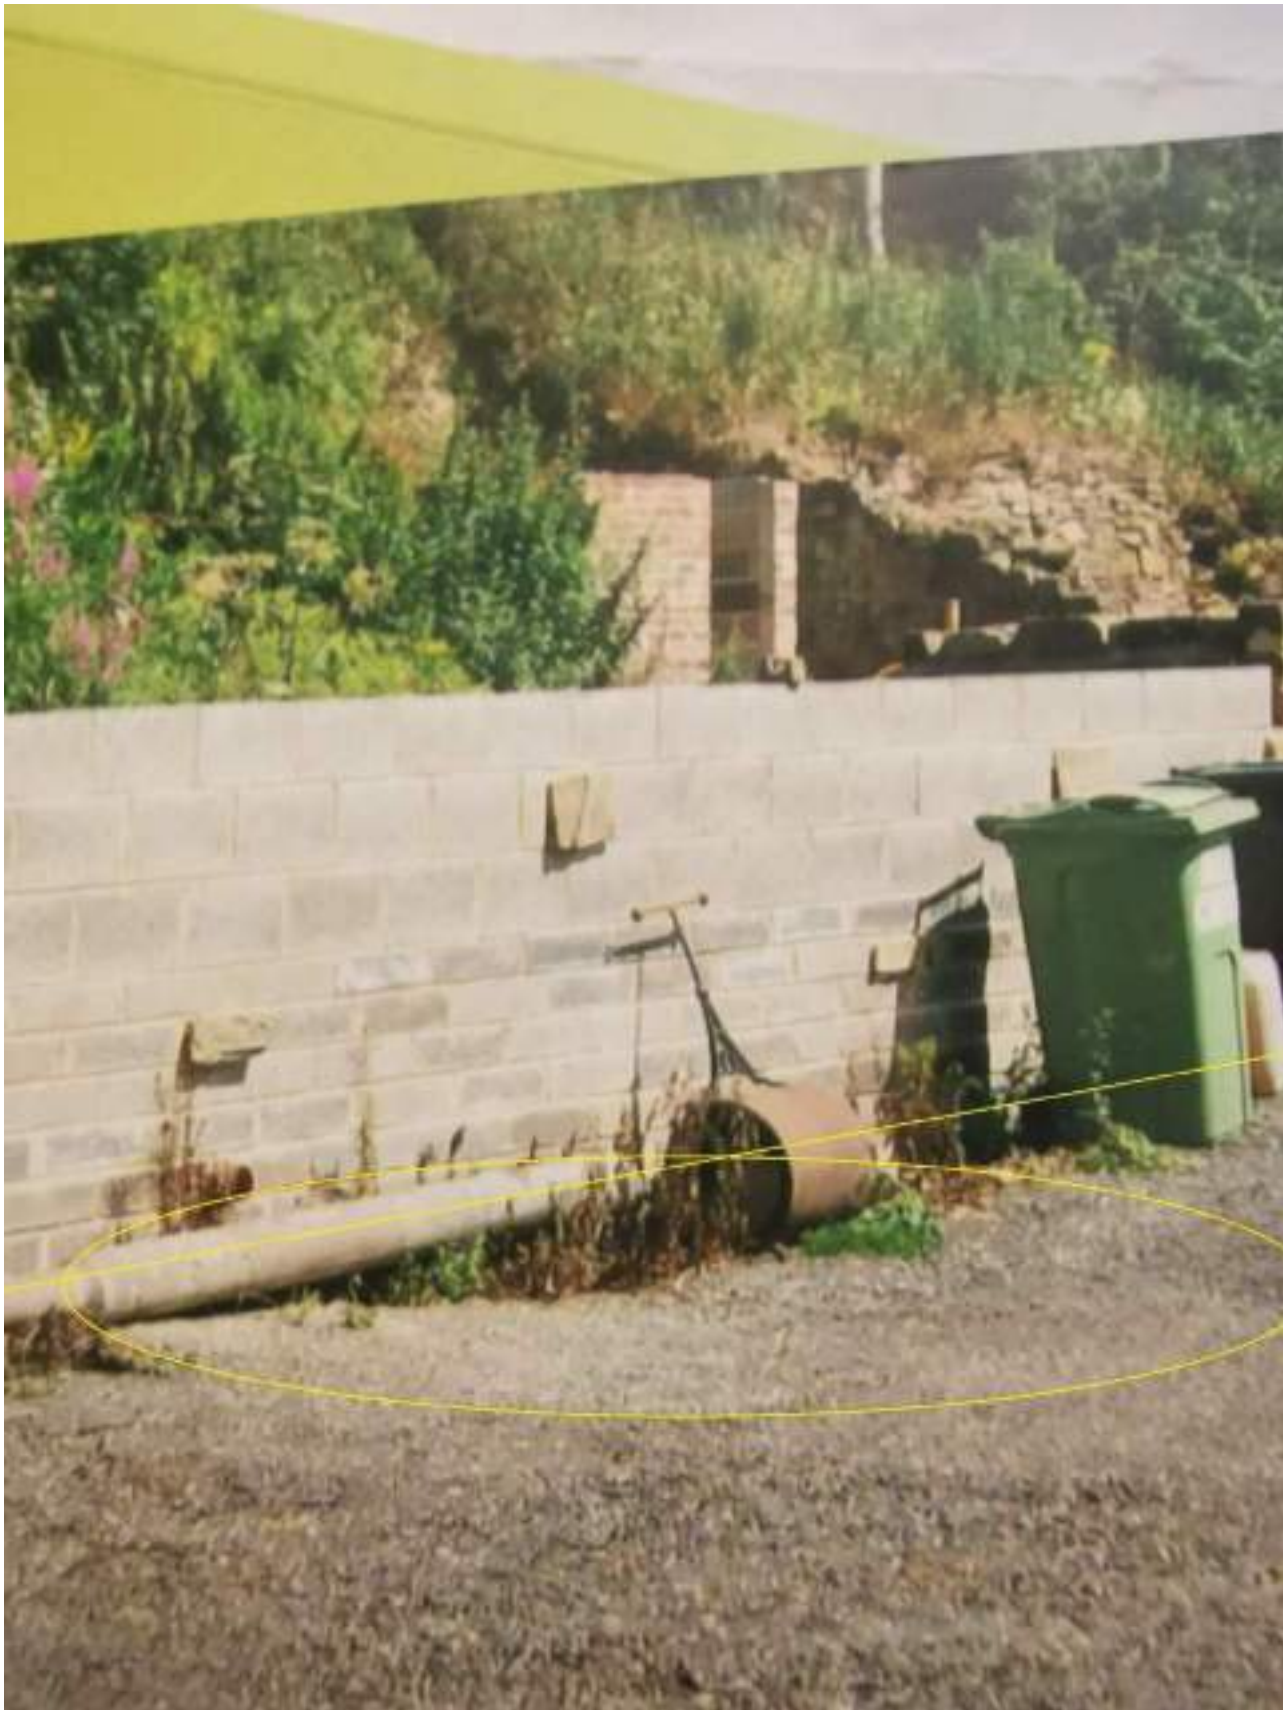
A while after the trenching investigation, the following image was provided by Lucy Buckley. It is understood to have been taken perhaps in 2017 by Alan Yates, the previous site owner. In our opinion, it shows a sinkhole/ground subsidence developing above mine shaft 004. The 2<sup>nd</sup> same image has been ringed by Geoinvestigate to show the possible approximate shaft position.

The original image was taken before or during the period of RTW construction prior to Paul Audsley's occupation of the site. Bell Cabin's ruined stone walls can be seen on the right side of the image.

This section of wall appears different in the October 2020 image when compared to Alan Yates's earlier image because in the interim it collapsed. Movement of the rebuilt wall is continuing as evidenced by the wall cracking and ground subsidence shown in the October 2020 image. It is understood from Lucy Buckley that the condition of the wall has deteriorated further in 2021.

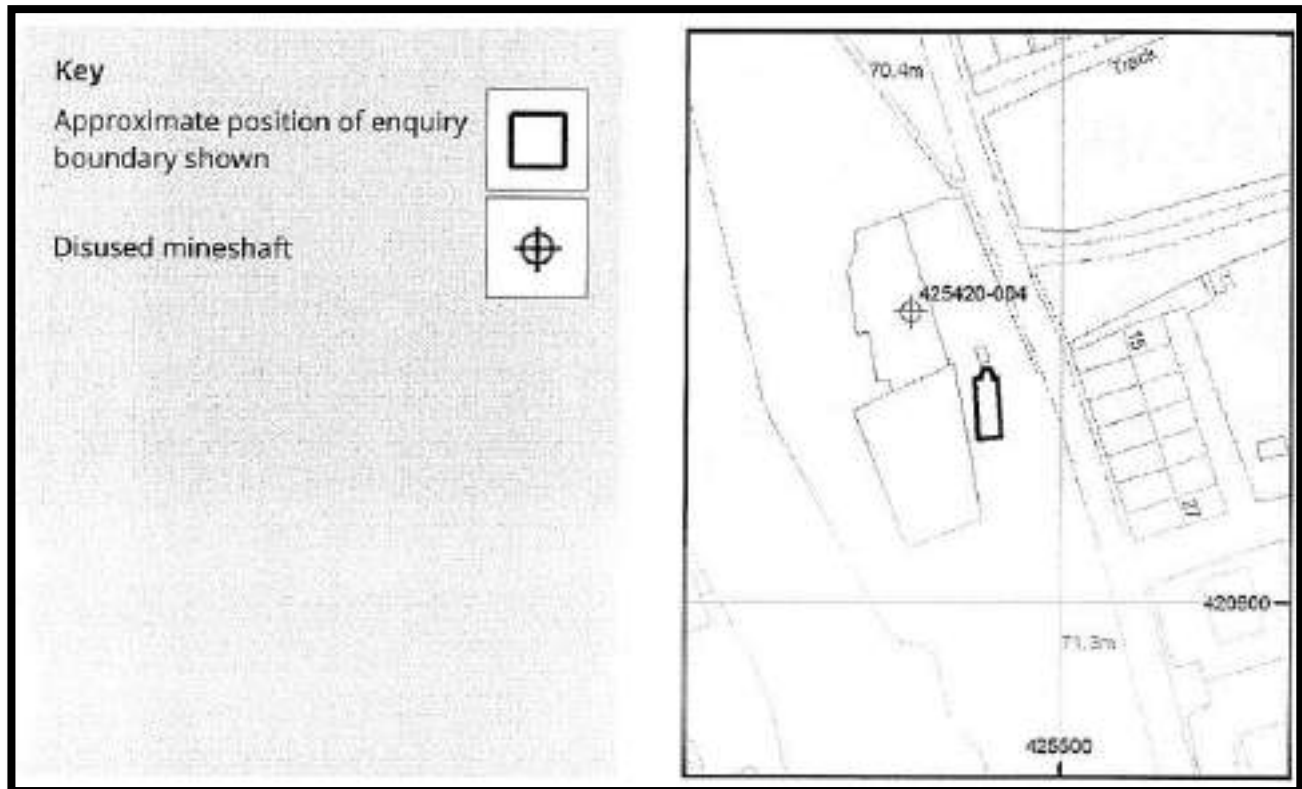
The coordinates obtained from the CAs earlier CON29M report of 5<sup>th</sup> July 2016 and the CAs current online interactive map service for mine shaft 425420-004 are identified as (425473, 420650) or (425473, 420653), respectively. Bell Cabin is identified by a thick outline.

CA online information gives a depth of 32m, assumed diameter of 2.5m and departure/positional uncertainty of 10m for shaft 004. No information is provided on shaft treatment. Therefore, initially the shaft was assumed to be untreated though perhaps haphazardly infilled, which is not uncommon.

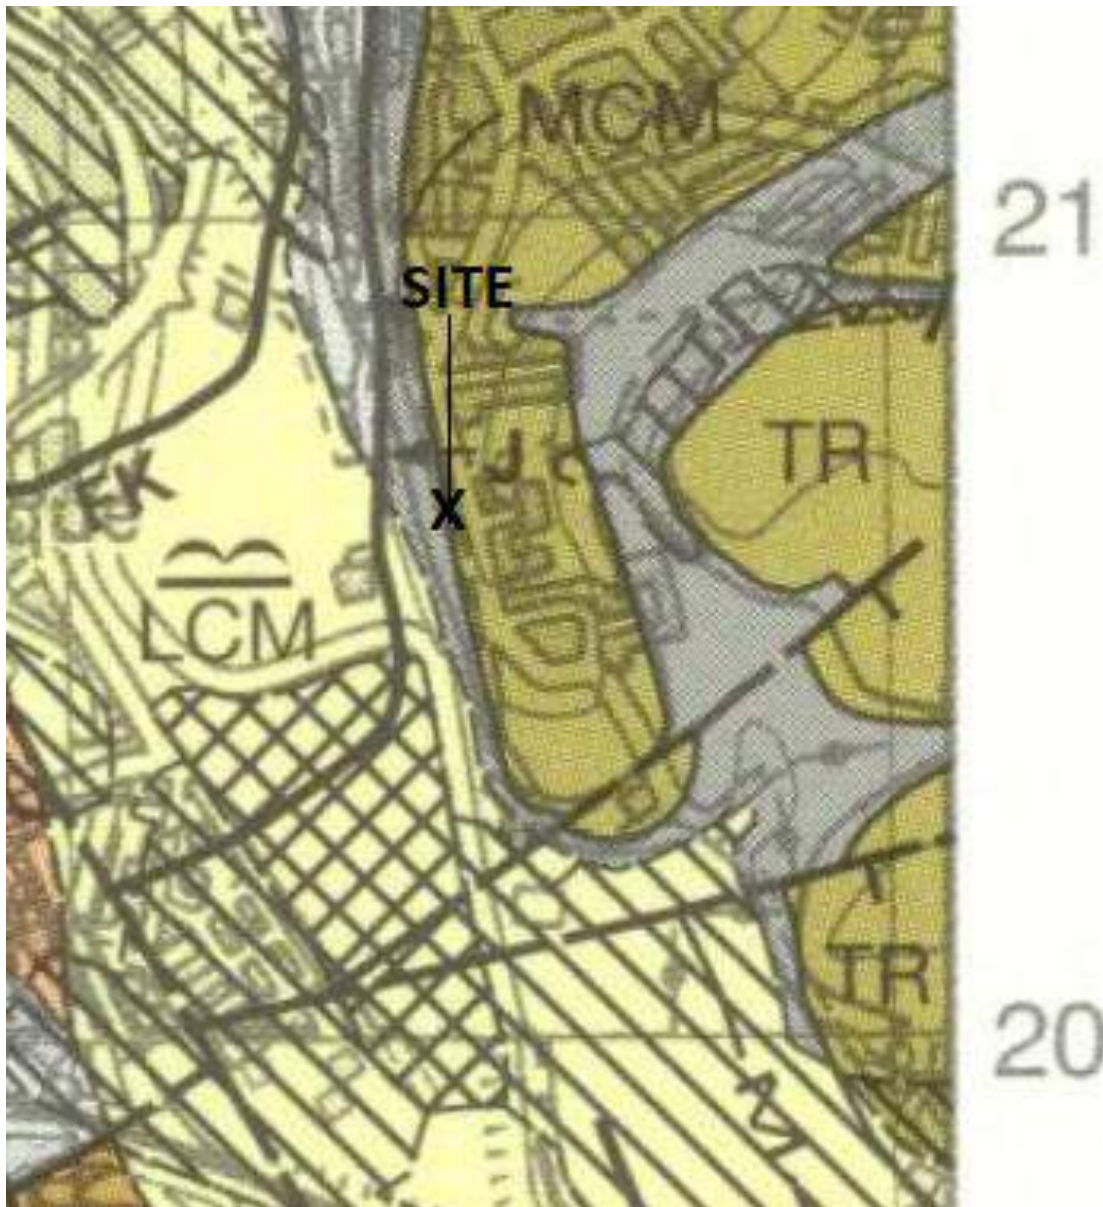
The site's location is shown on the extract of the BGS solid geology map Sheet 77 Huddersfield presented below. According to the map the uppermost section of site slope is underlain by Thornhill Rock (TR) - Sandstone.

The Joan Coal (J) seam is shown outcropping further down the slope to the west below alluvial deposit at an elevation perhaps around 30m AOD in the bed of the River Calder while the site occupies a platform at around 61m AOD. This broadly accords with the CAs depth for the shaft of 32m.
