## Phase 1 Desk Study Site Investigation Report

| <b>LOCATION</b> | Bell Cabin, Long Lane, Earlsheaton, Dewsbury, WF12 8LG |
| <b>OUR REF.</b> | G23326 |

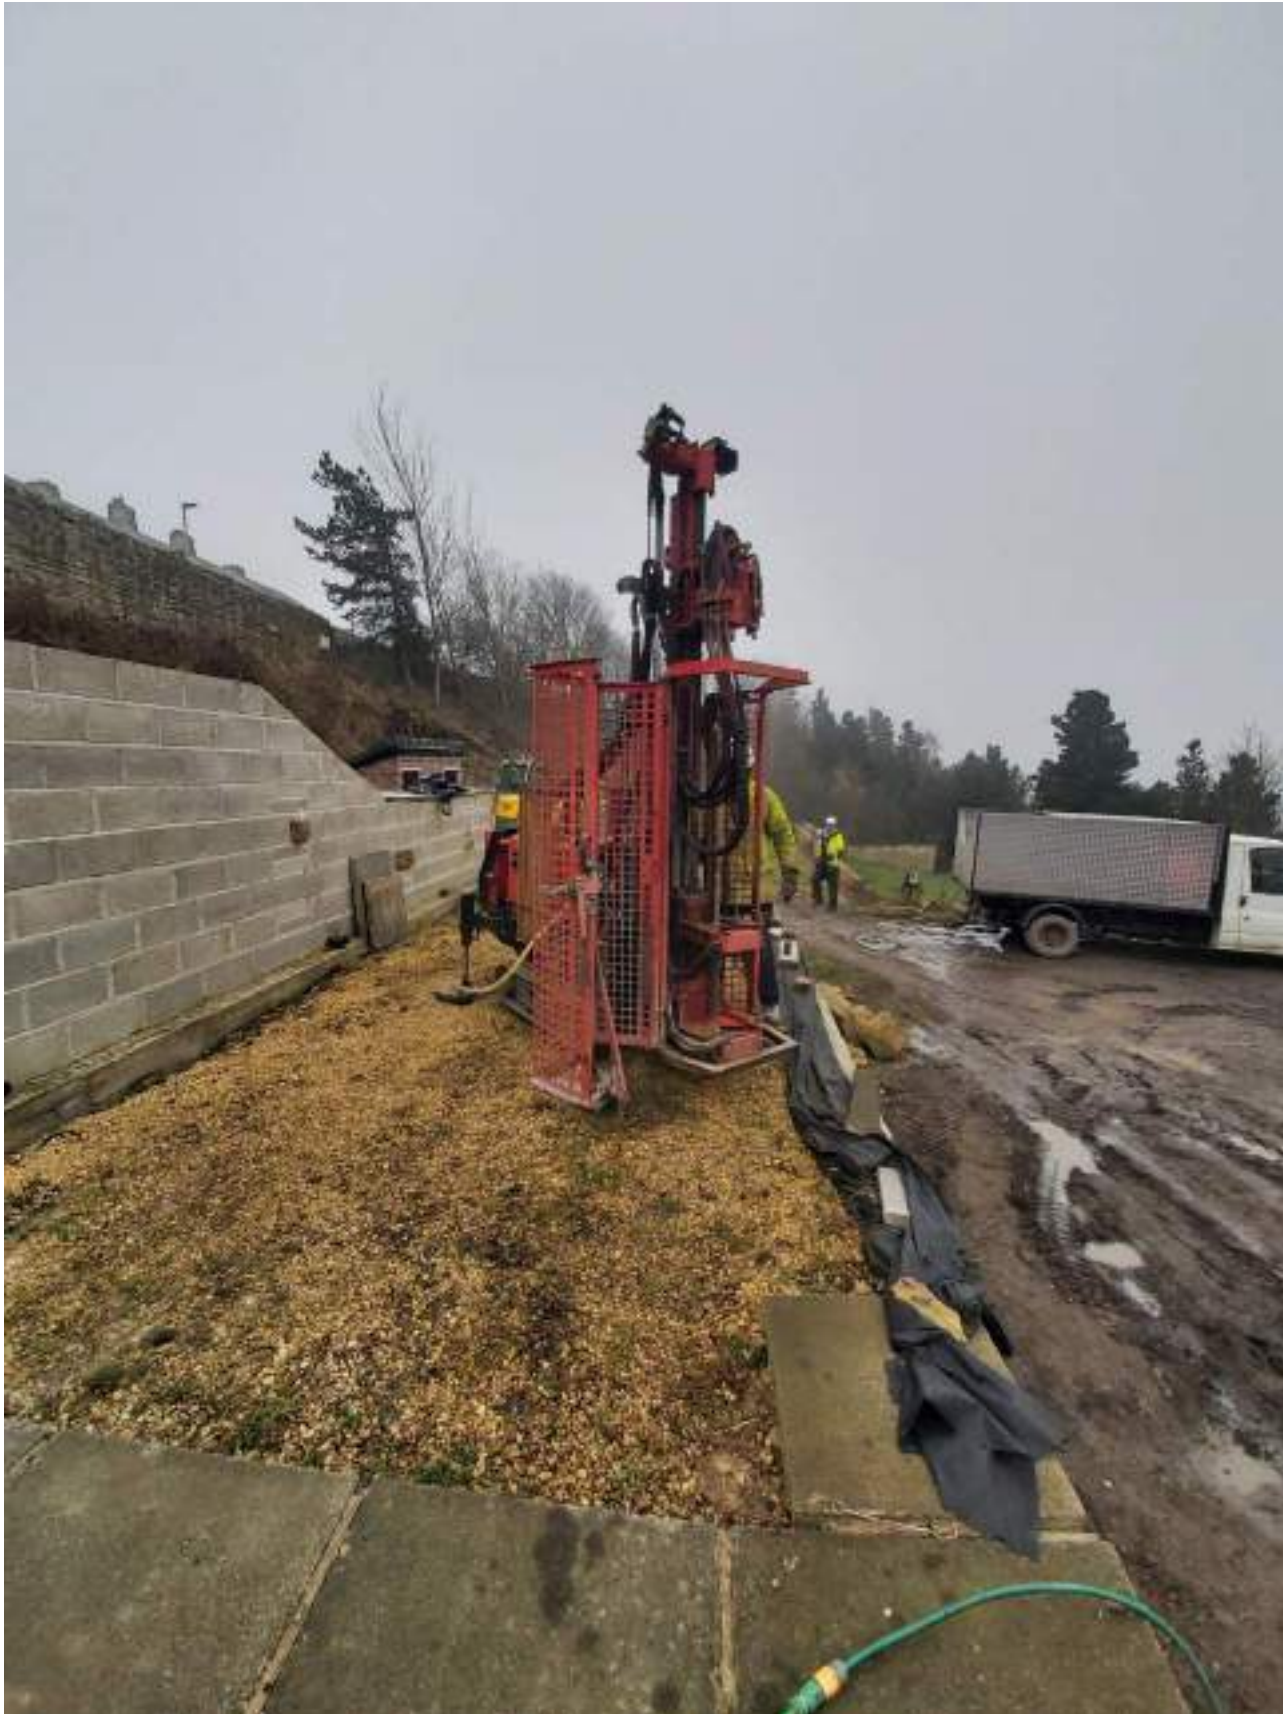
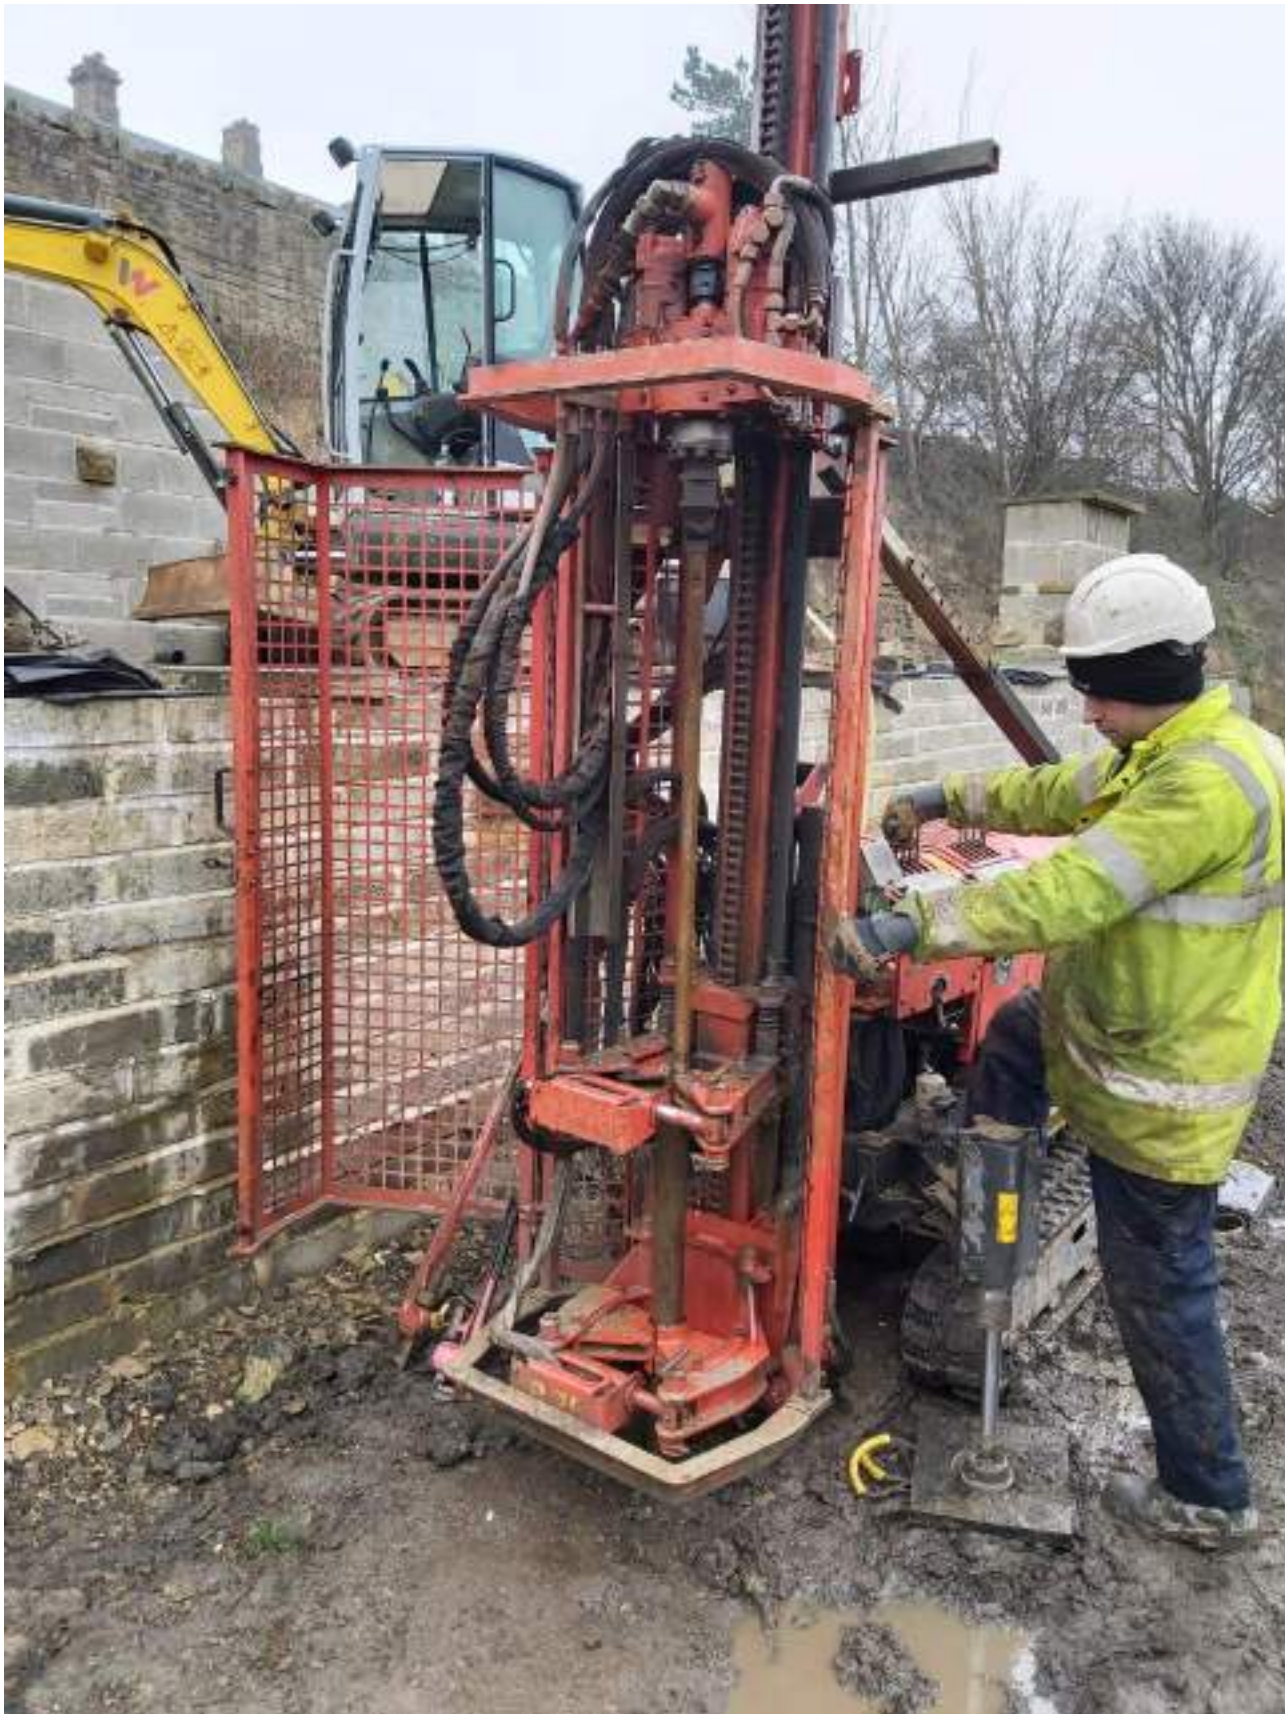
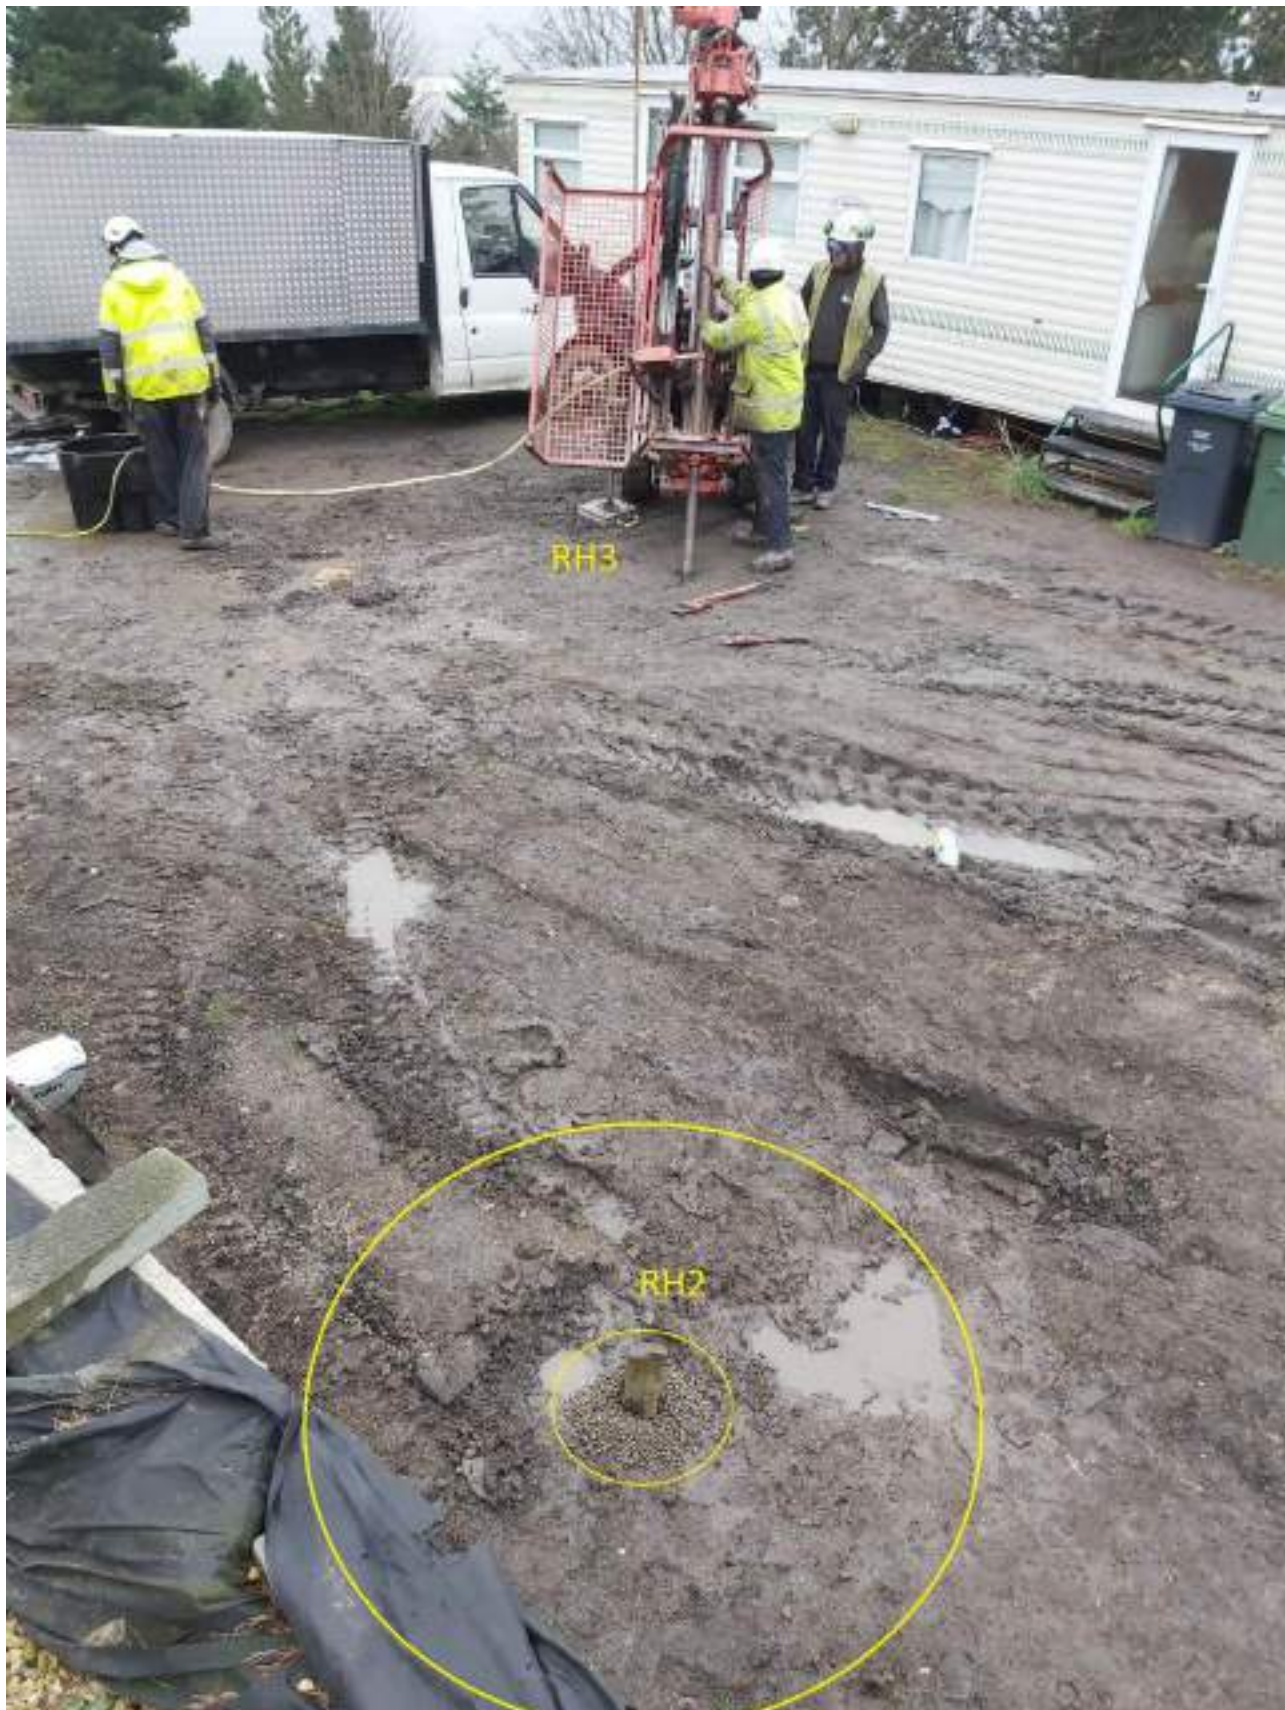
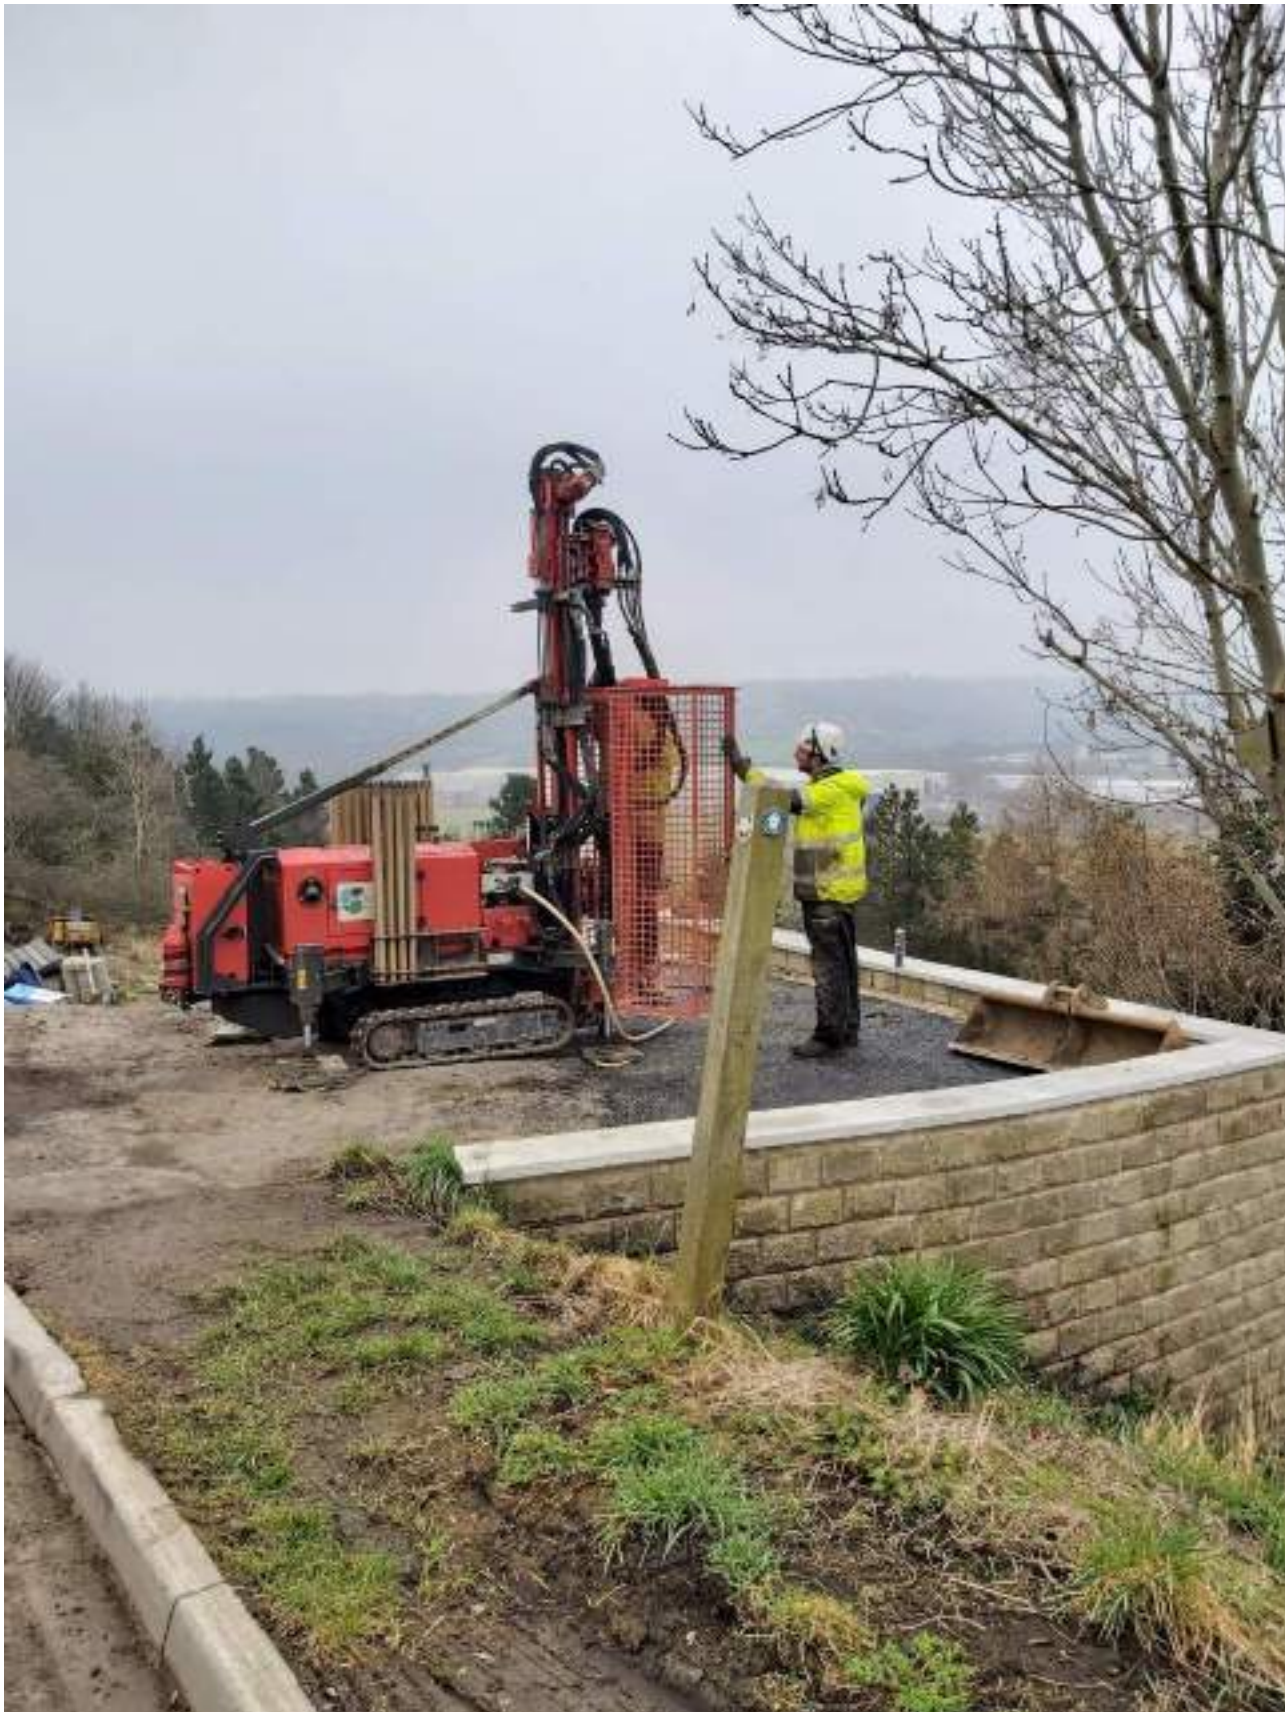
Images of boreholes RH1, 2, 3 and 4 are presented in order as follows. Both RH2 and RH3 penetrated mine shaft 004.

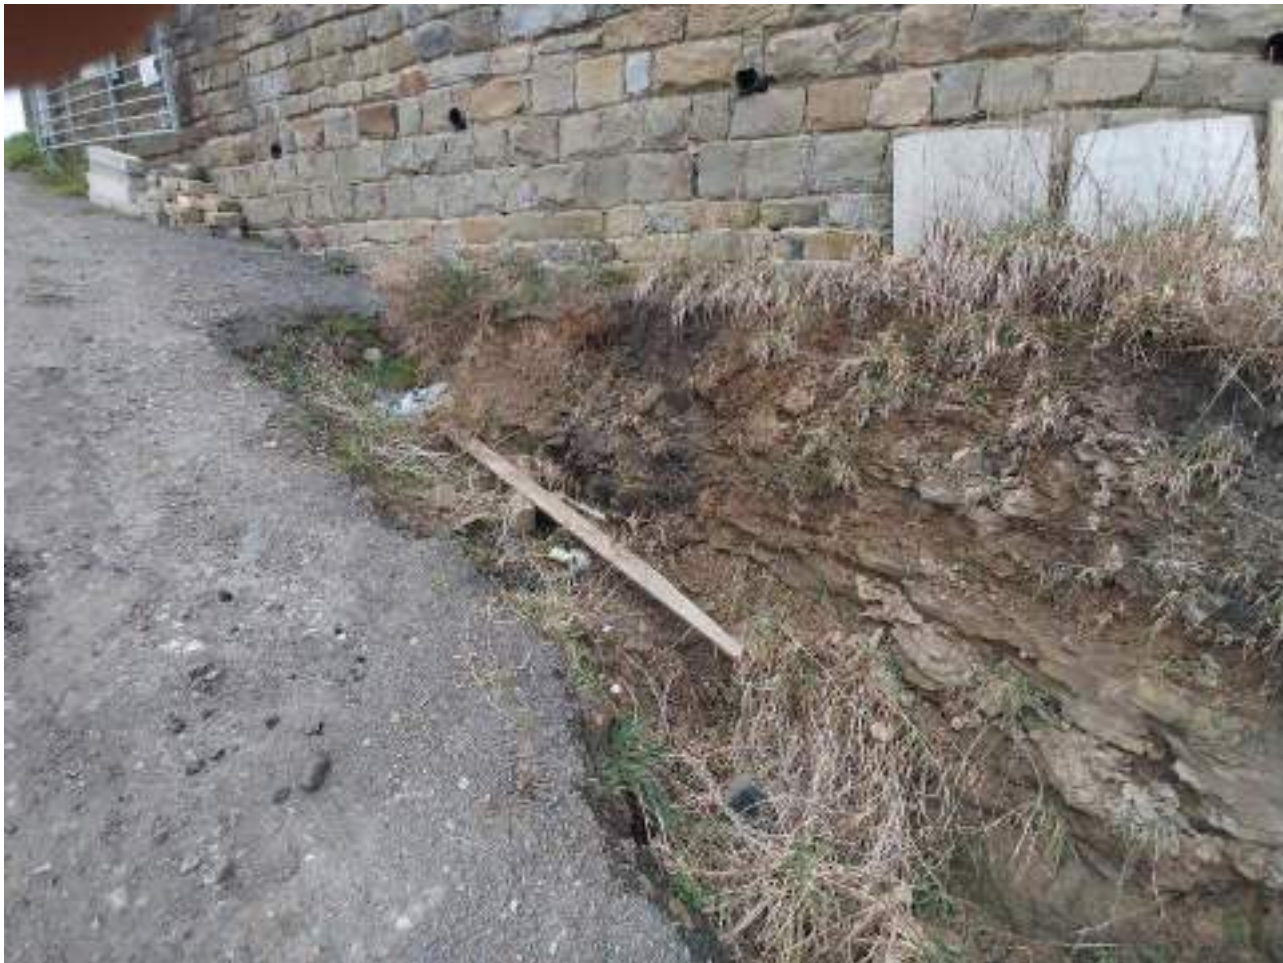
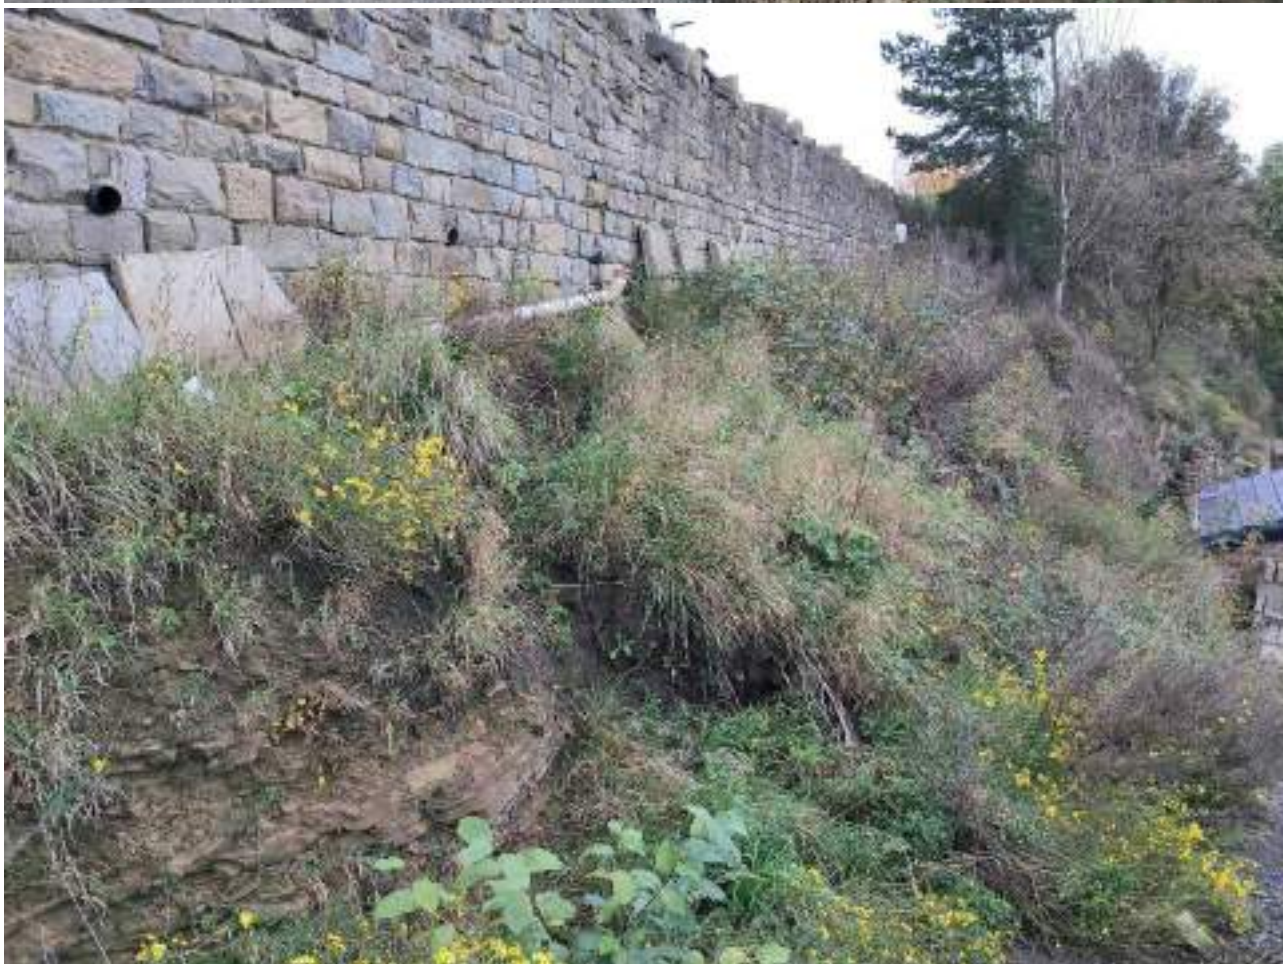
The images below show the roadside wall and weathered mudstone bedrock exposed high up on the access track approaching the site entrance and Long Lane.

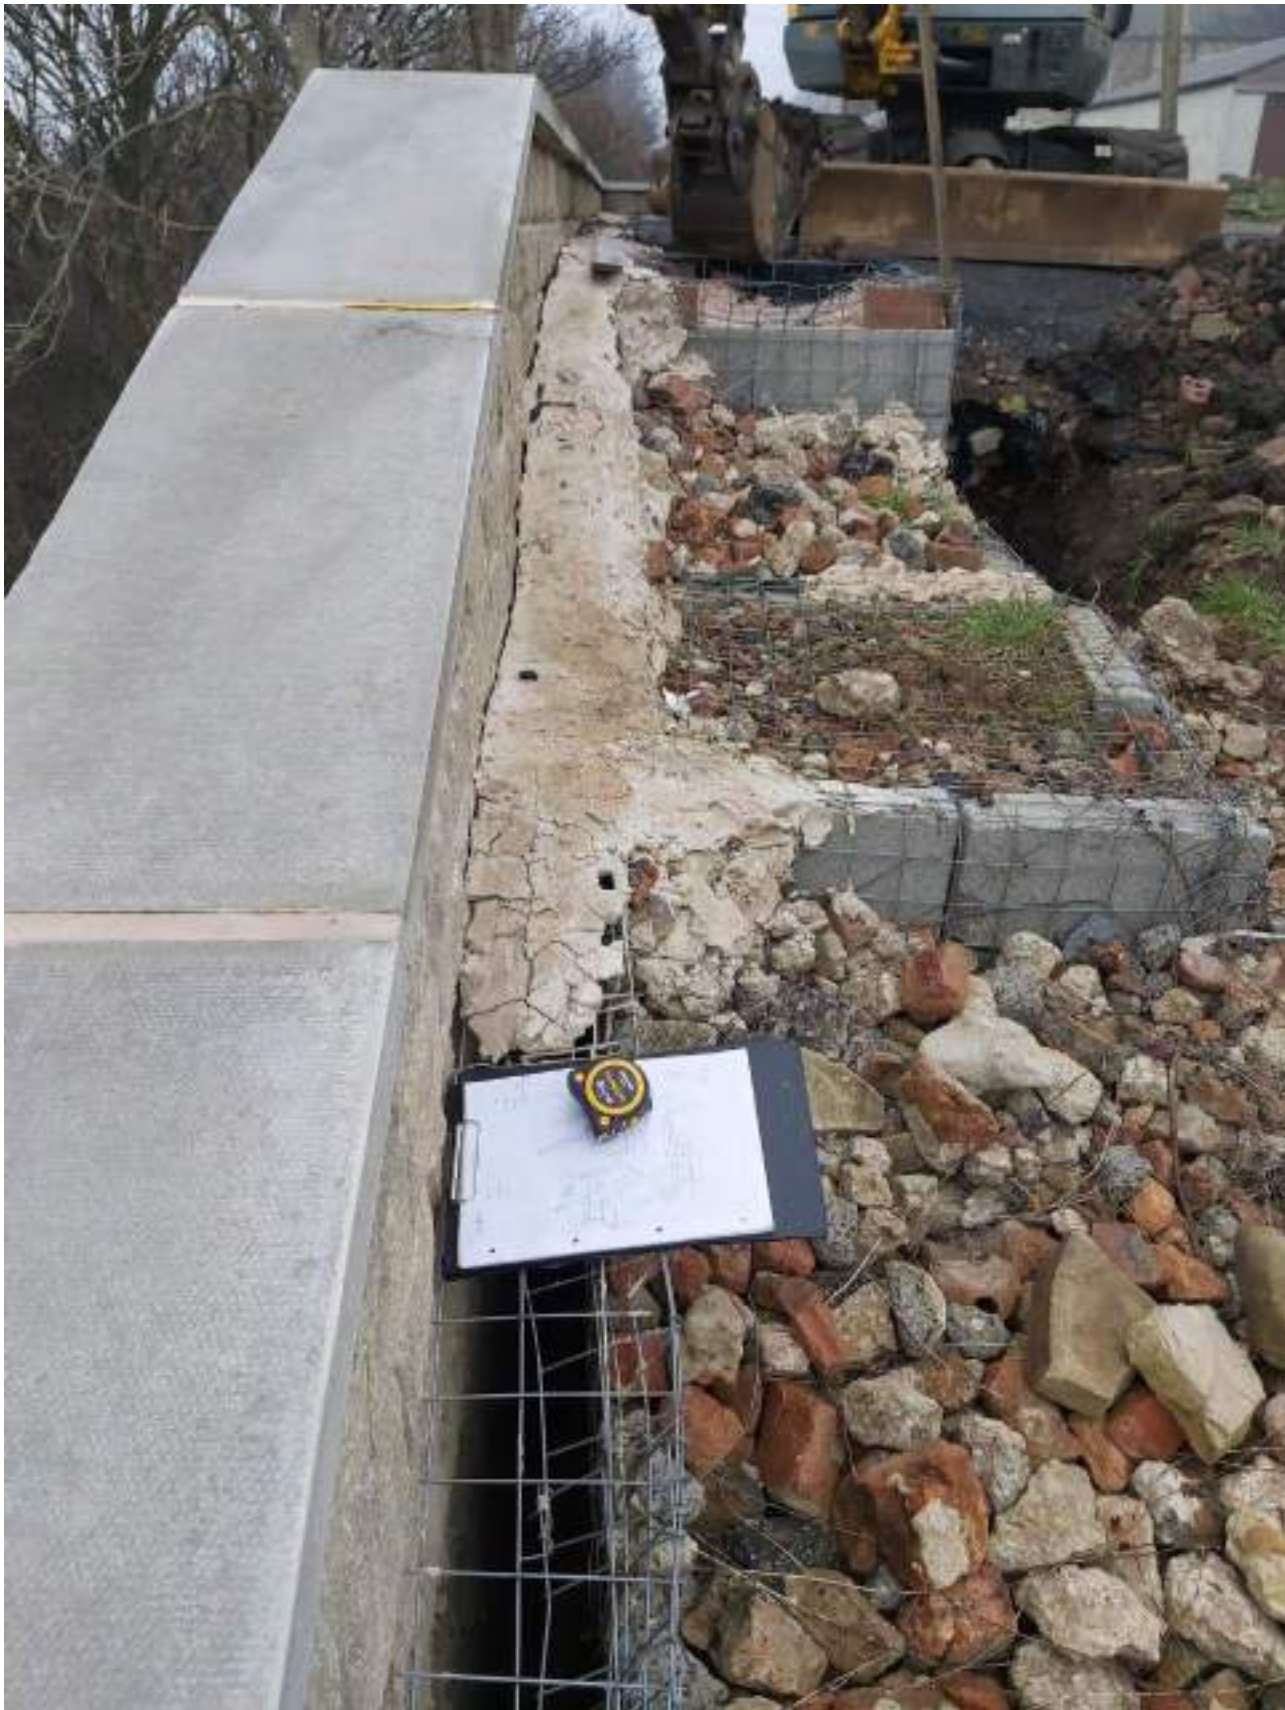
A 1.5m high gabion basket wall at the back of the top/ 3<sup>rd</sup> wall (presumably to reduce the earth pressure on this wall) was installed by Paul Audsley. There is evidence of slight further forward (perhaps rotational) movement of this wall as indicated by the open surface crack below the wall coping in the following image. The concrete footing of this wall is seated at shallow depth on very steep slope and is potentially underlain by un-engineered fill. The wall is essentially free-standing as a gap with a drain at the bottom has been constructed between it and the gabion basket retaining structure behind it.

The 1<sup>st</sup> / lower RTW has a history of movement caused by mine shaft instability below it. This caused the sudden collapse of a section of the wall straddling the top of the shaft in recent years and there is ongoing movement and cracking of the same rebuilt section first noted by Geoinvestigate on 27<sup>th</sup> October 2020, during our initial site investigation but, according to Lucy Buckley has subsequently worsened in 2021.

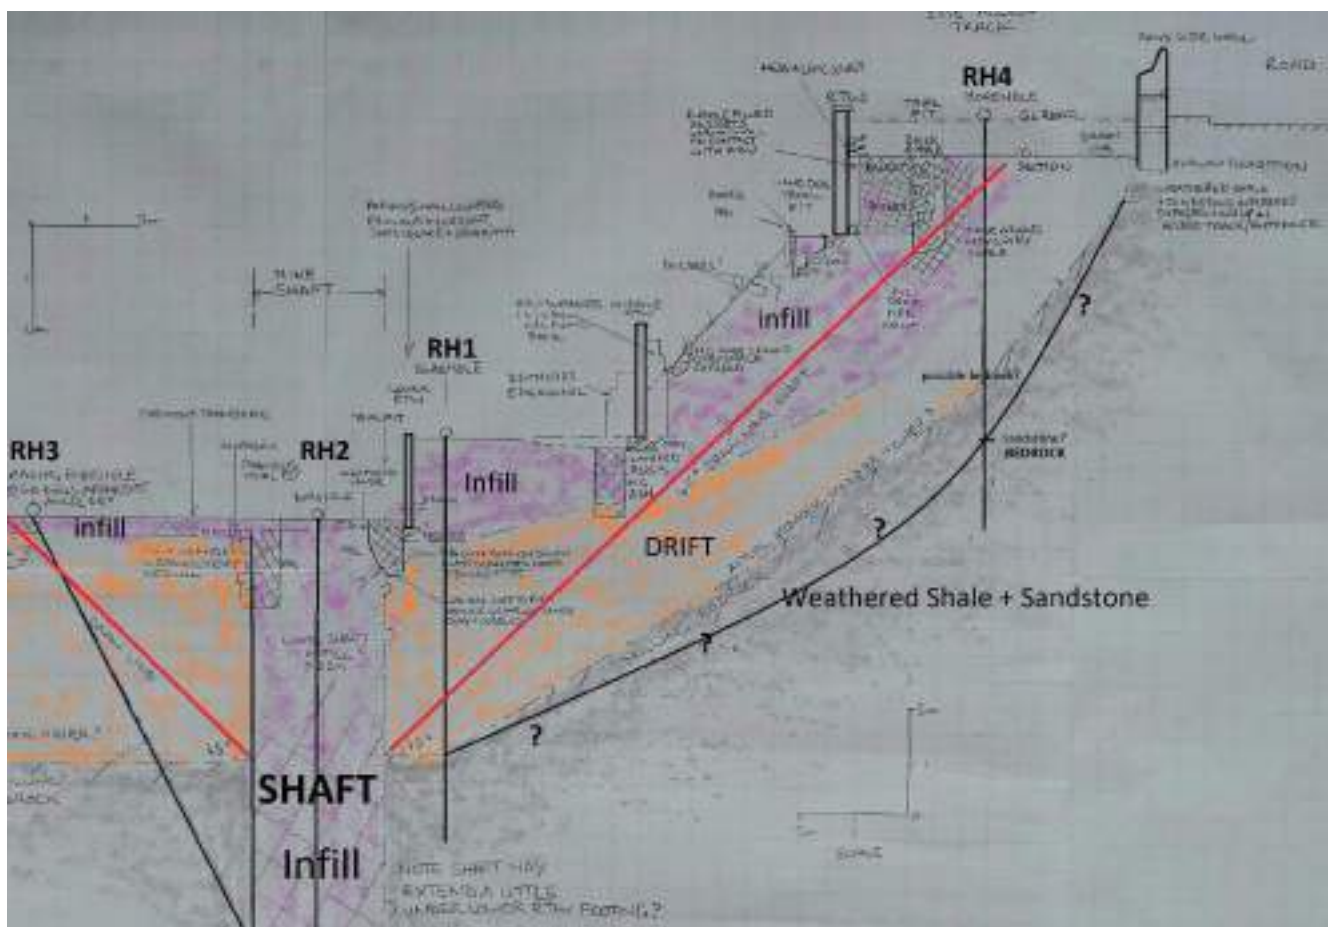
The shaft is uncapped, around 2.5m diameter, circular, > 35m depth and haphazardly infilled with weak/loose material over its full depth. The shaft fill is subject to ongoing subsidence/settlement as evidenced by an earlier image showing possible sinkhole formation above it, the subsequent collapse of the section of wall above it, and ongoing cracking and subsidence of the rebuilt section of wall.

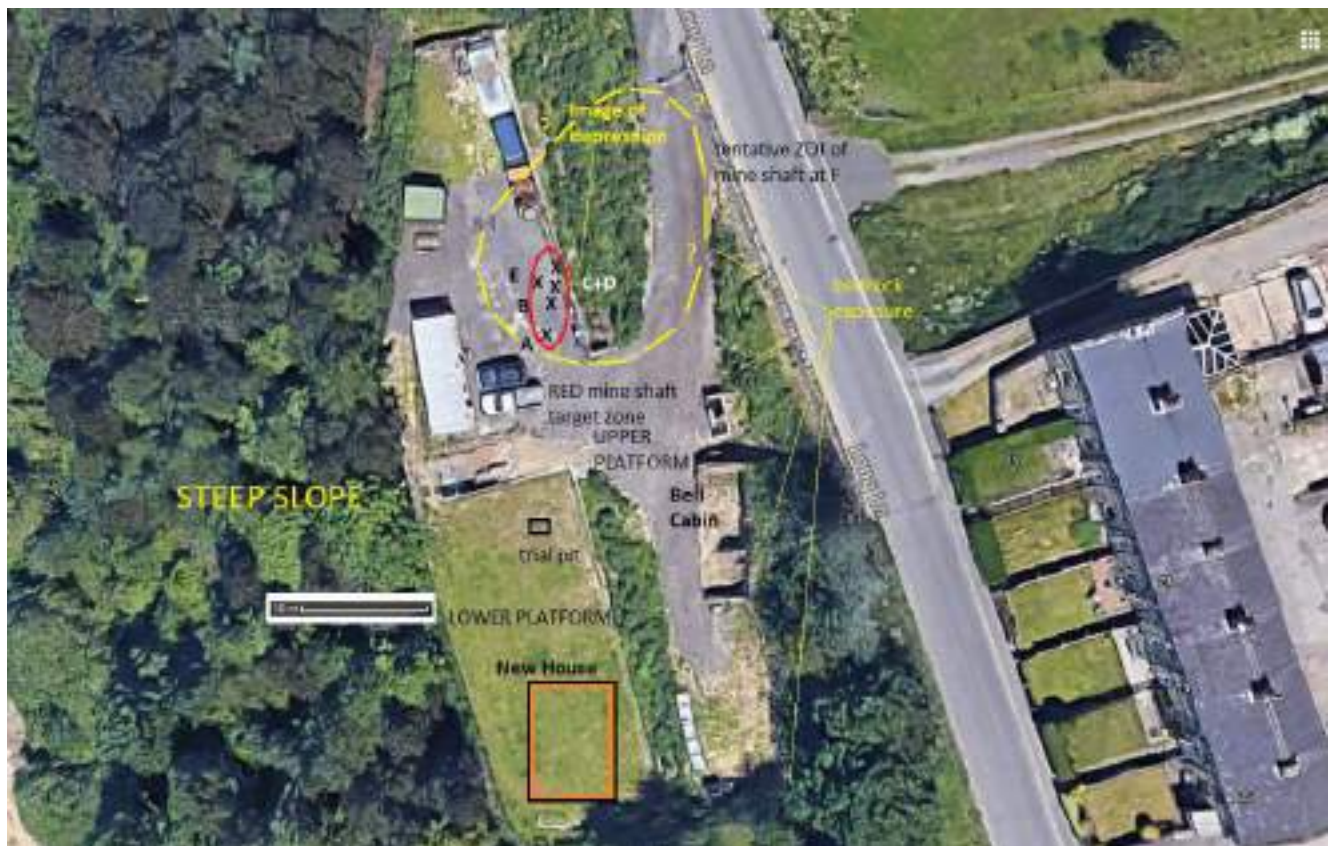
The March 2020 report on the trenching exercise tentatively identified a possible ZOI for shaft 004 shown in the image below together with several initial shaft targets A – F and the position of the earlier sinkhole/mine shaft subsidence image taken by Alan Yates as provided in section 3 of this report.

Based on the presence of bedrock outcrop on the east side of the upper platform and the trial pit information from the lower platform bedrock is expected to occur around 4.5m to perhaps 5m adjacent to the shaft and 2.5m below the lower platform where the house is located.

The estimated mine shaft ZOI on the upper platform is 6.5m radius from the probable shaft position encountered in Trench 1 at F. The tentative ZOI around F is shown on the following image.

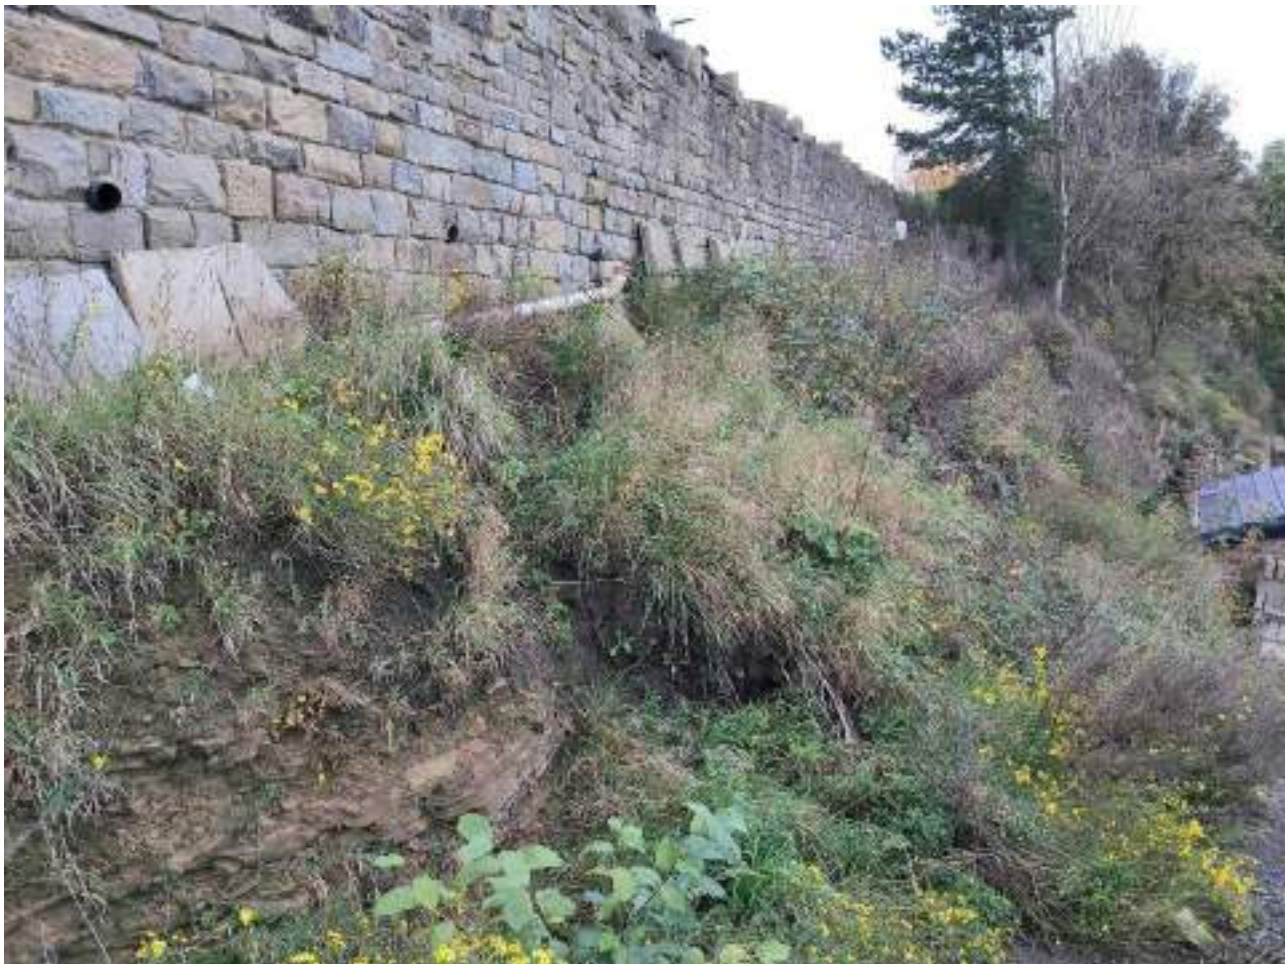
During Geoinvestigate's October 2020 site inspection, the presence of drains which in wet weather are understood to freely discharge road run-off waters onto the unprotected grassy surface within the site were noted. Our concern was raised by evidence of ground instability and slippage of the surface soil layer probably caused by the discharge of this water on to the unprotected site slopes. In our opinion, unless the matter is rectified the situation is likely to deteriorate leading to further instability of the wall and the main road as well as perhaps endangering access to the Bell Cabin site.
