PHASE I/II GEO-ENVIRONMENTAL INVESTIGATION REPORT

SCAPEGOAT HILL, GOLCAR, HUDDERSFIELD HD7 4ND

Brierstone Ltd

Project Reference: JS/ST/40706-Rp001

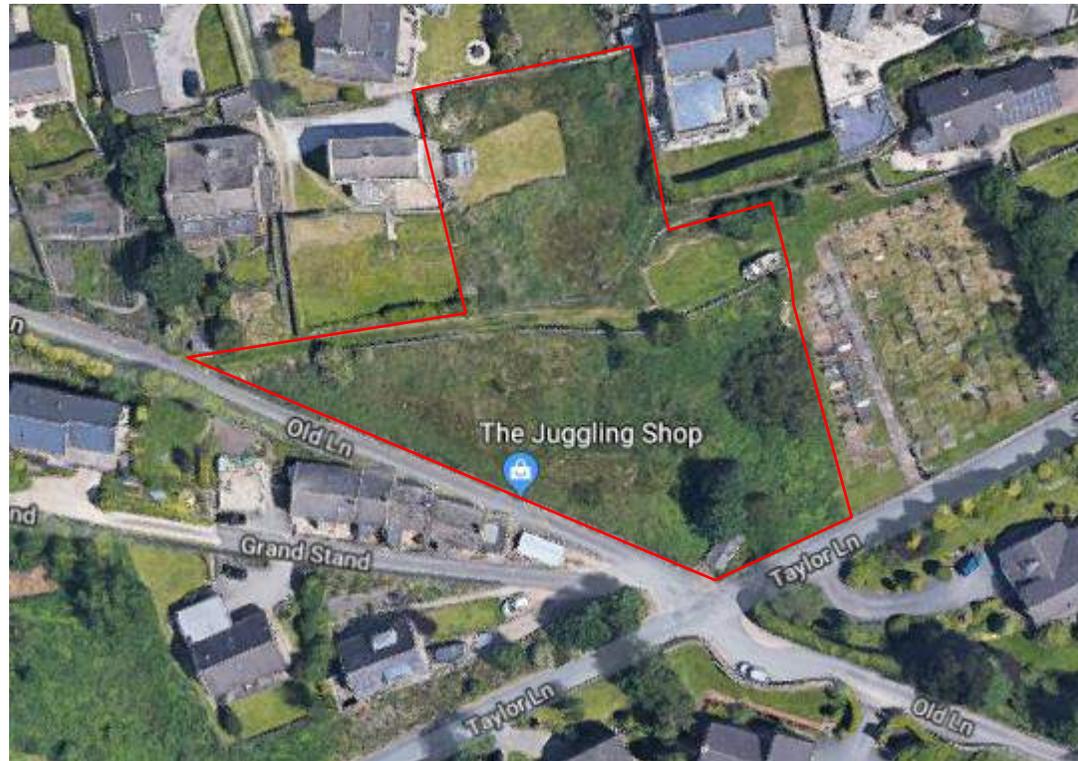
Client.		
Brierstone Ltd		
Project.		
Scapegoat Hill		
Drawing.		
Site Location Plan		
Date.	29.03.18	Scale.
		NTS
Drawn by.	Check by.	Approved by.
ST		
Status:		
FINAL		
Job no.	Fig. no.	Rev.
40706	001

Approximate Red Line Site Boundary
