**Coal Mining Risk Assessment**

**22 CROWLEES ROAD  
MIRFIELD**

Report Number 4388

## Coal Mining Risk Assessment

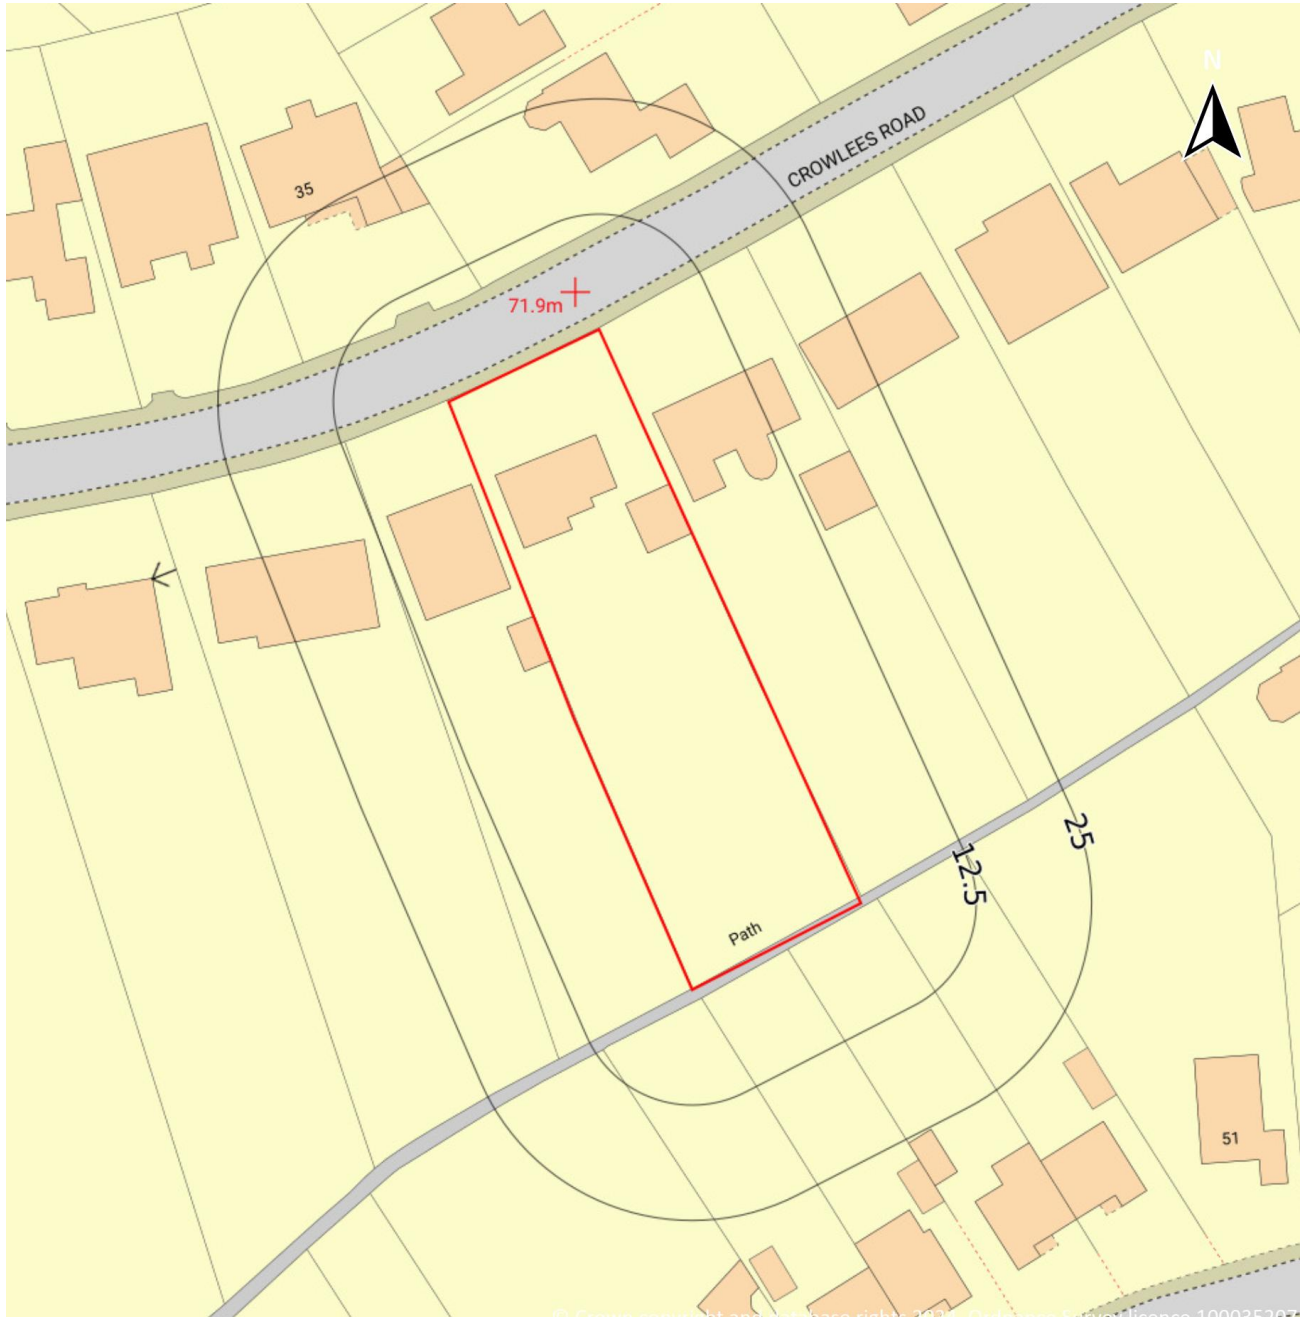
Figure: 1

**22 Crowlees Road, Mirfield**  
Site Location

2.1 The property is located at 22 Crowlees Road, approximately 1½km northeast of the centre of Mirfield. The Ordnance National Survey Grid Reference is E420605, N420215. Figure 1 shows the general site location, whilst figure 2 shows the site and development proposals in more detail.

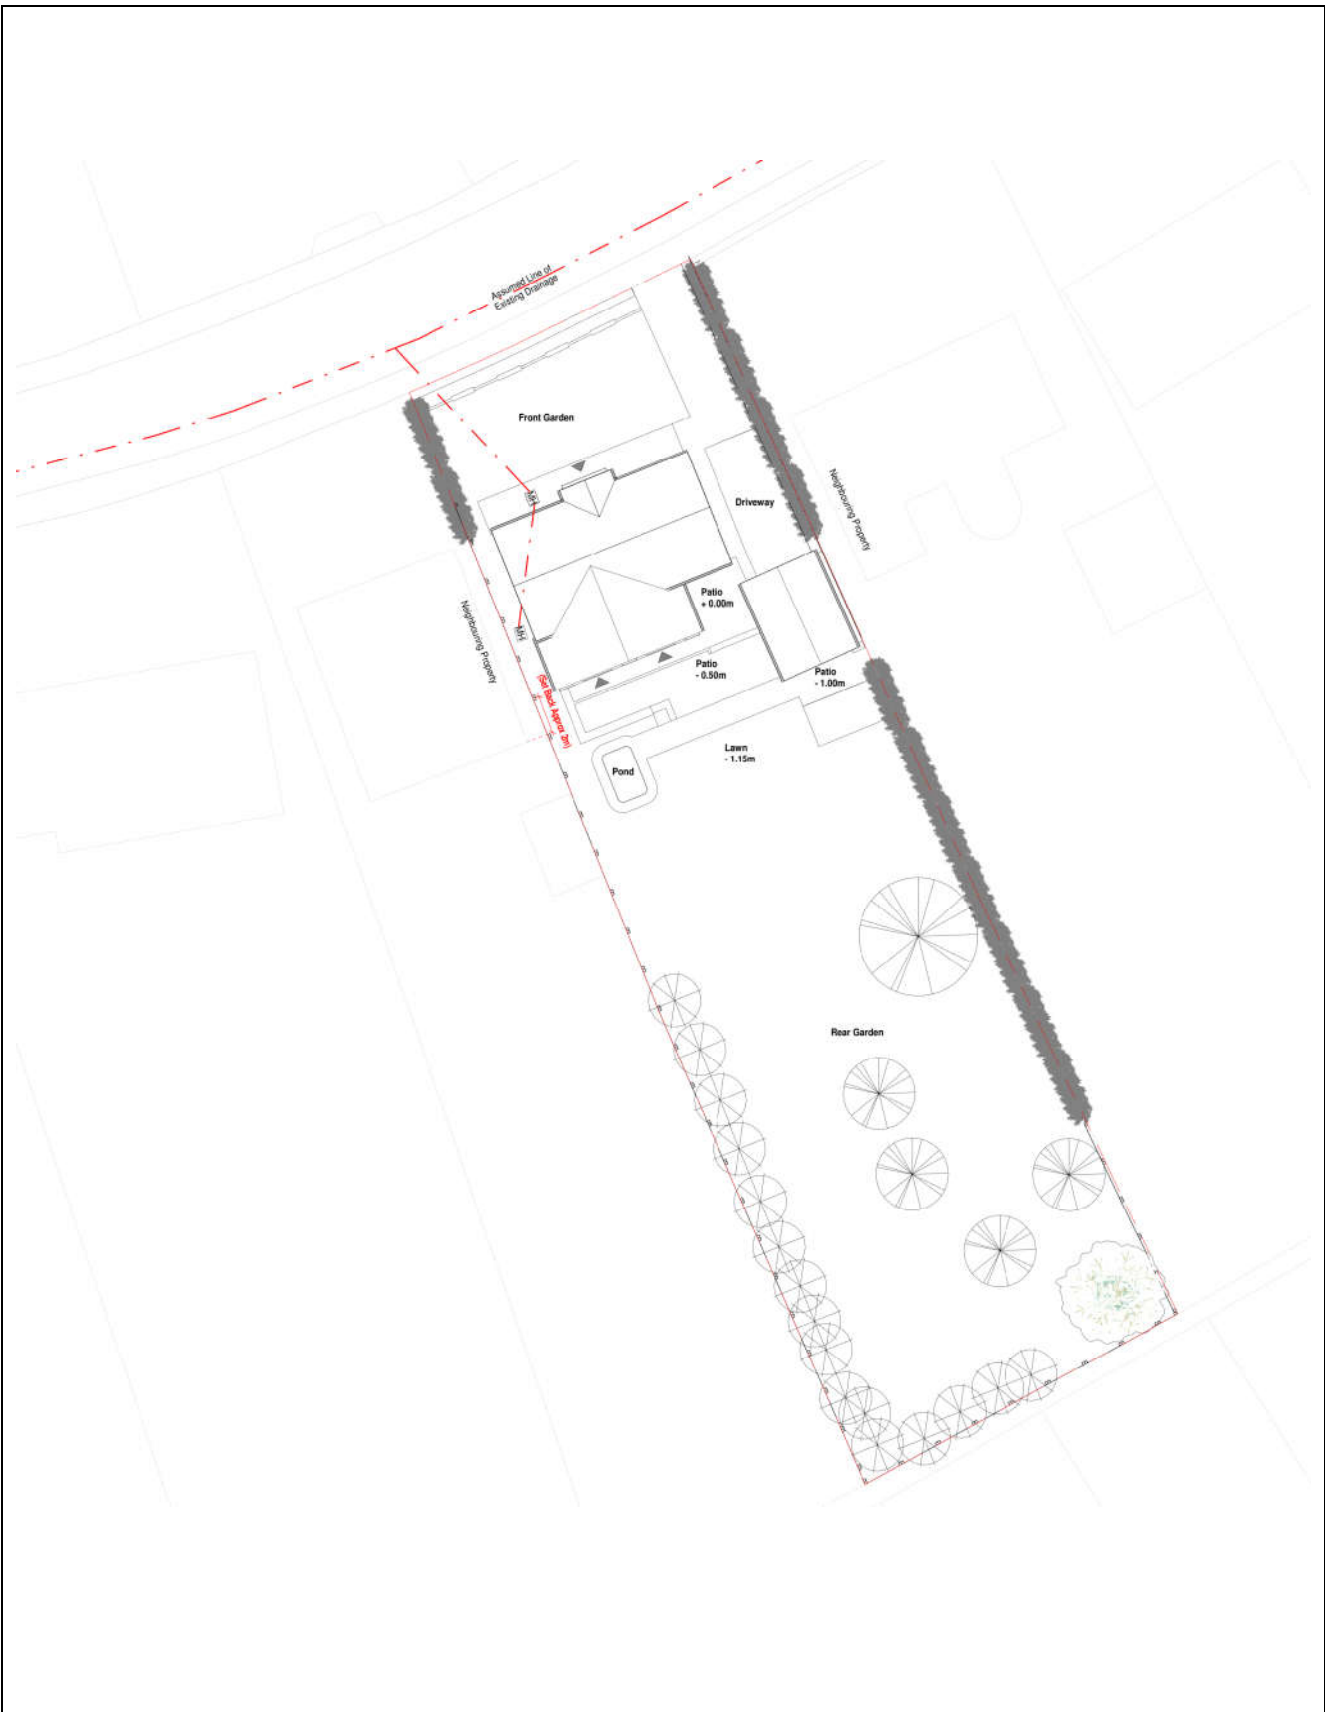
Figure: 2

**22 Crowlees Road, Mirfield**  
Development Proposals

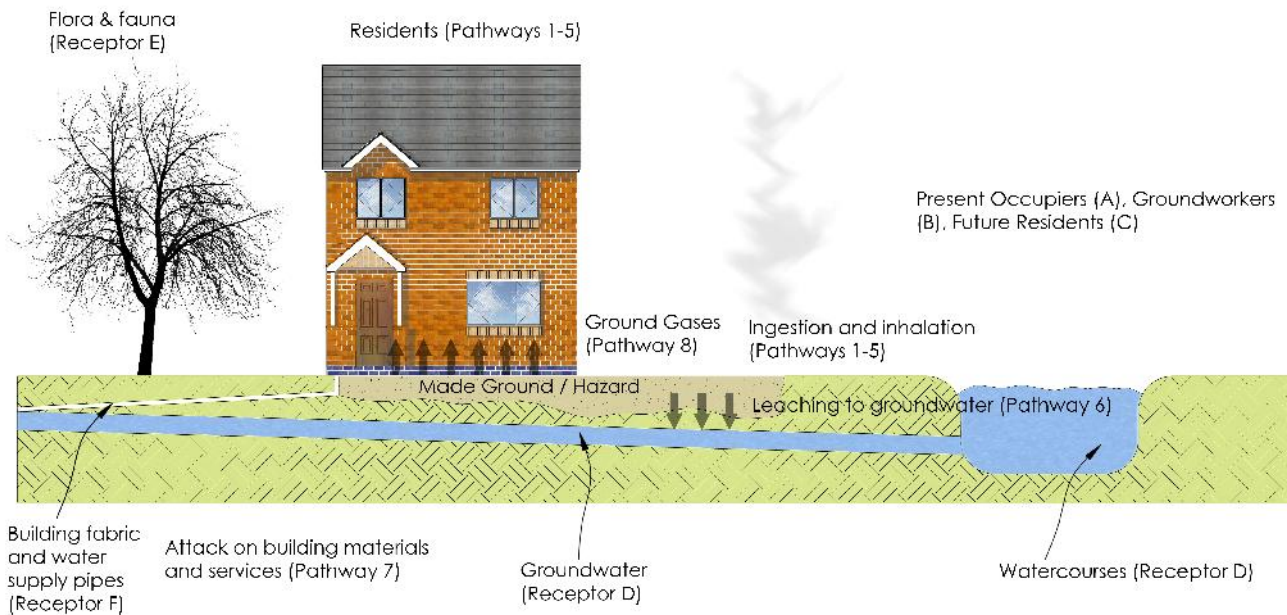
**Pathways**

1. Ingestion of contaminated soil/dust
2. Ingestion of contaminated food
3. Ingestion of contaminated water
4. Inhalation of contaminated vapours
5. Dermal contact with contaminated soil/dust or water
6. Pollution of controlled water and off site migration
7. Attack on building materials and services
8. Migration of landfill gases and radon
