## River Condition Assessment Report

Report Ref. ER-7780-02

A Modular River Physical (MoRPh) survey has been undertaken at Station Lane, Heckmondwike, to inform a River Condition Assessment of the River Spen, Heckmondwike.

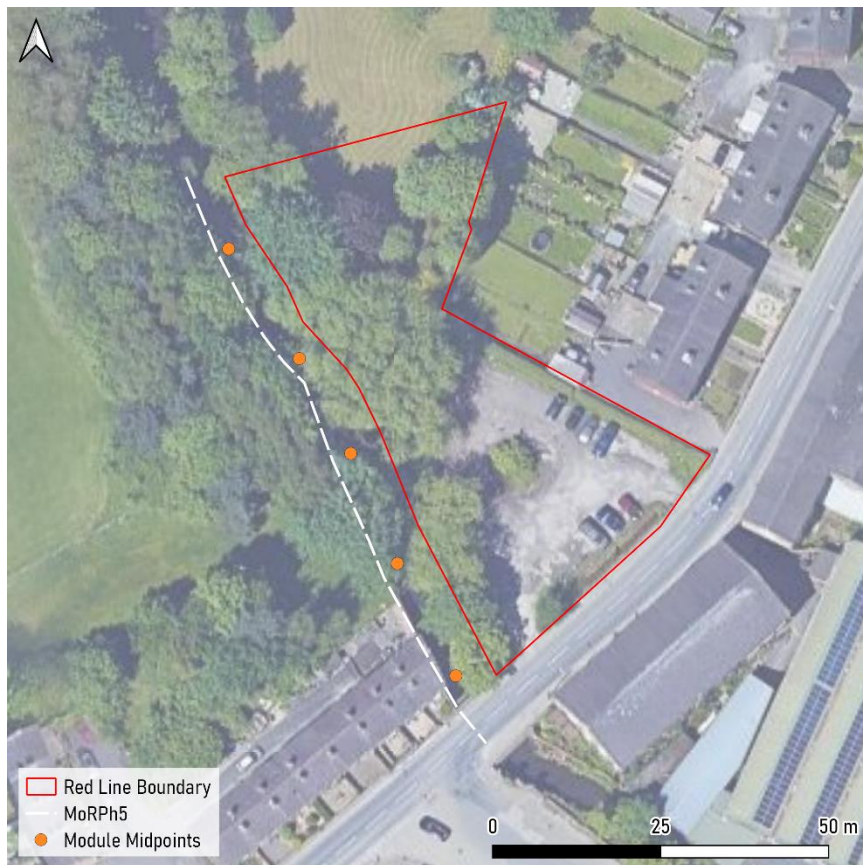
**Figure 2** MoRPh survey sites on the River Spen.

20. The river was assessed as having a MoRPh river width of 5 to <10m. Therefore, modules were 20m long, and MoRPh5 100m long. The beck runs for c. 87m alongside the Site, and so a single 100m MoRPh5 was carried out to achieve survey of at least 20% of the river's length.

21. During the walkover, general differences in bank reinforcement and shape were identified, with the upper portion of the beck being more naturally presenting than the lower two-fifths, henceforth referred to as the upstream and downstream sections respectively.

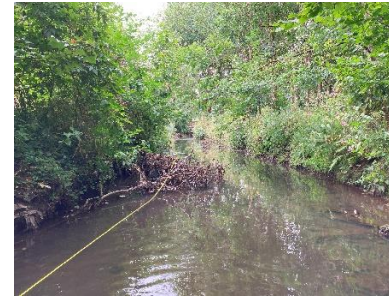
23. The upstream section appears generally natural, with no evident reinforcement to the bank faces or river bed, and no artificial features such as bridges, jetties, or weirs observed in the channel. The downstream section appears to have a generally reshaped and reinforced right (western) bank face, with a semi-reinforced left face. There are no artificial features present in the channel bed, but the river does flow under a bridge at the end of the fifth module.

**Figure 3** Typical view of upstream section, facing downstream

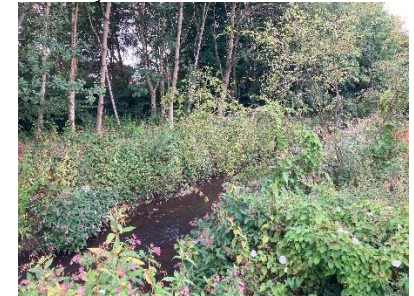
25. The right bank face supports patchy vegetation in the upstream section where eroding cliffs alternate with large patches of Himalayan balsam. This gives way to scrubrier sections which also contain short and tall grasses before becoming largely reinforced in the last module of the downstream section.
26. The upstream section of the right bank top is characterised by broadleaved woodland with an understory of scrub and short and tall grasses. The downstream section is characterised by residential housing.
27. Evidence of NNIPS (non-native invasive plant species) (Himalayan balsam) were observed on both banks for the length of the surveyed section.

**Figure 4** View from module 3 midpoint, facing upstream, showing right bank top broadleaved woodland and Himalayan balsam cover

- Minimisation of managed ground cover on the left bank top by converting the entire riparian zone to deciduous woodland (B5).
  - Reduce left bank face NNIPS cover (C10) by controlling invasive weeds, such as Himalayan balsam.

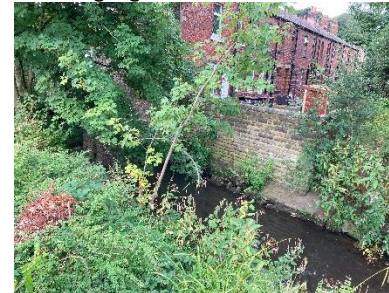
**Figure 5** View from module 2 midpoint, facing downstream, showing right bank reinforcement

35. Affecting modification to the artificial bank top and bank face reinforcement on the right bank, and to the channel bed materials, feature richness and hydraulic processes, has been deemed to be unrealistic as only the left bank top and upper half of the bank face lies within the bounds of the Site. On top of this, modifications to the right bank and channel bed are likely to affect the structural integrity of nearby infrastructure and would require advice from a hydrogeomorphologist.

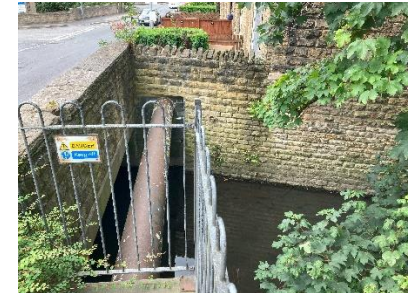
**Figure 6** Module 5 bridge

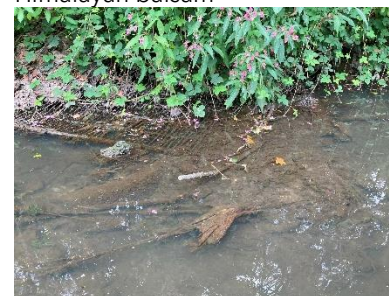
22. The beck has an average MoRPh river width of 6.9m (7.5m in the upstream section, 6m downstream). The bed is generally shallow, averaging 30cm along the length, and comprises sediment of boulder, cobble and silt, which is unvegetated. There are frequent accumulations of large industrial trash, organic material (e.g., twigs and leaves), and filamentous algae that layers the channel bed sediments, in the channel.

**Figure 7** Module 2 midpoint, showing industrial waste, filamentous algae cover and Himalayan balsam

- Reduce channel bed artificial features (E10) by removing large trash.
38. **Opportunities for enhancement - Moderate potential impact**
  - Enhance left bank face tree feature richness (C2) by increasing the cover of deciduous woodland.

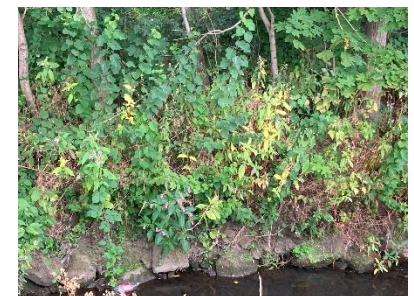
**Figure 8** Module 3 midpoint, showing bare bank face and Himalayan balsam cover

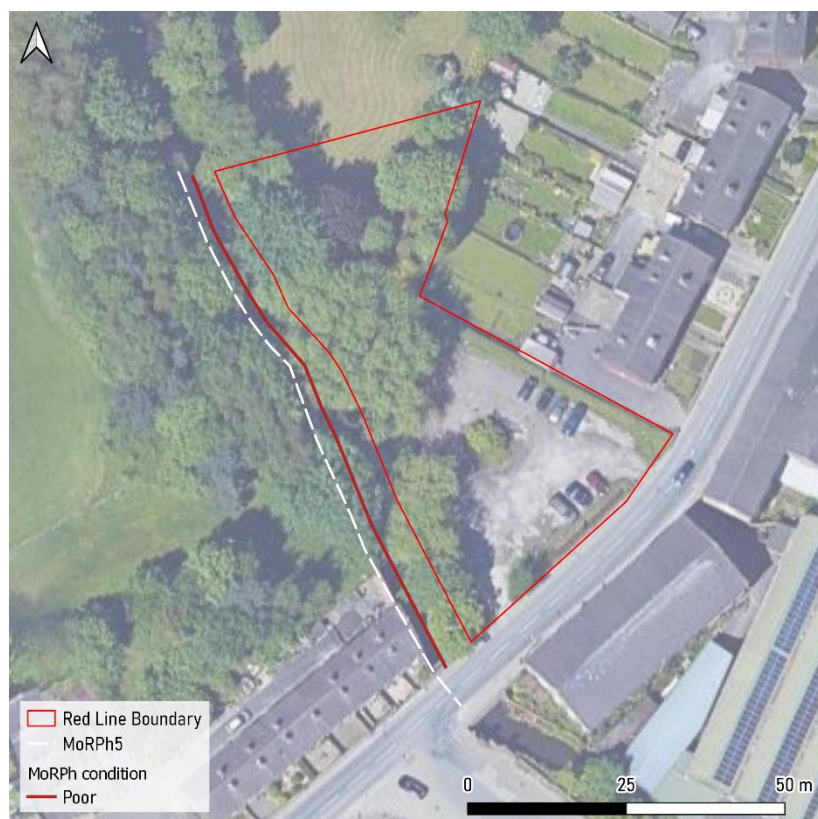
28. The river was assessed as being of **type H**. The rationale supporting this assessment is presented in Appendix B.
29. A preliminary condition score of -0.498 was generated for the River Spen. When assessed against the table of threshold values (see Appendix A), for a type H river, this is indicative of **Fairly Poor** condition.
30. The river is considered to be overdeep, and therefore this condition class has been adjusted. This results in approximately 87m of the River Spen assessed as being in **Poor** condition.
31. This data will be used to inform a BNG Assessment of the Site, reported separately.

**Figure 9** Condition class/final score of surveyed sections of the River Spen.
