**Colne Valley Masonic Lodge, Slaithwaite**

**Bat Survey Report**

**11<sup>th</sup> September 2025**

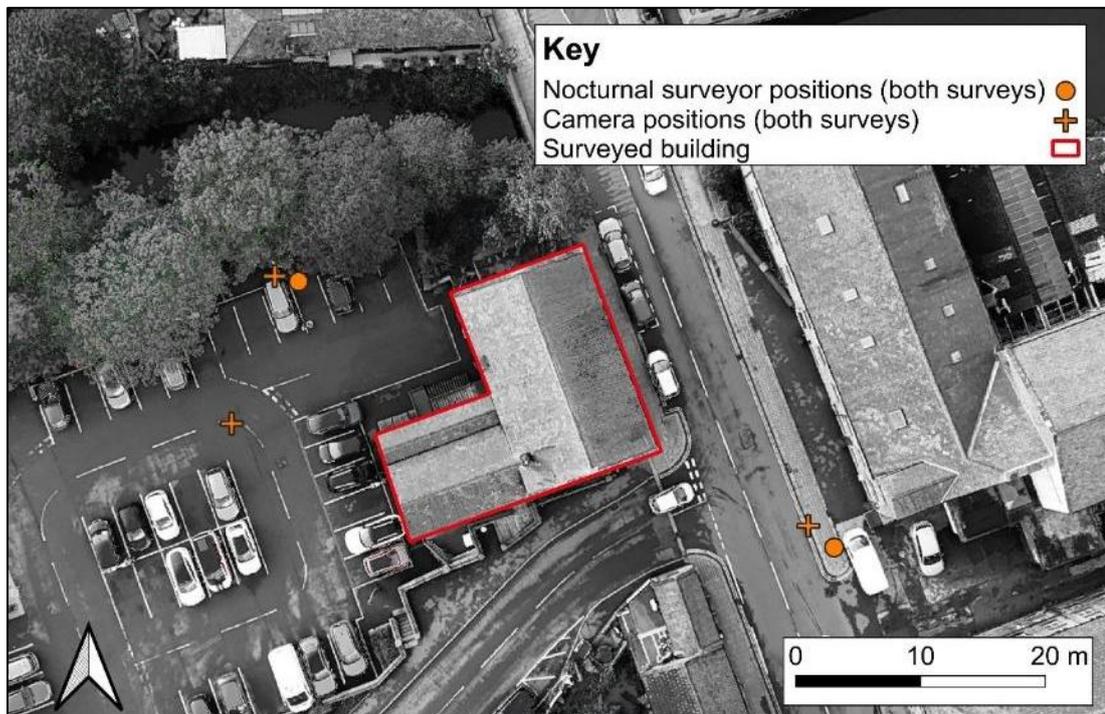
**Figure 3. Nocturnal survey plan**

4.3.2 Two nocturnal surveys were undertaken in compliance with the Bat Survey Guidelines (Collins 2023). Two surveyor positions were covered during both visits. Surveyor positions are shown on Figure 3.

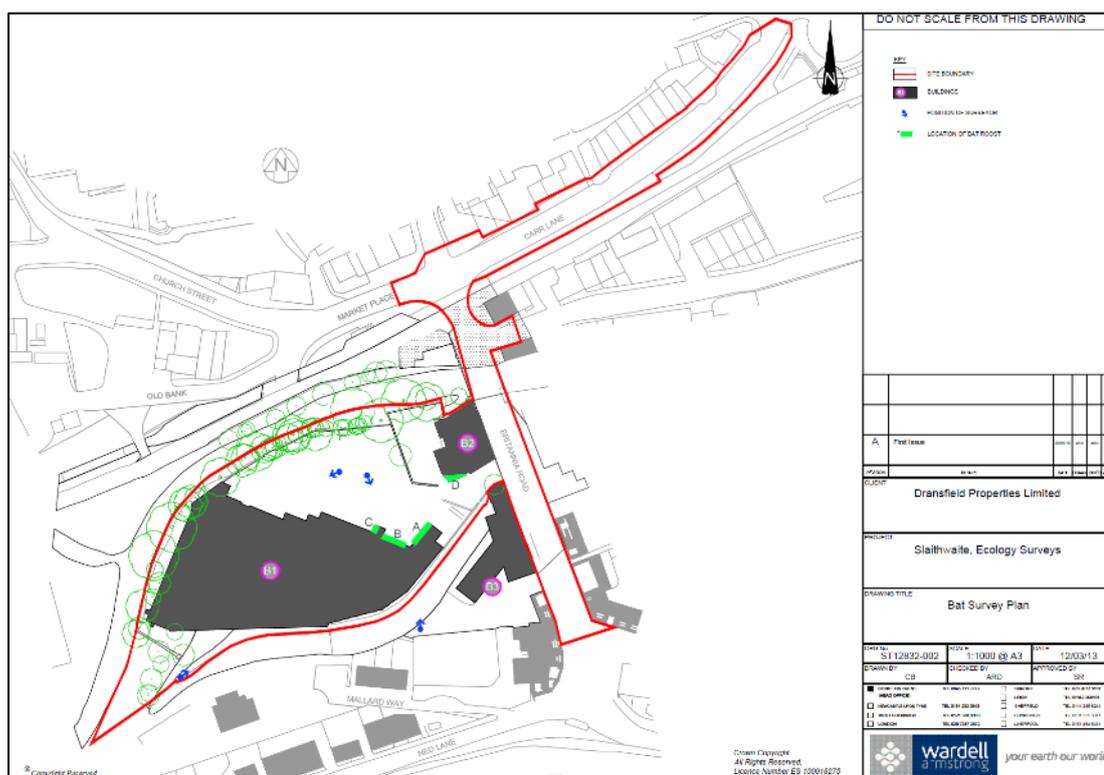
**Figure 4. Bat survey plan from 2013 survey of Colne Mills (WA, 2013)**

- 5.1.1 A total of 82 bat records were provided by West Yorkshire Bat Group, with 148 records provided by West Yorkshire Ecology.
- 5.1.2 A single bat record was provided with a ten figure grid reference relating to the surveyed building. This record which was collected on 1<sup>st</sup> July 2012 detailed the presence of a common pipistrelle day roost, used by one bat. The record detailed the presence of the roost in 'Colne Mills, Slaithwaite'. A search online showed that Colne Mills comprised a former woollen mill demolished to make way for the Aldi supermarket and car park, now located adjacent to Colne Valley Lodge on its west elevation. A review of planning history related to this site showed that a single common pipistrelle was recorded roosting within the southwest corner of Colne Valley Lodge (WA, 2013). The exact location of the recorded roost was not detailed in the report. A plan taken from the relevant bat survey report is included in Figure 4, with the relevant roost labelled D (green triangle at south end of Colne Valley Masonic Lodge building).

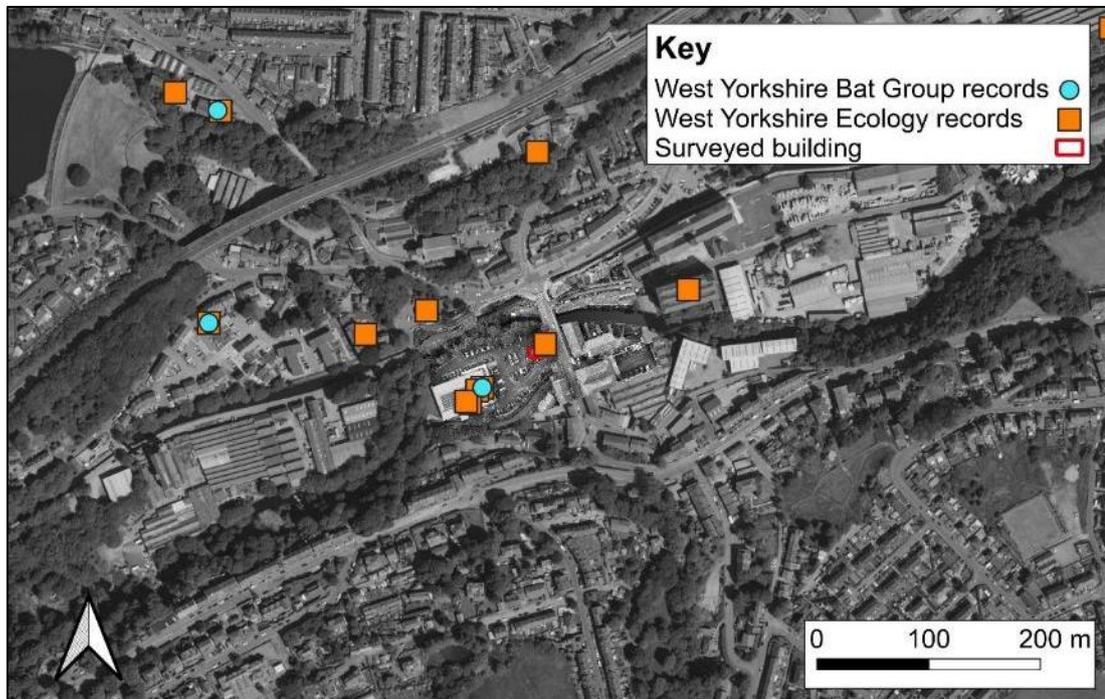
**Figure 5. Historic bat records located close to site**

5.1.4 In addition to the single record relating to the surveyed building, additional common pipistrelle and soprano pipistrelle day roosts were recorded from the Colne Mills buildings (now demolished), during surveys in 2012 & 2013. Local bat records received from either West Yorkshire Bat Group or West Yorkshire Ecology are shown in Figure 5.

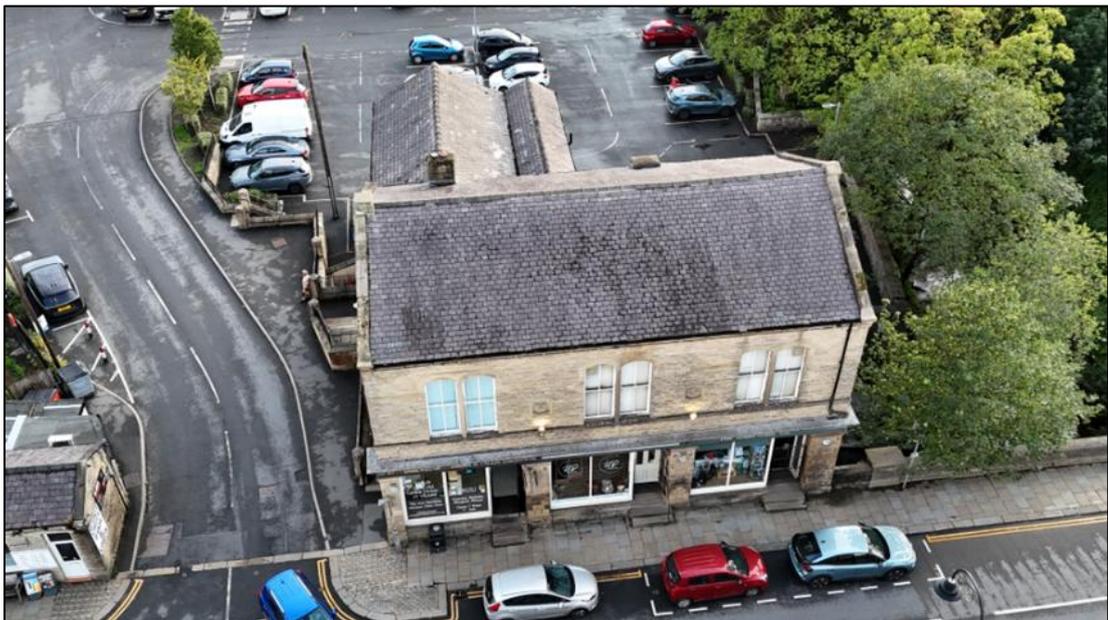
### **Plate 1. East elevation of surveyed building**

5.2.2 The surveyed building comprised an L-shaped three storey stone built masonic lodge, constructed in 1879 (Plates 1-5). The roof of the building was multi-pitched and covered with Welsh slate with mortar-bedded clay ridge tiles. Stone coping was present on the main northwest and southeast gables, with mortar-filled verges on the two southwest gables. One stone chimney was present, with two additional former chimneys capped. The northwest and southeast gables both supported pairs of wooden louvres. The building was part-rendered on the southwest elevation with a section of wood fascia on the northwest elevation.

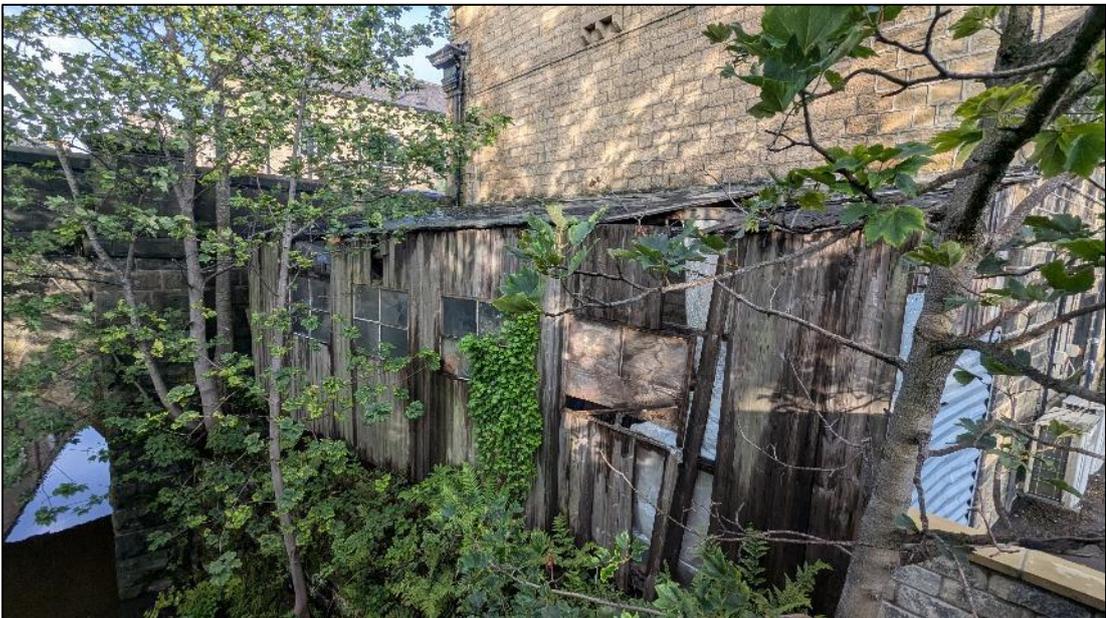
**Plate 5. Wooden extension on northwest gable**

5.2.3 A single storey wooden extension, with a gently sloping single-pitch wooden covered roof and wood panel walls adjoined the mills northwest gable, adjacent to the River Colne (Plate 5). The main building had wood-framed single-pane sash windows. Guttering was a mix of metal and plastic. A steel fire escape was present on the southwest elevation.

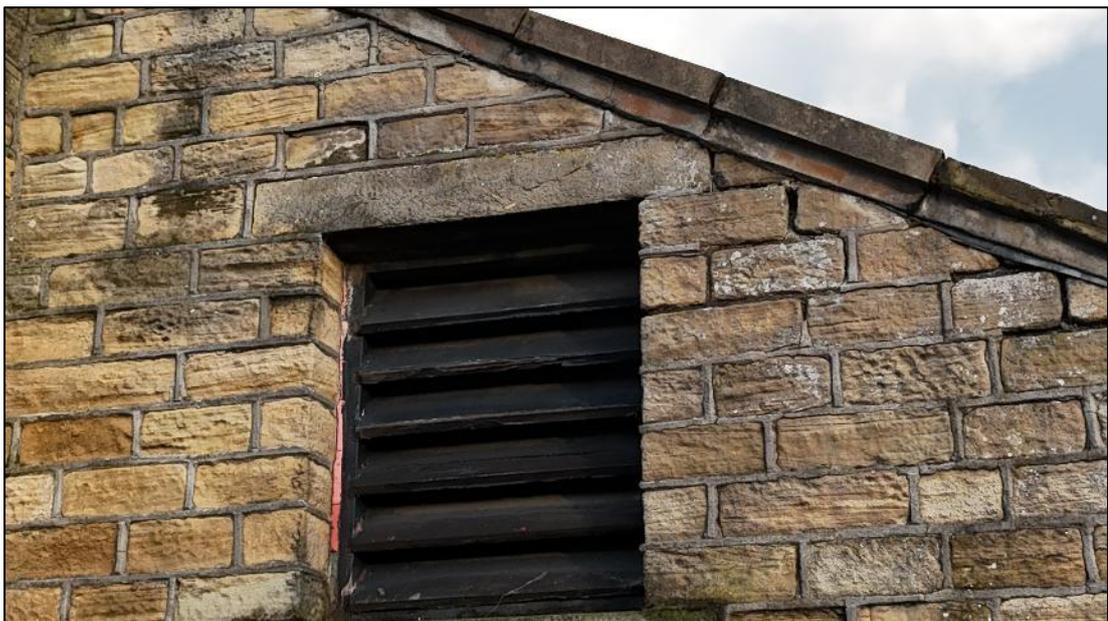
**Plate 6. Close view of louvre on northwest gable**

- Potential access to the main roof void via the louvre panels in the northwest and southeast gables. It could not be confirmed whether these has been blocked (i.e. with a mesh) on their internal face (Plate 6).
- Access to wall tops, behind guttering was considered likely.
- Lifted flashing was present on the western corner of northwest gable (Plate 7).
- Air bricks within the southwest elevation. A honey bee *Apis mellifera* nest was recorded from the ground floor air brick on the southwest elevation.
- Gaps between frame of wood louvre and adjacent masonry on southeast gable.

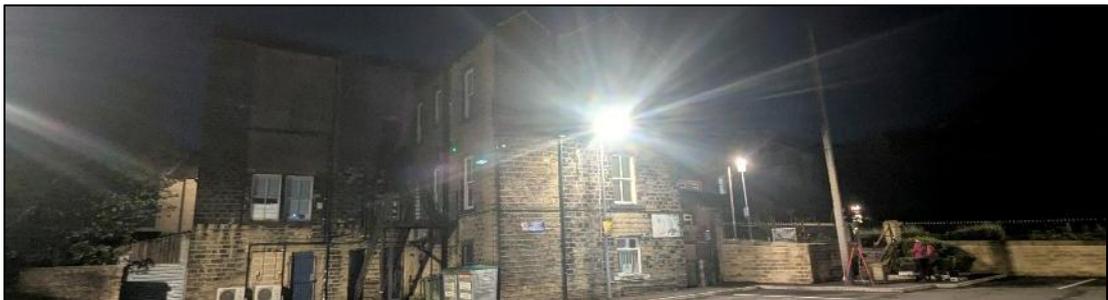
**Plate 8. Artificial lighting levels west of the building**

- 5.3.1 The temperature at the beginning of monitoring was 14 °C, with a light air (Beaufort Scale Force 1) and one okta of cloud cover (1/8 okta). The temperature increased to 15 °C during the survey, with the wind level remaining the same and the cloud clearing completely. Sunset was at 21:22 and the weather was dry throughout.
- 5.3.2 No bat roosting activity was recorded.
- 5.3.3 The first bat activity recorded comprised a common pipistrelle call heard by the surveyor west of the building at 21:53 (31 minutes after sunset). Intermittent common pipistrelle activity was recorded thereafter, almost exclusively from the west of the building. The only other bat activity noted comprised a noctule pass, heard by the surveyor west of the building at 22:18.
- 5.3.4 It was noted that artificial lighting levels were high on all sides of the building, with light levels shown in Plates 8 & 9.

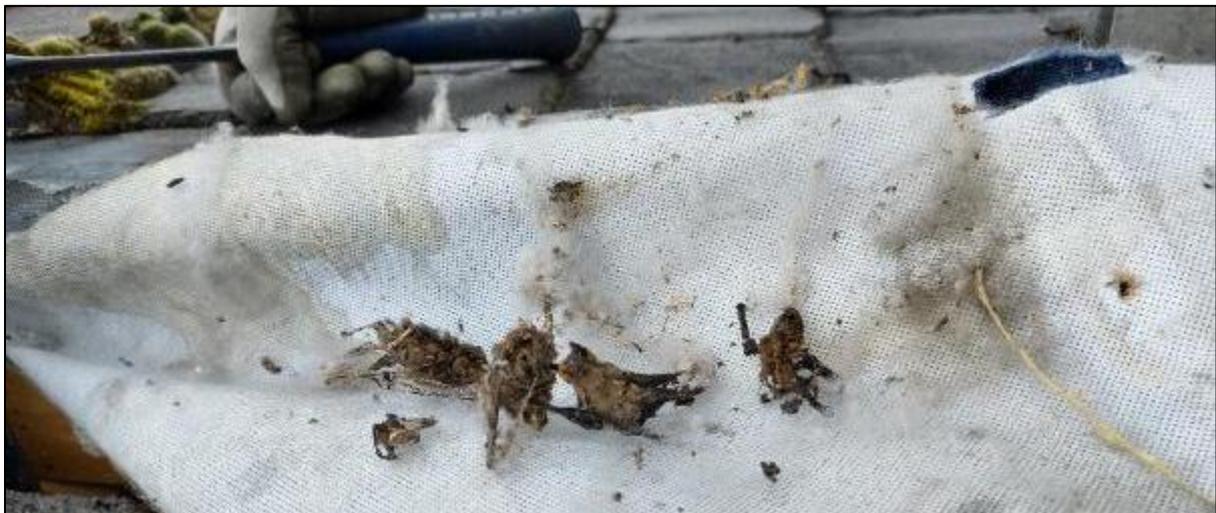
### Plate A2.1. Four dead pipistrelles tangled in breathable roofing felt

Non-bitumen coated membranes used below roof slates and tiles present a significant problem for bats. Over time, strands are pulled away from the surface of these materials as bats crawl over them. These fuzzy strands are very strong and can tangle and trap bats, sometimes causing the death of bats over multiple years<sup>1</sup>.

One example we have encountered comprised a pipistrelle roost which formed in a building extension constructed in 2009. Over the course of just 13 years the roofing felt degraded to the extent that it trapped and killed more than 10 bats. Fortunately, the problem in this roost was identified and remedial work was undertaken to replace the roofing membrane in 2022.

The best roofing membrane option for areas where bat roosts are expected is traditional Type 1F bitumen coated hessian backed roofing felt. Bitumen coated roofing felts have been widely and safely used as a secondary weather barrier since approximately the 1950s/1960s. Wooden sarking has also been used for many decades and if appropriately treated, is safe for use in bat roosts, or where bats could be, present. Most commercially available products come
