Oldfield House Farm, Honley

Bat Survey Report

16th October 2023

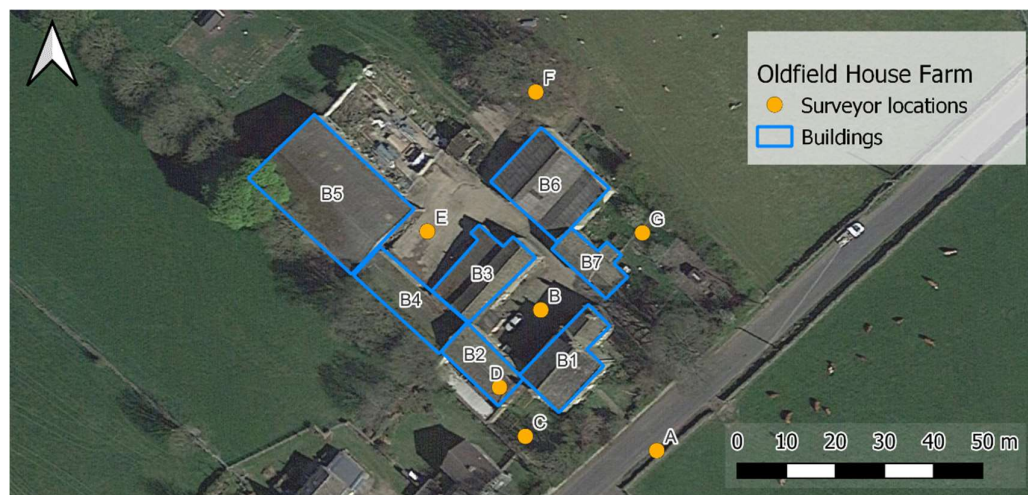
Figure 3 – Nocturnal survey surveyor positions

shown in Figure 2 and coverage during each survey is shown in Table 2.

Surveyor Position	Coverage		
	5 th May 222	24 th May 22	14 th June 22
A	N/A	Surveyor and IR Camera	Surveyor without IR Camera
B	Surveyor and IR Camera	Surveyor and 3 x IR Cameras (B1, B2, & B3); & Surveyor without IR Camera (B7)	Surveyor and 3 x IR Cameras (B1, B2, & B3); & Surveyor without IR Camera (B7)
C	Surveyor and IR Camera	Surveyor without IR Camera	Surveyor without IR Camera
D	N/A	N/A	Unsupervised IR Camera
E	N/A	Surveyor without IR Camera	Surveyor and IR Camera
F	N/A	Surveyor and IR Camera	N/A
G	N/A	Surveyor and IR Camera	Surveyor and IR Camera

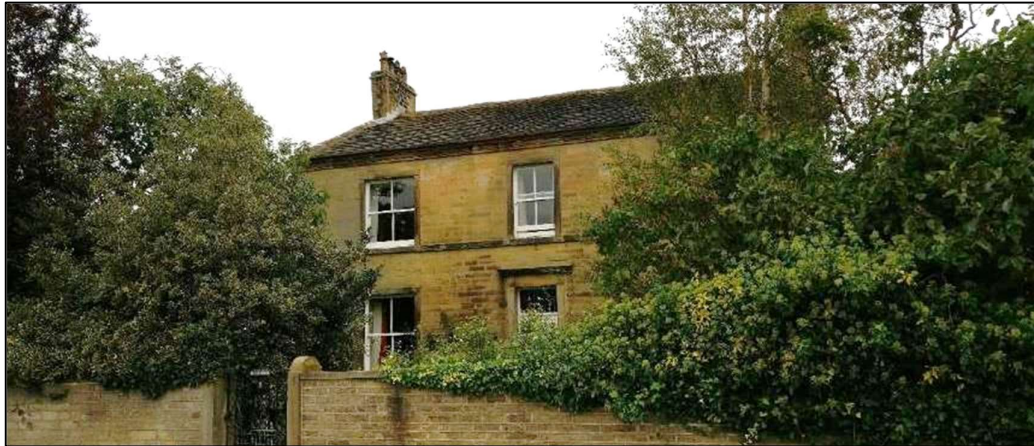
Plate 1. Southeast elevation of B1 (Oldfield House), viewed from Oldfield Road

5.3.3 Building 1 (B1) is a large 19th Century three-storey (at the rear) Grade II listed dwelling

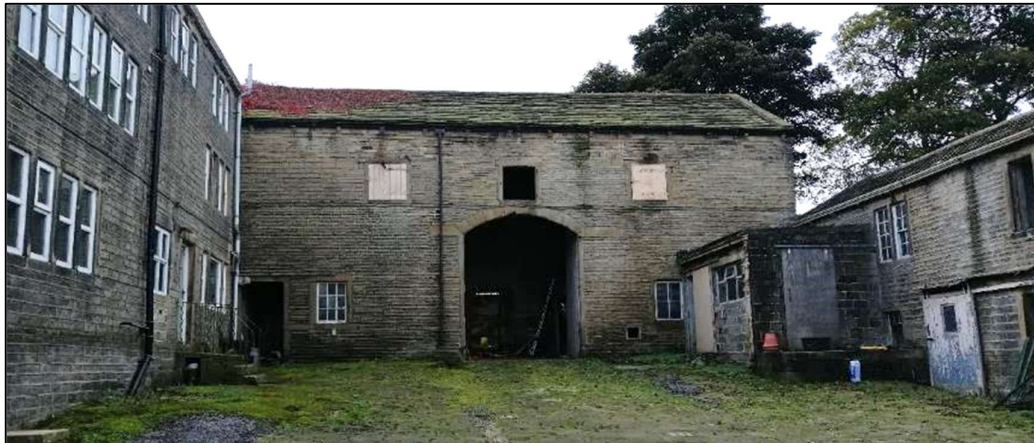
Plate 3. Front (southeast elevation) of B2, B1 on left and B3 on right

- 5.3.4 Building 2 (B2) is a traditional 19th Century barn beneath a pitched stone-slate roof with stone copings and ridges. The barn has a large ground floor opening (uncovered), a single wood door, two ground floor single pane wood-framed windows and three loft hatches on the front (northeast) elevation, whilst at the rear, there is a further wood door. This building has cast iron guttering and a uPVC down pipe. The front (southeast elevation) is accessed from the courtyard (Plate 3).

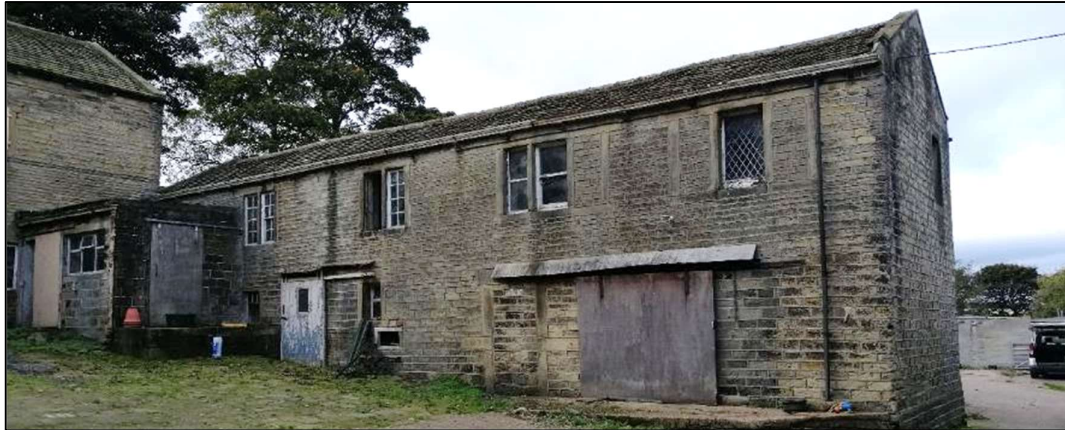
Plate 4. B3 from courtyard

- 5.3.5 Building 3 (B3) is a rectangular 19th Century two-storey outbuilding beneath a pitched stone slate roof with stone copings and ridges. The front elevation (southeast) which faces the courtyard has a flat roofed single-storey extension, single pane wood-framed windows, two timber sliding doors, cast iron guttering and a uPVC down pipe (Plate 4). At the rear (northwest) (Plate 5) there is a stone built, part open-fronted extension with a mono-pitched corrugated asbestos cement roof.

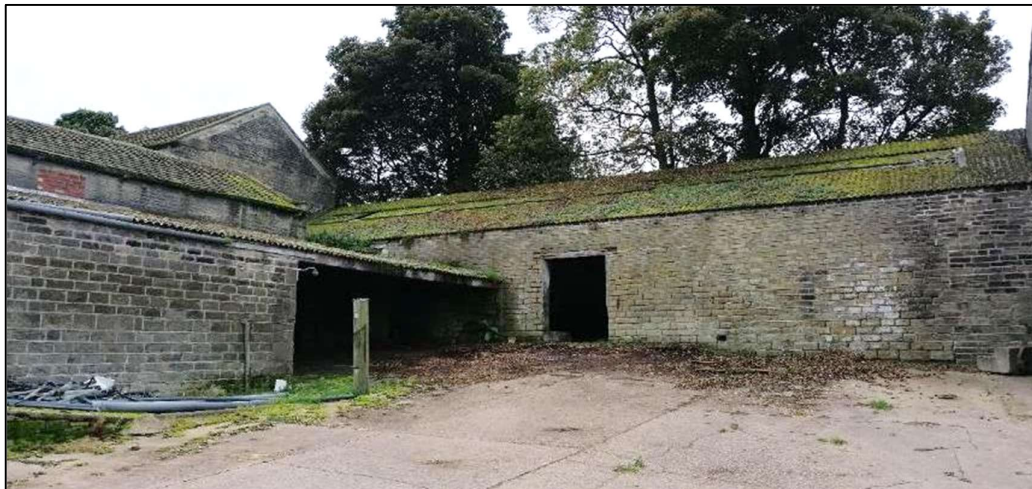
Plate 5. Rear (northwest elevation) of B3 on left with B4 on right

5.3.7 Building 4 (B4) is a long rectangular stone-built livestock building beneath a pitched corrugated asbestos-cement sheet roof, covered in mosses. The building has just one large entrance on the northeast elevation (Plate 5).

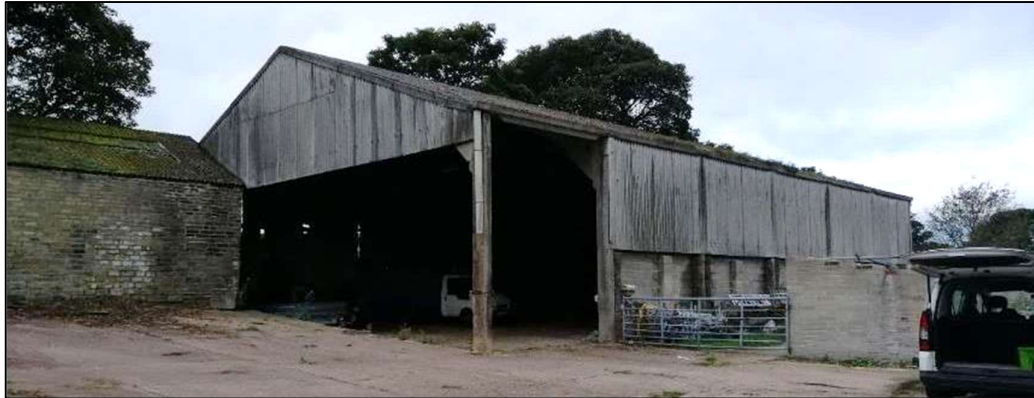
Plate 6. B5 with B4 on left

5.3.8 Building 5 (B5) is a fairly modern large concrete-framed agricultural building with a pitched corrugated asbestos-cement sheet roof. The building has single skin concrete block walls with frequent strengthening pillars on the exterior which are 3m in height. Above the concrete walls is asbestos-cement sheet cladding which also covers the gables (Plate 6).

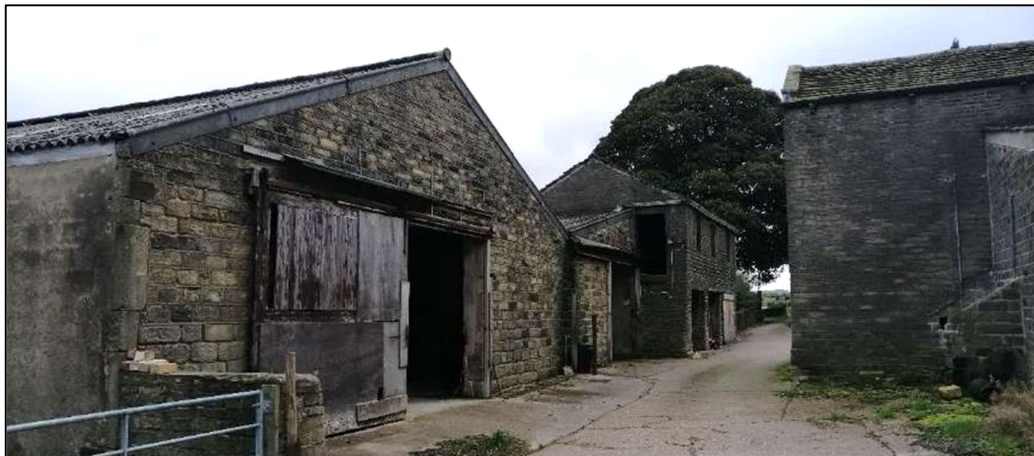
Plate 7. B6 in foreground and B7 in distance, B3 is on the right of photo

- 5.3.9 Building 6 (B6) comprises a later addition to the farm (livestock building), it has a stone façade and a pitched corrugated asbestos-cement sheet roof with the south-eastern end having a sloping (mono-pitched) asbestos roof (there is a rainwater channel between the two sections). Asbestos-cement verge cladding is present on gables. This building has a large timber sliding door whilst the south-eastern end is partly open-fronted (Plate 7).

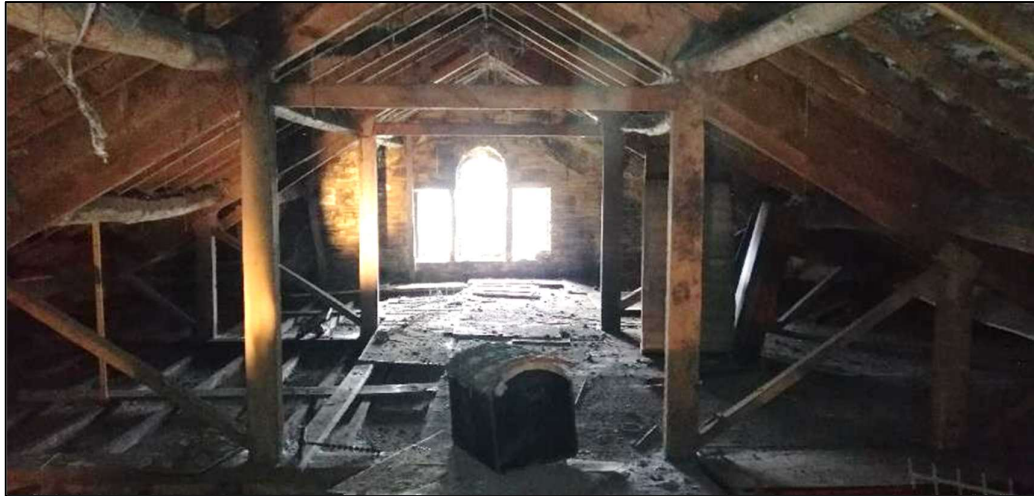
Plate 9. Roof-space of B1

- 5.3.11 The roof-space of B1 has a height to the ridge of 2.5m. The roof is supported by queen-post roof trusses, purlins, rafters, battens and a ridge board. There is no roofing membrane beneath the slates, but all slates are back pointed. There is no insulation on the ceiling and light enters the void from a window on the northeast gable. The space and ridge board were found to be extremely 'cobwebby' and no signs of bats were found (Plate 9).

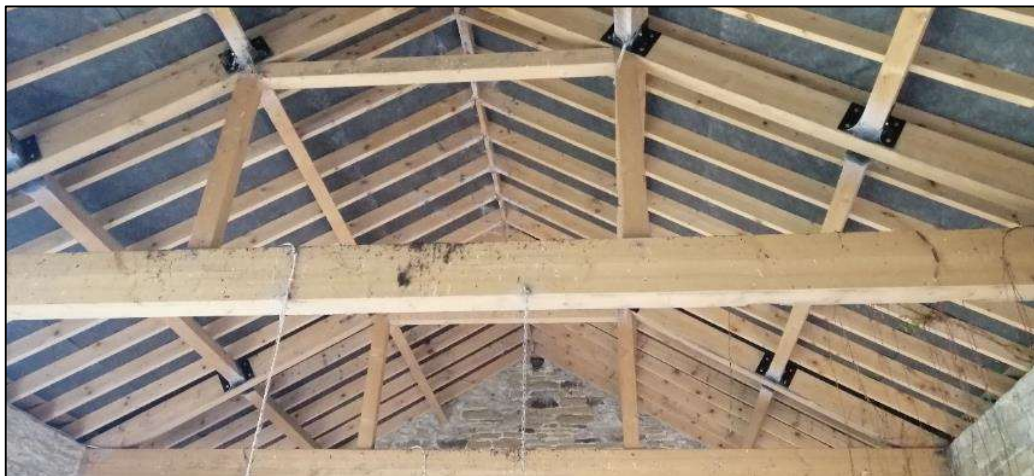
Plate 10. Inside of B2

- 5.3.13 The inside of the barn is open to the underside of the roof covering which is supported by recently built queen-post roof trusses, purlins, rafters, battens and a ridge board (Plate 10). There is a breathable roofing membrane beneath the slates and several swallow *Hirundo rustica* nests were recorded. A third of the building has a second floor which was accessed from a ladder, several probable old (degraded to fragments) bat droppings were found in amongst the swallow droppings. There is a moderate number of features associated with mortar joints of the masonry on the walls of the interior of the building.
- 5.3.14 Features on the exterior of B2 displaying potential to accommodate roosting bats include wall tops, holes in the mortar of masonry, crevices between slates, the void between slates and membrane and a gap behind a wood fascia board on the rear southwest elevation.

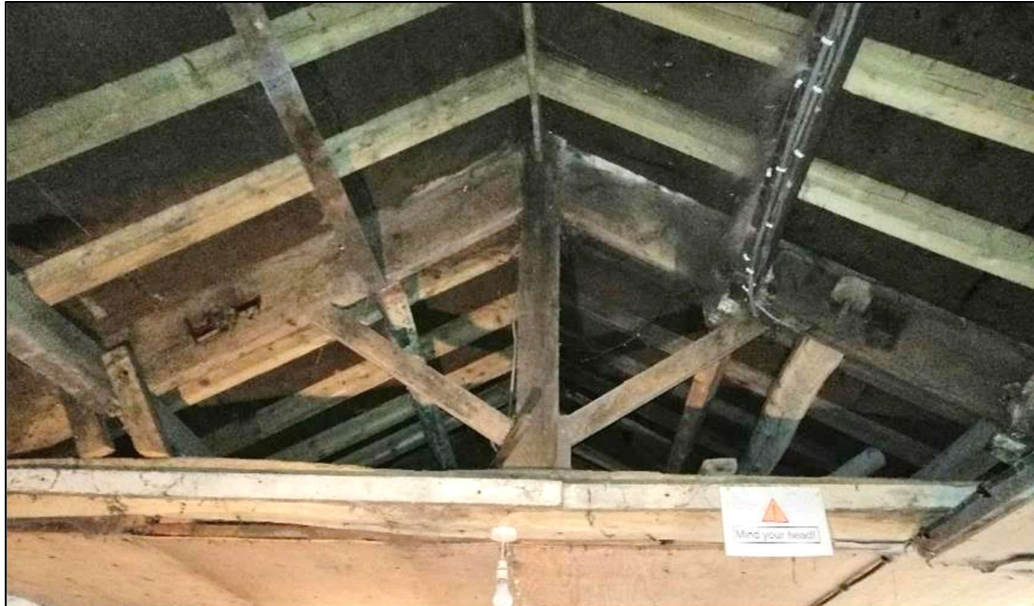
Plate 11. Inside of B3 showing Type 1F felt

- 5.3.15 The upper floors of this building are open to the underside of the Type 1F bitumen felt beneath the slates in parts. The roof is supported by king-post roof trusses, purlins, rafters, battens and a ridge board (Plate 11). Several swallow nests were recorded on both floors of this buildings with a former house martin *Delichon urbicum* nest recorded from one window. No definitive signs of bat occupation were noted (one old probable bat dropping was found). The ridges were found to be very 'cobwebby'.

- 5.3.16 Features identified on the exterior of B3 with potential to support roosting bats include the wall tops and the void between slates and also between slates and the roof membrane.

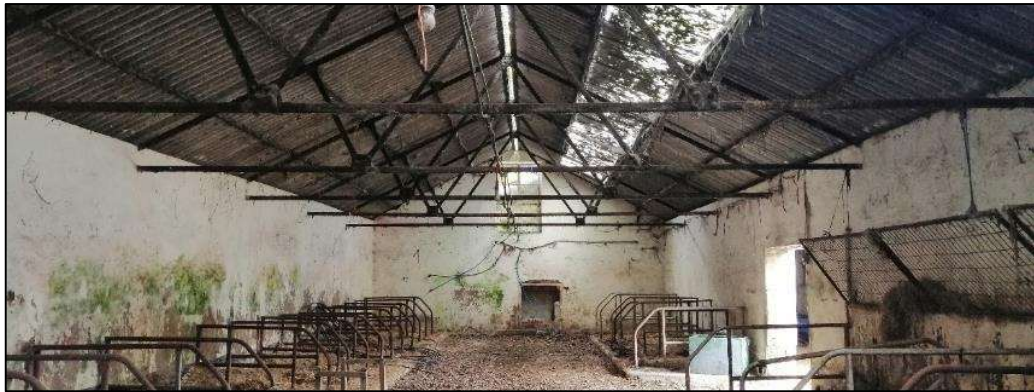
Plate 12. Inside B4

- 5.3.17 The inside of B3 is open to the underside of the roof covering which is supported by a steel frame. The internal walls are cement rendered and there is a large 75-100mm gap between the wall top and asbestos sheet roof covering, thus rendering the wall top unsuitable for use by roosting bats (Plate 12). The exterior of this building lacks features with potential to accommodate roosting bats.

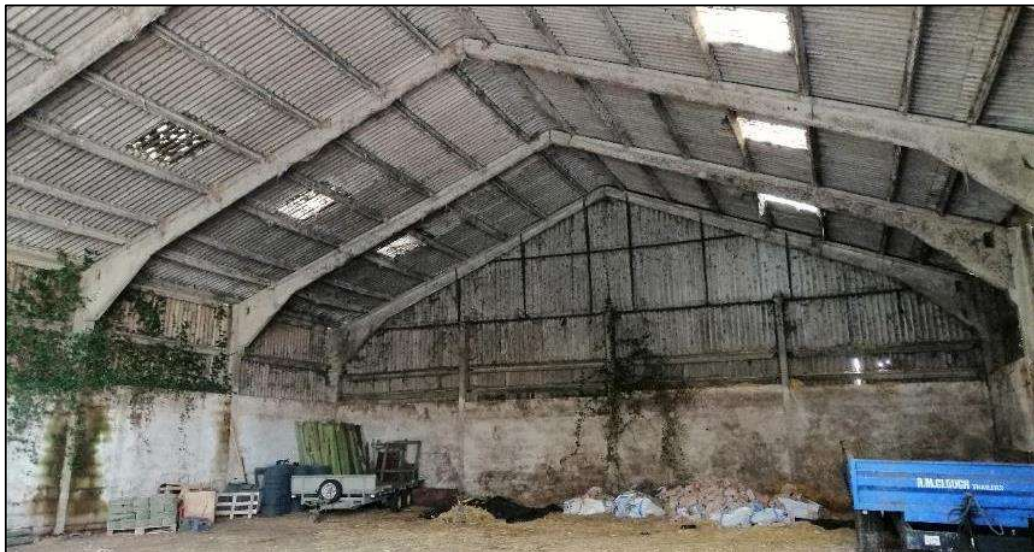
Plate 13. Inside of B5

5.3.18 The inside of B5 is open to the underside of the roof covering. This building has a concrete frame and rafters (see Plate 13). The only possible roost features are the voids between the corrugations of the asbestos sheets and the concrete rafters. The exterior of this building lacks features with potential to accommodate roosting bats.

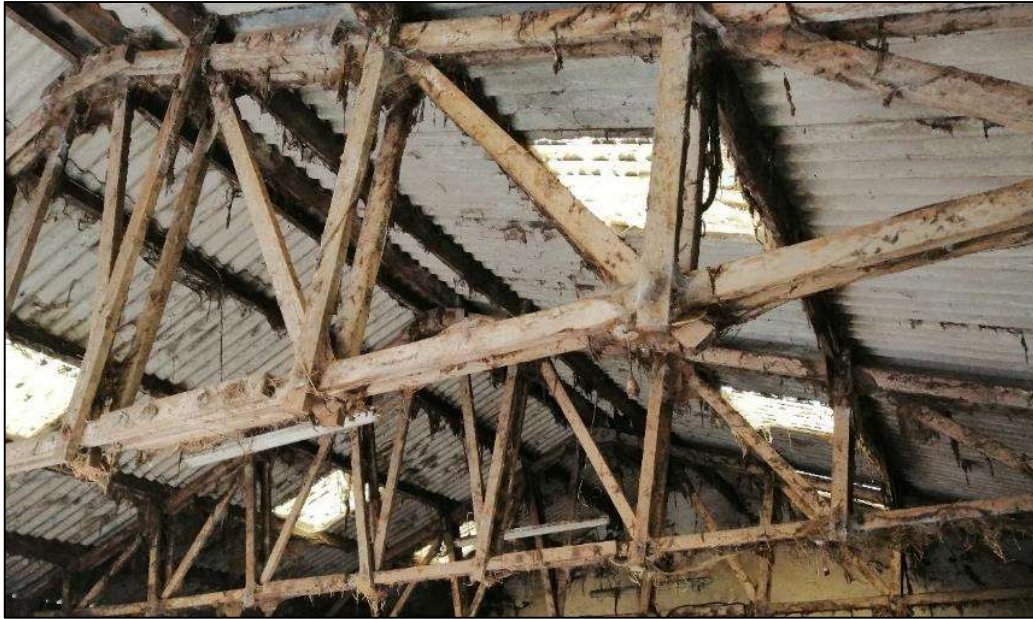
Plate 14. Roof trusses of B6

5.3.19 The inside of B6 is open to the underside of the asbestos roof covering which is supported by a prefabricated bolted roof trusses which were heavily cobwebbed (Plate 14). The walls both inside and out plus the internal livestock compartments are cement rendered. No signs of bats were found. Bat roost features on the exterior of the building are restricted to the wall tops of the gables potentially accessed from behind the asbestos verge capping.

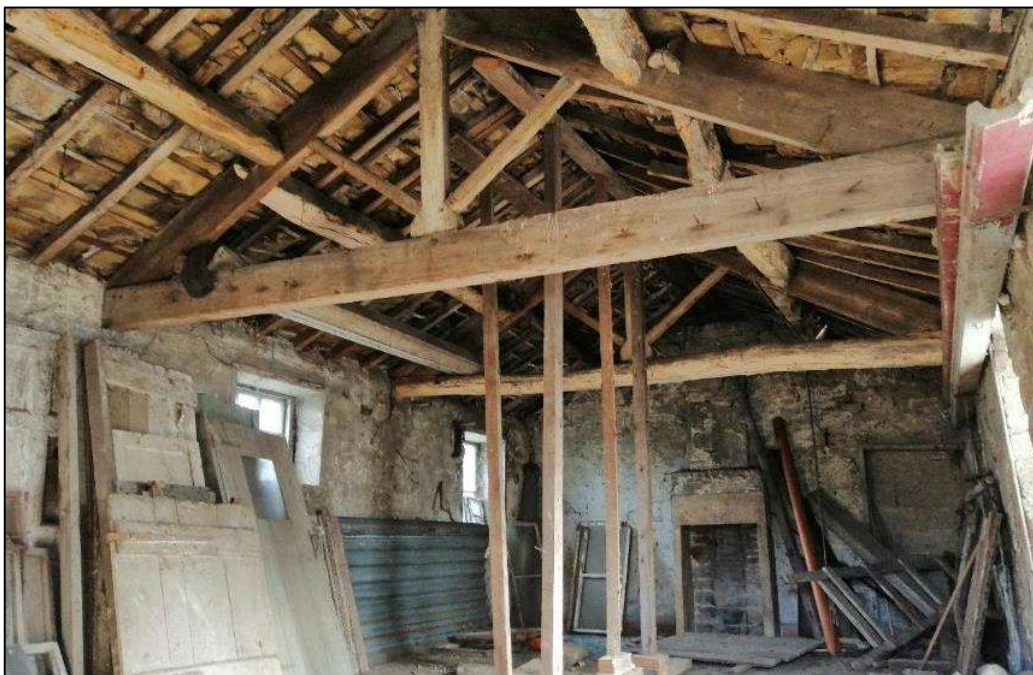
Plate 15. Upper floor of B7

5.3.20 The upper floor of B7 is open to the underside of the stone slates which are supported by king-post roof trusses, purlins, rafters, battens and a ridge beam (Plate 15). Access to this space was limited for reasons of health and safety, nevertheless, the ridge was found to be fairly 'cobwebby'.

5.3.21 Features identified on the exterior of this building offering potential to accommodate roosting bats include wall tops and gaps between slates.

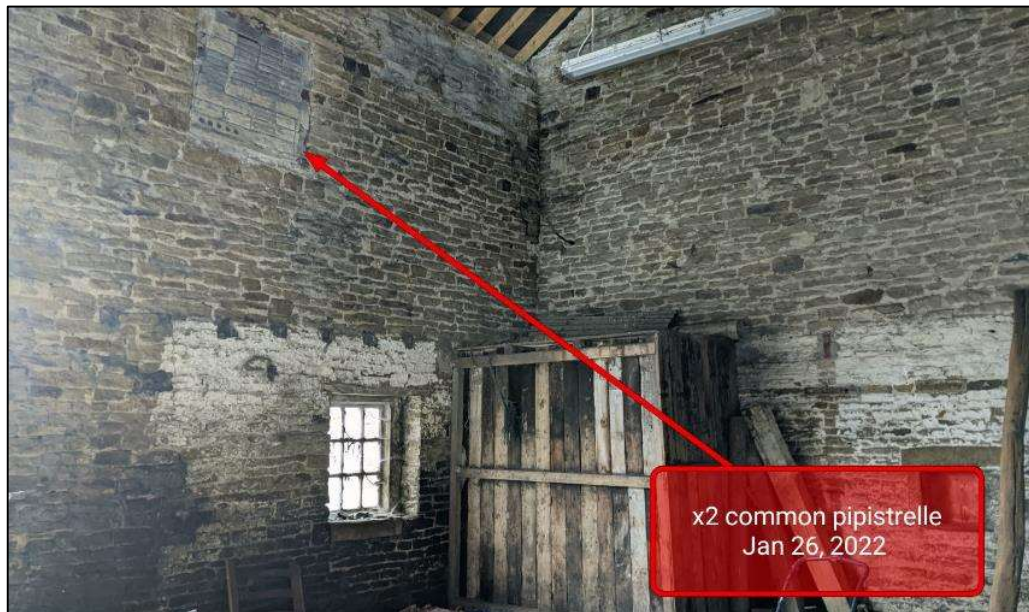
Plate 16. Common pipistrelle hibernation roost location in B2

5.3.25 The two roosting common pipistrelle bats in B2, recorded during the first visit were both observed in the same roost location. No other evidence of bat roosting was recorded.

- 6.2.2 A bat mitigation licence will be required to permit re-development of B2, due to the confirmed presence of the common pipistrelle bat hibernation roost, two common pipistrelle summer day roost locations, and brown long-eared bat day and night roost used by one bat within this building. The licence application will include the mitigation identified within this report and can only be applied for once planning permission has been granted and any wildlife related conditions have been discharged.

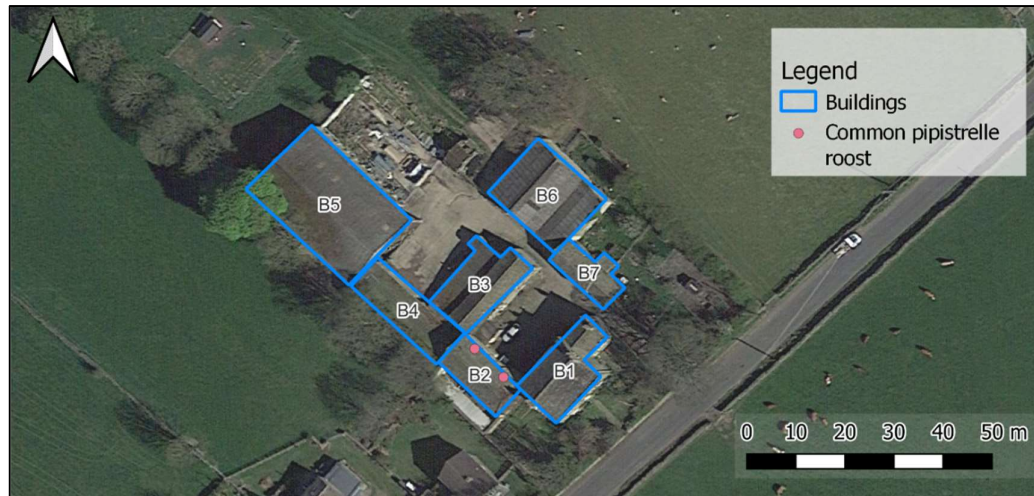
Figure 5. Bat roost summary plan

- 5.3.29 One common pipistrelle was observed in the formerly recorded hibernation roost prior to the start of the survey. This bat was observed emerging from the building at 20:59. A second bat was recorded emerging from a second roost location on the inside of the building on the same wall. The second roost location was located to the northwest of the initial roost location, on the other side of the barn door. The roost locations are shown on Figure 5.
