# ENVIRONMENTAL REPORT

# Report on a Phase 2 Environmental Investigation

Location:	<b>15 Halifax Road</b> Scapegoat Hill, Huddersfield, West Yorkshire, HD7 4NS	
For:	John Holmes	
Report No.	C2405/24/E/6623	Report date: June 2024

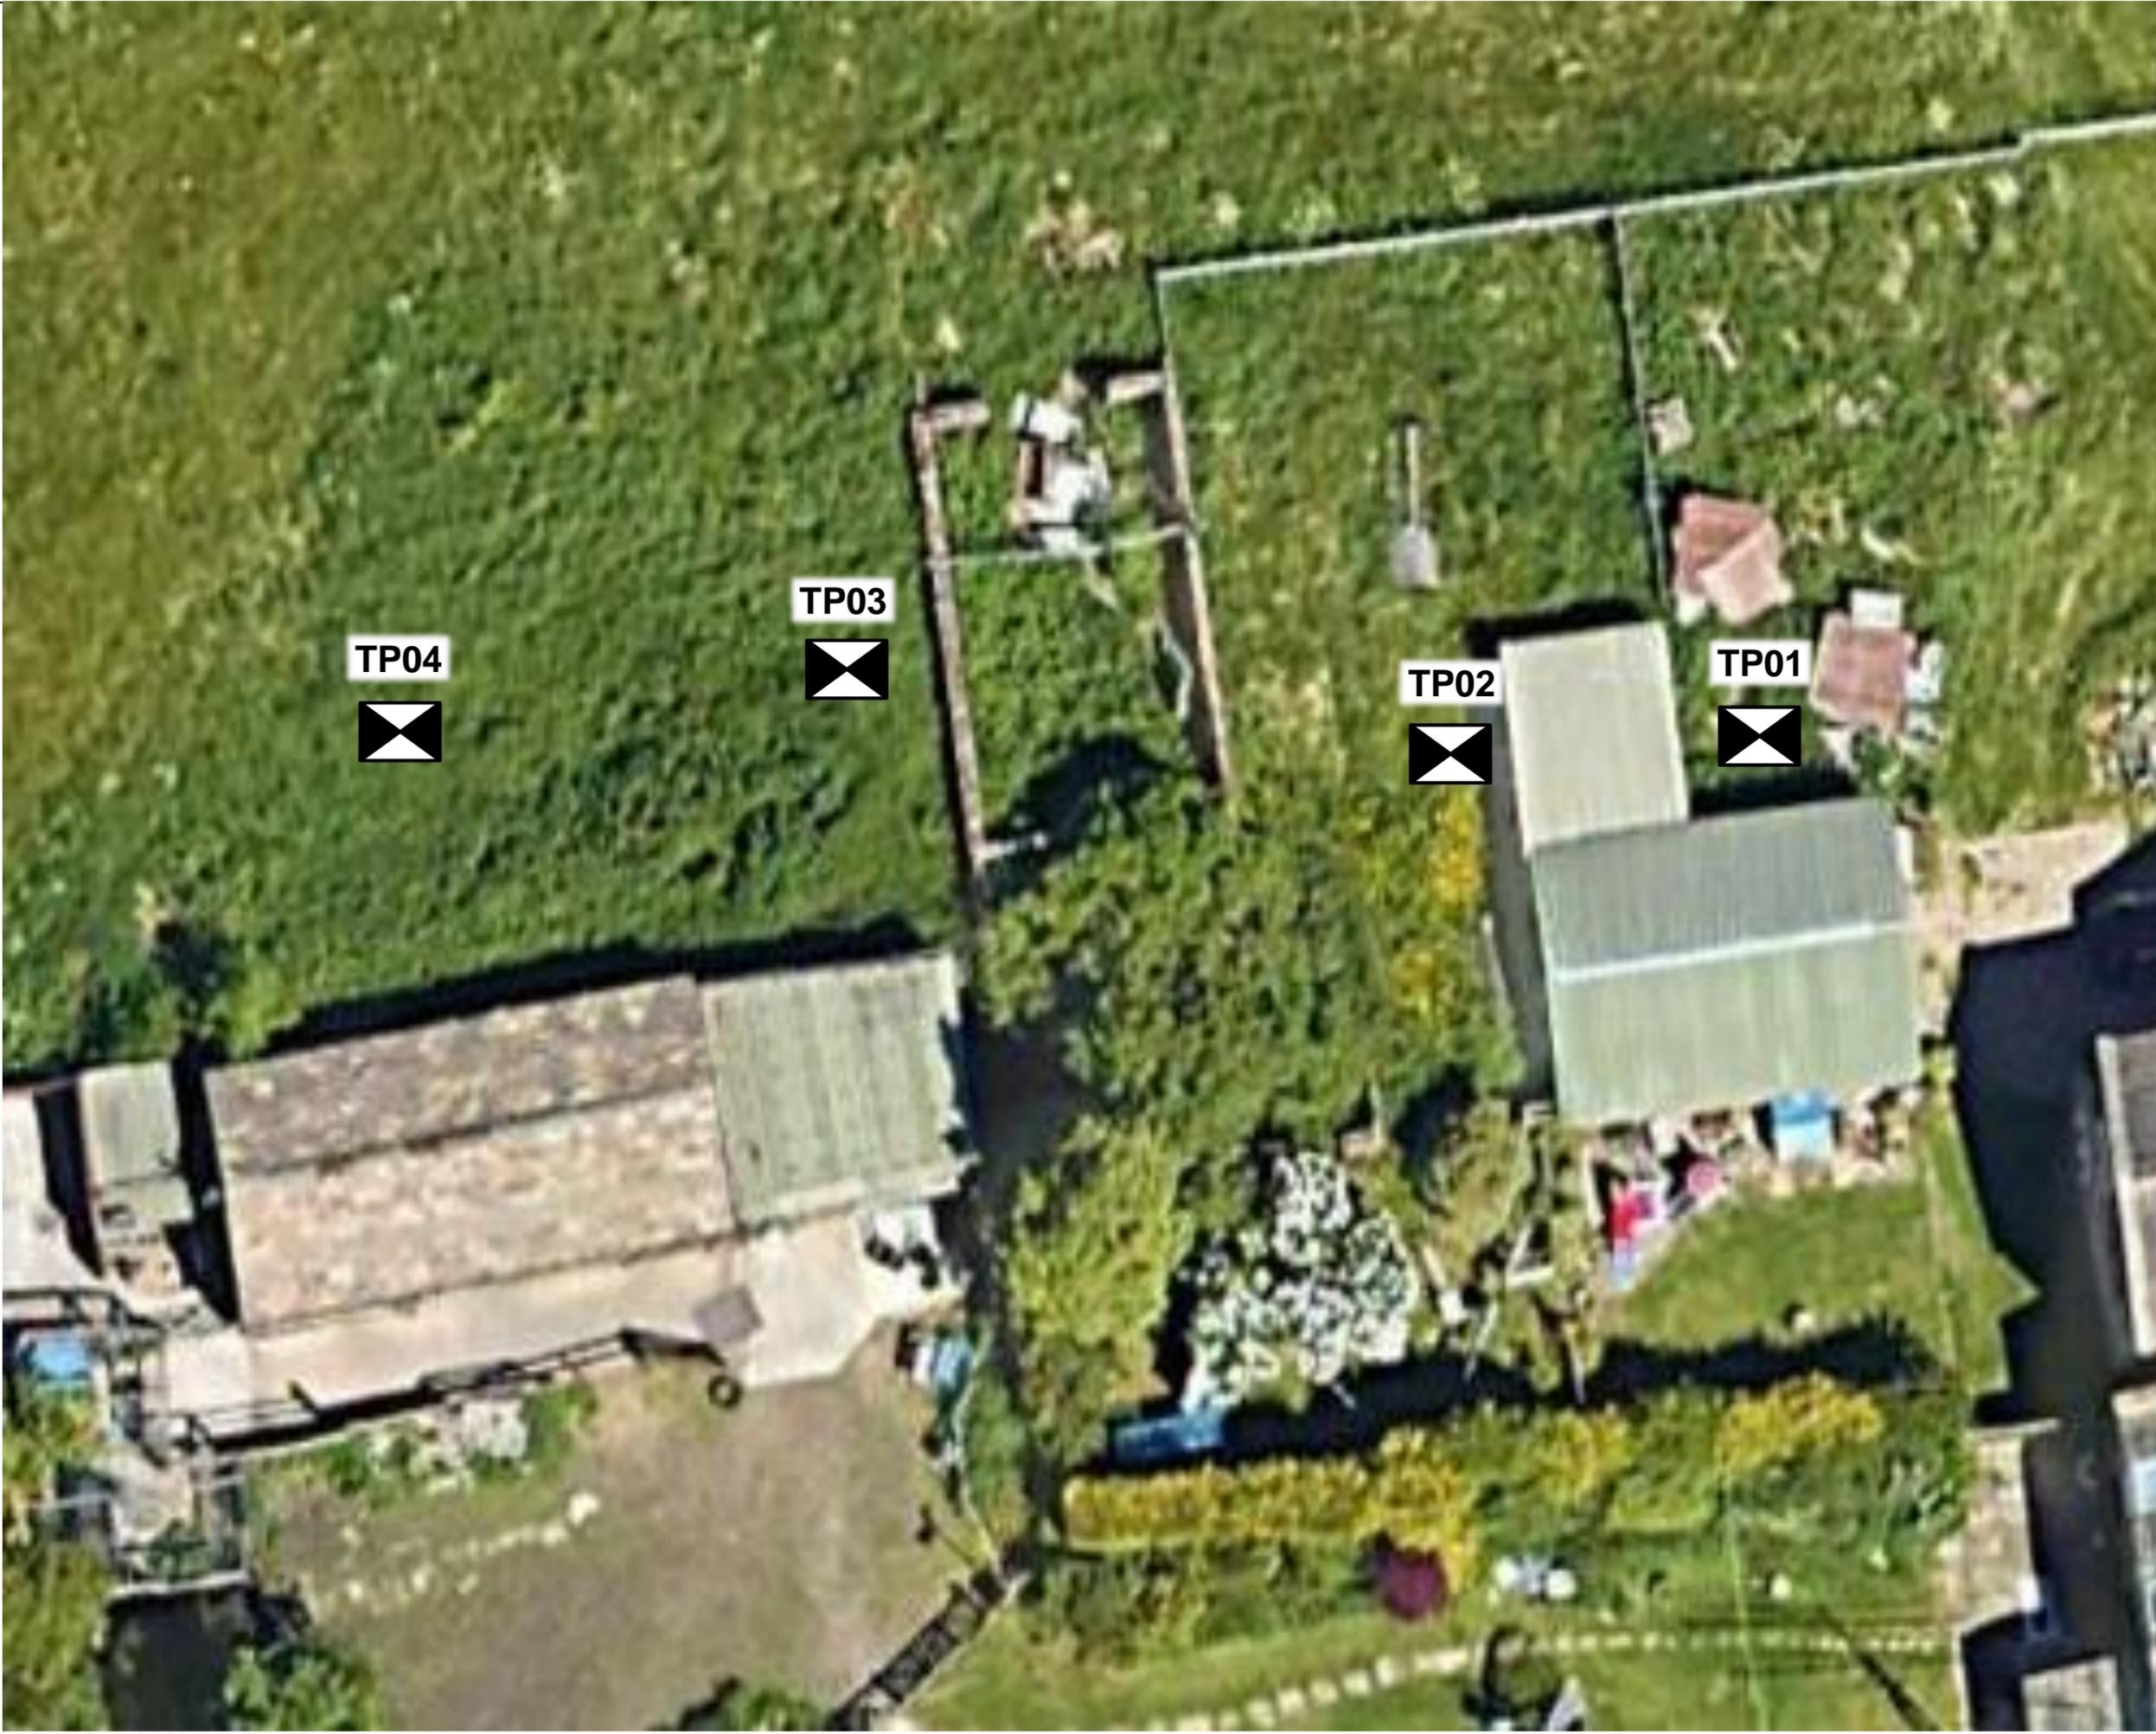
The fieldworks were undertaken on the 8<sup>th</sup> May 2024 and included four trial pits excavated by the client utilising a tracked mini-digger. The investigatory locations are shown on the site plan which is presented in Appendix 1 to this report.
