# Phase 2 Geoenvironmental Appraisal

Healey Lane, Batley

Planned Contracts Ltd

H17075

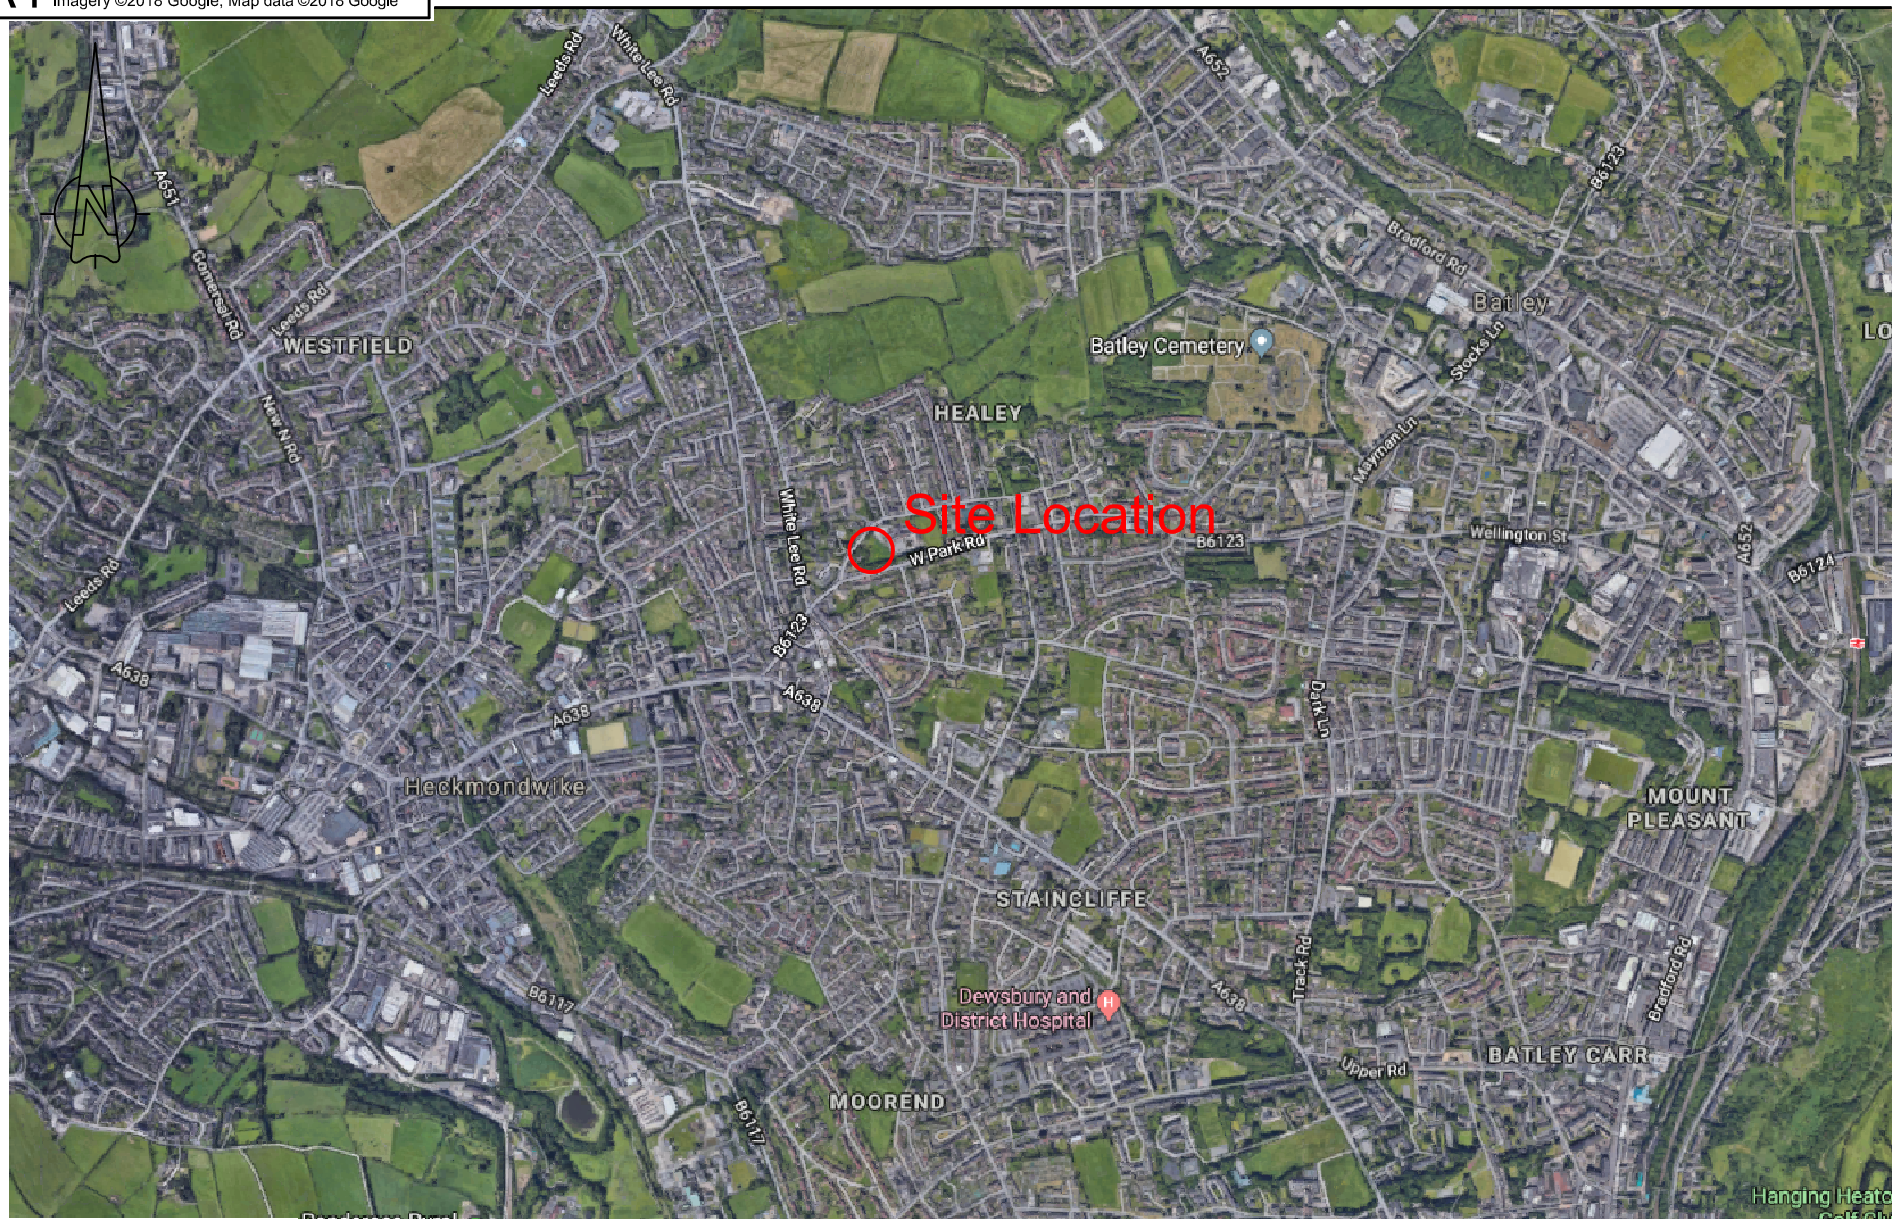
Patrick Parsons Ltd (PPL) was commissioned by Planned Contracts Ltd (PCL) to undertake a Phase 2 Ground Investigation for a proposed residential development of a parcel of land adjacent to Healey Lane, Batley. A site location plan is presented as Drawing No. H17075-701 in Appendix A.
