## Ground Investigation Report

Ossett Lane, Dewsbury

**Campbell Homes Limited**

SHF.1888.002.GE.R.002.C

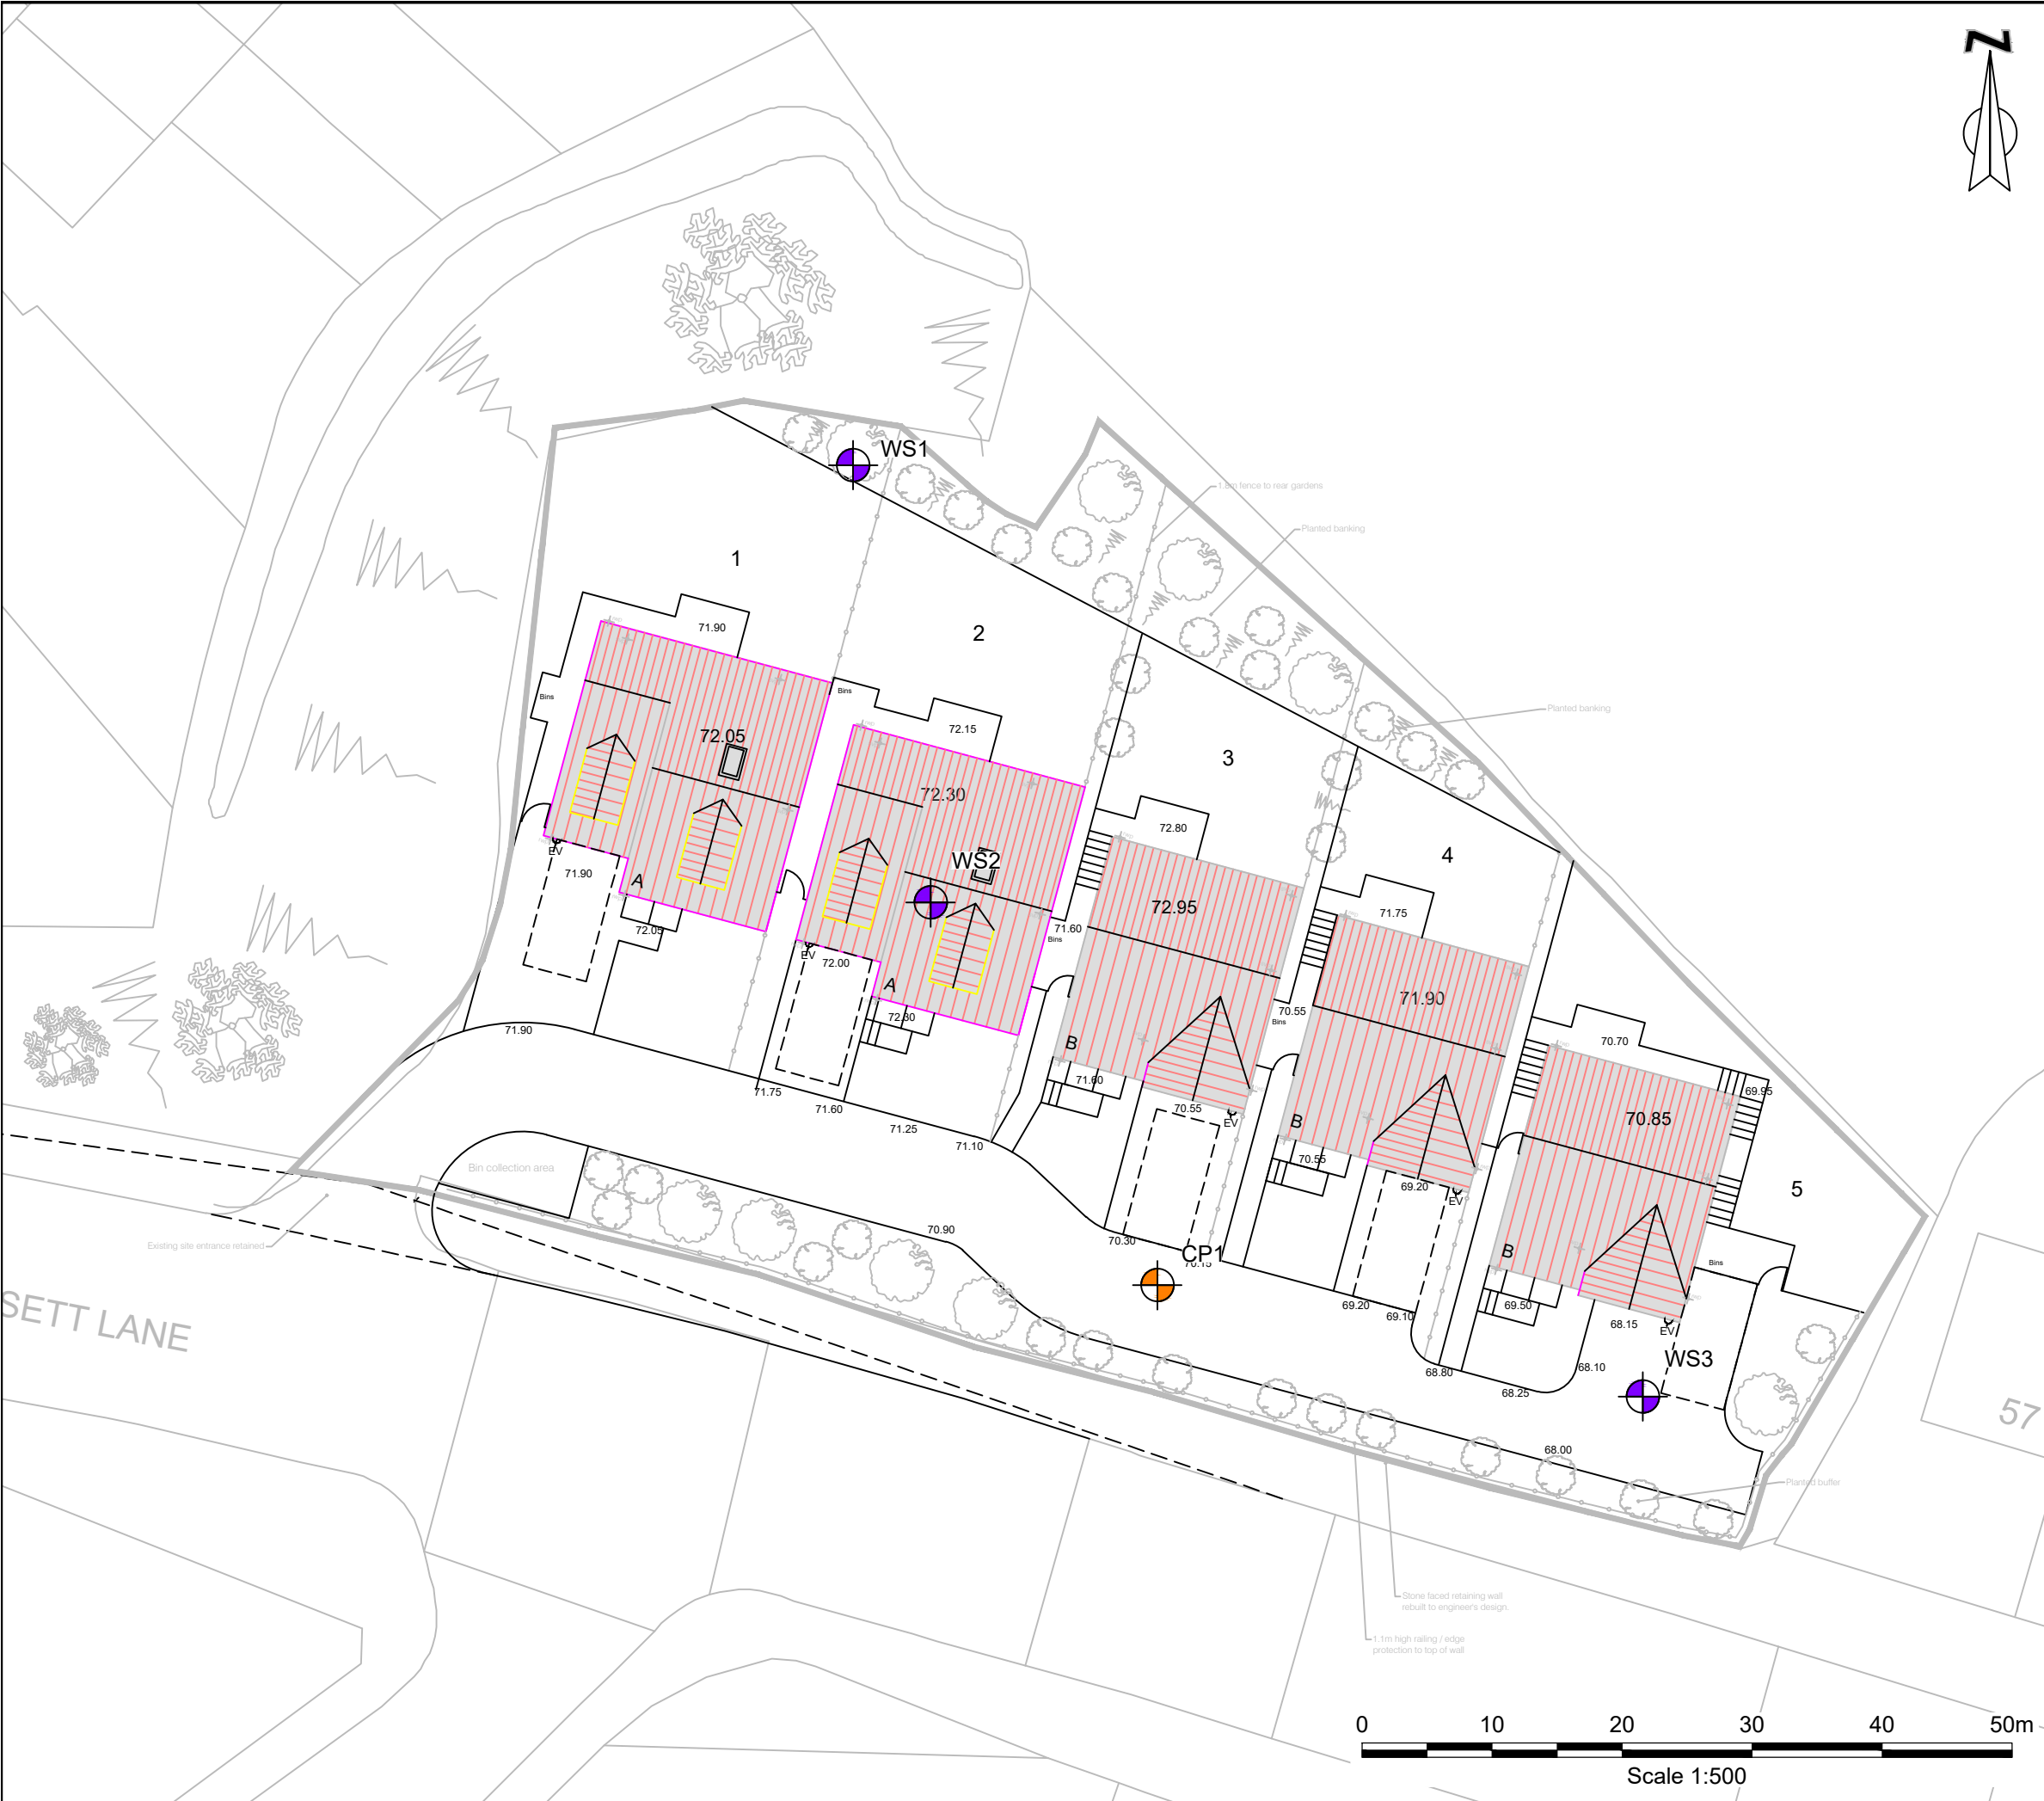
KEY:

- Site Boundary
- Cable Percussion Boreholes (CP)
- Window Sampler Borehole (WS)

- 3.2.1 A GI was undertaken based upon the findings of the PRA and development proposals. The locations of the exploratory holes are shown on the Enzygo 'Exploratory Hole Location Plan' [Drawing No: SHF1888002-ENZ-XX-XX-DR-Z-0002] dated September 2023, included within Appendix 1.
