Bat Scoping Survey to

Lightridge House
Lightridge Road
Huddersfield

11th October 2023

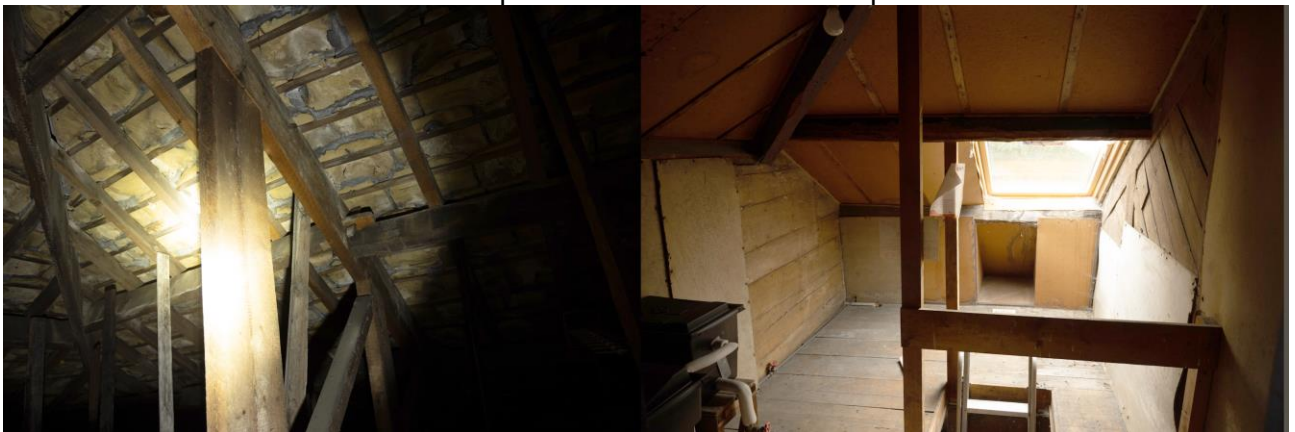
An internal search of the roof space was undertaken looking for droppings, discarded prey remains or other signs of bats (dead animals etc). The stone roof is hipped and is unlined and all back-pointing is present. The short ridge section is heavily covered with cobwebs and there are no droppings trapped in the webs. Over half the loft space has been boarded out which make searching for evidence an easy task. There were no scattered droppings and there is a roof window allowing light to flood the boarded half of the roof space. The wall tops are ramped with mortar to the first tile and this will prevent access to the wall tops from the outside.

Photo 1: Illustrating roof interior.

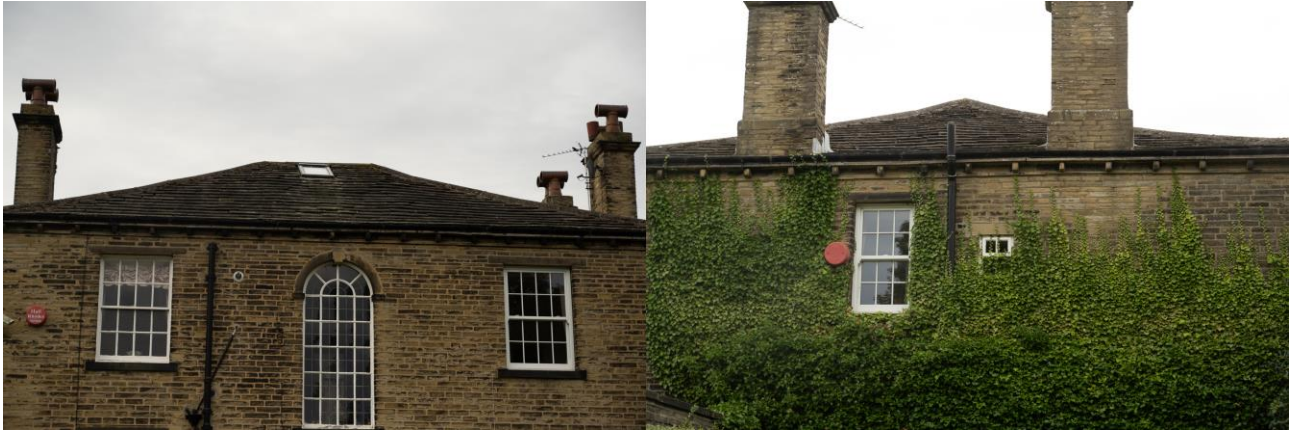
Externally, the roof is sound and has no missing or slipped tiles and all ridge tiles and flashings are present and appear sound. The roof is hipped and quite shallow and therefore less likely to appeal to ridge dwelling species and lacks the flight space preferred by brown long-eared bats. There are natural gaps beneath the tiles which could provide roosting spaces for small numbers of bats but unlikely to support a nursery roost.

Photo 2: Illustrating roof section

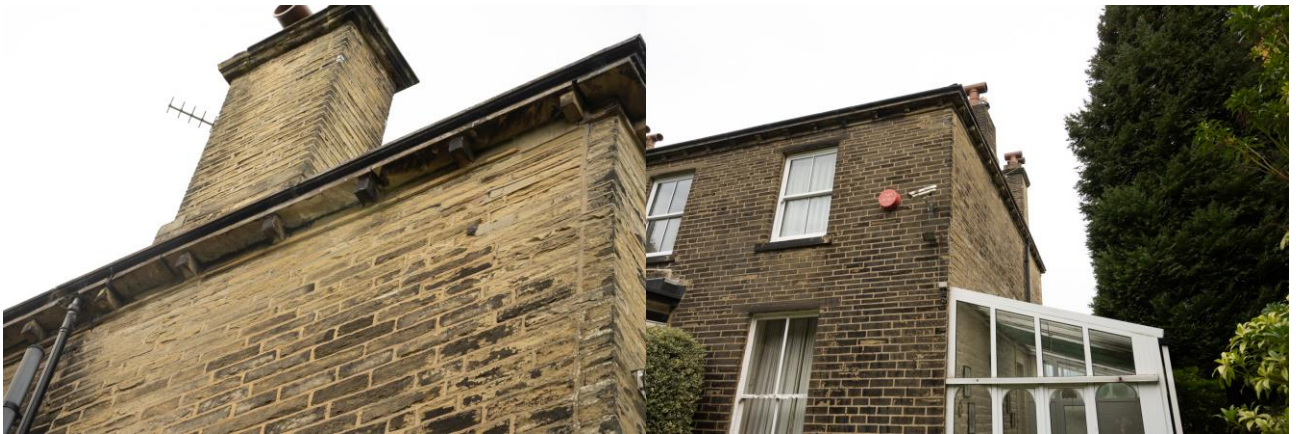
The stone walls are rubble-filled and are sound and have no cracks or structural gaps and are very well pointed. Being hipped, there are no gable walls and no decorative wooden features externally. The top of the walls has a wide, protruding flat stone on which the gutters sit, and this offers no potential roosting features.

Photo 3: Showing flat stone gutter support and pointed walls

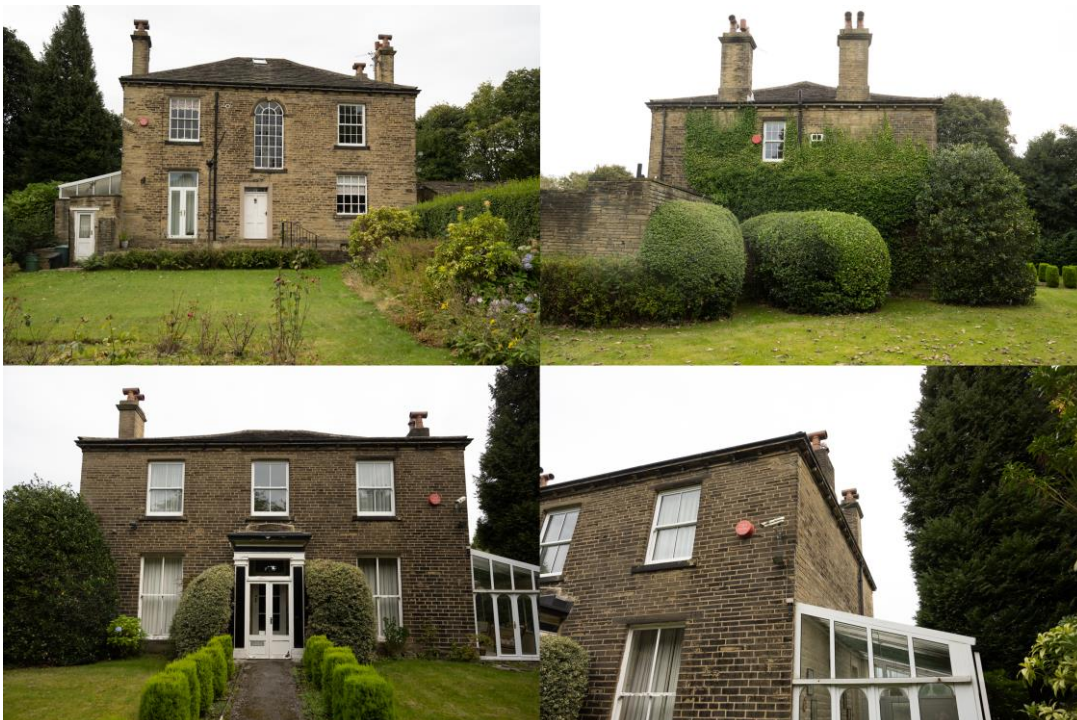
The site comprises a large, period dwelling standing in its own grounds and remote from other dwellings. The building is stone and has a hipped roof with stone covering and is in a very good state of repair.

Photo 4: Showing all four elevations of the house.
