**Slate Pitts, Slaithwaite**  
**PRELIMINARY BAT ROOST ASSESSMENT**

**June 2024**

**Report Ref:** 101\_01

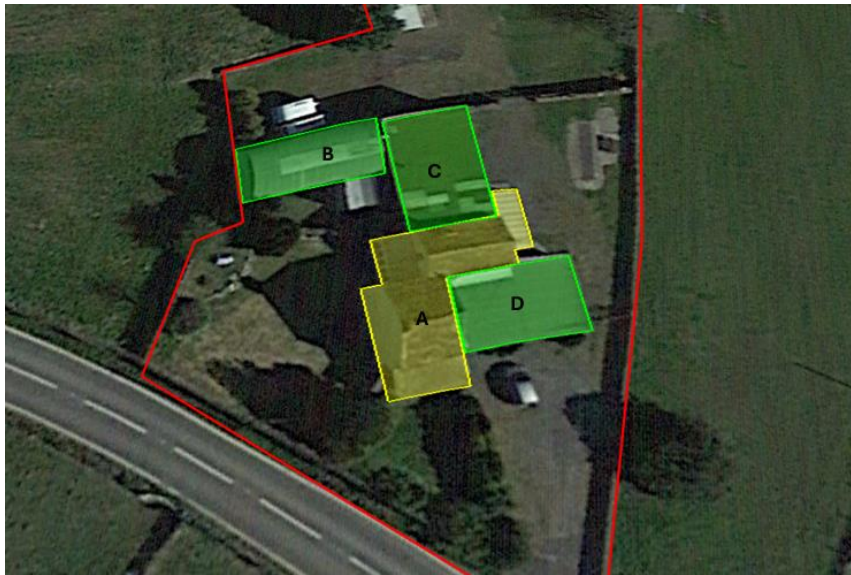
**Figure 3.1. Building layout**

Photos of the property are provided in Appendix B for a general overview and an illustration of any identified potential bat roost features. A total of four buildings are located at the site. A layout of the buildings is provided in Figure 3.1. It should be noted that there were also several containers and a timber shed to the direct north; however, these buildings did not offer any potential for use by bats.

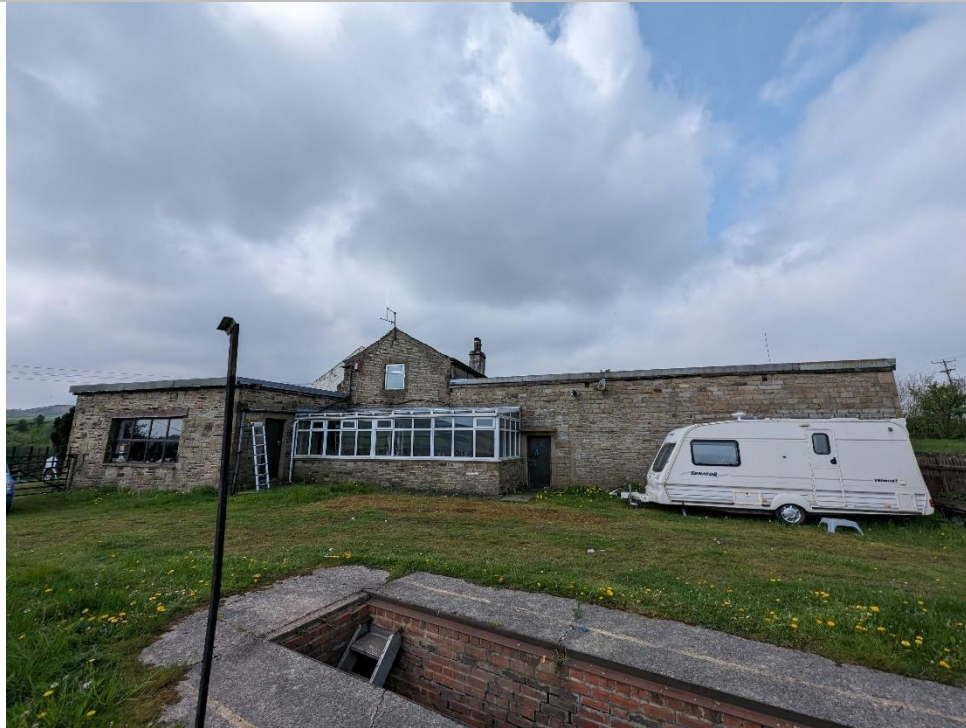
**Photo 1.**  
East  
elevations  
of garage  
(left of  
photo),  
dwelling  
(centre)  
and  
workshop  
(right).

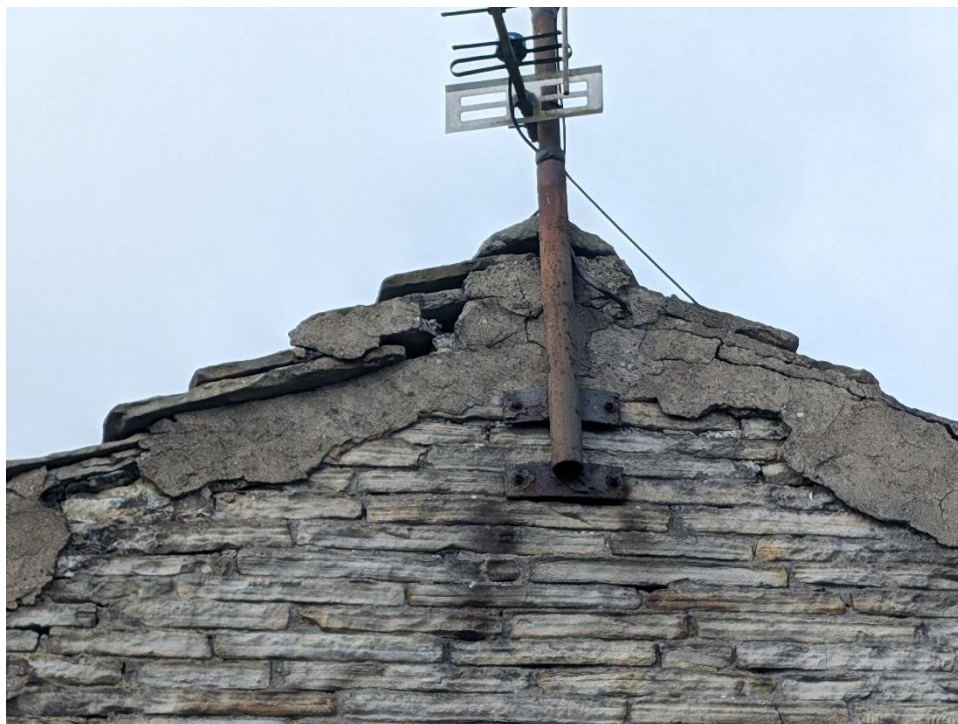
On the east elevation, the stonework appeared in good repair. However, there were gaps under the roof verge slates towards the ridge of the roof due to broken / missing mortar.

**Photo 2.**  
Gaps at  
ridge of  
dwelling  
(east  
elevation)

In accordance with good practice guidelines (Collins, 2023), it is recommended that further surveys are required to establish the presence or absence of a bat roost. These surveys would comprise dusk emergence surveys which can be undertaken between May and August (inclusive). A minimum of two surveys are required for the dwelling in order to provide a sufficient level of confidence that a bat roost is absent (one for the workshop). The first and second survey on the dwelling would need to be spaced at least three weeks apart.

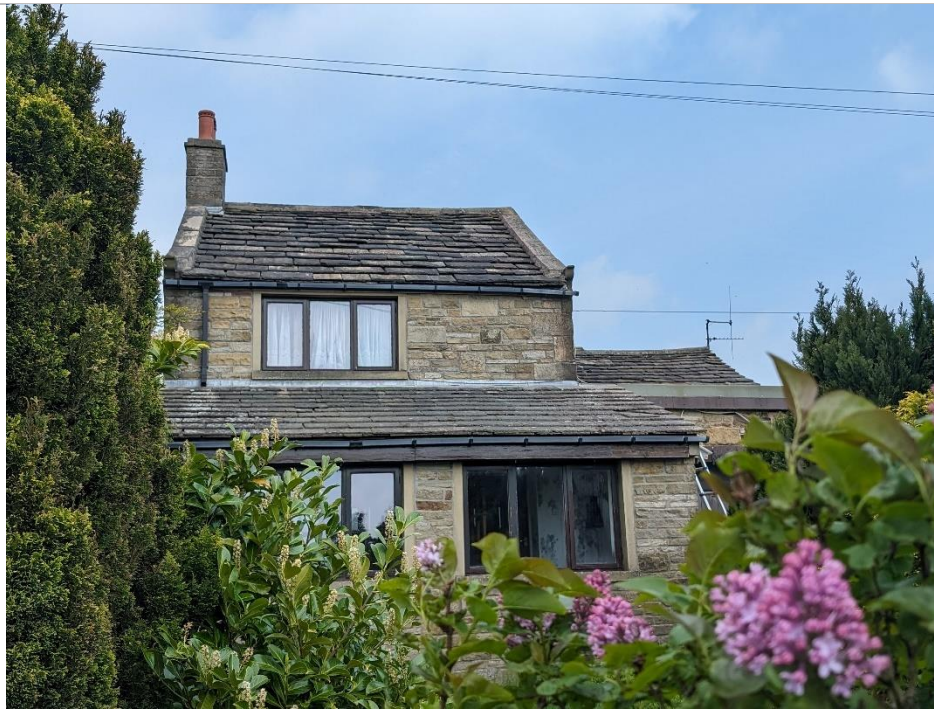
On the south elevations (front), the only potential roost feature (excluding the roof slates) comprised a gap (15-20mm) under the timber eaves board.

**Photo 3.**  
South  
elevation  
of dwelling

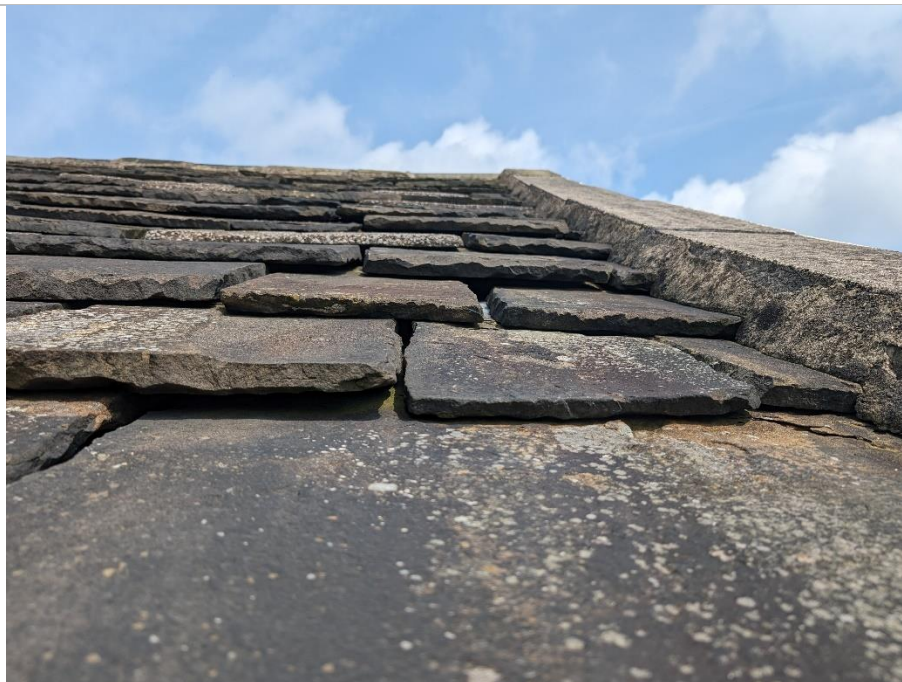
The dwelling comprised two connected sections and each section had a shallow pitched, gable roof with traditional stone slates. As is typical of such roof types, there were numerous gaps under and between the stone slates.

**Photo 4.**  
Numerous  
gaps in  
roof of  
dwelling.

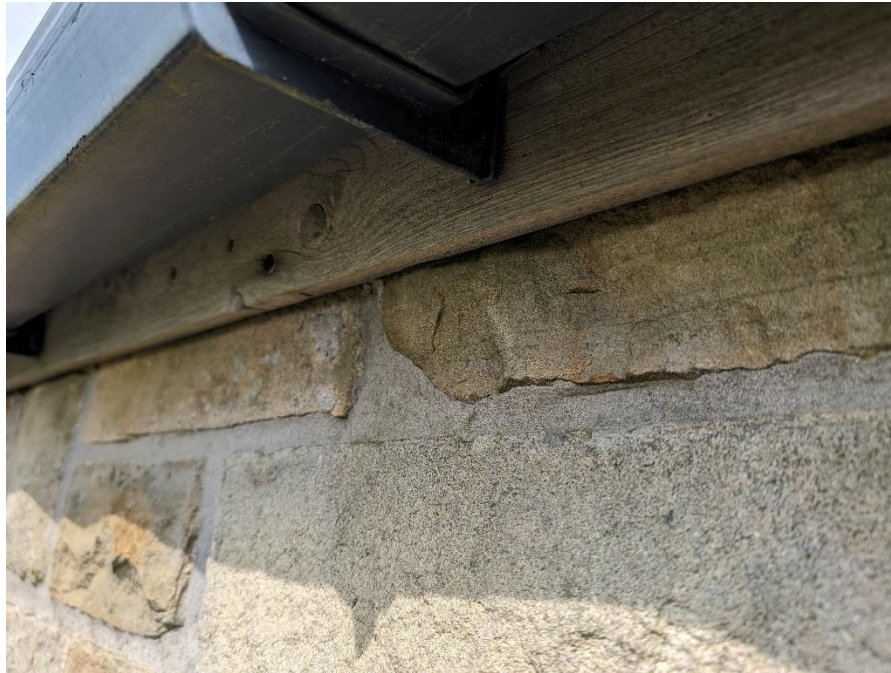
**Photo 5.**  
Gap under  
fascia  
board of  
dwelling  
(south  
aspect).

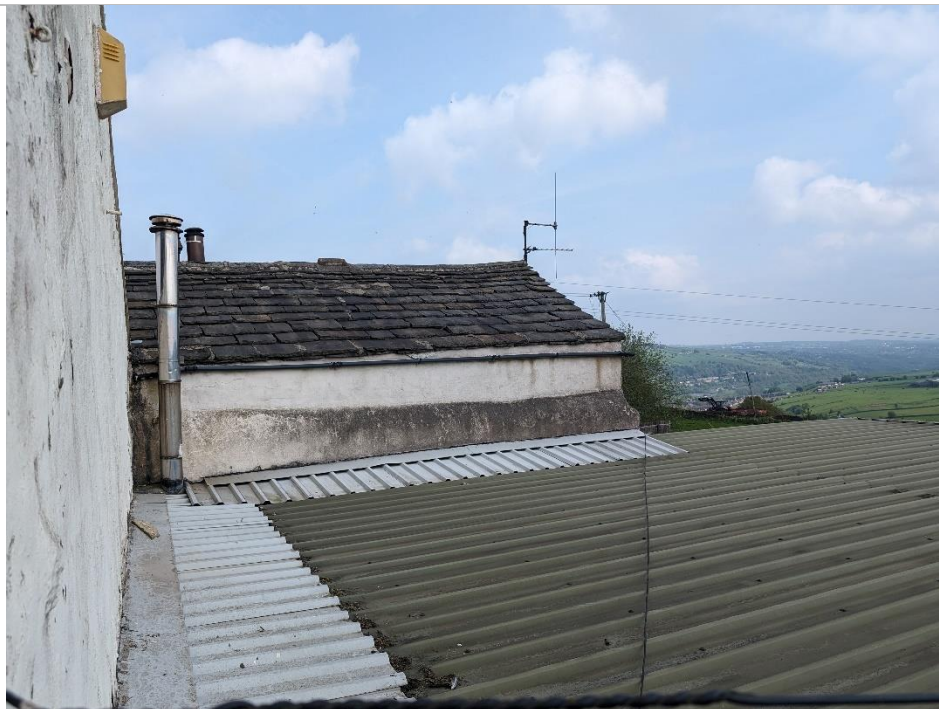
**Photo 6.**  
View of  
dwelling  
roof and  
garage  
roof.

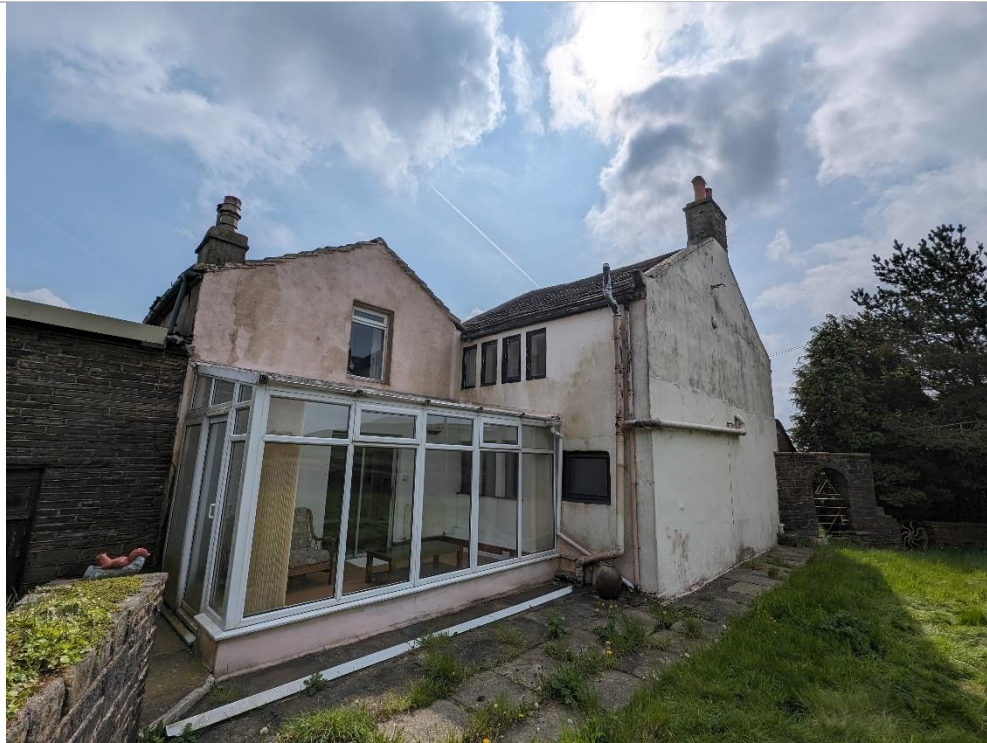
The property had been rendered on the west elevations. The render appeared solid, particularly around the roof verges. There was a single, relatively large gap on the corner of the roof of the northern section of the dwelling. This gap was possibly too open and exposed for suitability by bats but could not be viewed closely.

**Photo 7.**  
West  
elevations  
of  
dwelling.

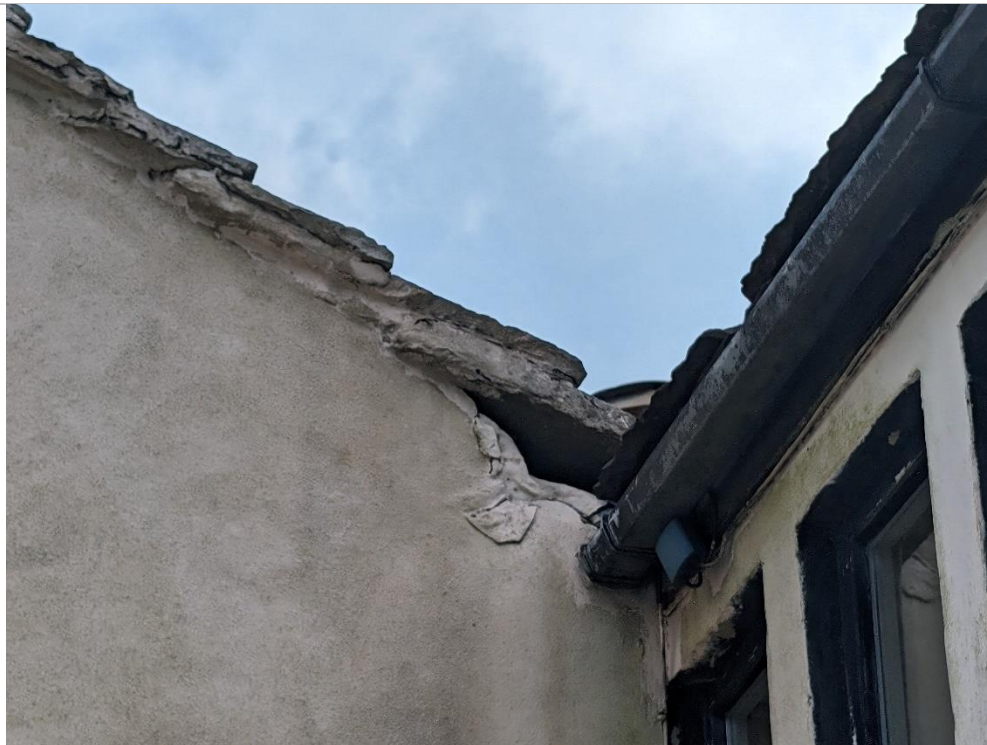
**Photo 8.**  
Large gap  
on corner  
of roof of  
dwelling.

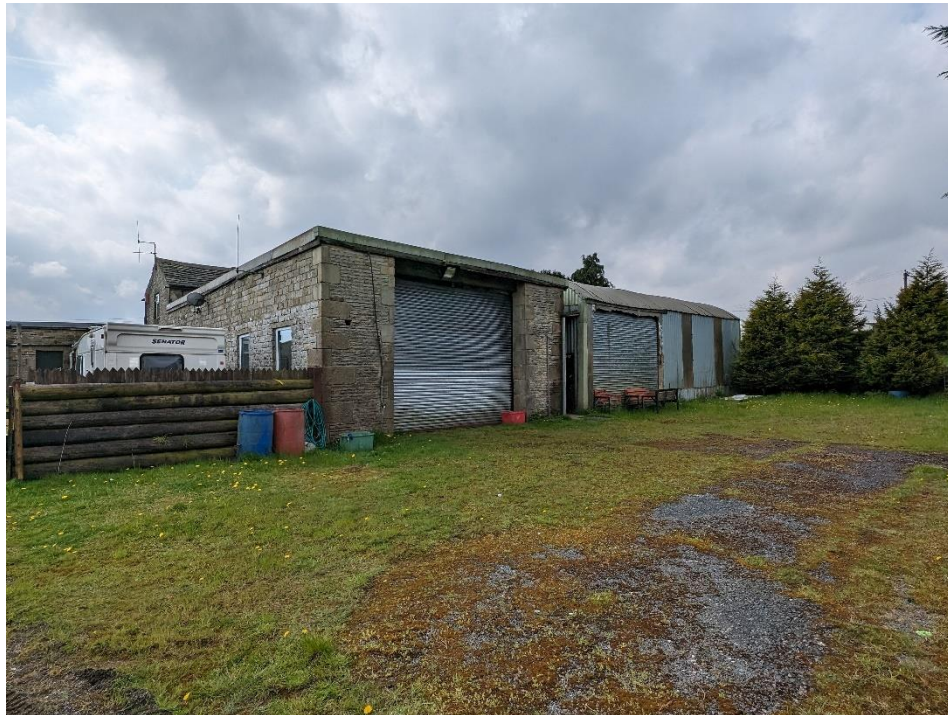
The outbuilding comprised a large, metal framed shed previously used as a games room. The outbuilding was clad entirely with corrugated metal sheets (including the dome shaped roof) and such construction types are not typically associated with bat roosts. No potential roost features were observed.

**Photo 9.**  
Workshop  
(left) and  
outbuilding  
(right)

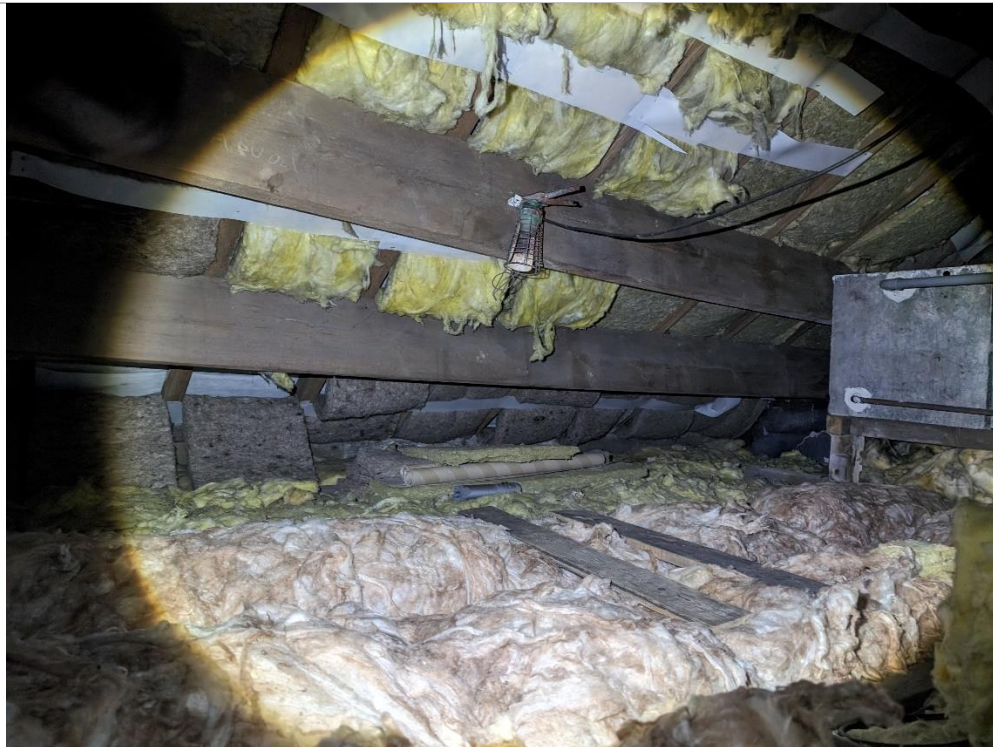
The dwelling had two lofts. One loft was inaccessible. The other loft was relatively small and shallow (1-1.2m from loft floor to ridge). The loft including the roof had been insulated with a rock wool type insulation. The roof underside had also been partially clad with timber boards. No light gaps within the roof were observed.

**Photo 10.**  
Loft of  
dwelling.

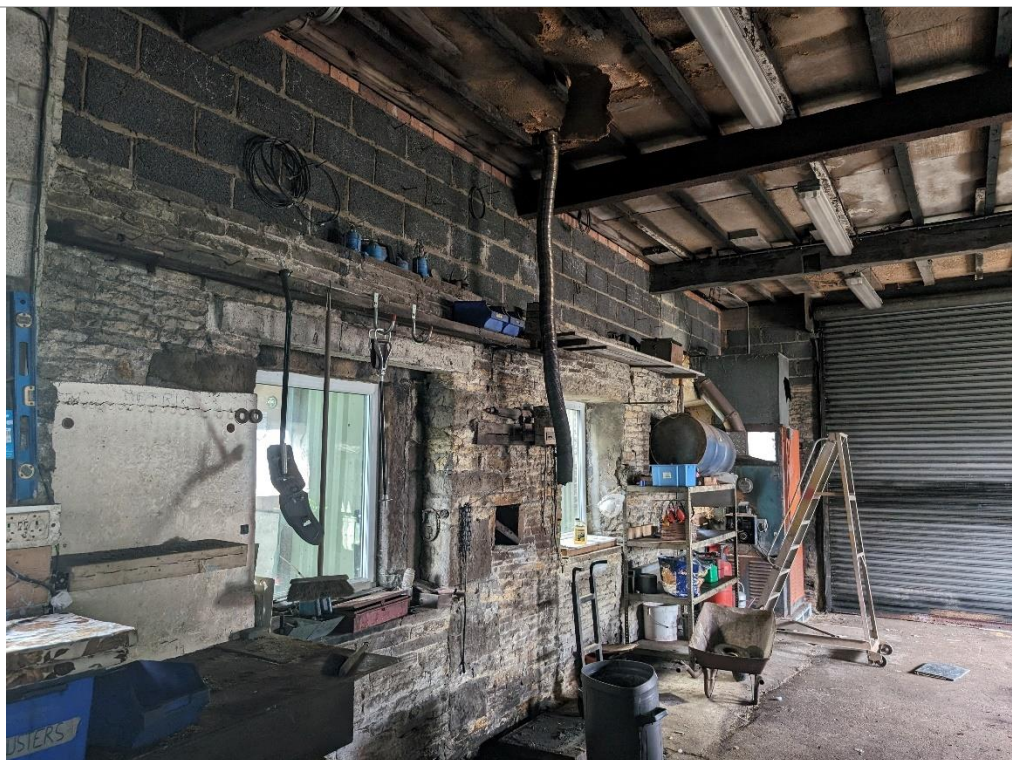
The workshop is attached to the north side of dwelling. It comprised a stone-built structure with a flat, metal roof. There was a large roller door on the north aspect. There was a large gap in the stonework on

the north elevation; however, this did not lead to any suitable crevices. The only potential roost feature observed was a gap under the timber eaves board along the east elevation. Internally, the building did not have any loft spaces and the roof underside was clad with timber sheets. The structure had concrete block walls and no potential roost features were observed internally.

**Photo 12.**  
Workshop.

One potential roost feature was observed on the workshop. The building was categorised as low in its suitability to support bats. This potential roost feature can be easily covered during the surveys recommended for the dwelling (see Section 5).
