Validation Report Lower Lark Hill, Cleckheaton

Validation Report

Arcon was retained by Knabbs Ash Barn to validate an engineered cover system installed in all soft landscaping and garden areas at land adjacent to 15 Lower Lark Hill, Cleckheaton, BD19 6JJ in order to discharge planning condition No. 10, (Ref: 2022/70/93166/E) .

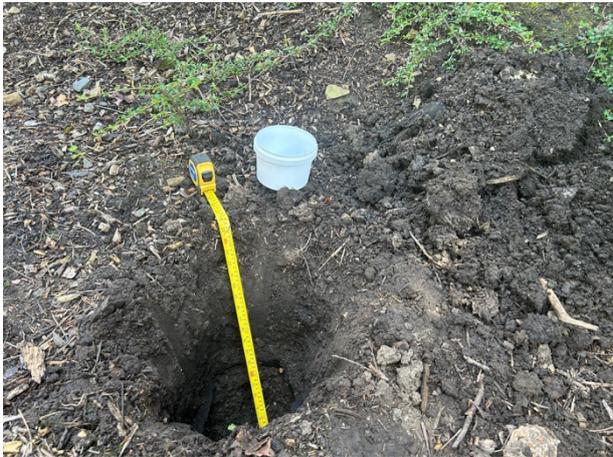
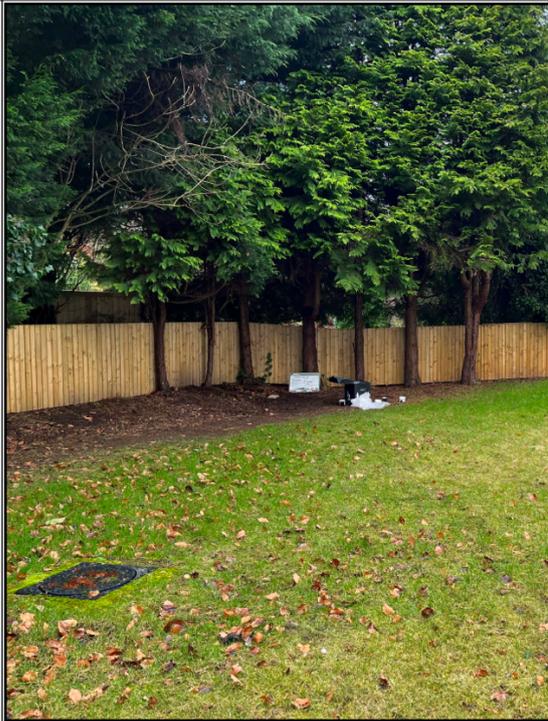
HAND PIT TP101

Capping Observed	Total Depth
Topsoil	250 mm bgl
Subsoil	350 mm bgl
TOTAL DEPTH	600mm bgl

Validation Photograph	Locational Photograph

HAND PIT VALIDATION: PASS

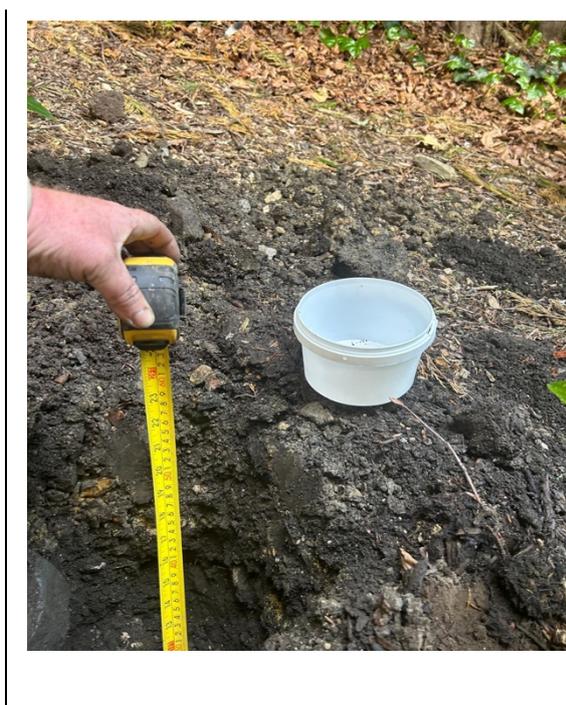
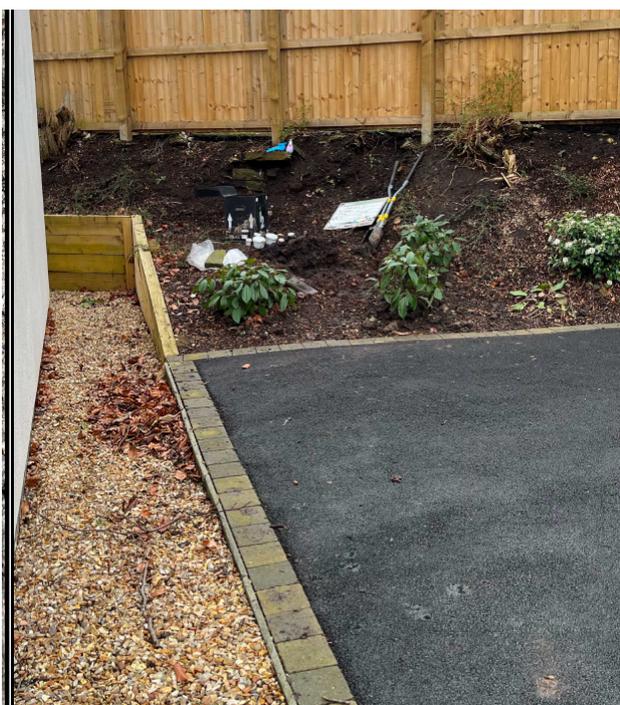
HAND PIT TP102

Capping Observed	Total Depth
Topsoil	300 mm bgl
Subsoil	300 mm bgl
TOTAL DEPTH	600mm bgl

HAND PIT VALIDATION: PASS

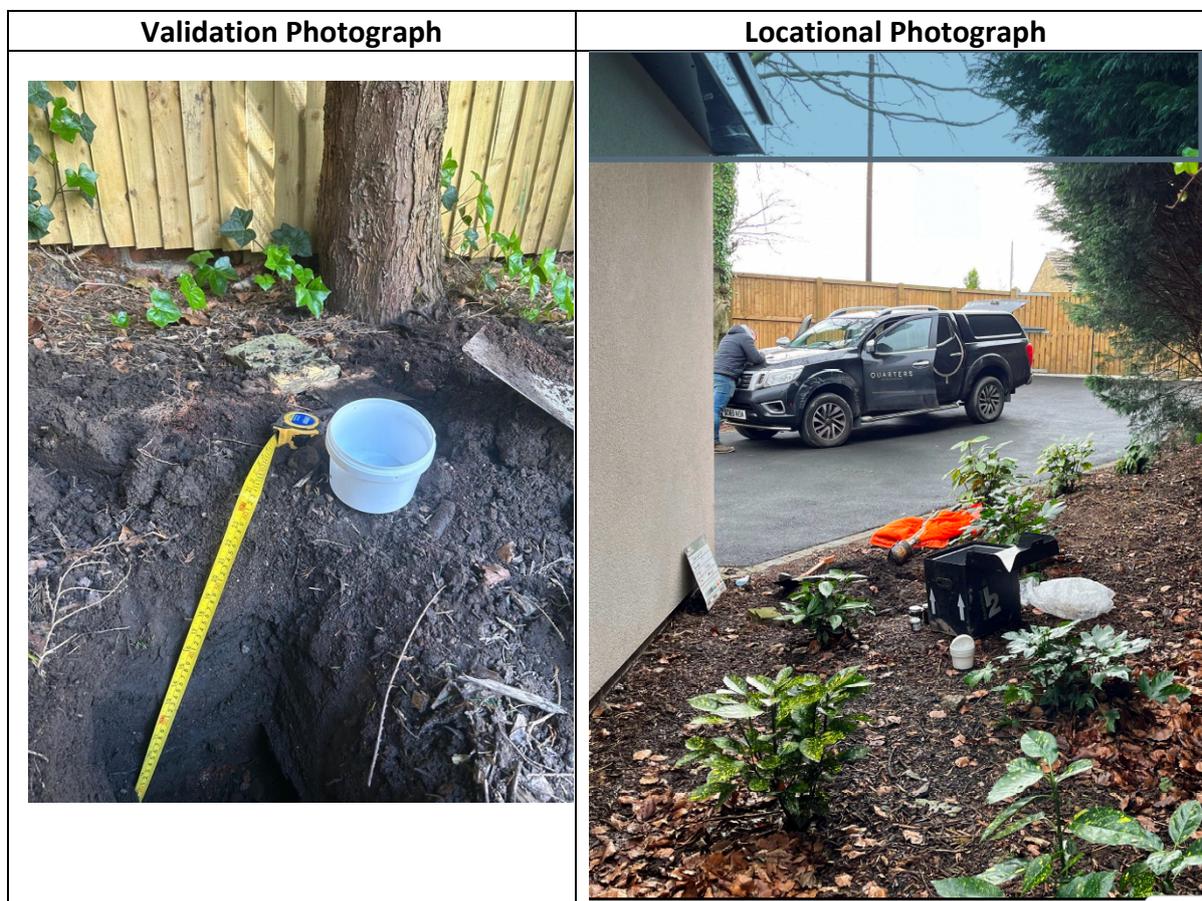
HAND PIT TP103

Capping Observed	Total Depth
Topsoil	150 mm bgl
Subsoil	400 mm bgl
TOTAL DEPTH	550mm bgl

HAND PIT VALIDATION: PASS
