# 11 Wood Street, Skelmanthorpe

## Bat Survey Report

22<sup>nd</sup> May 2025

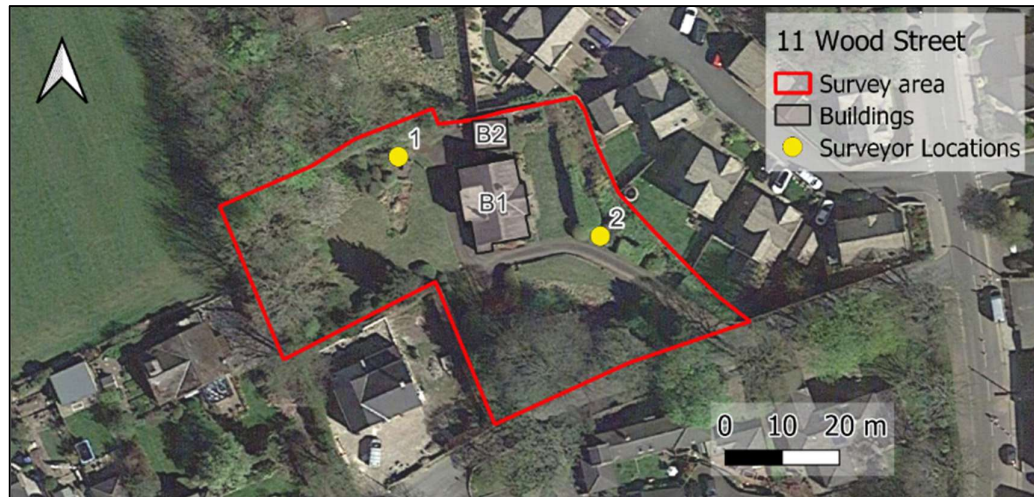
**Figure 2. Nocturnal survey plan**

- Greg Slack (MCIEEM, Natural England Bat (WML-A34-Level 4, licence number: 2016-25236-CLS-CLS);
  - Carl Dixon; and
  - John Pearse.
- 4.2.2 The surveyors covered two surveyor positions during the survey. The surveyor Locations are shown on Figure 2.

- 4.2.4 During the second survey the surveyor in Position 1 used a Canon XA10 camera, the surveyor in Position 2 used a Nightfox Whisker.
- 4.2.5 The footage from the night vision aids was reviewed as required to check and confirm the observations made by the surveyors.

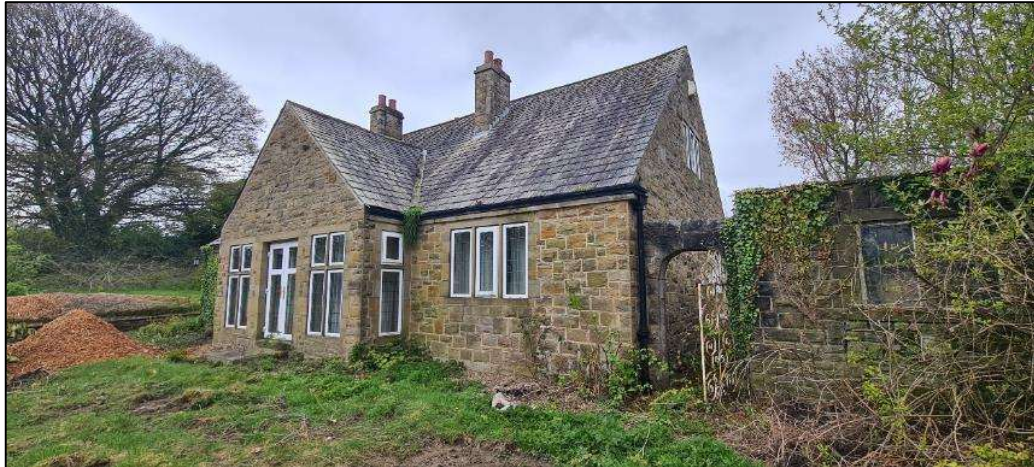
**Plate 1. The house viewed from the northeast with the corner of the garage shown on the right hand side**

- 5.3.4 The two-storey building was a stone dwelling constructed in 1954. The dwelling had a two pitched roof with dormers on both pitches. The dormer on the east pitch had a two-pitched roof and the dormer on the west had a flat roof (Plate 1 and 2). A small, single-storey, flat-roofed porch was present on the southern end of the building and a staircase was present on the western aspect leading up to the dormer.
- 5.3.5 The pitched sections of roof were covered with Welsh slate and the ridges were covered with angled ridge tiles. The verges were mortared, and lead was present in

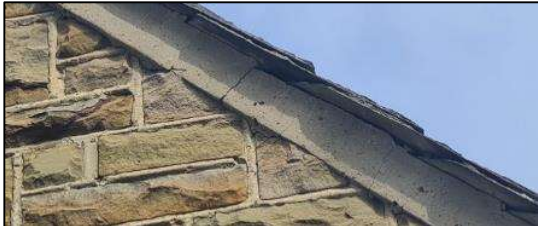
| PRF | Photo | Description |
|---|---|---|
| A | | Missing mortar. |

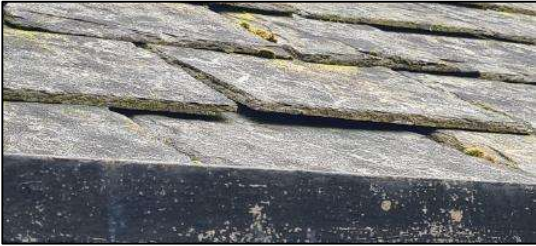
| PRF | Photo | Description |
|---|---|---|
| B | | Raised slates. |

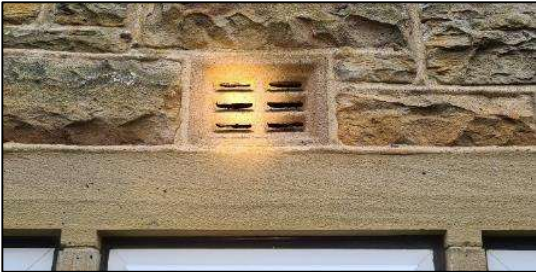
| PRF | Photo | Description |
|---|---|---|
| C | | Air vents. |

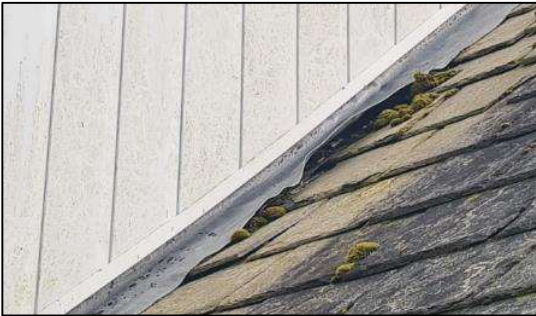
| PRF | Photo | Description |
|---|---|---|
| D | | Lifted lead flashing. |

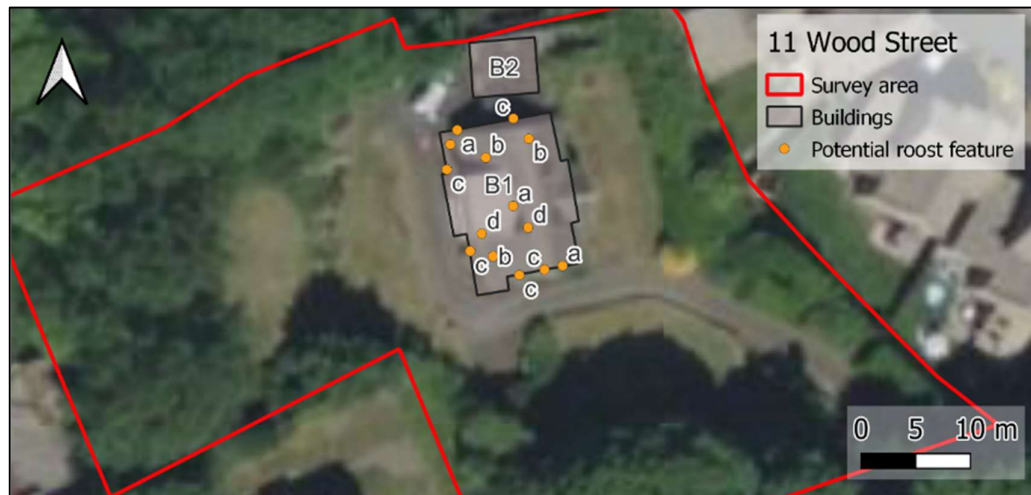
**Figure 2. PRF locations on the dwelling (B1) and garage (B2)**

- 5.3.6 Potential bat roost features present comprised raised slates, missing mortar, lifted lead flashing, and air vents leading into the cavity wall. The potential roost features (PRFs) are shown in Table 2 and Figure 2 below.

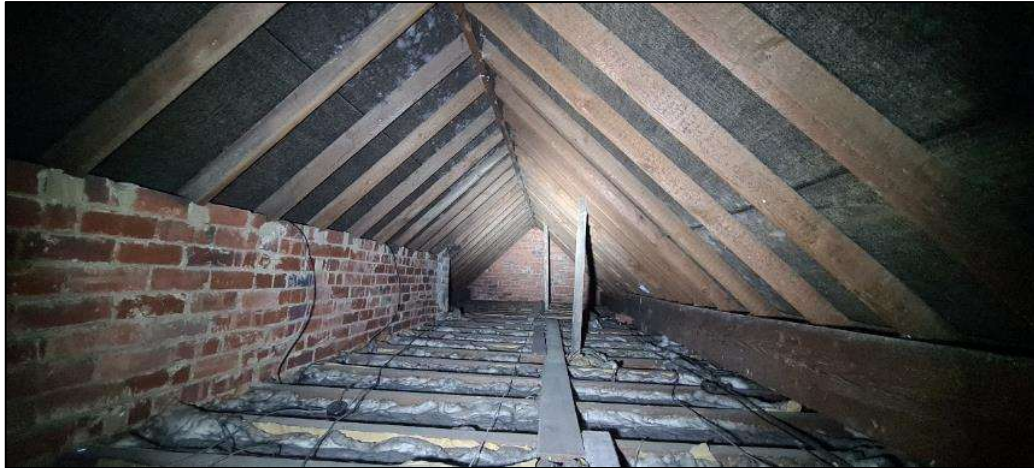
**Plate 3. The roof void in the apex of the pitched roof**

- 5.3.7 A roof void was present in the apex of the pitched roof with an additional void under the eaves on the east side of the building. The void in the apex was approximately 1.8 m high. The roof was supported with rafters and purlins (Plate 3). The slates were backed by Type 1F bitumen coated roofing felt. The entrance hatch was relatively small, and the void did not appear to have been used for storage.

- 5.3.9 No bats or signs of bats were recorded within the roof voids, although it is likely that the roofing felt would have prevented droppings from entering the void if bats were roosting between the slates and the felt.
- 5.3.10 Because the majority of features were relatively small, and no bats or signs of bats were recorded, the dwelling (B1) was considered to have low suitability to support roosting bats.

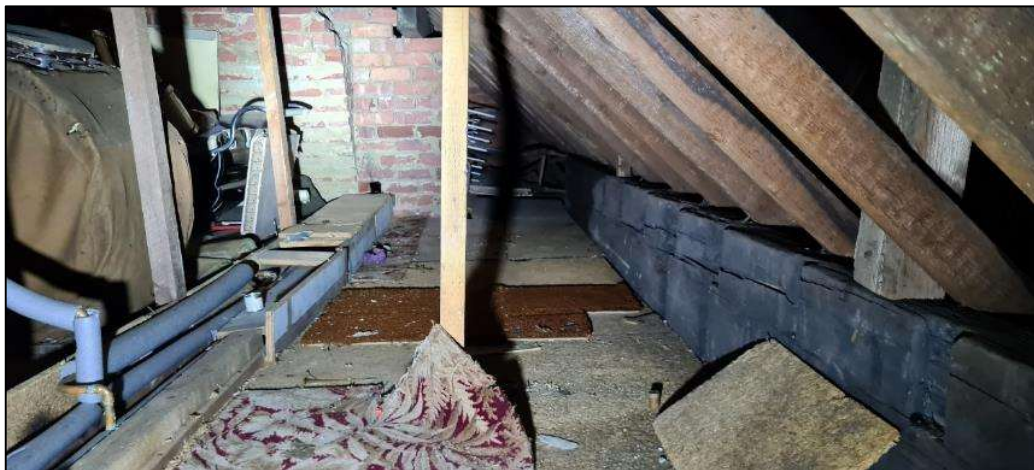
**Plate 4. The void in the eaves on the east side of the building**

- 5.3.8 The void in the eaves had been boarded out and appeared to have been used for storage

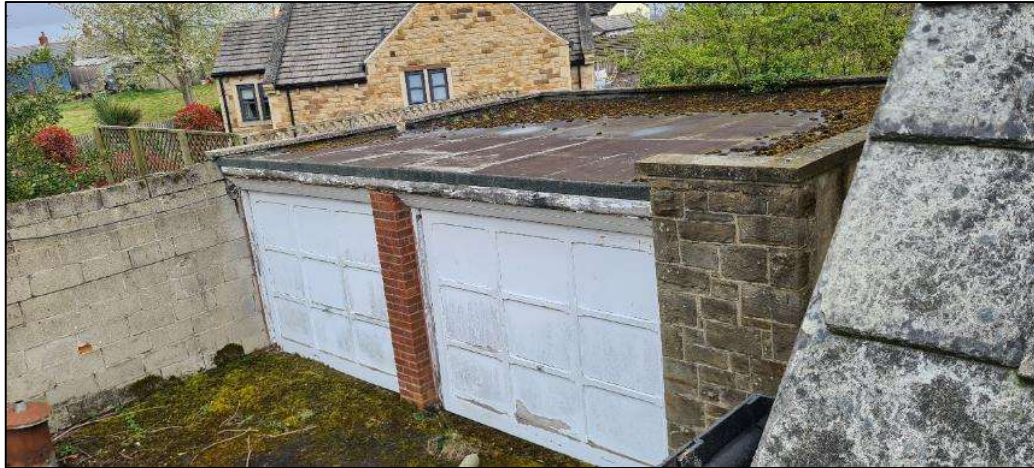
**Plate 5. The garage viewed from the steps of the adjacent dwelling**

- 5.3.11 The building was a stone, concrete block, and brick-built single-storey, double garage (Plate 1, 2, and 5). The garage doors were located at the rear (west) and were separated by a brick pillar. The flat roof was covered with bitumastic roofing felt. A single-glazed window was present on the front (east), the window had a wooden frame.

- 5.3.12 The masonry was well maintained, and no potential bat roost features were identified on the exterior of the building.

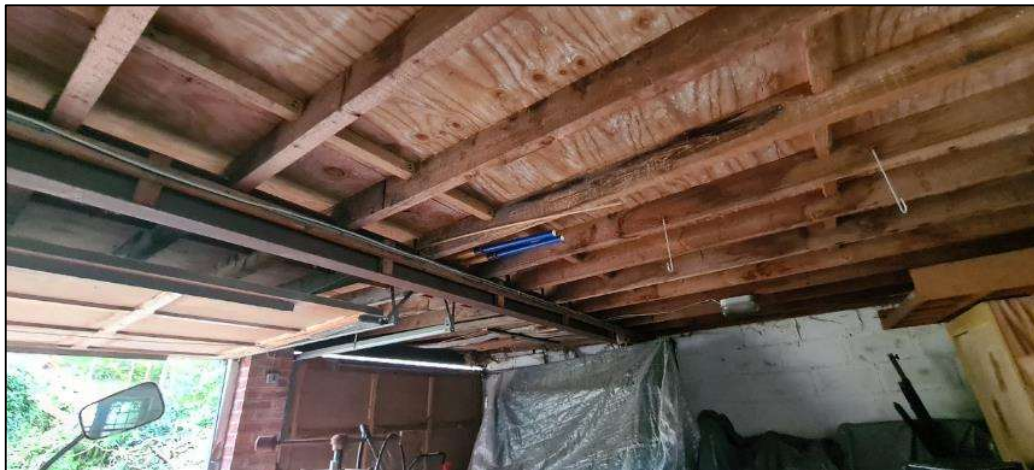
**Plate 6. The interior of the garage roof**

- 5.3.13 The flat roof of the garage was supported by wooden joists (Plate 6). No bats or evidence of bats was recorded within the garage.

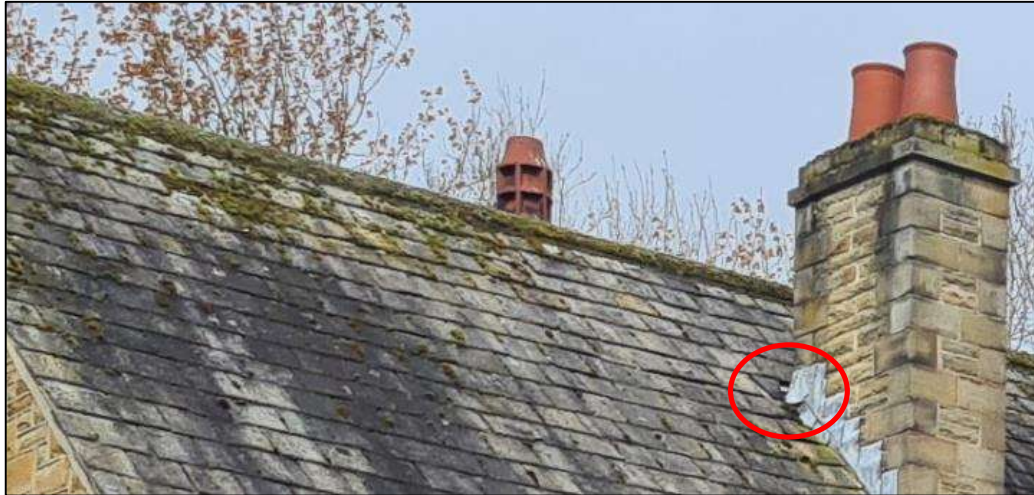
**Plate 7. Roost location**

- 5.3.16 One common pipistrelle *Pipistrellus pipistrellus* was recorded emerging from next to the chimney on the eastern roof pitch at 22:21 (64 minutes after sunset). The roost location is shown in Plate 7 below and a video of the emergence is available at: <https://youtu.be/SRqK0PGqRHg>.

- The demolition should take place outside of the core hibernation season (taken to be December, January, and February).
  - The loss of the pipistrelle roost should be mitigated by the inclusion of an integrated bat box into each of the new dwellings.

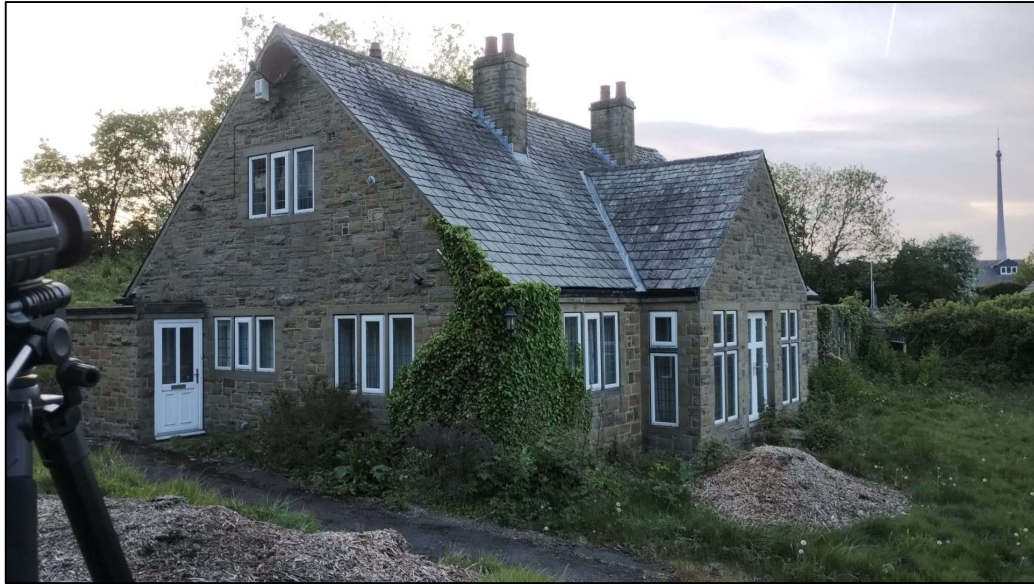
**Plate 8. Bungalow viewed from surveyor Position 2 on 6<sup>th</sup> May 2025**

- 5.3.20 The condition and suitability of the building was considered similar to that recorded in 2024 (Plate 8). The temperature at the beginning of monitoring was 11°C, with two oktas cloud cover and calm conditions (Beaufort Scale 0). The temperature dropped to 9°C by the end of the survey with no change in wind or cloud cover. No rain was recorded throughout. Sunset was at 20:46.

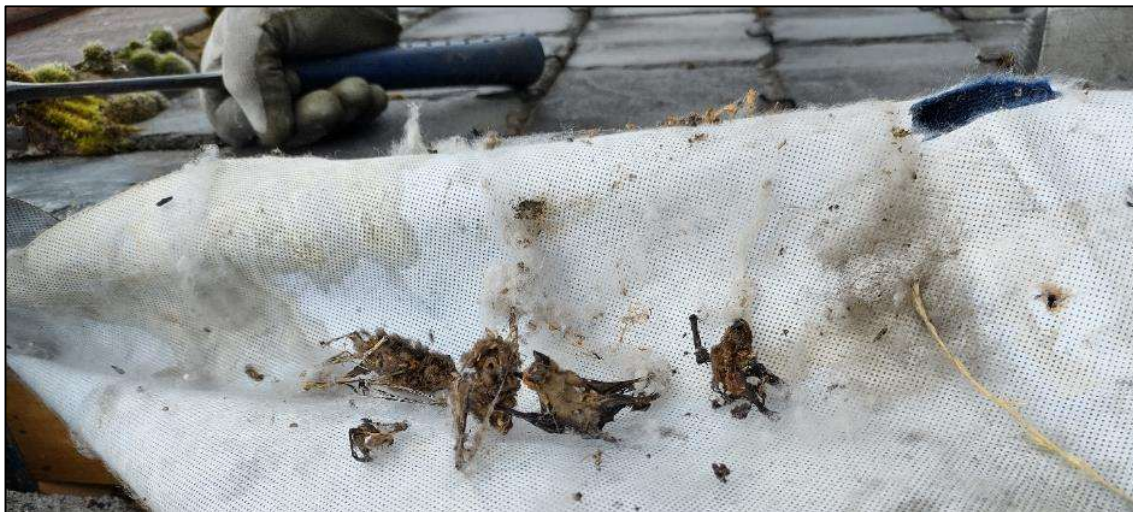
### Plate 1. Four dead pipistrelles tangled in breathable roofing membrane

Standard non-bitumen coated membranes (including almost all breathable membranes) used below roof slates and tiles present a significant problem for bats. Over time, strands are pulled away from the surface of these materials as bats crawl over them. These fuzzy strands are very strong and can tangle and trap bats, sometimes causing the death of bats over multiple years<sup>3</sup>.

One example we have encountered comprised a pipistrelle roost which formed in a building extension constructed in 2009. Over the course of just 13 years the roofing felt degraded to the extent that it trapped and killed more than 10 bats. Fortunately, the problem in this roost was identified and remedial work was undertaken to replace the roofing membrane in 2022.

From a bat perspective, the best membrane option for areas where roosts are expected comprises traditional hessian-backed Type 1F bituminous felt. This product has been widely and safely used as a secondary weather barrier since approximately the 1950s/1960s. Wooden sarking has also been used for many decades and if appropriately treated, is safe for
