# Land at Penistone Road, Fenay Bridge For Newett Homes

Report no: 4526/1

Date: December 2024

## SUMMARY OF GEOENVIRONMENTAL ISSUES

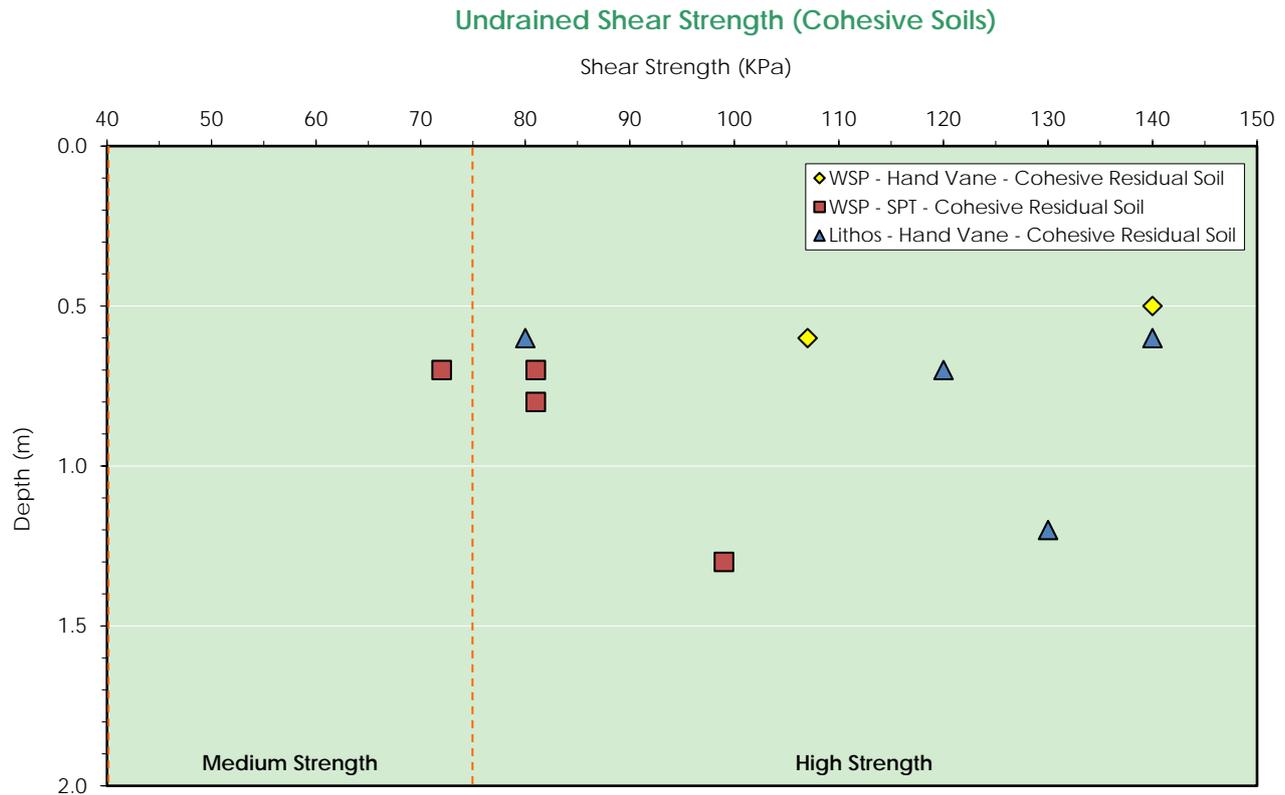
13.4.4 The plot below provides a summary of undrained shear strengths.

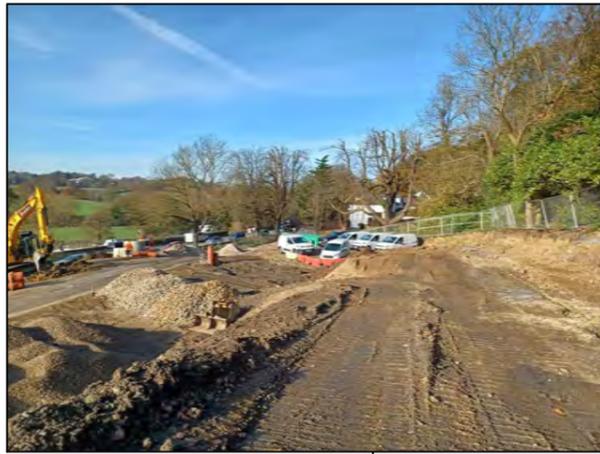
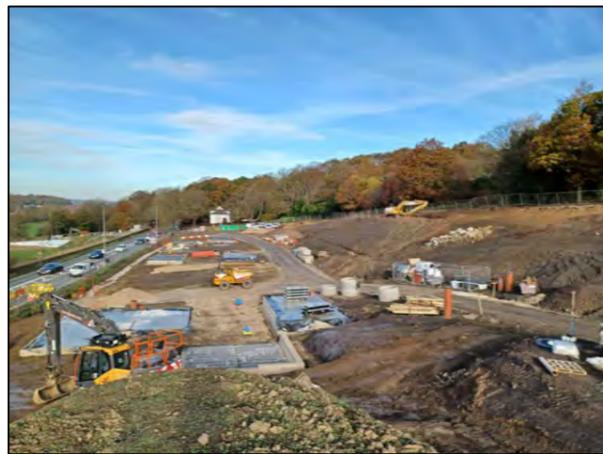
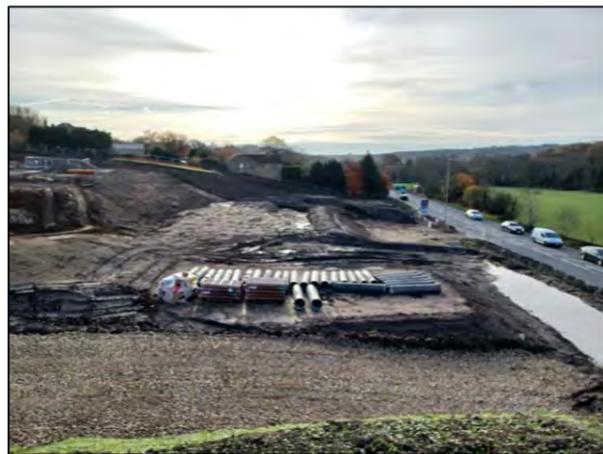
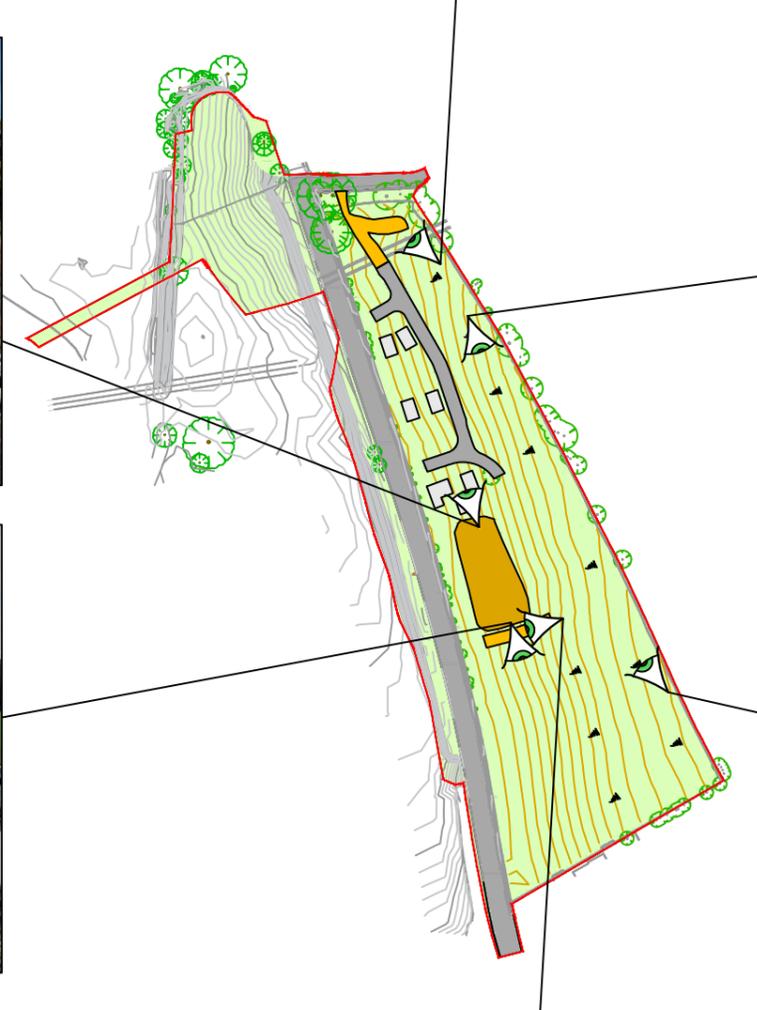
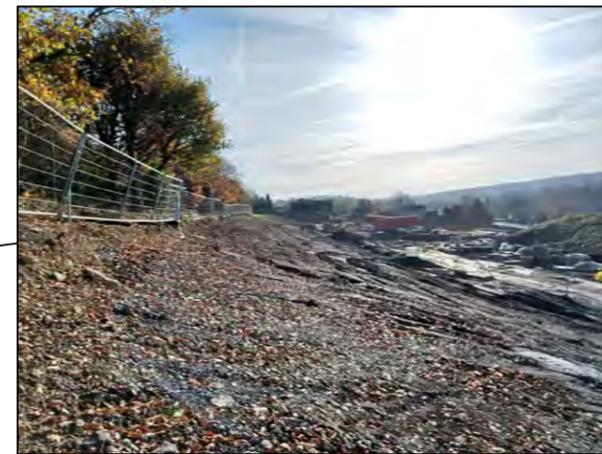
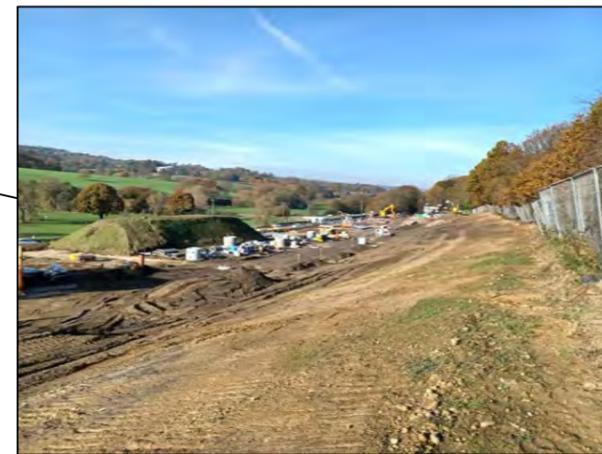
SCALE	SHEET	DRAWING NO.	REVISION
NOT TO SCALE	A3	4526/4

- NOTES
- GRASS / SUBSOIL (TOPSOIL STRIP)
  - TOPSOIL STOCKPILE
  - GRAVEL OR HARDCORE SURFACING
  - TARMAC HARDSTAND
  - PLOT FOOTPRINTS
  - SLOPE
  - APPROXIMATE SITE BOUNDARY
  - LOCATION & ORIENTATION OF PHOTOGRAPH

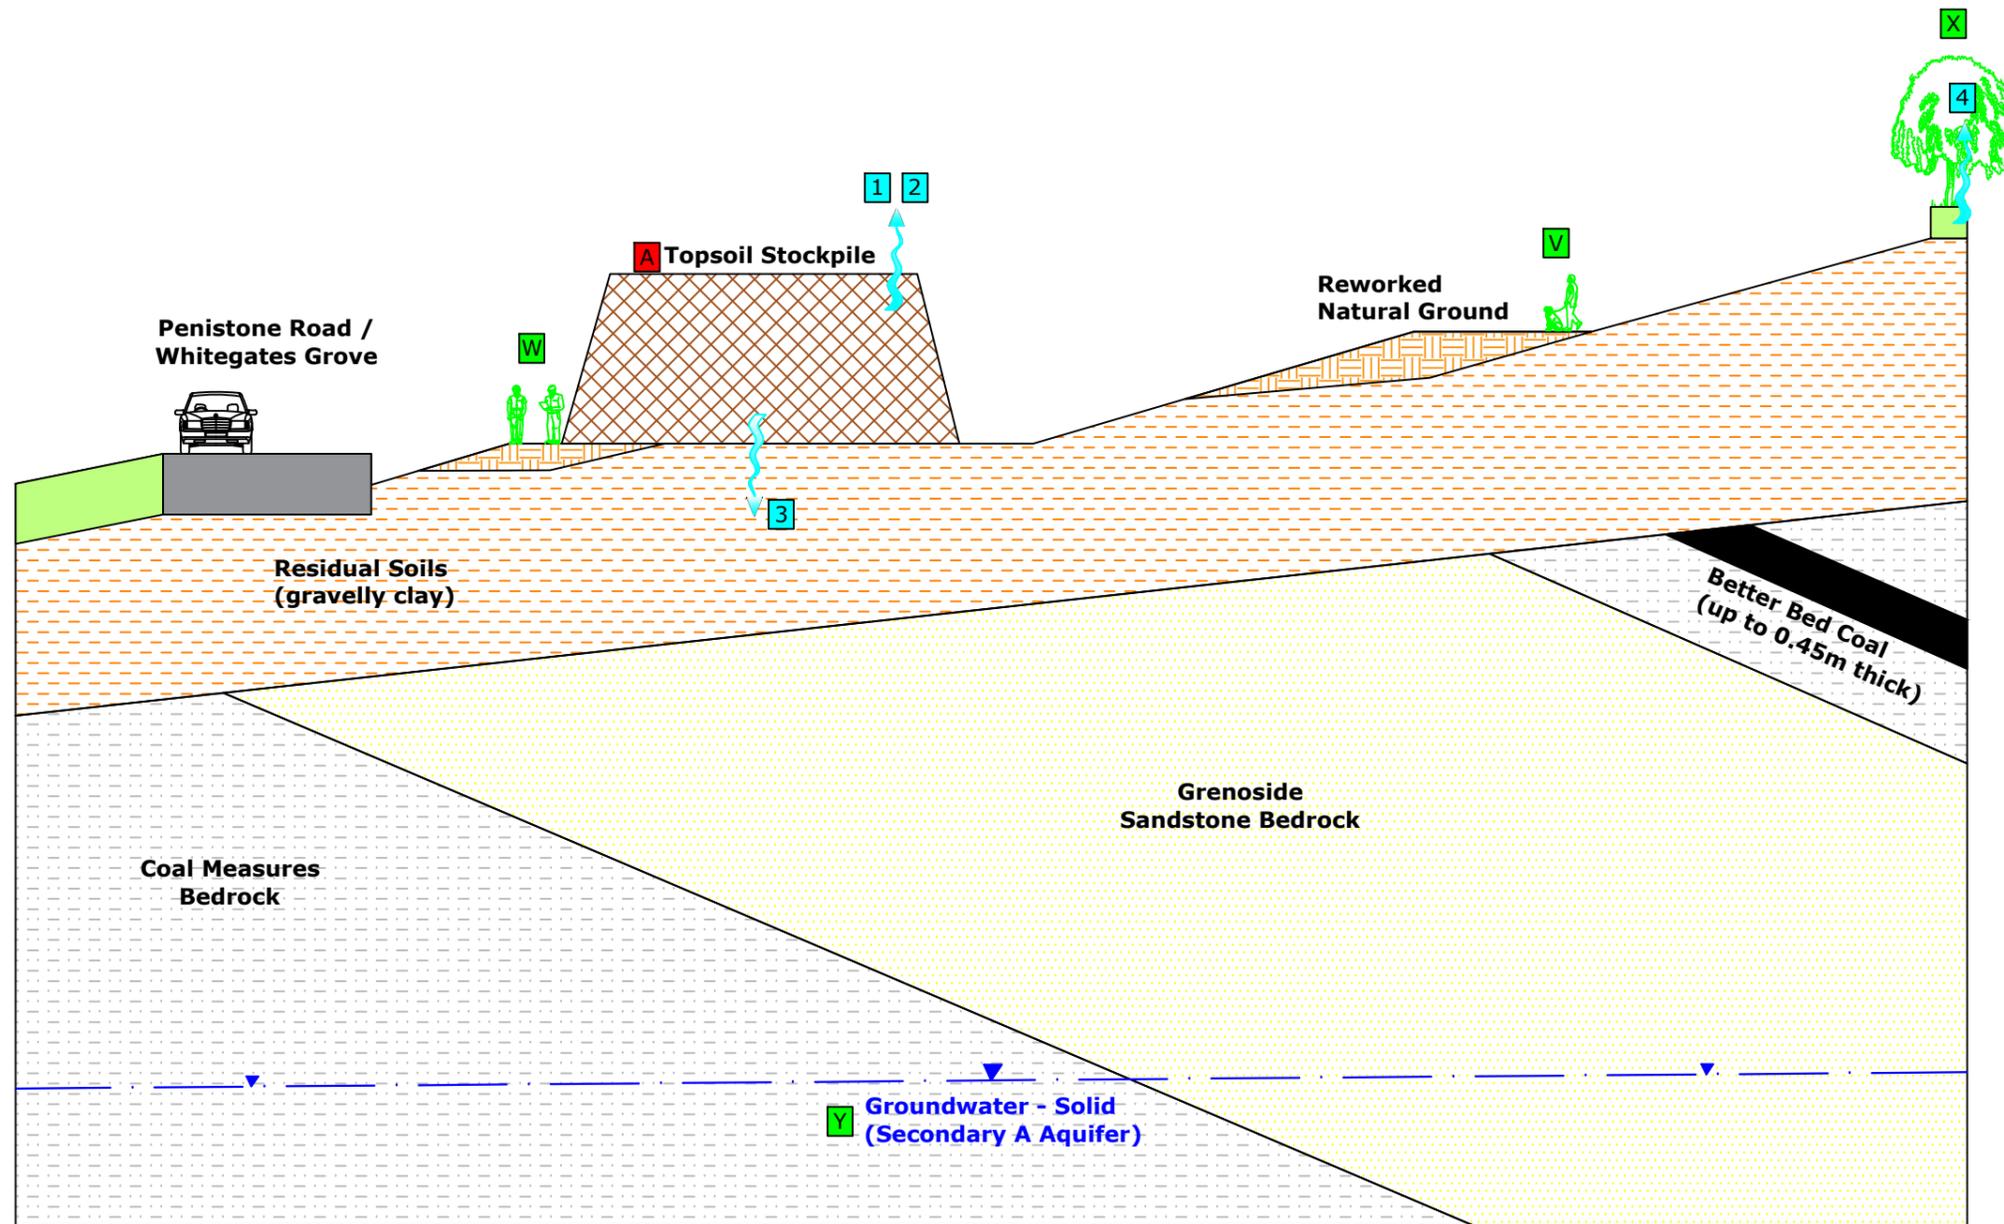
SCALE	Not to scale	SHEET	A3	DRAWING NO.	4526/5	REVISION	
-------	--------------	-------	----	-------------	--------	----------	--

SOURCES	
<b>A</b>	<b>FARMING ACTIVITIES (INORGANICS &amp; ORGANICS)</b>

PATHWAYS	
<b>1</b>	<b>DERMAL CONTACT</b>
<b>2</b>	<b>INGESTION/INHALATION</b>
<b>3</b>	<b>LEACHING OF CONTAMINANTS</b>
<b>4</b>	<b>UPTAKE BY PLANTS</b>

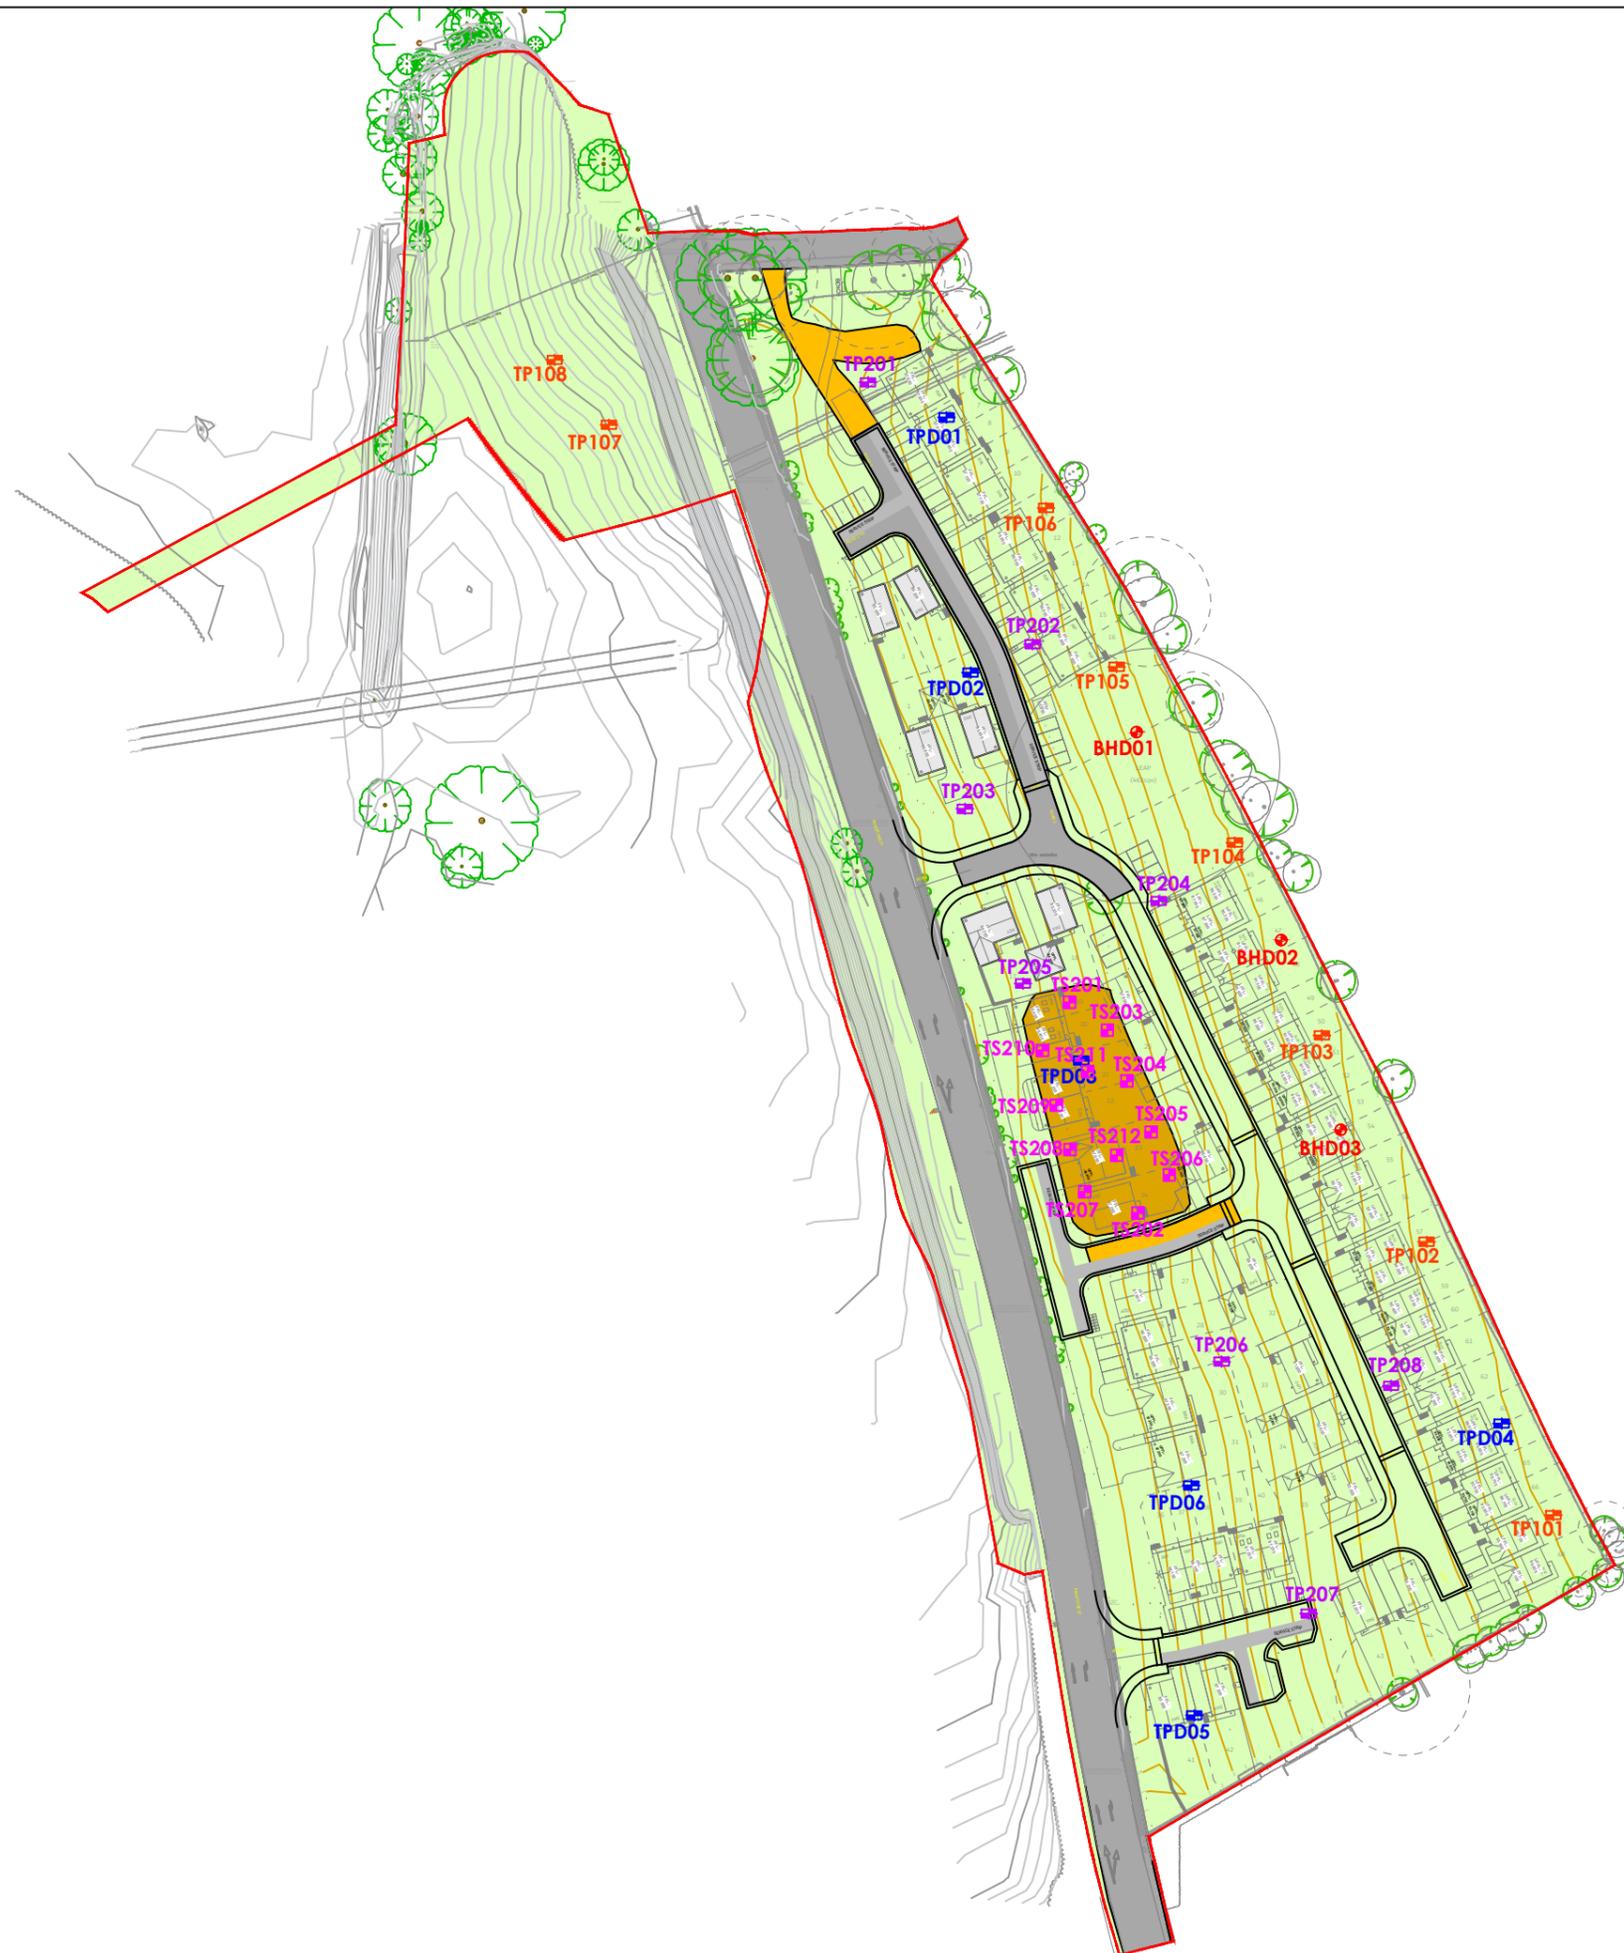
**PREVIOUS SI HOLE LOCATIONS**

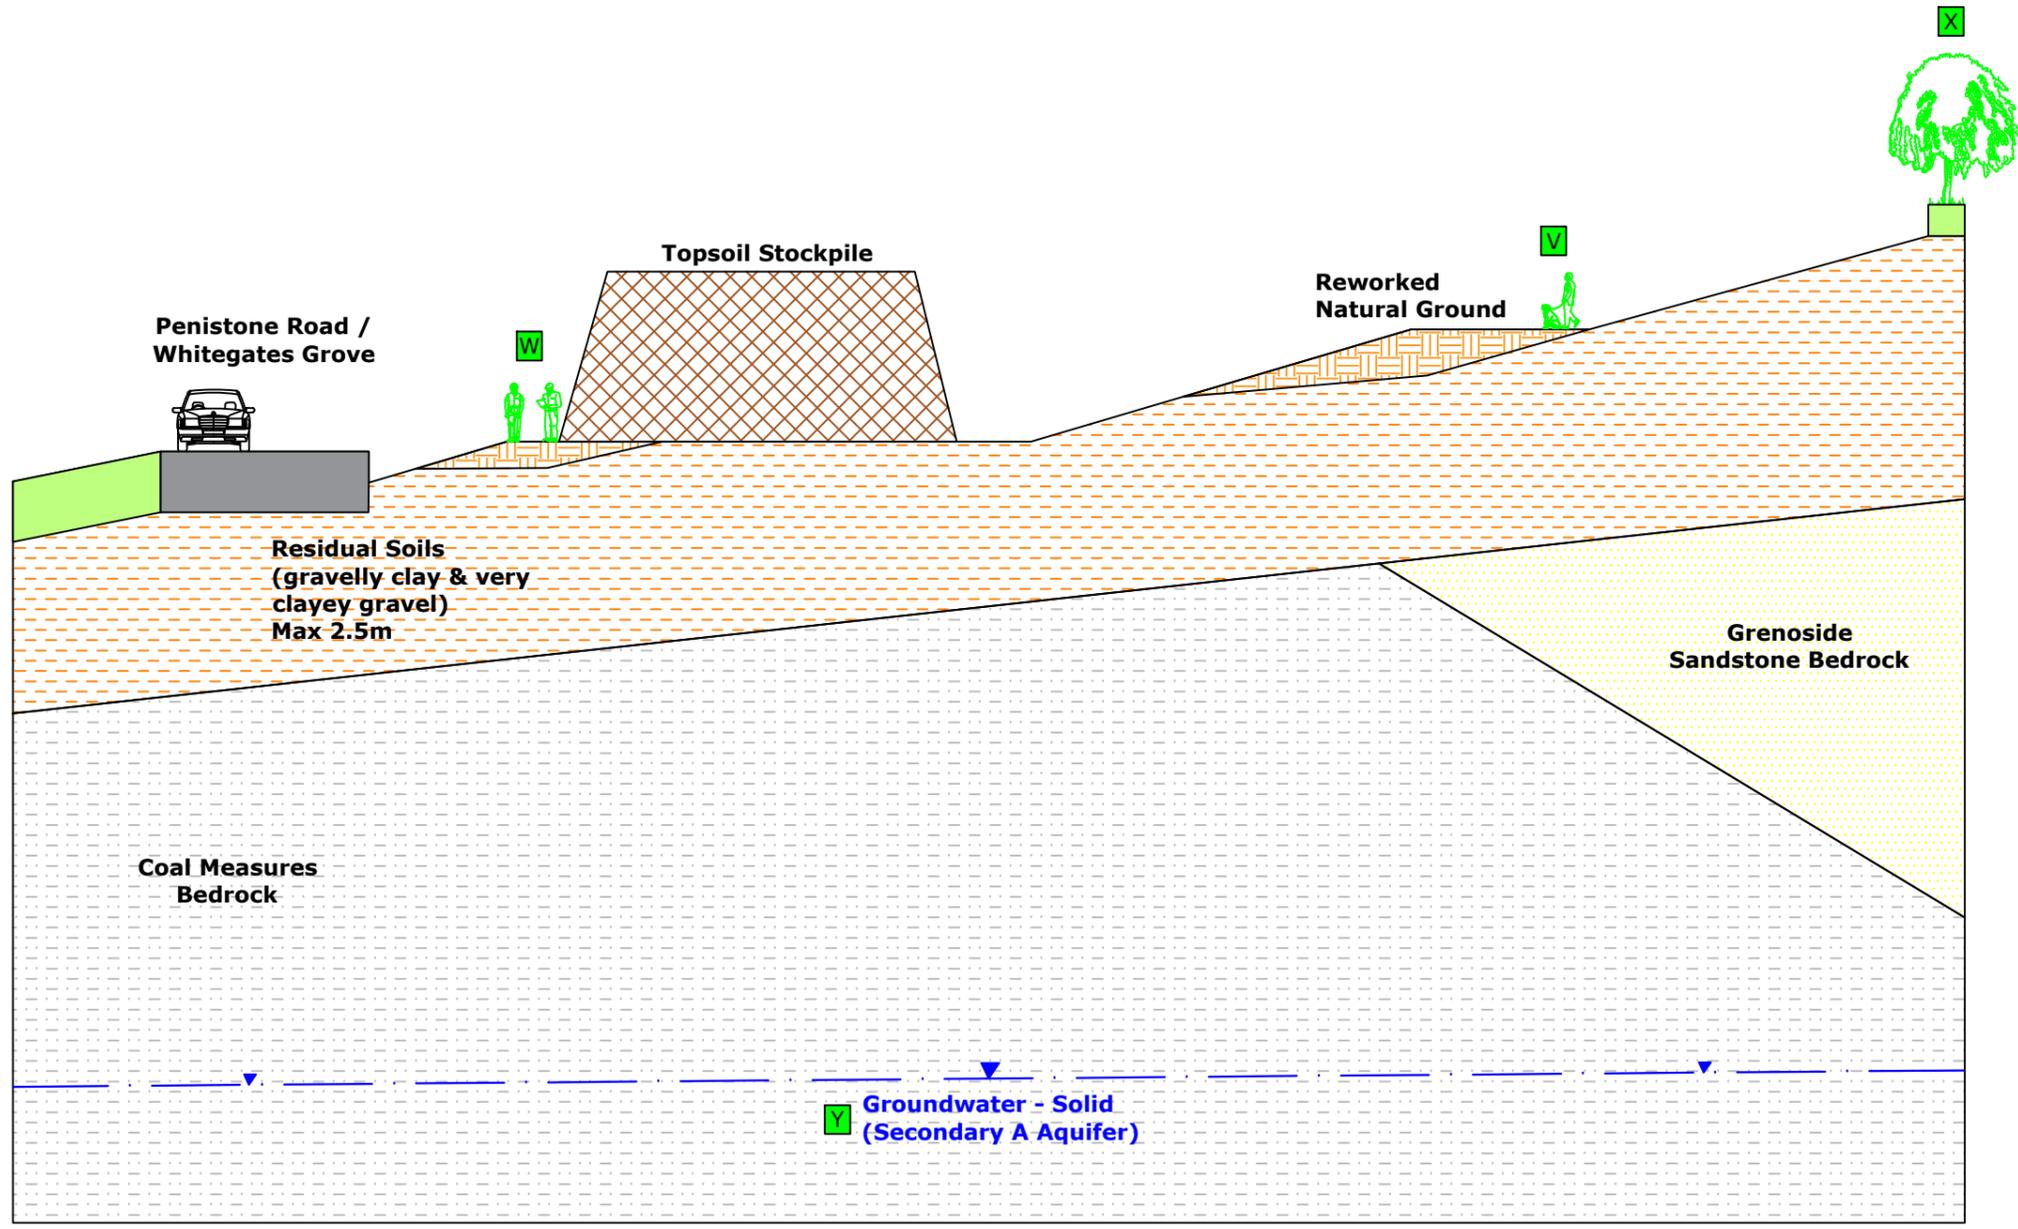
**SOURCES**  
NO SOURCES

**PATHWAYS**  
NO PATHWAYS

- RECEPTORS**
- V** END USERS (RESIDENTS)
  - W** SITE WORKERS
  - X** VEGETATION
  - Y** GROUNDWATER

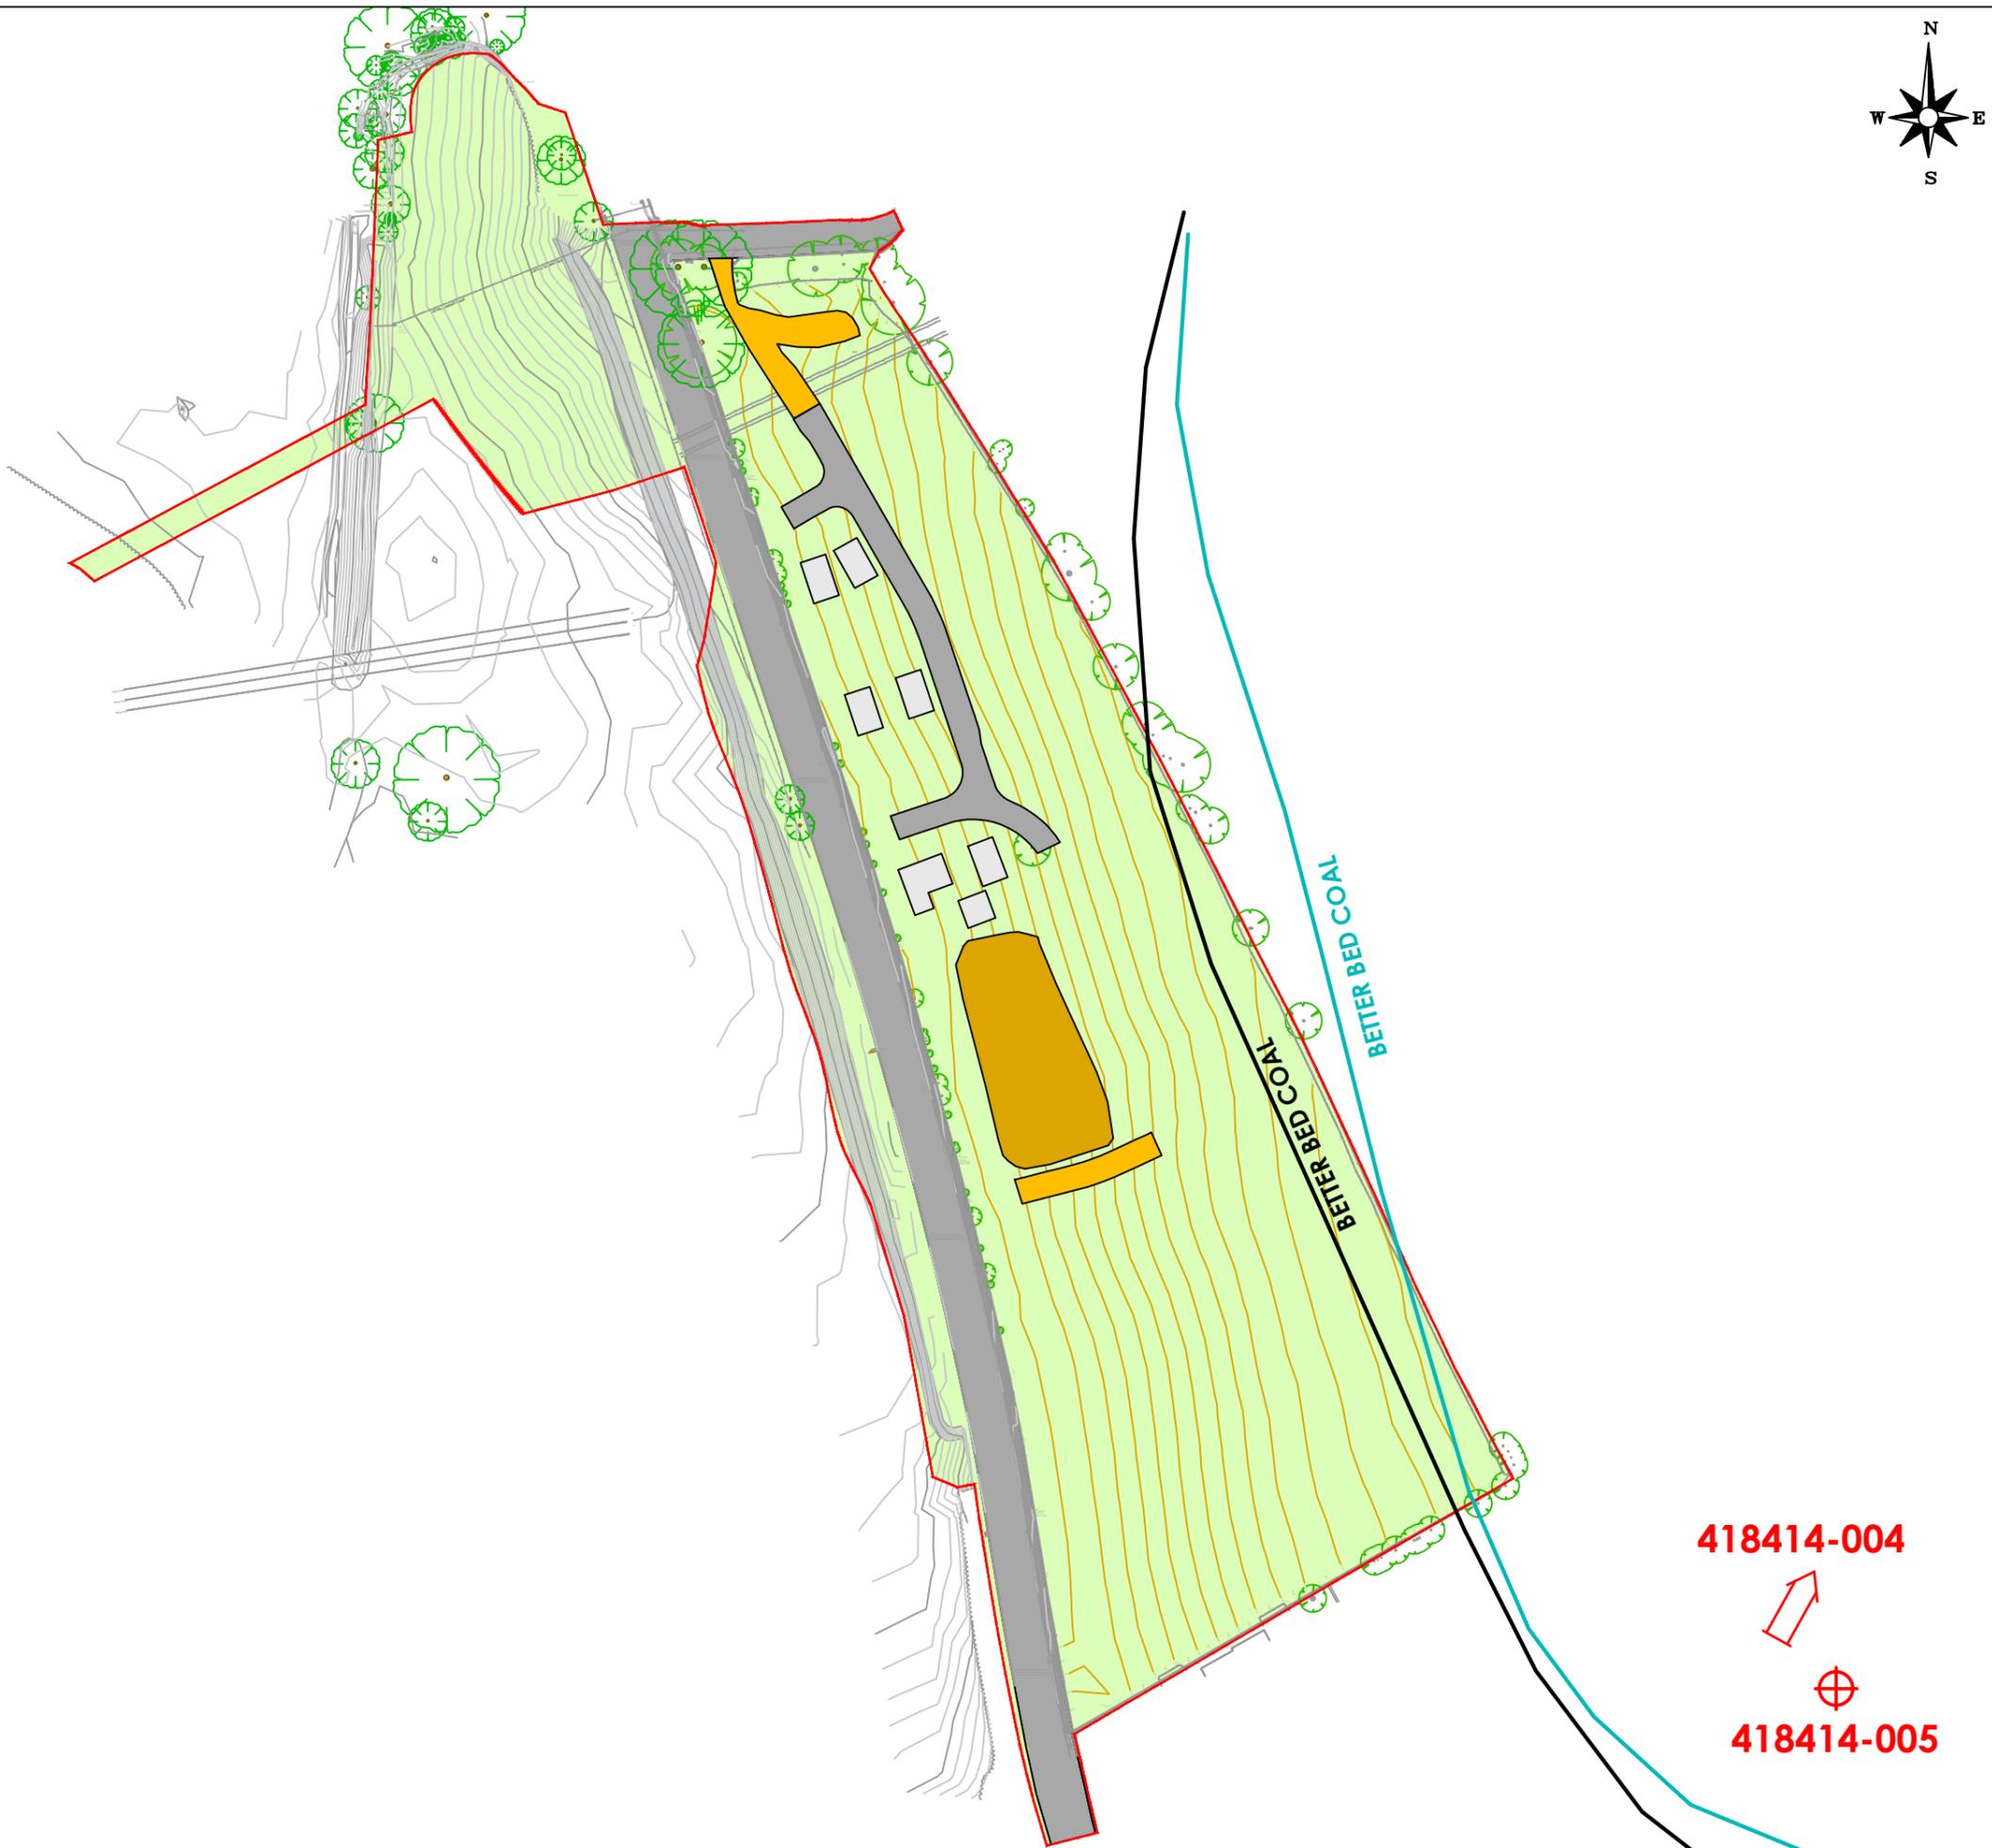
- NOTES
- BETTER BED COAL OUTCROP (BGS - SE11SE)
  - BETTER BED COAL OUTCROP (CA REPORT)
  - ◆ MINE SHAFT (CA REPORT)
  - ↗ ADIT (CA REPORT)
  - APPROXIMATE SITE BOUNDARY

- 4.2.5 Approximate outcrops are shown on Drawing 4526/8.
- 4.2.6 Given dip and topography, this seam is expected to underlie less than 1% of the site.
- 4.2.7 It should be noted that seam outcrops plotted on geological maps have been known to be inaccurate by distances in excess of 100m.

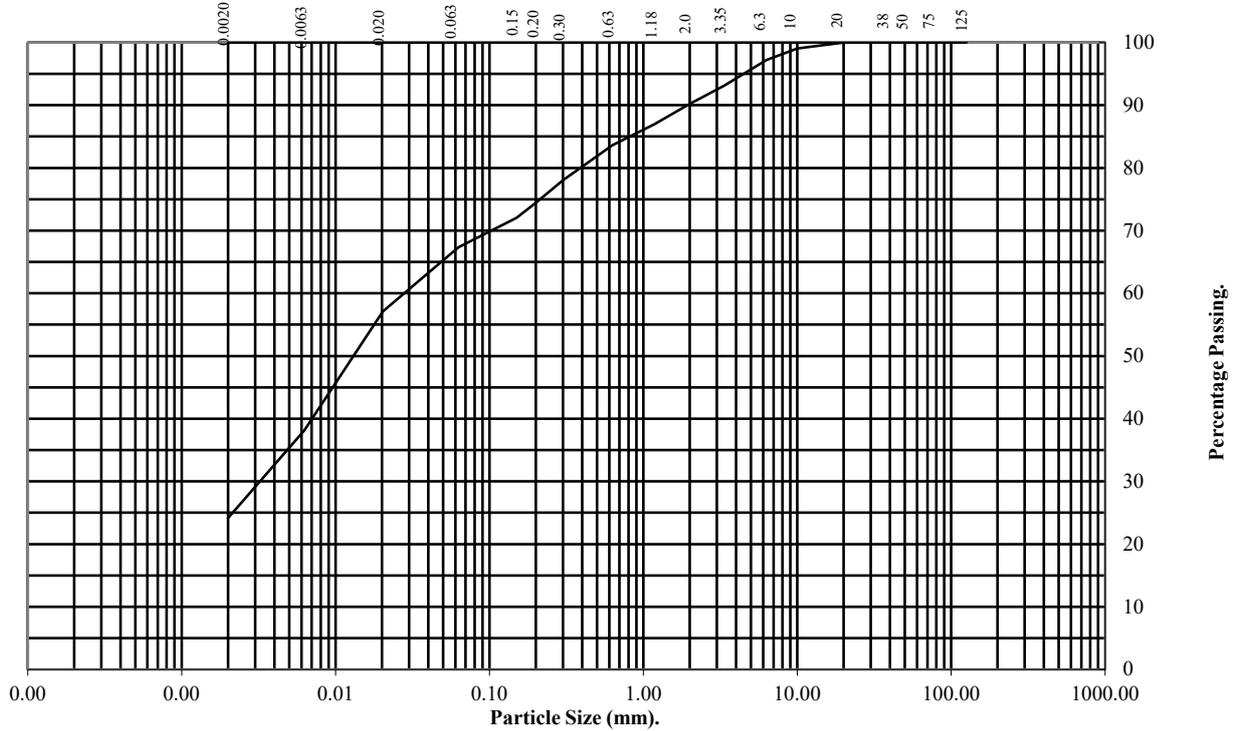
BS Test Sieve (mm)	Percentage Passing
125	100
75	100
50	100
37.5	100
20	100
10	99
6.3	97
3.35	93
2	90
1.18	87
0.63	84
0.3	78
0.2	74
0.15	72
0.063	67

Particle Diameter	Percentage Passing
0.020	57
0.0063	38
0.0020	24
<i>Particle Density - 2.65 Mg/m3 assumed</i>

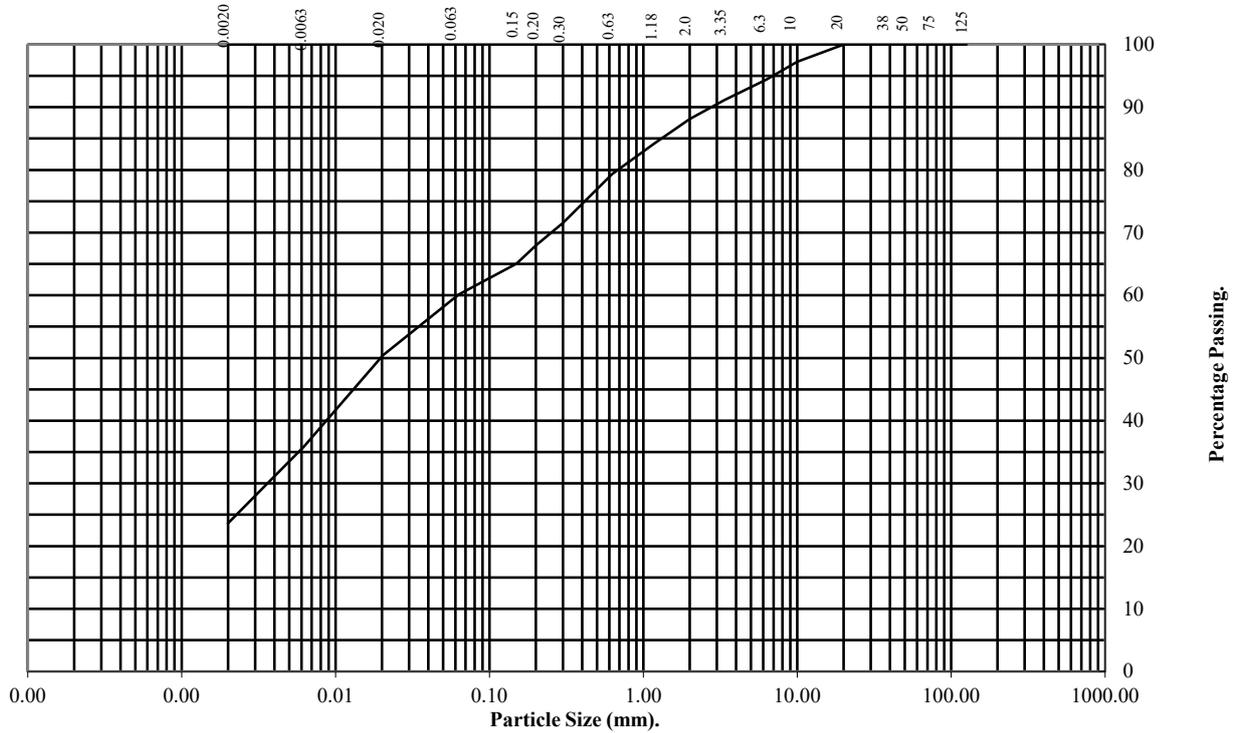
BS Test Sieve (mm)	Percentage Passing
125	100
75	100
50	100
37.5	100
20	100
10	97
6.3	94
3.35	91
2	88
1.18	84
0.63	79
0.3	72
0.2	68
0.15	65
0.063	60

Particle Diameter	Percentage Passing
0.020	50
0.0063	36
0.0020	24
<i>Particle Density - 2.65 Mg/m<sup>3</sup> assumed</i>

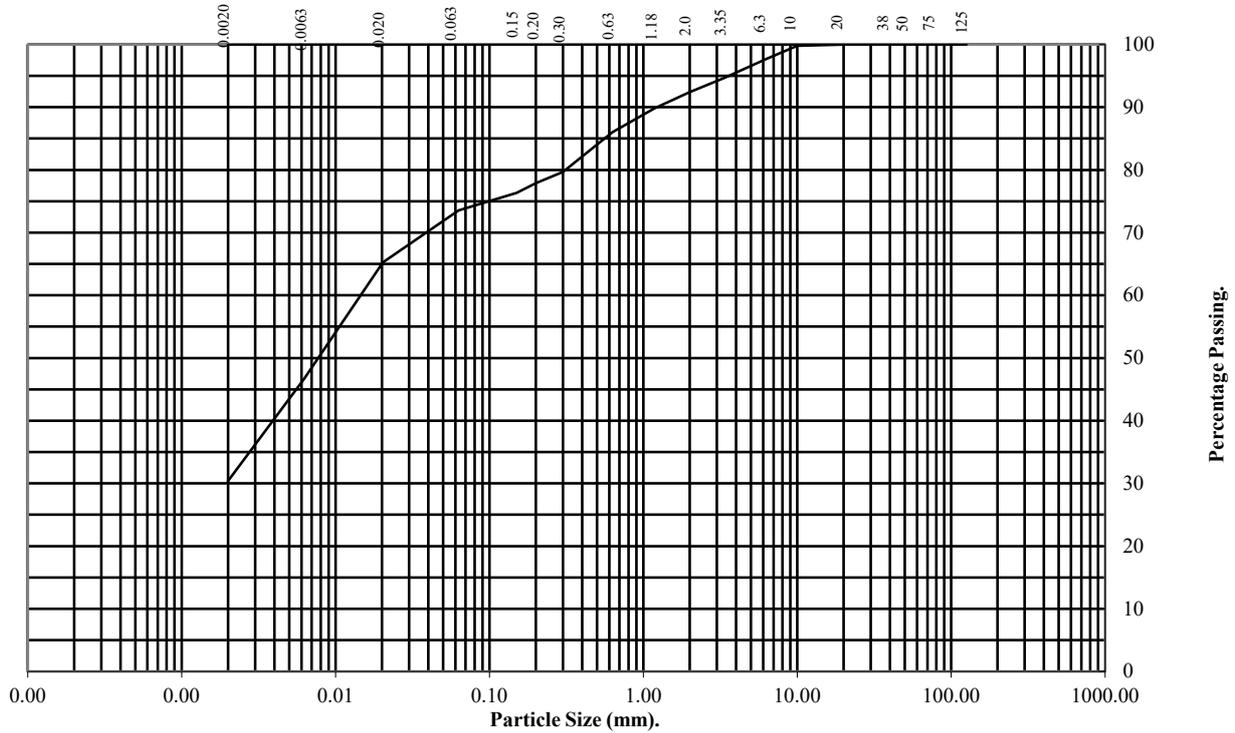
BS Test Sieve (mm)	Percentage Passing
125	100
75	100
50	100
37.5	100
20	100
10	100
6.3	98
3.35	95
2	92
1.18	90
0.63	86
0.3	80
0.2	78
0.15	76
0.063	74

Particle Diameter	Percentage Passing
0.020	65
0.0063	47
0.0020	30
<i>Particle Density - 2.65 Mg/m3 assumed</i>

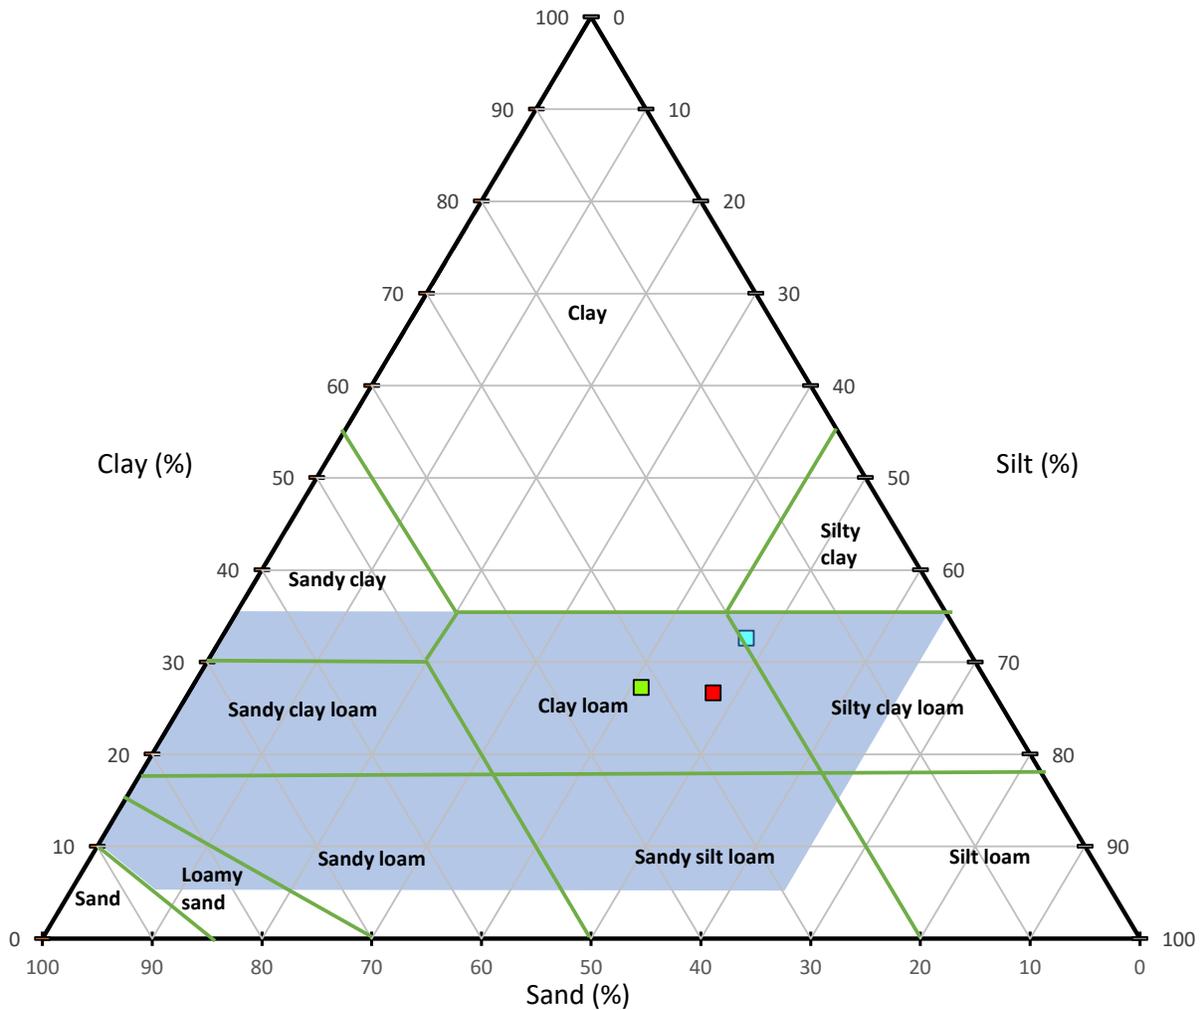
### Topsoil Classification

(Testing undertaken in accordance with BS3882:2015)
