HEADLANDS ROAD, LIVERSEEDGE.

BAT AND BADGER SURVEY.

Ref No: 240840.

Date: 19th September 2024.

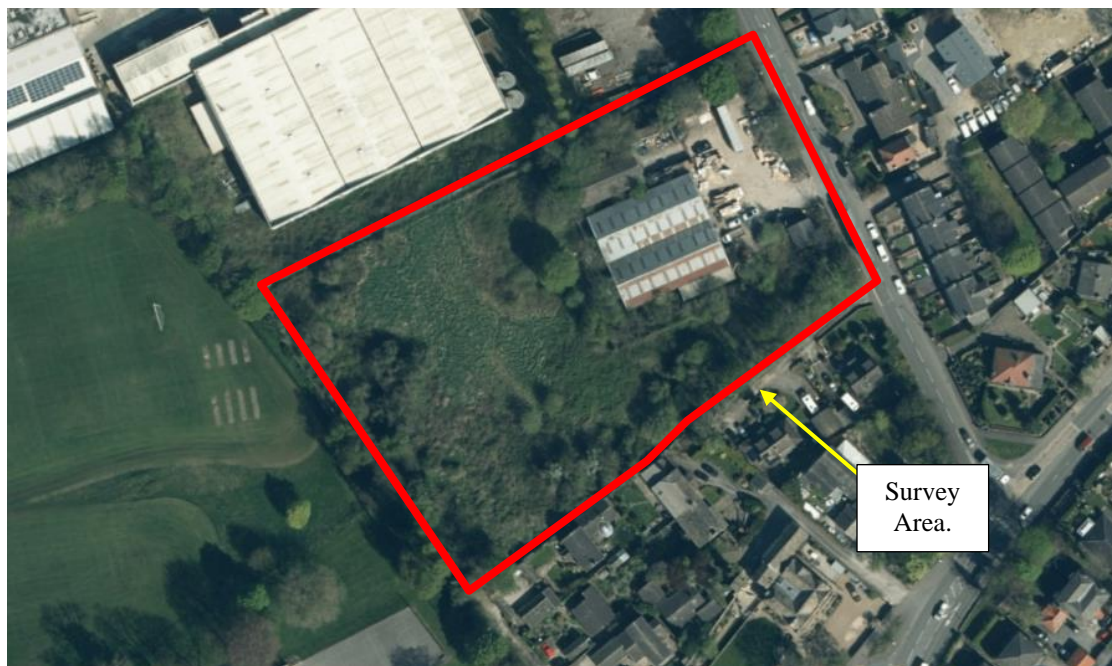
3.2.1. The survey area was heavily overgrown with trees and scrub, with buildings and hardstanding to the eastern end of the site. The area to the west comprised trees and scrub with an area of tussocky grassland in the centre. The aerial photograph below shows the survey area.

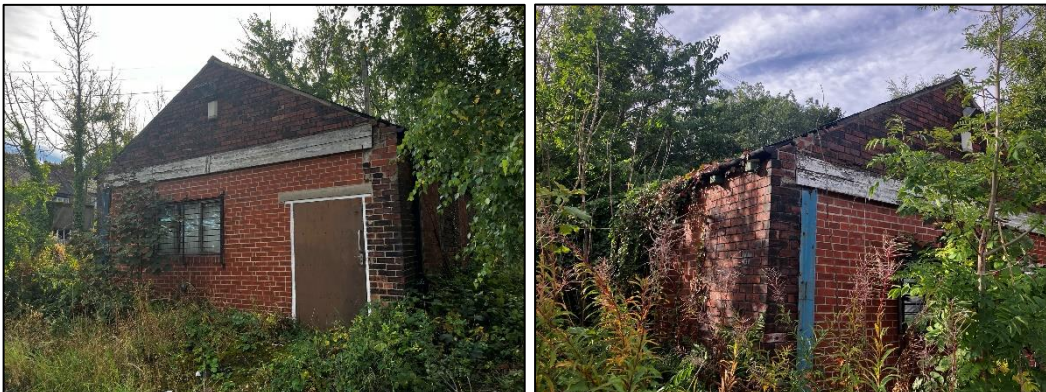
3.2.3.1. Building 1.

3.2.3.1.1. Building 1 was a single storey brick building, which was generally in a good condition with no cracks or gaps in the brickwork. There was a wooden fascia on the northern elevation of the building with a large gap behind. There was also dense ivy on the southern and eastern elevation of the building leading onto a small section of the roof.

3.2.3.1.2. The building had a pitched roof covered with blue slate with two gable ends with missing pointing between the brick and the slate and along the ridge tiles. There was a plastic gutter on both eaves resting on brick corbels.

3.2.3.1.3. The windows and doors were securely fitted, and no access could be gained internally during this survey.

3.3.1.1. The brick walls were generally in a good condition. However, there was a wooden fascia on the northern elevation and an area of dense ivy on the southern elevation of the building that could provide potential for roosting bats.

3.3.1.2. The roof of the building was generally in a good condition, although there was missing mortar at the gable ends and on the ridge tiles, which could provide a potential location for roosting bats.

3.3.1.5. As the building displays some potential roosting features externally, but could not be accessed internally to undertake a full assessment the building was assessed as providing a **moderate** potential for roosting bats. This potential is assessed to be limited

5.1. Based on the current assessment of the buildings, in line with current guidance it is recommended that two bat dusk emergence surveys are carried out of Buildings 1, 3 and 4 between May and August inclusive to establish presence/likely absence of roosting bats. It is strongly recommended that access into the internals of the buildings is also provided for these surveys for a full PRA to be carried out to confirm the current assessment. There is scope of the number of dusk emergence surveys required to change following the findings of that assessment.

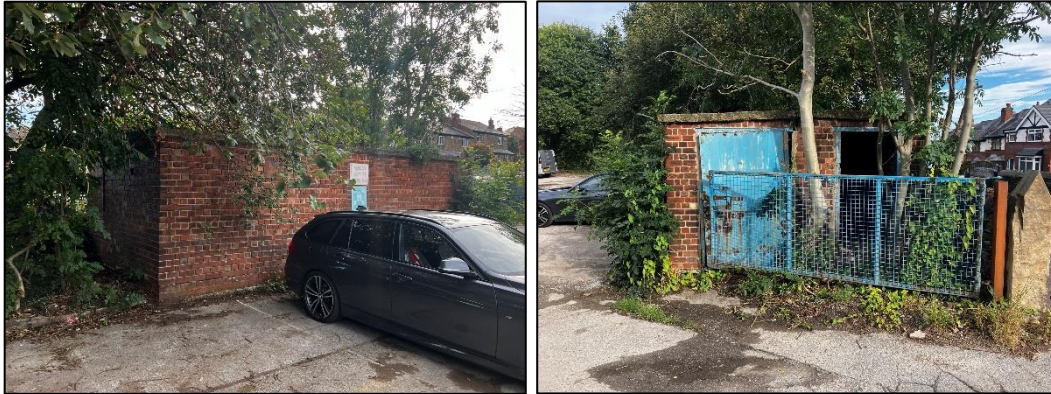
3.2.3.2. Building 2.

3.2.3.2.1. Building 2 was a single storey brick building, which was generally in a good condition with no cracks or gaps in the brickwork.

3.2.3.2.2. The building had a flat concrete roof, which had a large crack running through the entire building as shown in the photograph below.

3.3.2.2. The roof of the building was generally in a good condition. However, there was a large crack extending through the entire roof of the building which could provide a potential location and access for individual opportunistic roosting bats. Although this was limited due to the feature being exposed and allowing the ingress of water.

3.3.2.5. The building was assessed as providing a **low** potential for roosting bats in accordance with the Bat Conservation Trust Good Practice Guidelines 4th Edition. This potential is assessed to be limited to individual opportunistic common bat species but does not provide conditions that would contain a roost of more significant conservation status.

5.2. In line with current guidance, it is recommended that one bat dusk emergence survey is carried out of Building 2 to establish presence/likely absence of roosting bats. Again, this survey should be carried out between May and August.

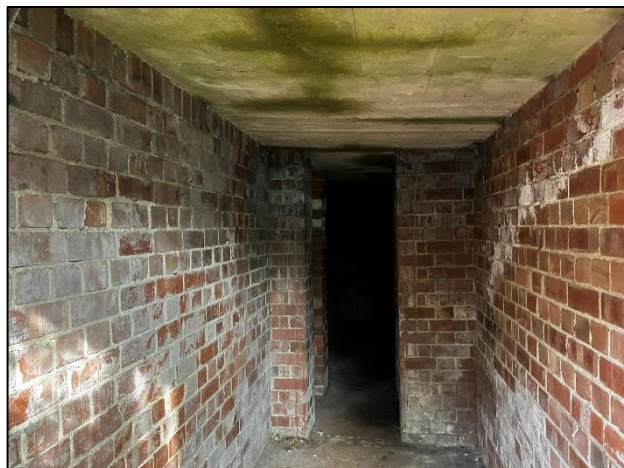
3.2.3.2.3. Internally the building was clean but full of large spider webs as shown in the photograph below.

3.2.3.2.4. Due to the missing windows and doors the building was exposed, cold and draughty throughout.

3.3.2.3. As the windows and doors were open, access was gained inside the building, which was covered with cobwebs and open to the elements.

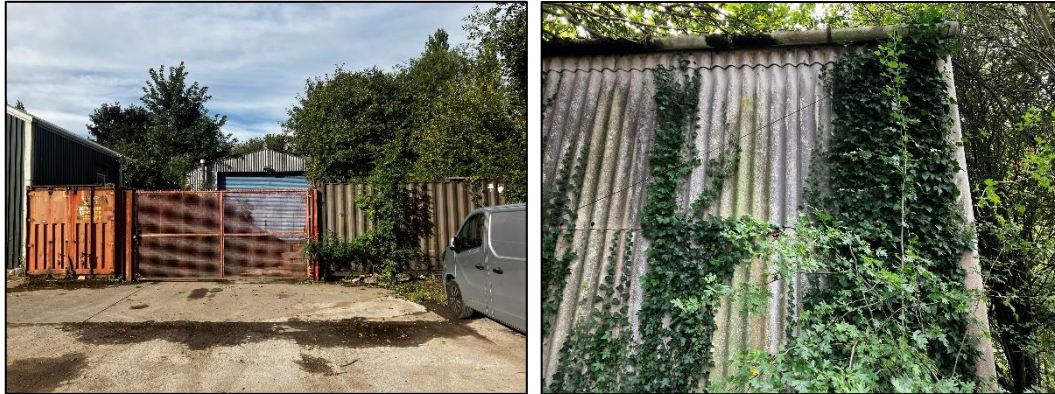
3.2.3.3. Building 3.

3.2.3.3.1. Building 3 was two-storey in height and constructed from corrugated cement sheets, which were generally in a good condition with no cracks or gaps.

3.2.3.3.2. The building had a pitched roof covered with cement sheets. There was guttering secured by metal brackets at both eaves. There was also some thin ivy cover on the walls at the northern elevation of the building.

3.2.3.3.3. There was one large roller shutter door on the eastern elevation. The door was securely fitted, and no access could be gained internally during this survey.

3.3.3.4. Until such time that access can be gained inside this building to undertake a thorough inspection and assessment of the internal areas, this building was assessed as providing a **moderate** potential for roosting bats. This is unlikely to provide conditions that would support a roost of more significant conservation status.

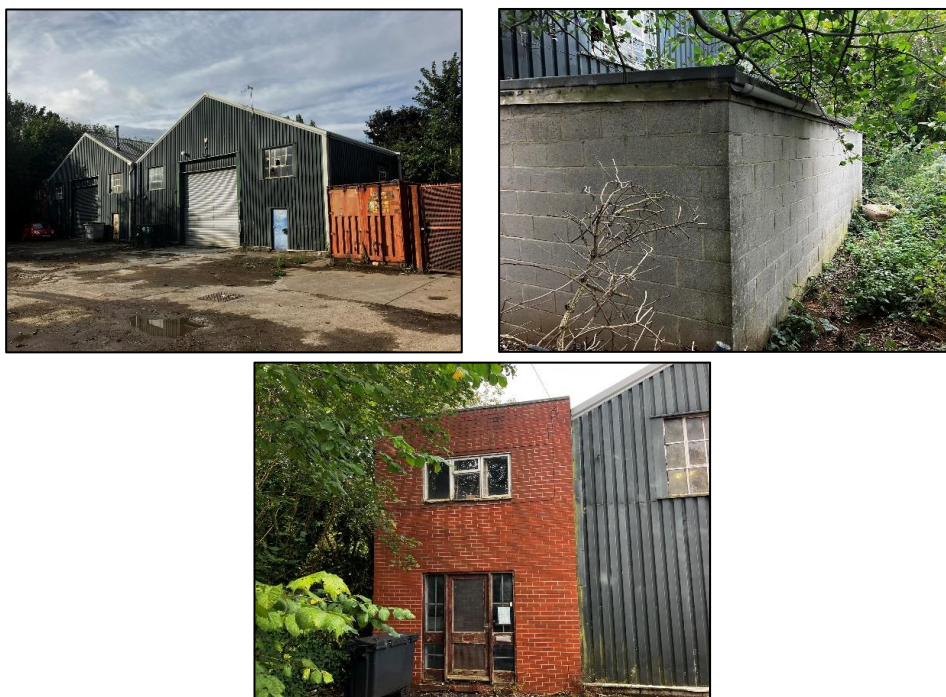
3.2.3.4. Building 4.

3.2.3.4.1. Building 4 was two-storey in height and constructed from corrugated metal sheets, which were generally in a good condition with no cracks or gaps.

3.2.3.4.2. The building had two pitched roofs covered with corrugated metal sheets. There was guttering secured by metal brackets at both eaves with a valley. There was also some thin ivy cover on the walls at the northern elevation of the building.

3.2.3.4.3. There was a brick office block constructed on the southern elevation and a breeze block single storey extension to the western elevation of the building. The brickwork and blockwork were generally in a good condition with no cracks or gaps.

3.2.3.4.4. The roof of the office block and the breeze block extension were flat and covered with felt, which was tight fitting with no gaps or crevices.

3.2.3.4.5. There were two large roller shutter doors, pedestrian doors and windows some of which were open or broken. No access could be gained internally during this survey.

3.3.4.2. The windows and doors were generally sealed, with only a few broken or open potentially providing access for foraging and roosting bats. No access could be gained during this survey to allow for an internal assessment.

3.3.4.6. As the building could not be accessed to undertake a full internal assessment, but there is access for bats inside, the building was assessed as providing a **moderate** potential for roosting bats. This potential is assessed to be limited to the building providing access for bats and potentially supporting one or more roost sites of small numbers of common bat species but does not provide conditions that would support a roost of more significant conservation status.

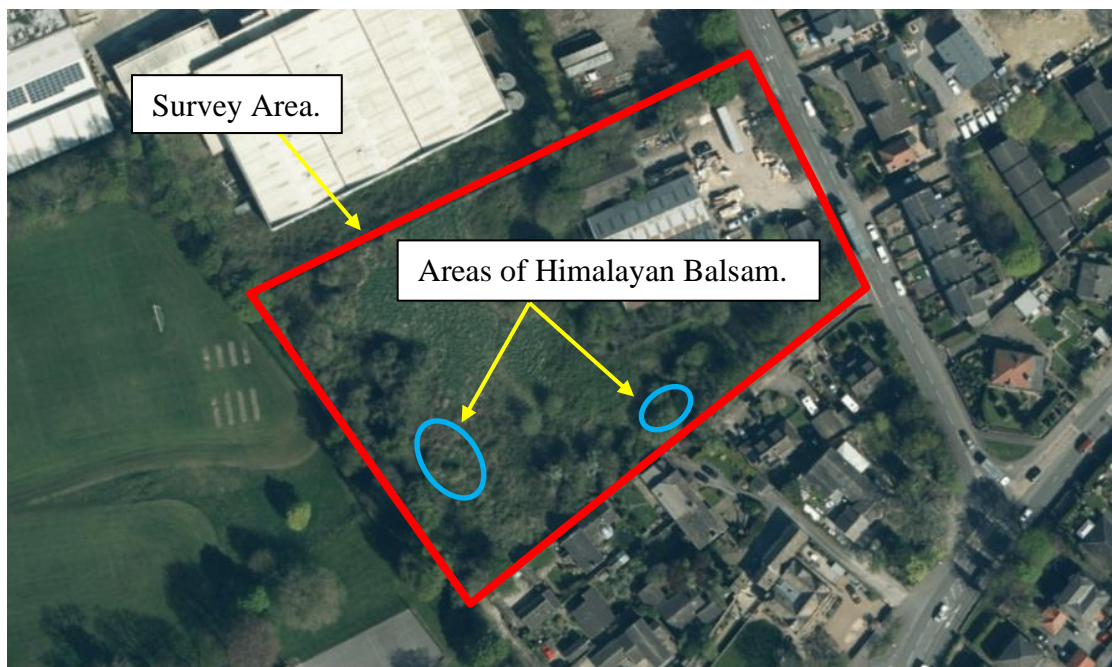
3.6.1. The survey area contained two areas of Himalayan Balsam as shown on the aerial photograph below.

5.6. It is recommended that either a method statement is prepared, or specialist contractors are contacted, in order to prevent the spread of Himalayan balsam. The plants should be pulled before it goes to seed, which is usually between July and September. The soil should be excavated up to 1m deep and 7m around all plants and disposed of as controlled waste.

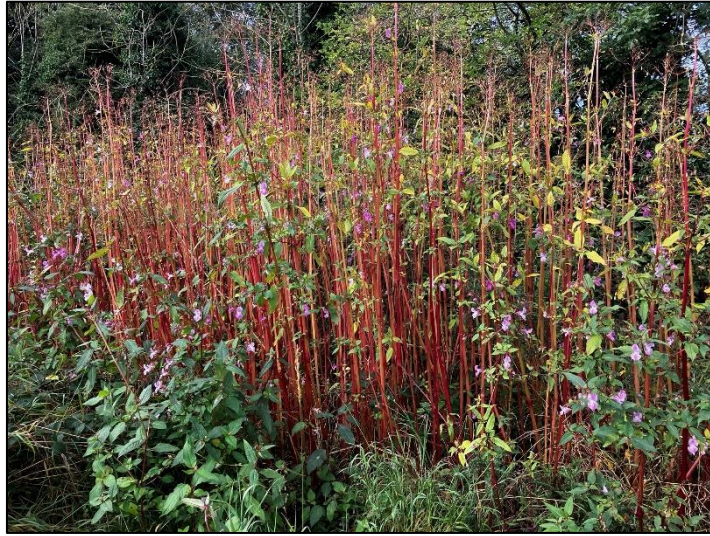
3.6.2. The photograph below shows one of the areas of Himalayan Balsam.
