## Bat Emergence Survey

Rajan Gupta

Wesley House

Reference: Q16225

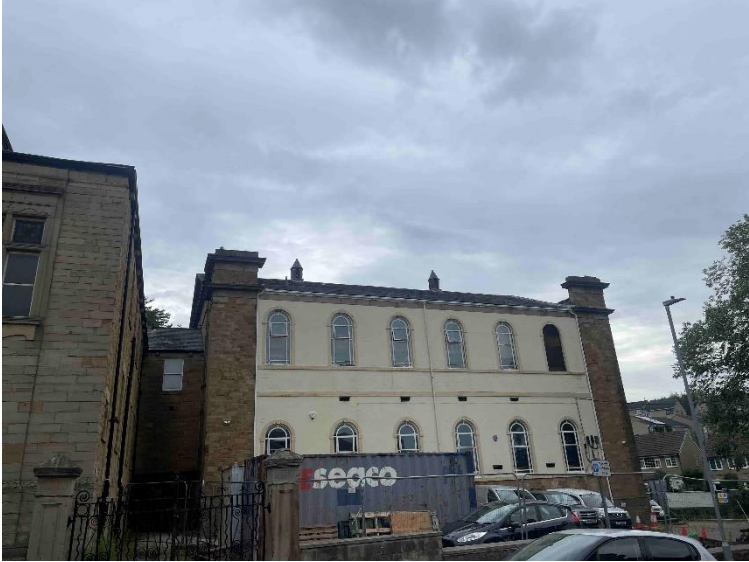
| Building name | Description | Bat roosting potential |
|---|---|---|
| <p data-bbox="383 261 658 293">Wesley House (B1)</p> | <p data-bbox="920 261 1503 293">A two-storey brick disused office building.</p> <p data-bbox="920 341 1823 416">There was an internal loft space. There was ongoing work in the loft space, involving the installation of insulation to the roof.</p> <p data-bbox="920 464 1823 699">The roof is pitched and gable-ended. It is constructed of slate tiles and there was some external damage recorded during the survey. There were multiple areas of damage to the brickwork throughout the building. There were areas where the soffit was raised on the front aspect. There were also several raised and missing tiles, particularly on the rear aspect of the building.</p> <p data-bbox="920 746 1823 895">Internally, the roof void was composed of wooden rafters and beams, which were presented in good condition. Wooden Sarking was secured around these and insulation panels had been partially installed.</p> <p data-bbox="920 943 1823 1257">The loft space was inspected carefully and all potential cavities and spaces that could typically contain voids were checked thoroughly. These areas were well lit with temporary work lights and were clear of cobwebs. There were some potential roosting features present within the space. For example, there was damage to the brickwork on both gable ends. Additionally, there was light ingress on the front aspect, indicating a potential entry point to the loft space.</p> <p data-bbox="920 1305 1823 1374">There were no signs of bats or roosting birds observed internally and externally.</p> | <p data-bbox="1895 261 2029 293">Moderate</p> |

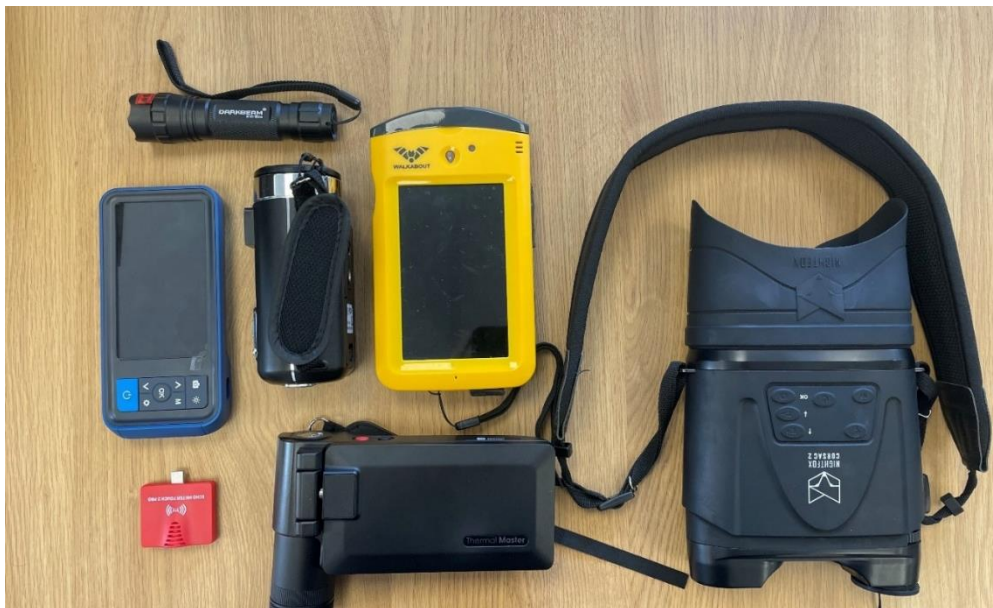
Figure 2 – The equipment used on site.

- Anabat Walkabout and Anabat Express Static Bat detectors.
- Nightfox Corsac 2 Digital Infrared Night Vision goggles
- Darkbeam Infrared torch

- Video camcorder with infrared night vision.
- Echo Meter Touch 2 active Bat detector
- 8mm Dual Lens Cavity Camera and Endoscope with 4.5 inch HD IPS Colour Screen

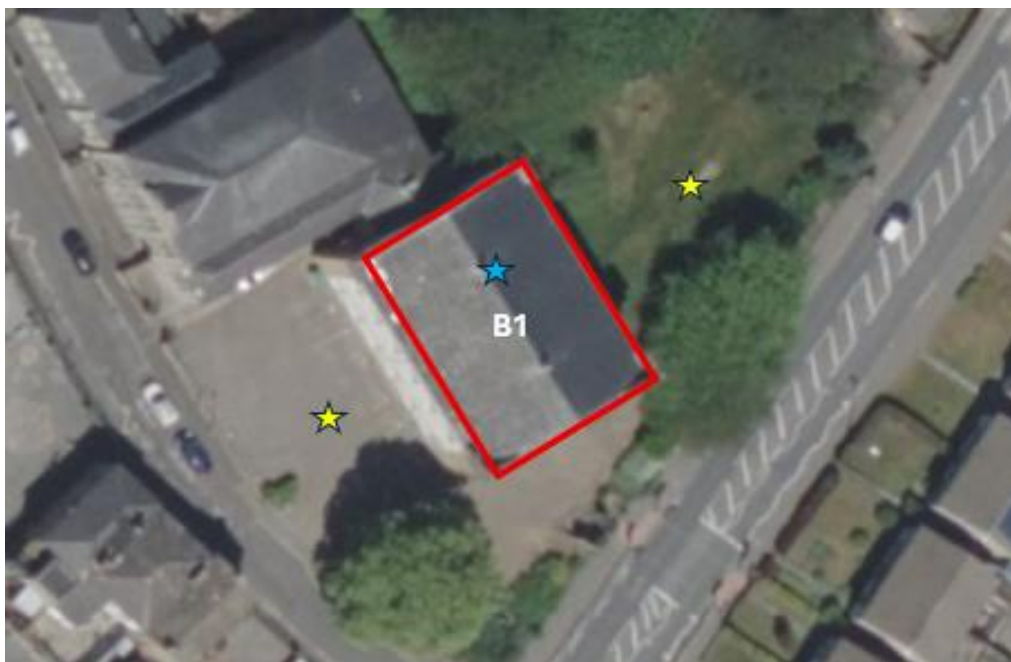
Figure 3 – The site layout and locations of surveyors (yellow star) / location of video camcorder with infrared night vision (blue star)

Two bat emergence surveys were undertaken on the 12<sup>th</sup> of August and the 2<sup>nd</sup> of September 2024, at dusk, on Wesley House. Survey methodology followed the Bat Conservation Trust's *Bat Surveys for Professional Ecologists* (Collins, 2023). These surveys fall within the optimal period of bat emergence activity. To provide the ultimate coverage of the potential roosting features and access points, two surveyors and a video camcorder with infrared night vision positions were identified (see Figure 2 for locations).
