INTERIM VALIDATION REPORT

FORMER ROYD EDGE MILL,  
MELTHAM  
WEST YORKSHIRE

ROYD EDGE MILL DEVELOPMENTS LTD

REPORT REF: REMD 3537VAL

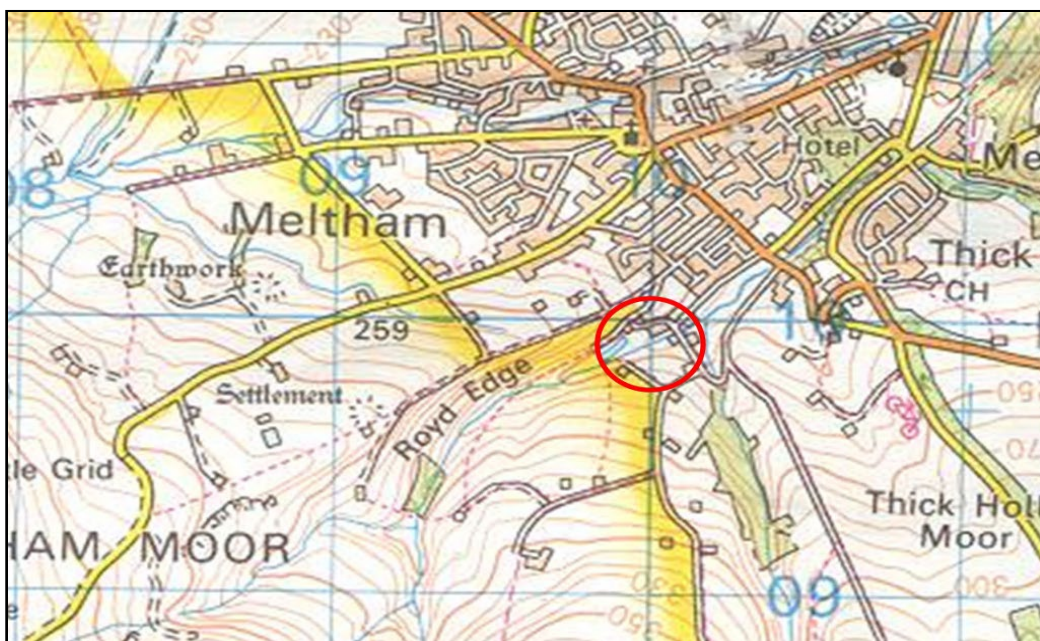
**Figure 1 Site Location Plan**

The site is accessed from the lane leading off Thick Hollins Road on the south side of Meltham in West Yorkshire. The centre of the site lies around National Grid Reference 410100E 409900N at a height of around 180m aOD.

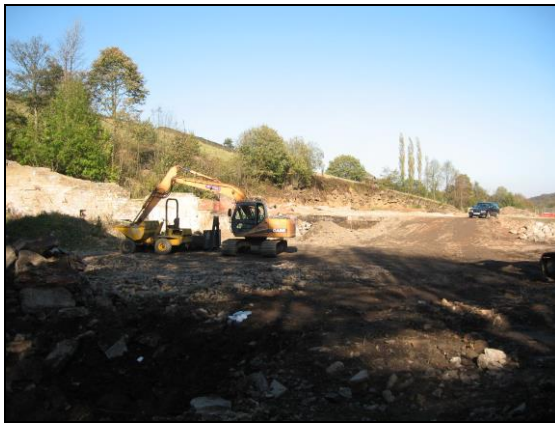
Elevated levels of polyaromatic hydrocarbons were detected in Area 2 following removal of 0.50m of soils. A further 0.50m was therefore removed and visual evidence indicated three areas of the ground that still exhibited a hydrocarbon odour and black staining. These areas were tested as 1/2A, 1/2B and 1/2C and results indicated that some hydrocarbons remained. The soil in these three areas with black staining and a hydrocarbon odour were over excavated to reveal clear odourless soil. The chromium levels were within guidelines.

- 2 Area 2 - excavating and removing area of PAH contamination east of Plot 18 to 0.50m. Area 75m<sup>2</sup> x 0.50m depth = 37.5m<sup>3</sup>. To be replaced with hard cover or geotextile and 600mm of uncontaminated topsoil

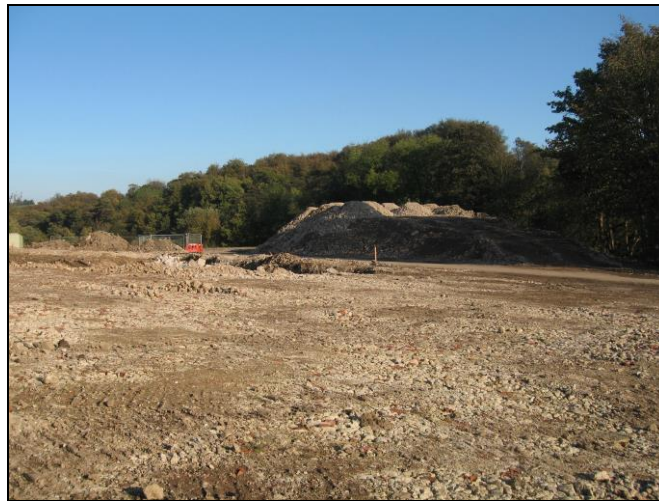
Areas 2 and 3

Areas 2 and 3, either side of the access road leading to the mill pond, were investigated by borehole 17, 18, 19 and S and by boreholes 7, N and NN. These areas were over excavated to remove 0.50m depth of soil to landfill and will be replaced with a geotextile and 600mm of topsoil.
