**COMBINED STAGE 1 & 2  
DESK STUDY AND GEO-ENVIRONMENTAL REPORT**

**SITES FOUR AND FIVE**

**LAND AT CROSSLEY LANE, DALTON  
HUDDERSFIELD**

**MARCH 2017**

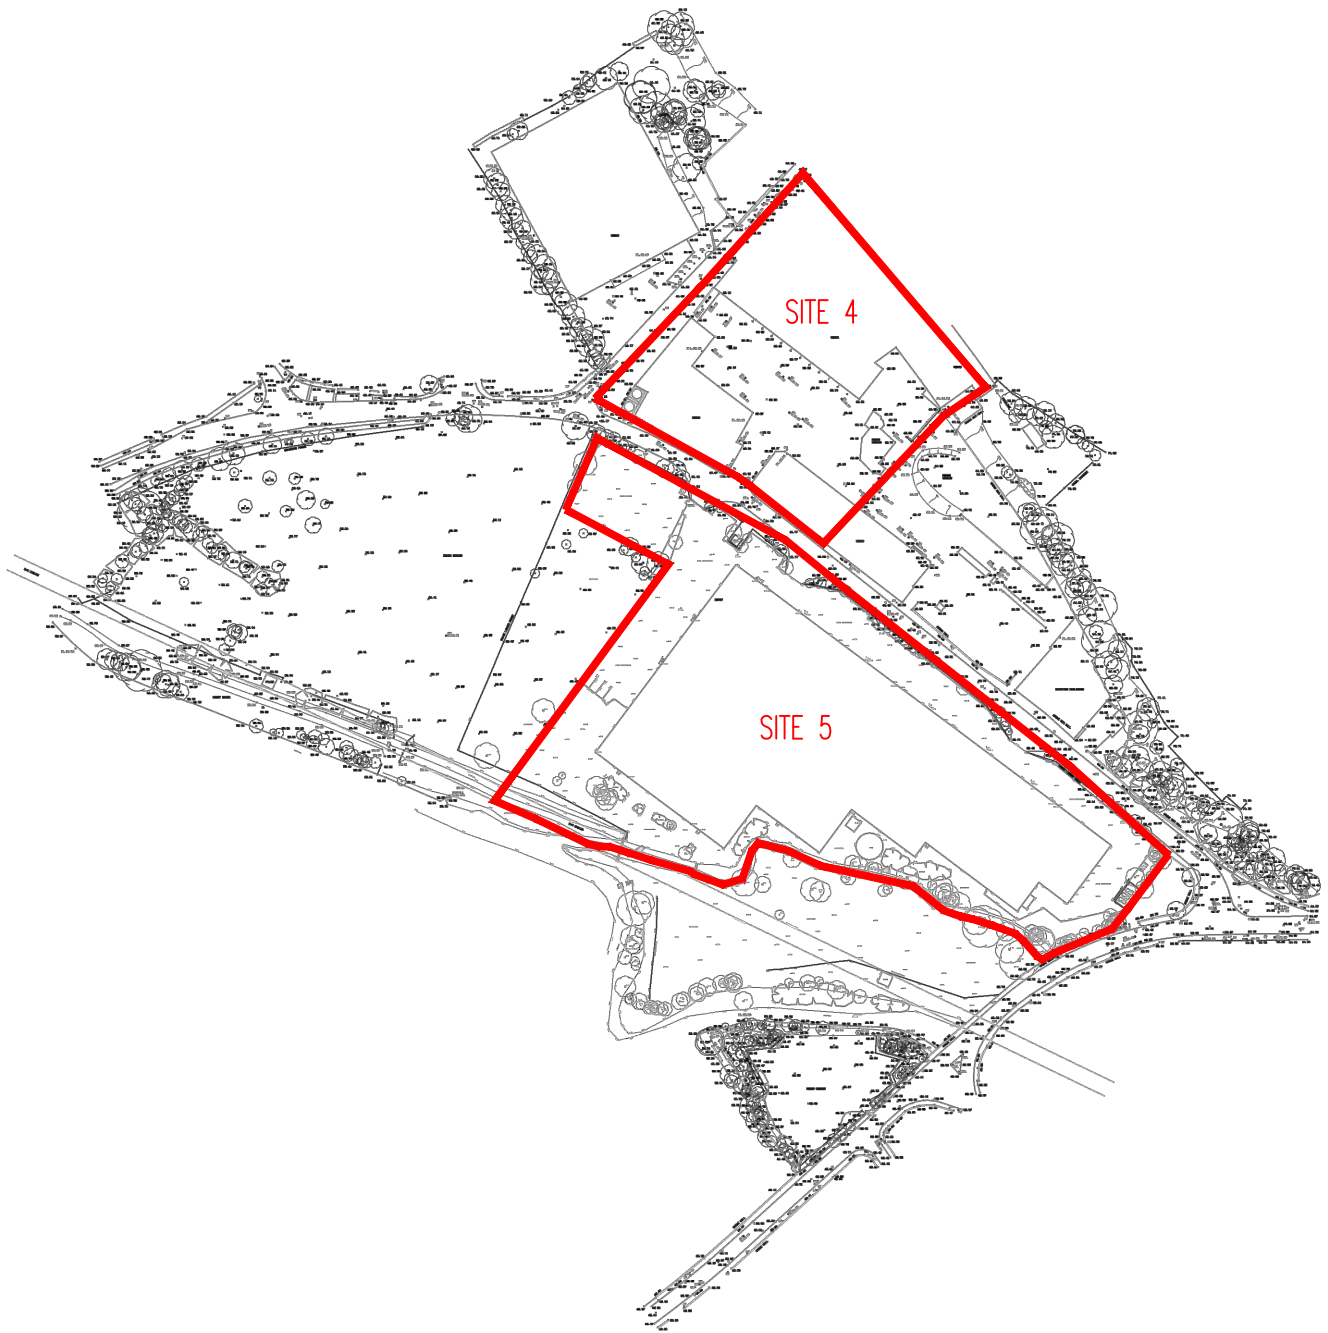
Rev	By	Date	Amendment	Chk
/	FTH	.	Issued for approval	HM
Title			Scale	Drawn
SITE PLAN			NTS @ A4	FTH
Project/Client			Date	Chk.
Crossley Lane, Dalton Minerva Works Developments LTD			AUG 16	HM
ARP ASSOCIATES CHARTERED CONSULTING ENGINEERS Northwest House • 5/6 Northwest Business Park Servia Hill • Leeds LS6 2QH Telephone : 0113 245 8498 • Fax : 0113 244 3864 E-Mail : leeds@arpassociates.co.uk			Drg. No.	Rev
			MWD/01/SI.06	/
