## Land at Crossley Lane, Dalton For Harron Homes Yorkshire

Report no: 3435/1

Date: March 2020

## SUMMARY OF GEOENVIRONMENTAL ISSUES

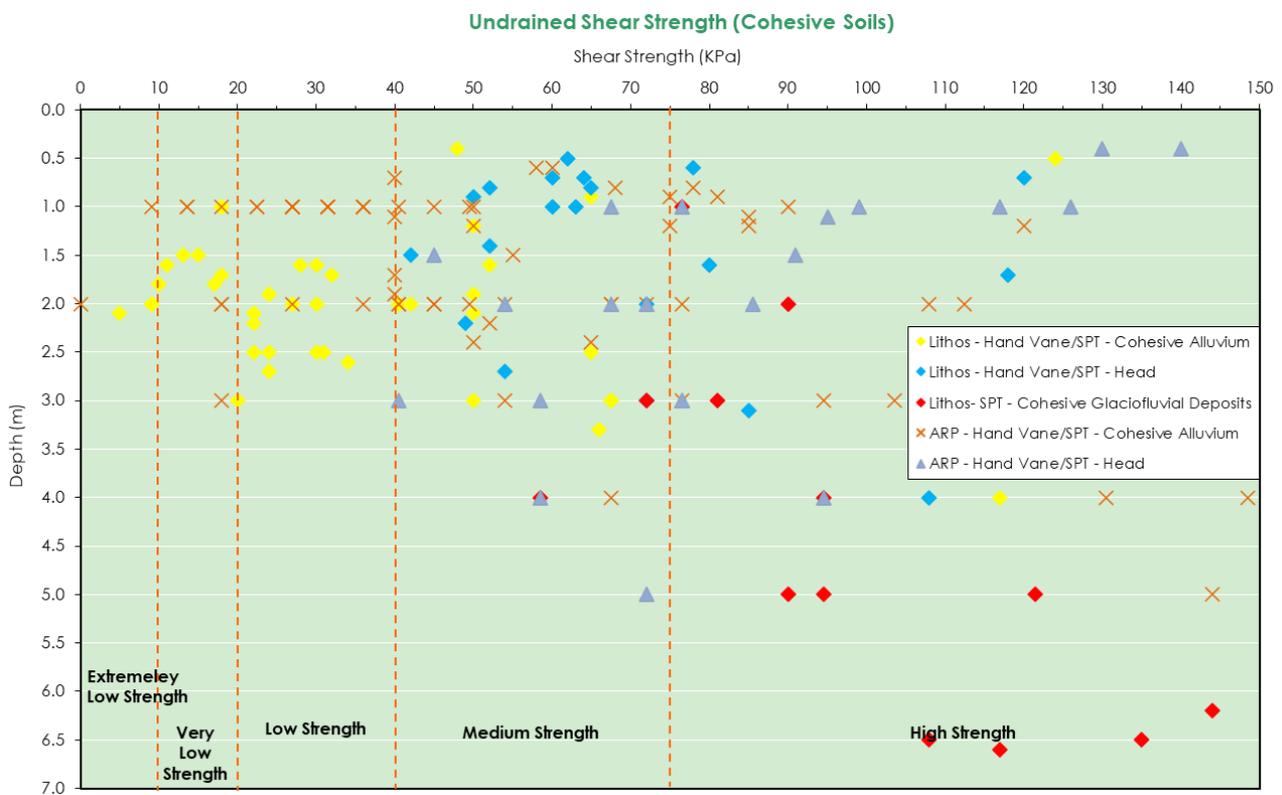
12.6.2 SPTs were performed when drilling through cohesive soils during dynamic sampling and cable percussion boreholes as part of ARP's and Lithos' ground investigation. SPT results within cohesive soils can be broadly equated to undrained shear strength values (SPT 'N' value x 4.5). Undrained shear strength results derived from SPTs are included in the graph on page 44.

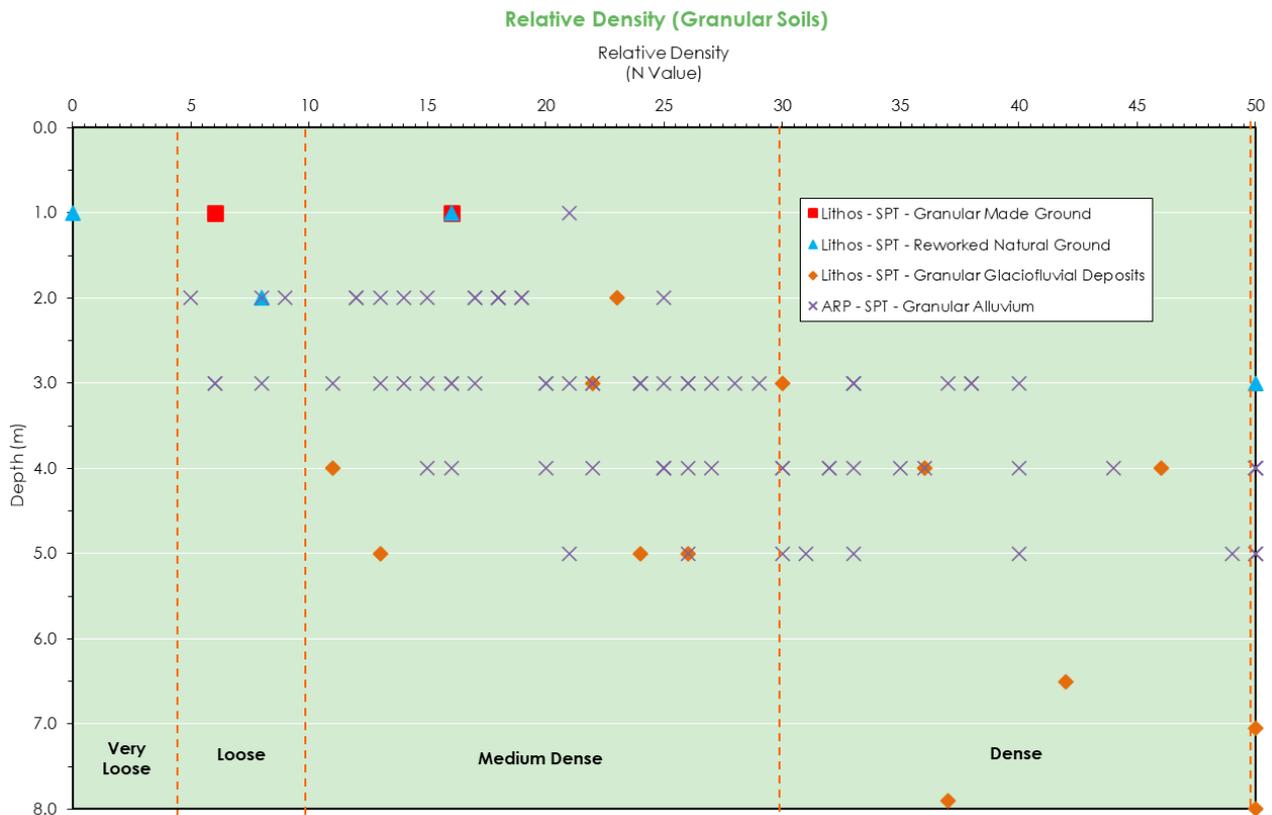
## 12.7 Standard penetration test (SPT)

12.7.1 The in-situ relative density of granular soils was established by carrying out Standard Penetration Tests (SPTs) during the drilling of the cable percussion boreholes.

12.7.3 The plot below presents a summary of SPT 'N' values.

- 12.8.1 The Cohesive Alluvium is generally of low strength (average 36 kPa), although ARP recorded predominantly medium strength clays (average 60 kPa). It is possible that some of the cohesive deposits logged as 'alluvium' by ARP were actually Head deposits.

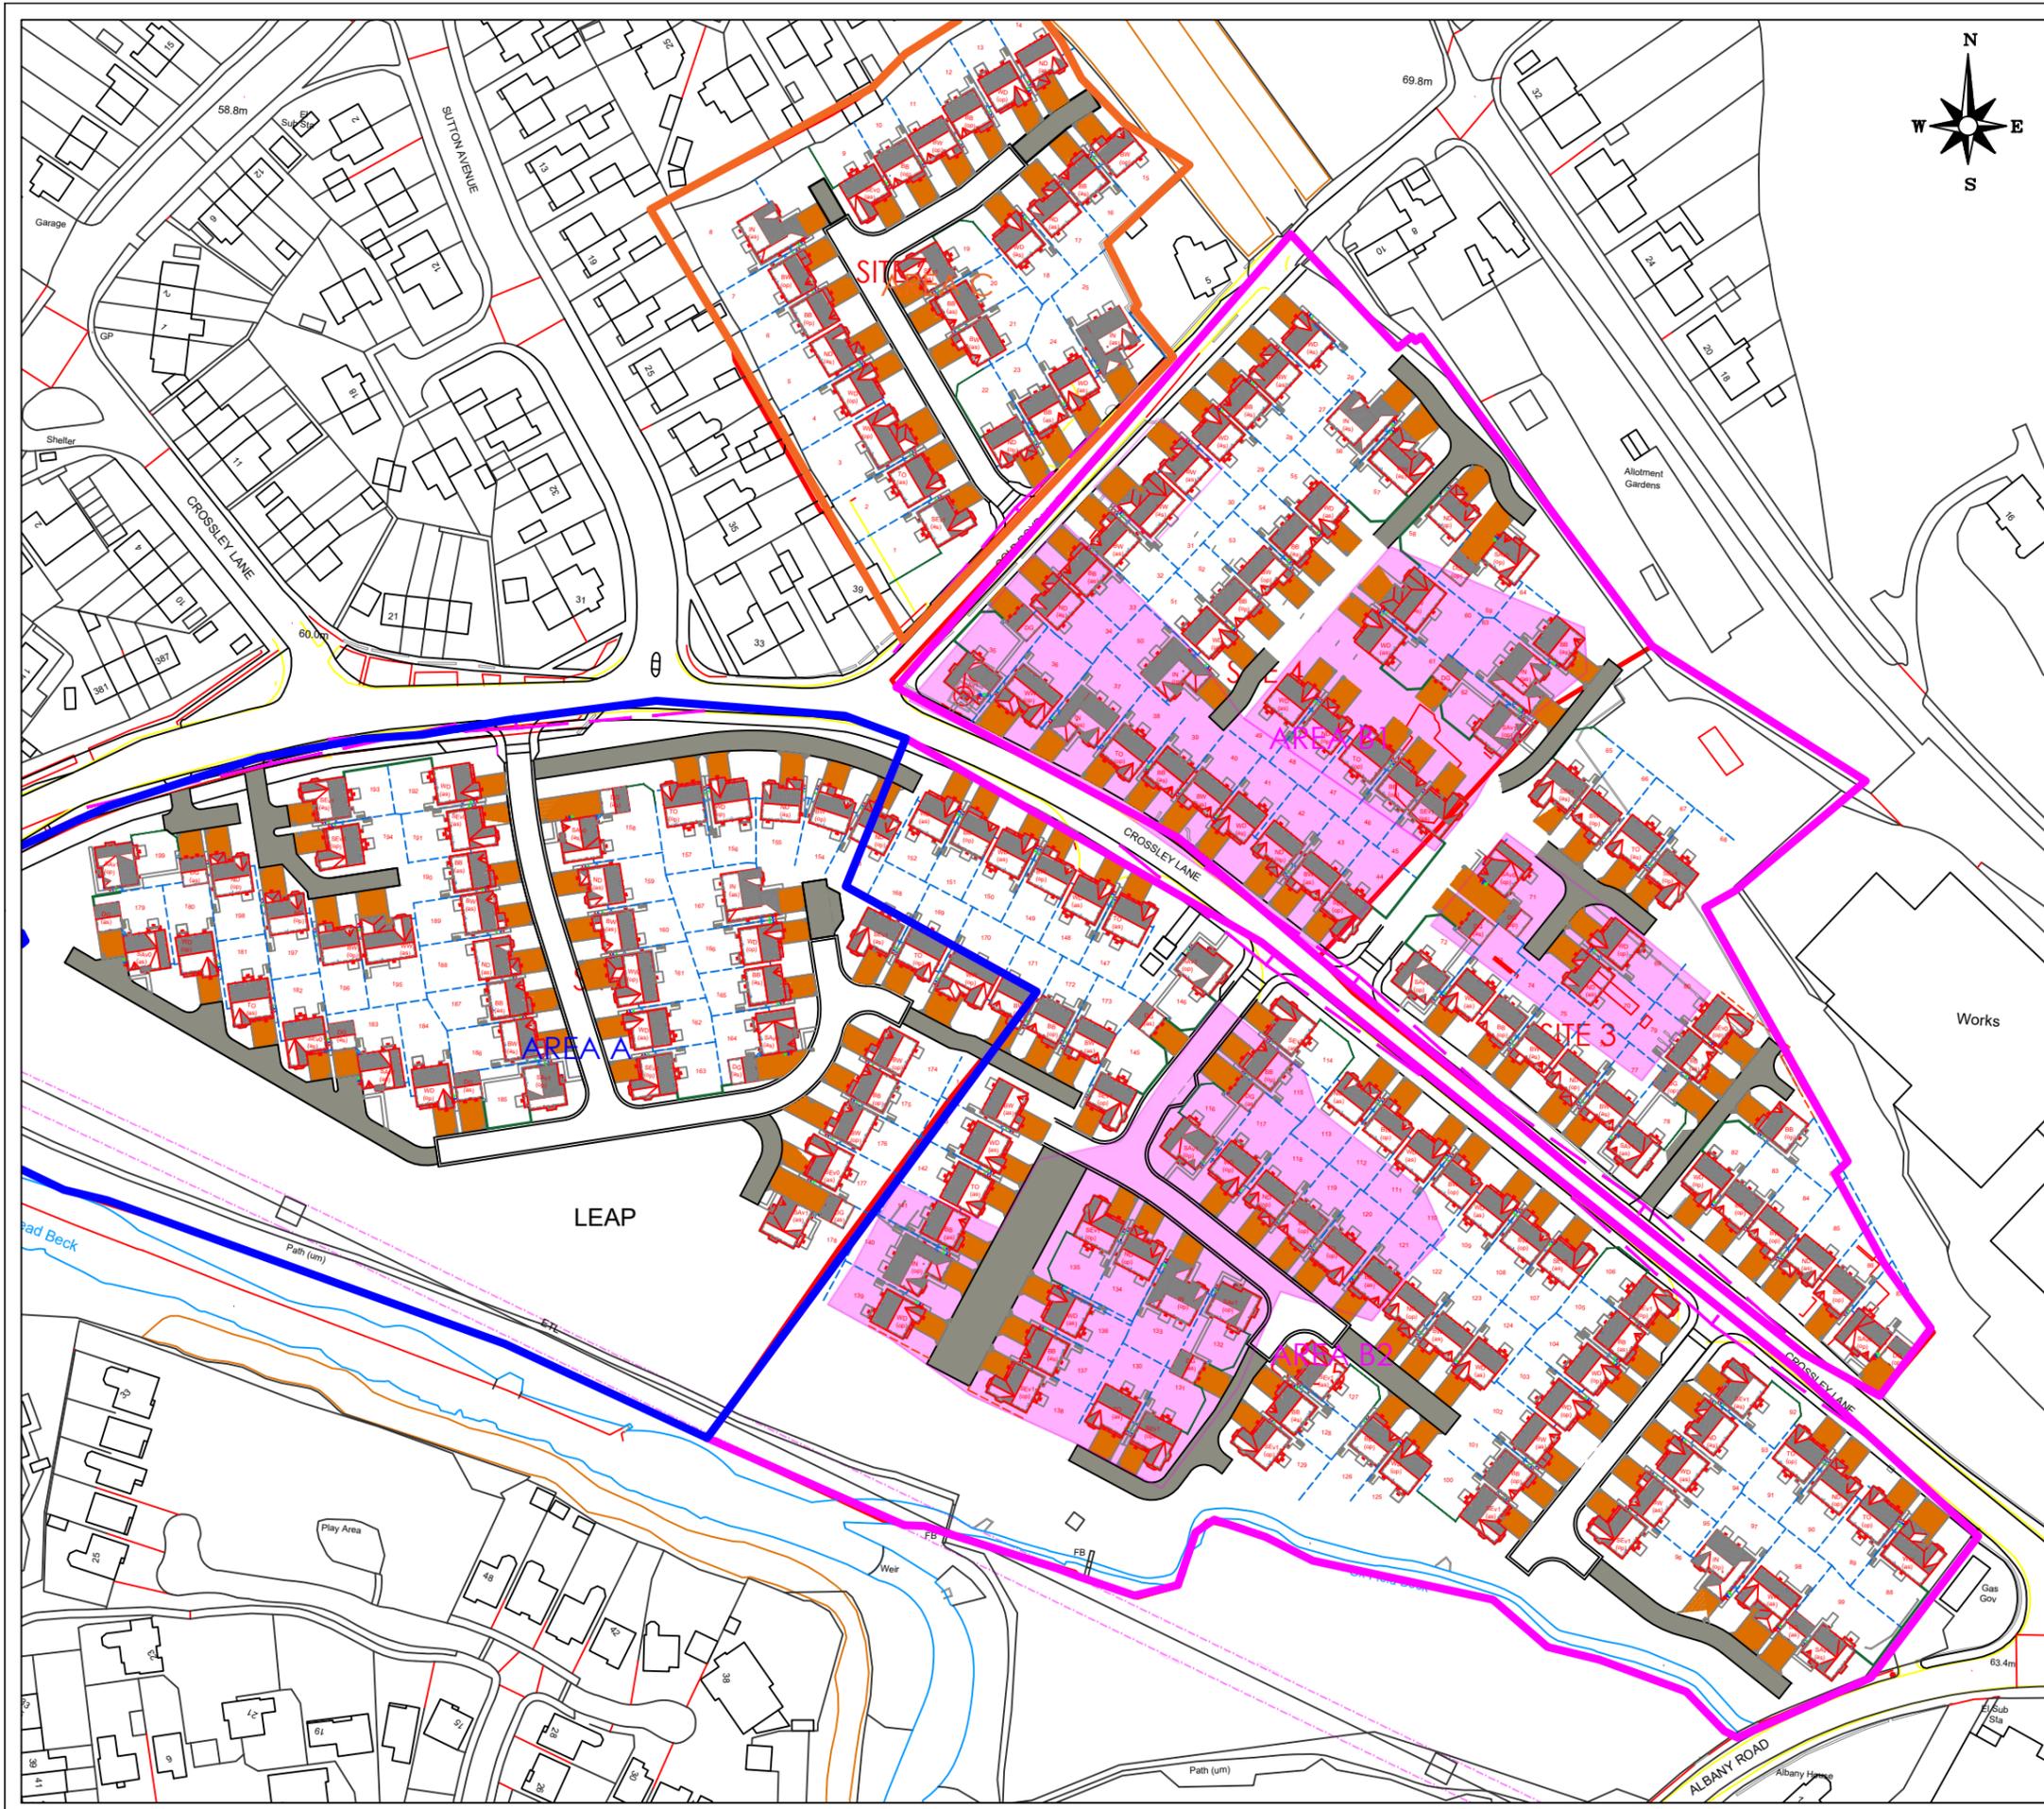
DRAWN	MJT	DATE	14/01/2019	STATUS	FOR COMMENT	<input type="checkbox"/>
CHECKED	REG	DATE	14/01/2019	FOR APPROVAL	DRAFT	<input type="checkbox"/>
					FINAL	<input checked="" type="checkbox"/>
SCALE	1:1,500	SHEET	A3	DRAWING NO.	3435/2	REVISION

**PILED FOUNDATIONS**  
 (made ground and/or soft/loose ground to >2.5m)  
 Elsewhere, strip/trench fill foundations potentially feasible depending on supplementary site investigation

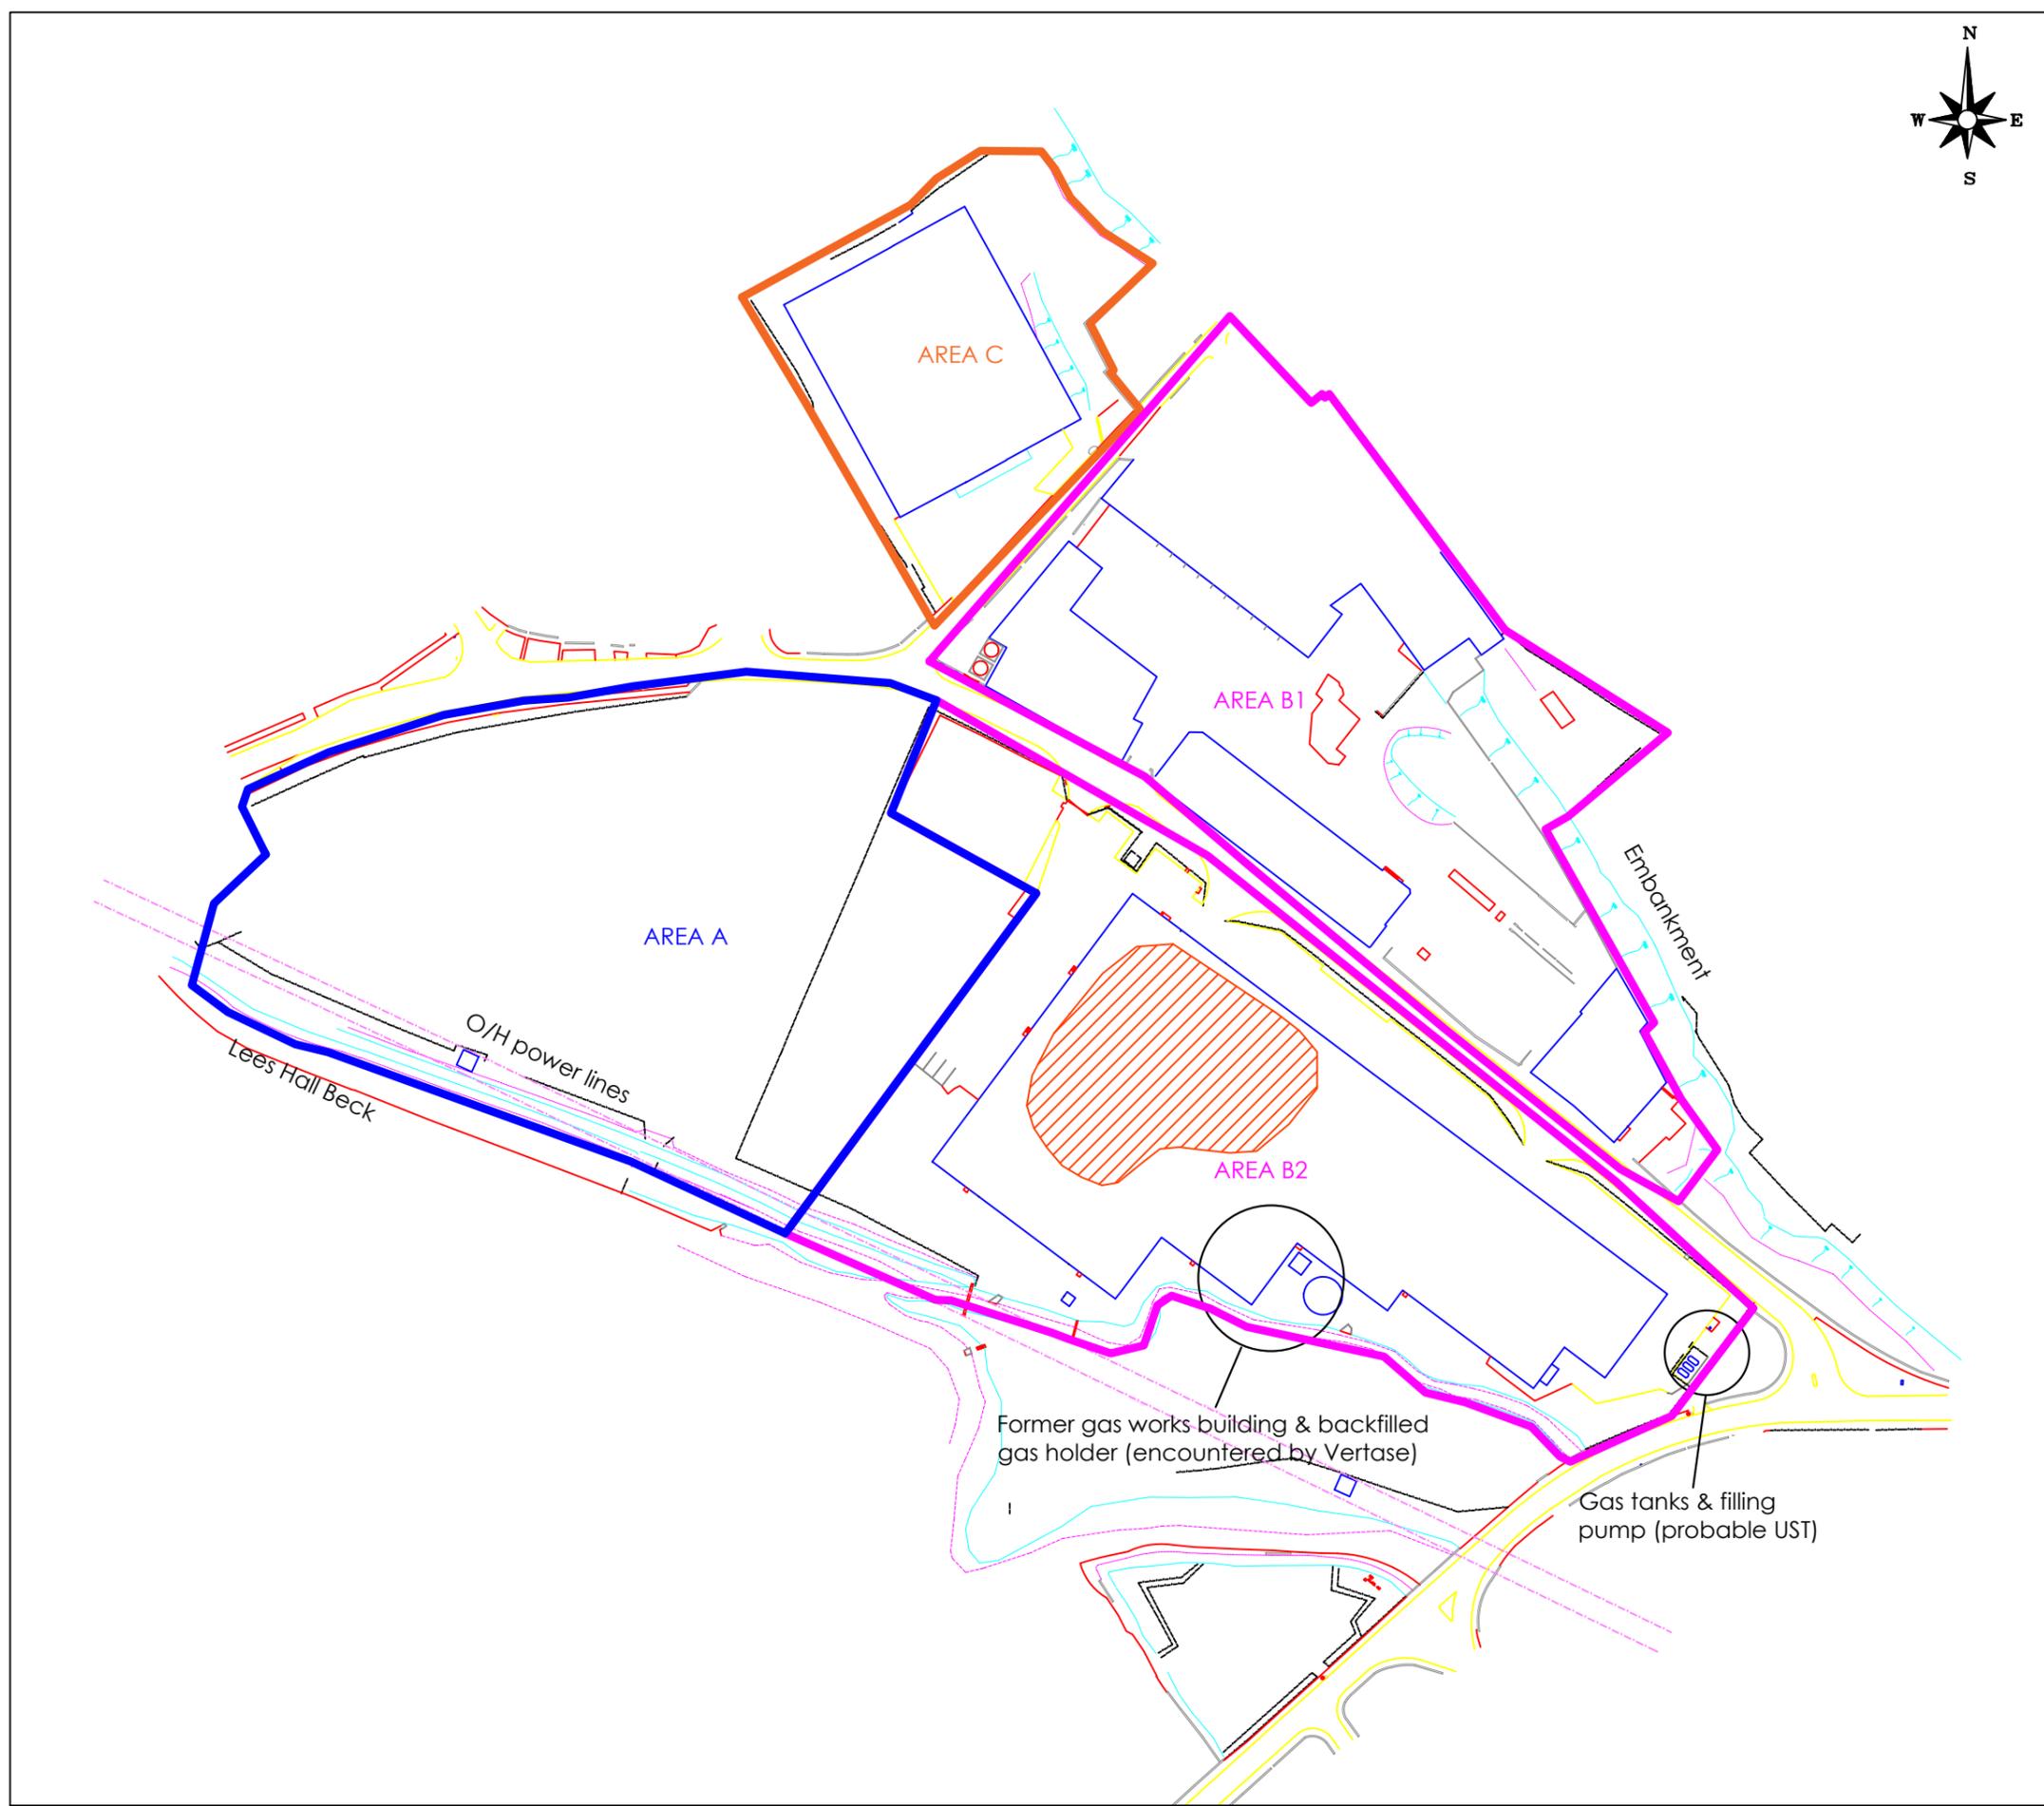
SCALE	1:2,000	SHEET	A3	DRAWING NO.	3435/3	REVISION	
-------	---------	-------	----	-------------	--------	----------	--

- NOTES
- AREA A - No remediation required
  - AREA B - 600mm soil cover and 100mm hard-dig layer
  - AREA C - 600mm clean soil cover
  - HYDROCARBON HOTSPOT - Grossly contaminated soils encountered by ARP

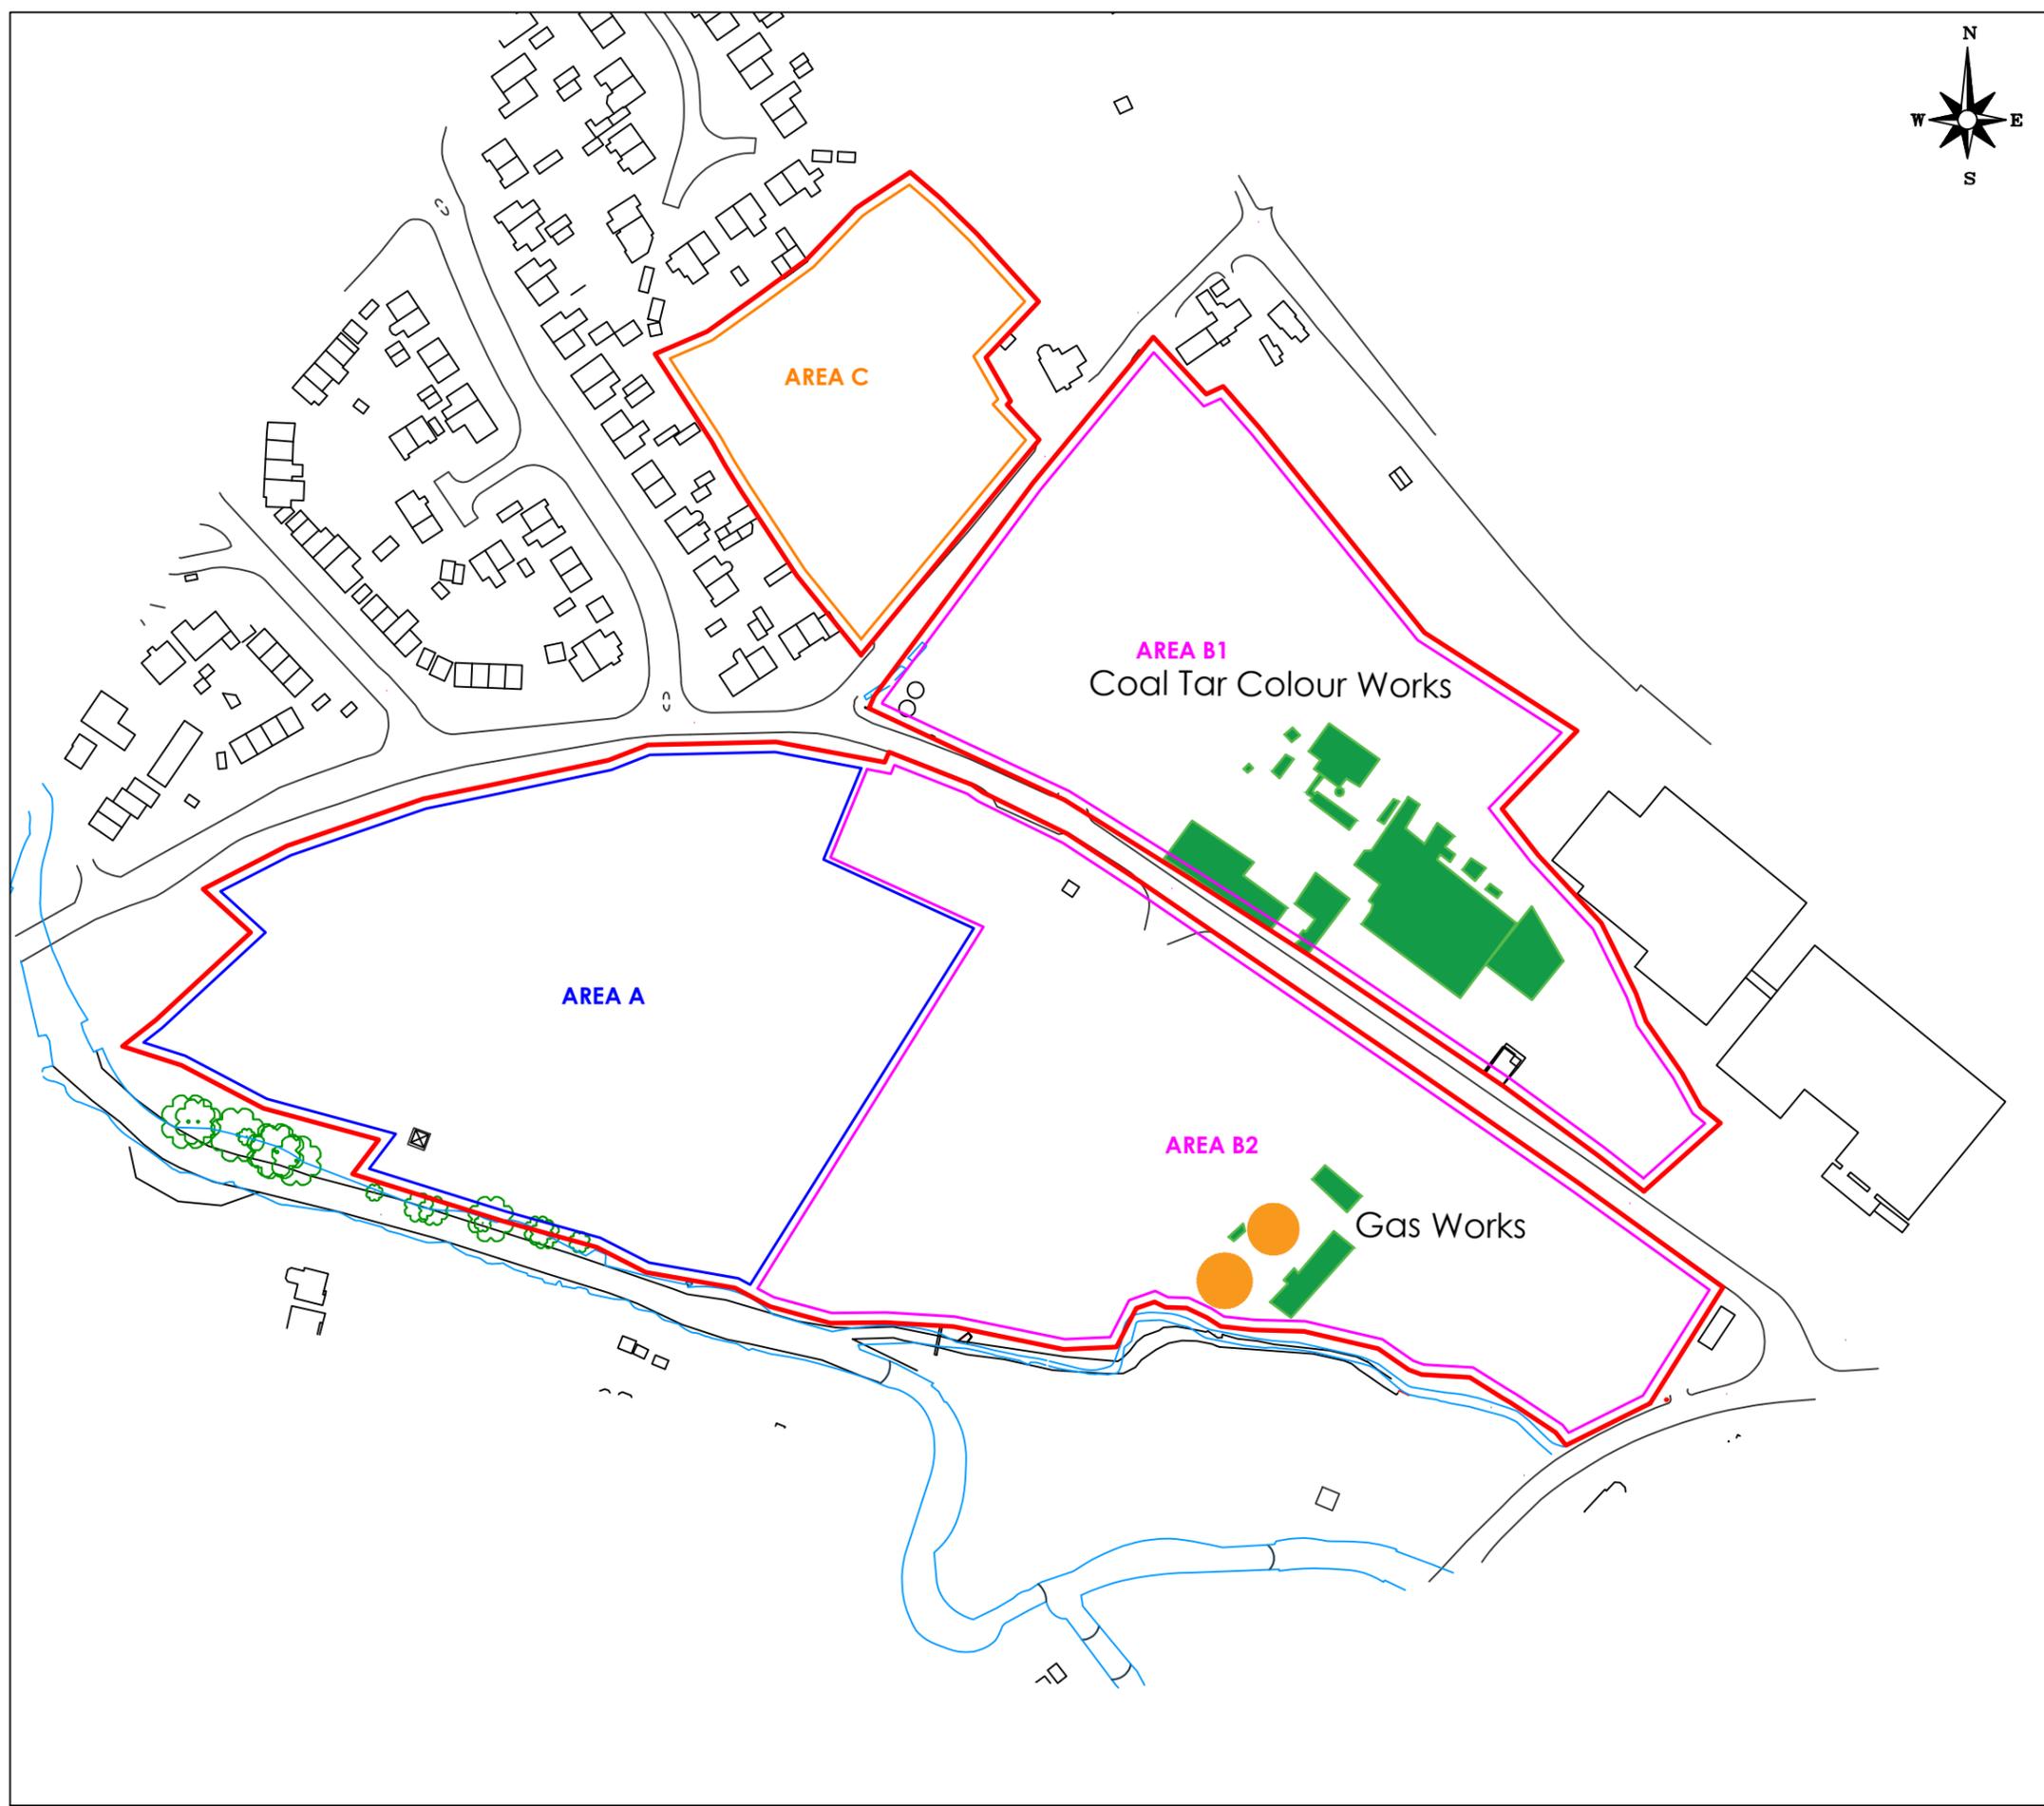
SCALE	1:2,000	SHEET	A3	DRAWING NO.	3435/104A	REVISION	
-------	---------	-------	----	-------------	-----------	----------	--

- NOTES
- HISTORICAL BUILDING FOOTPRINT
  - HISTORICAL GAS HOLDERS
  - APPROXIMATE SITE BOUNDARY

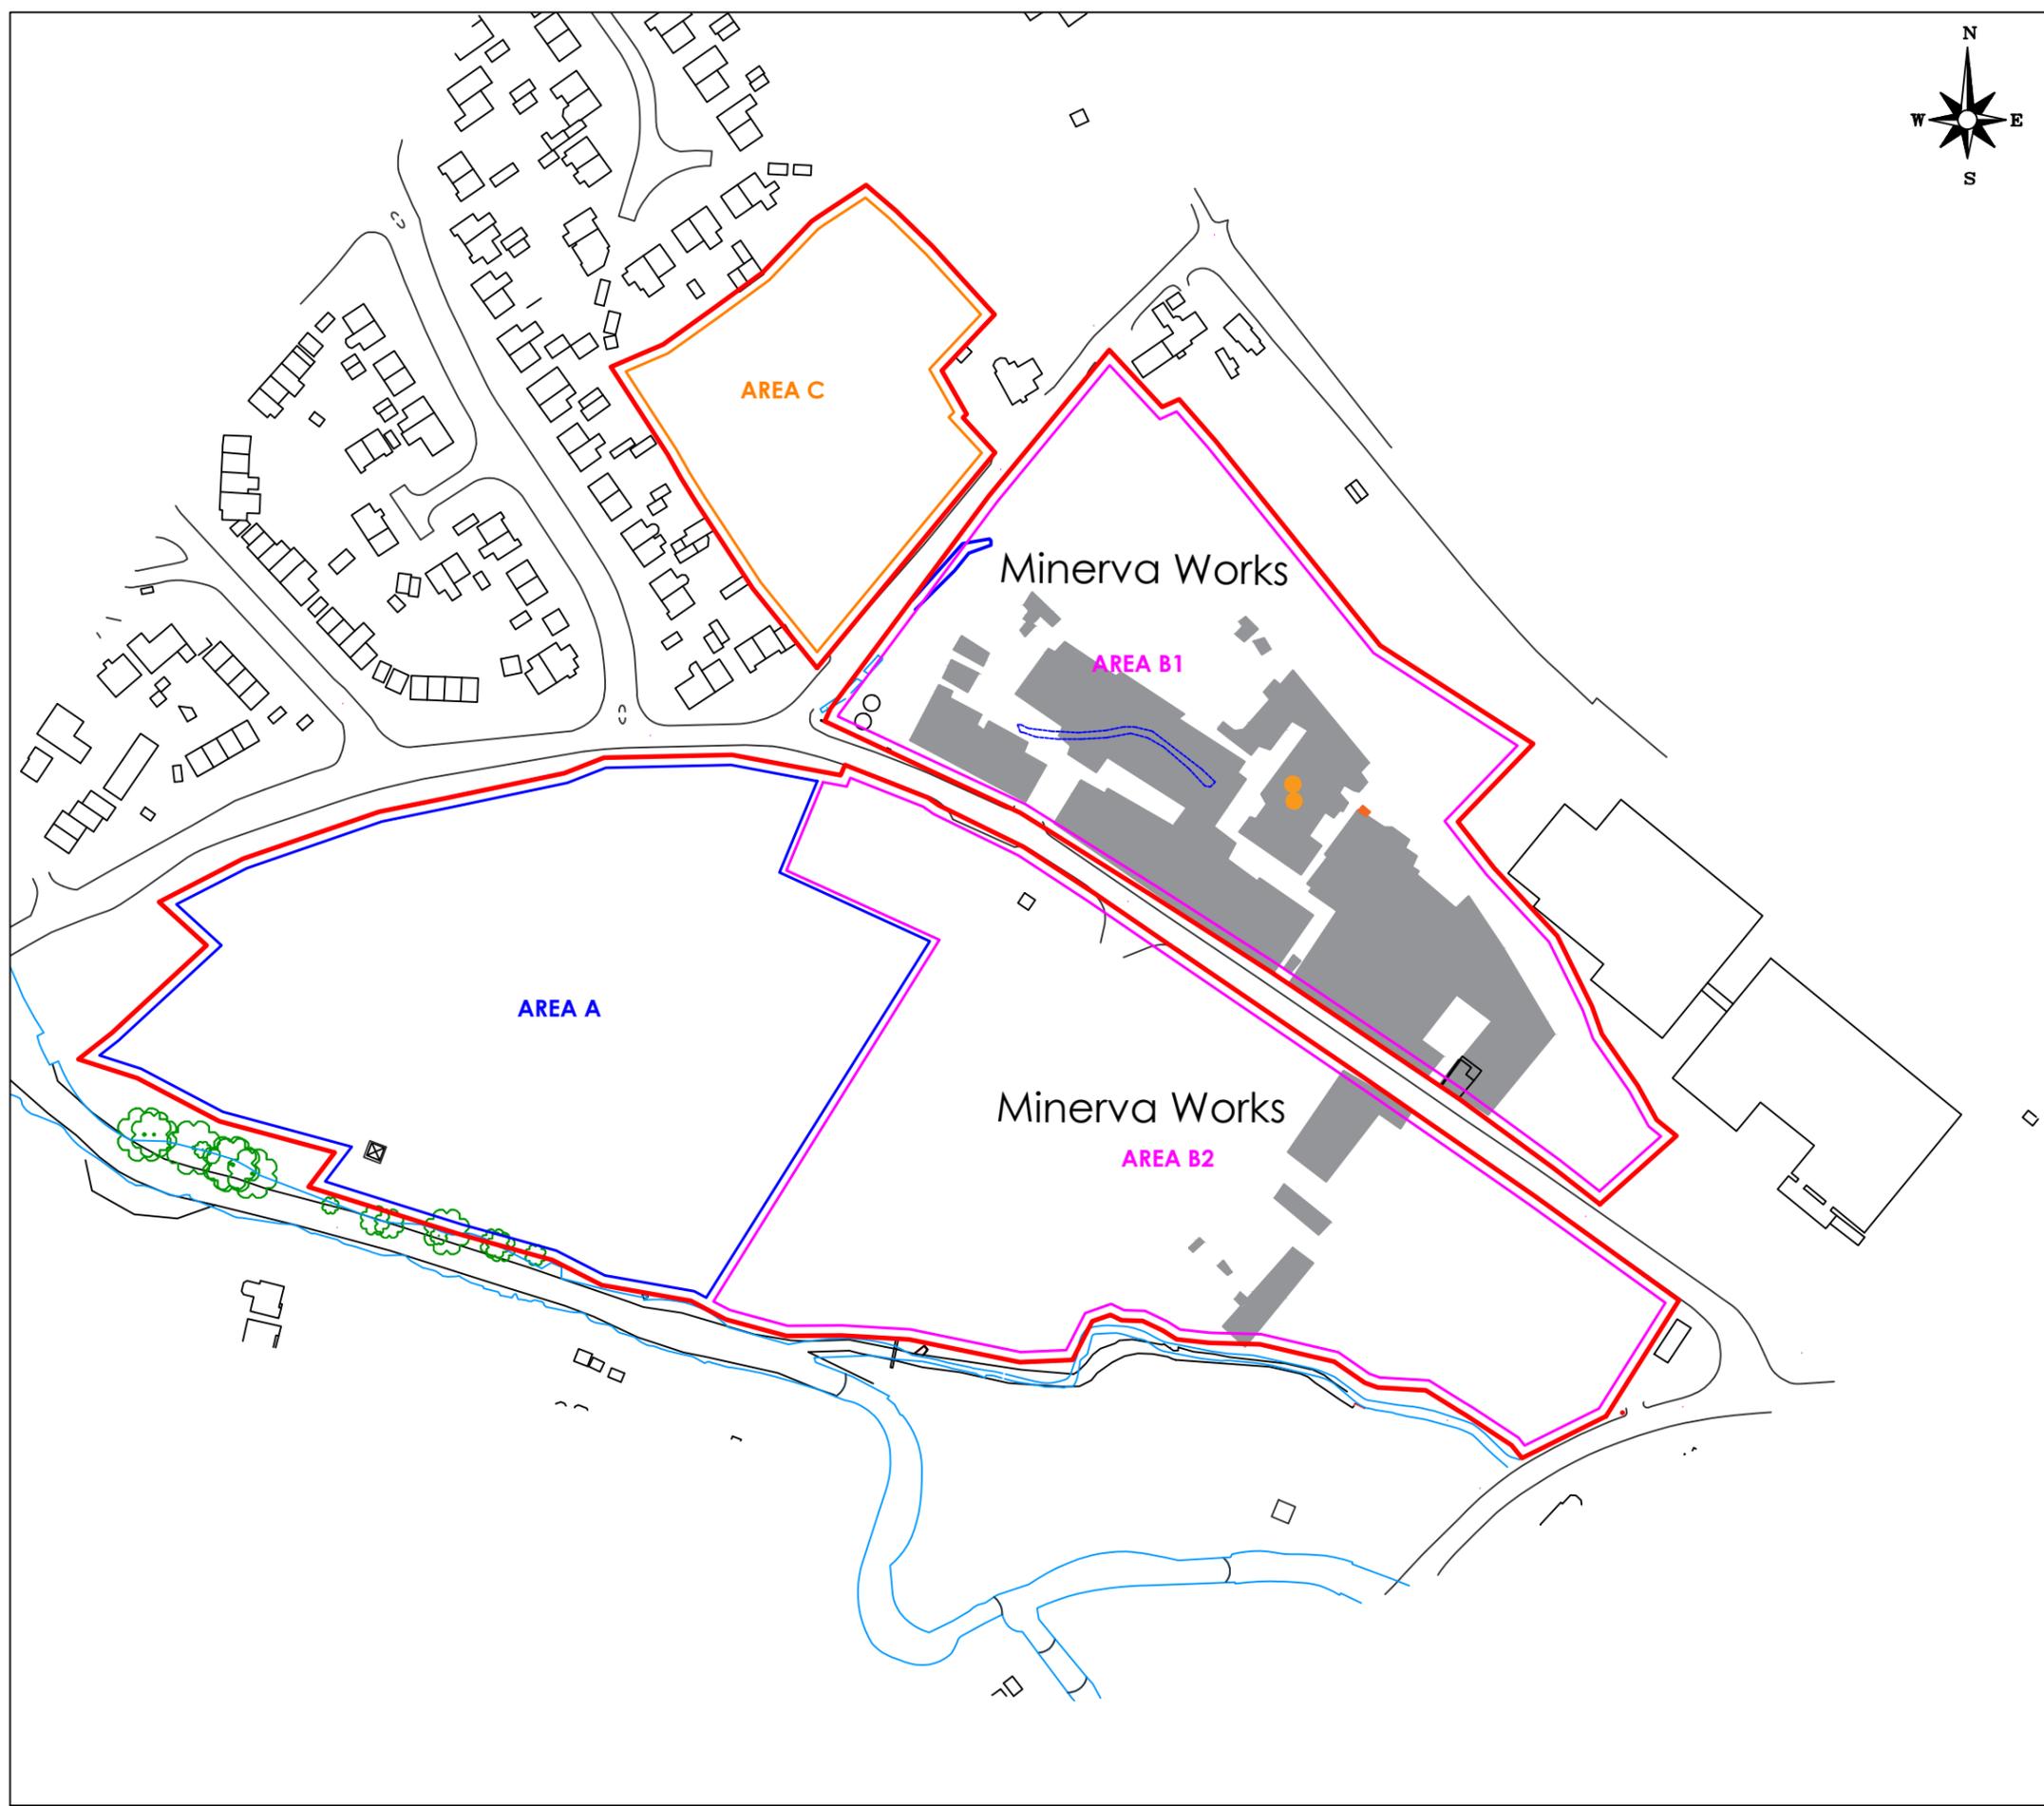
SCALE 1:2,000	SHEET A3	DRAWING NO. 3435/104B	REVISION
------------------	-------------	--------------------------	----------

- NOTES
- HISTORICAL BUILDING FOOTPRINT
  - HISTORICAL FUEL STORAGE TANKS
  - HISTORICAL LINEAR FEATURE (1907)
  - HISTORICAL LINEAR FEATURE (1918)
  - APPROXIMATE SITE BOUNDARY

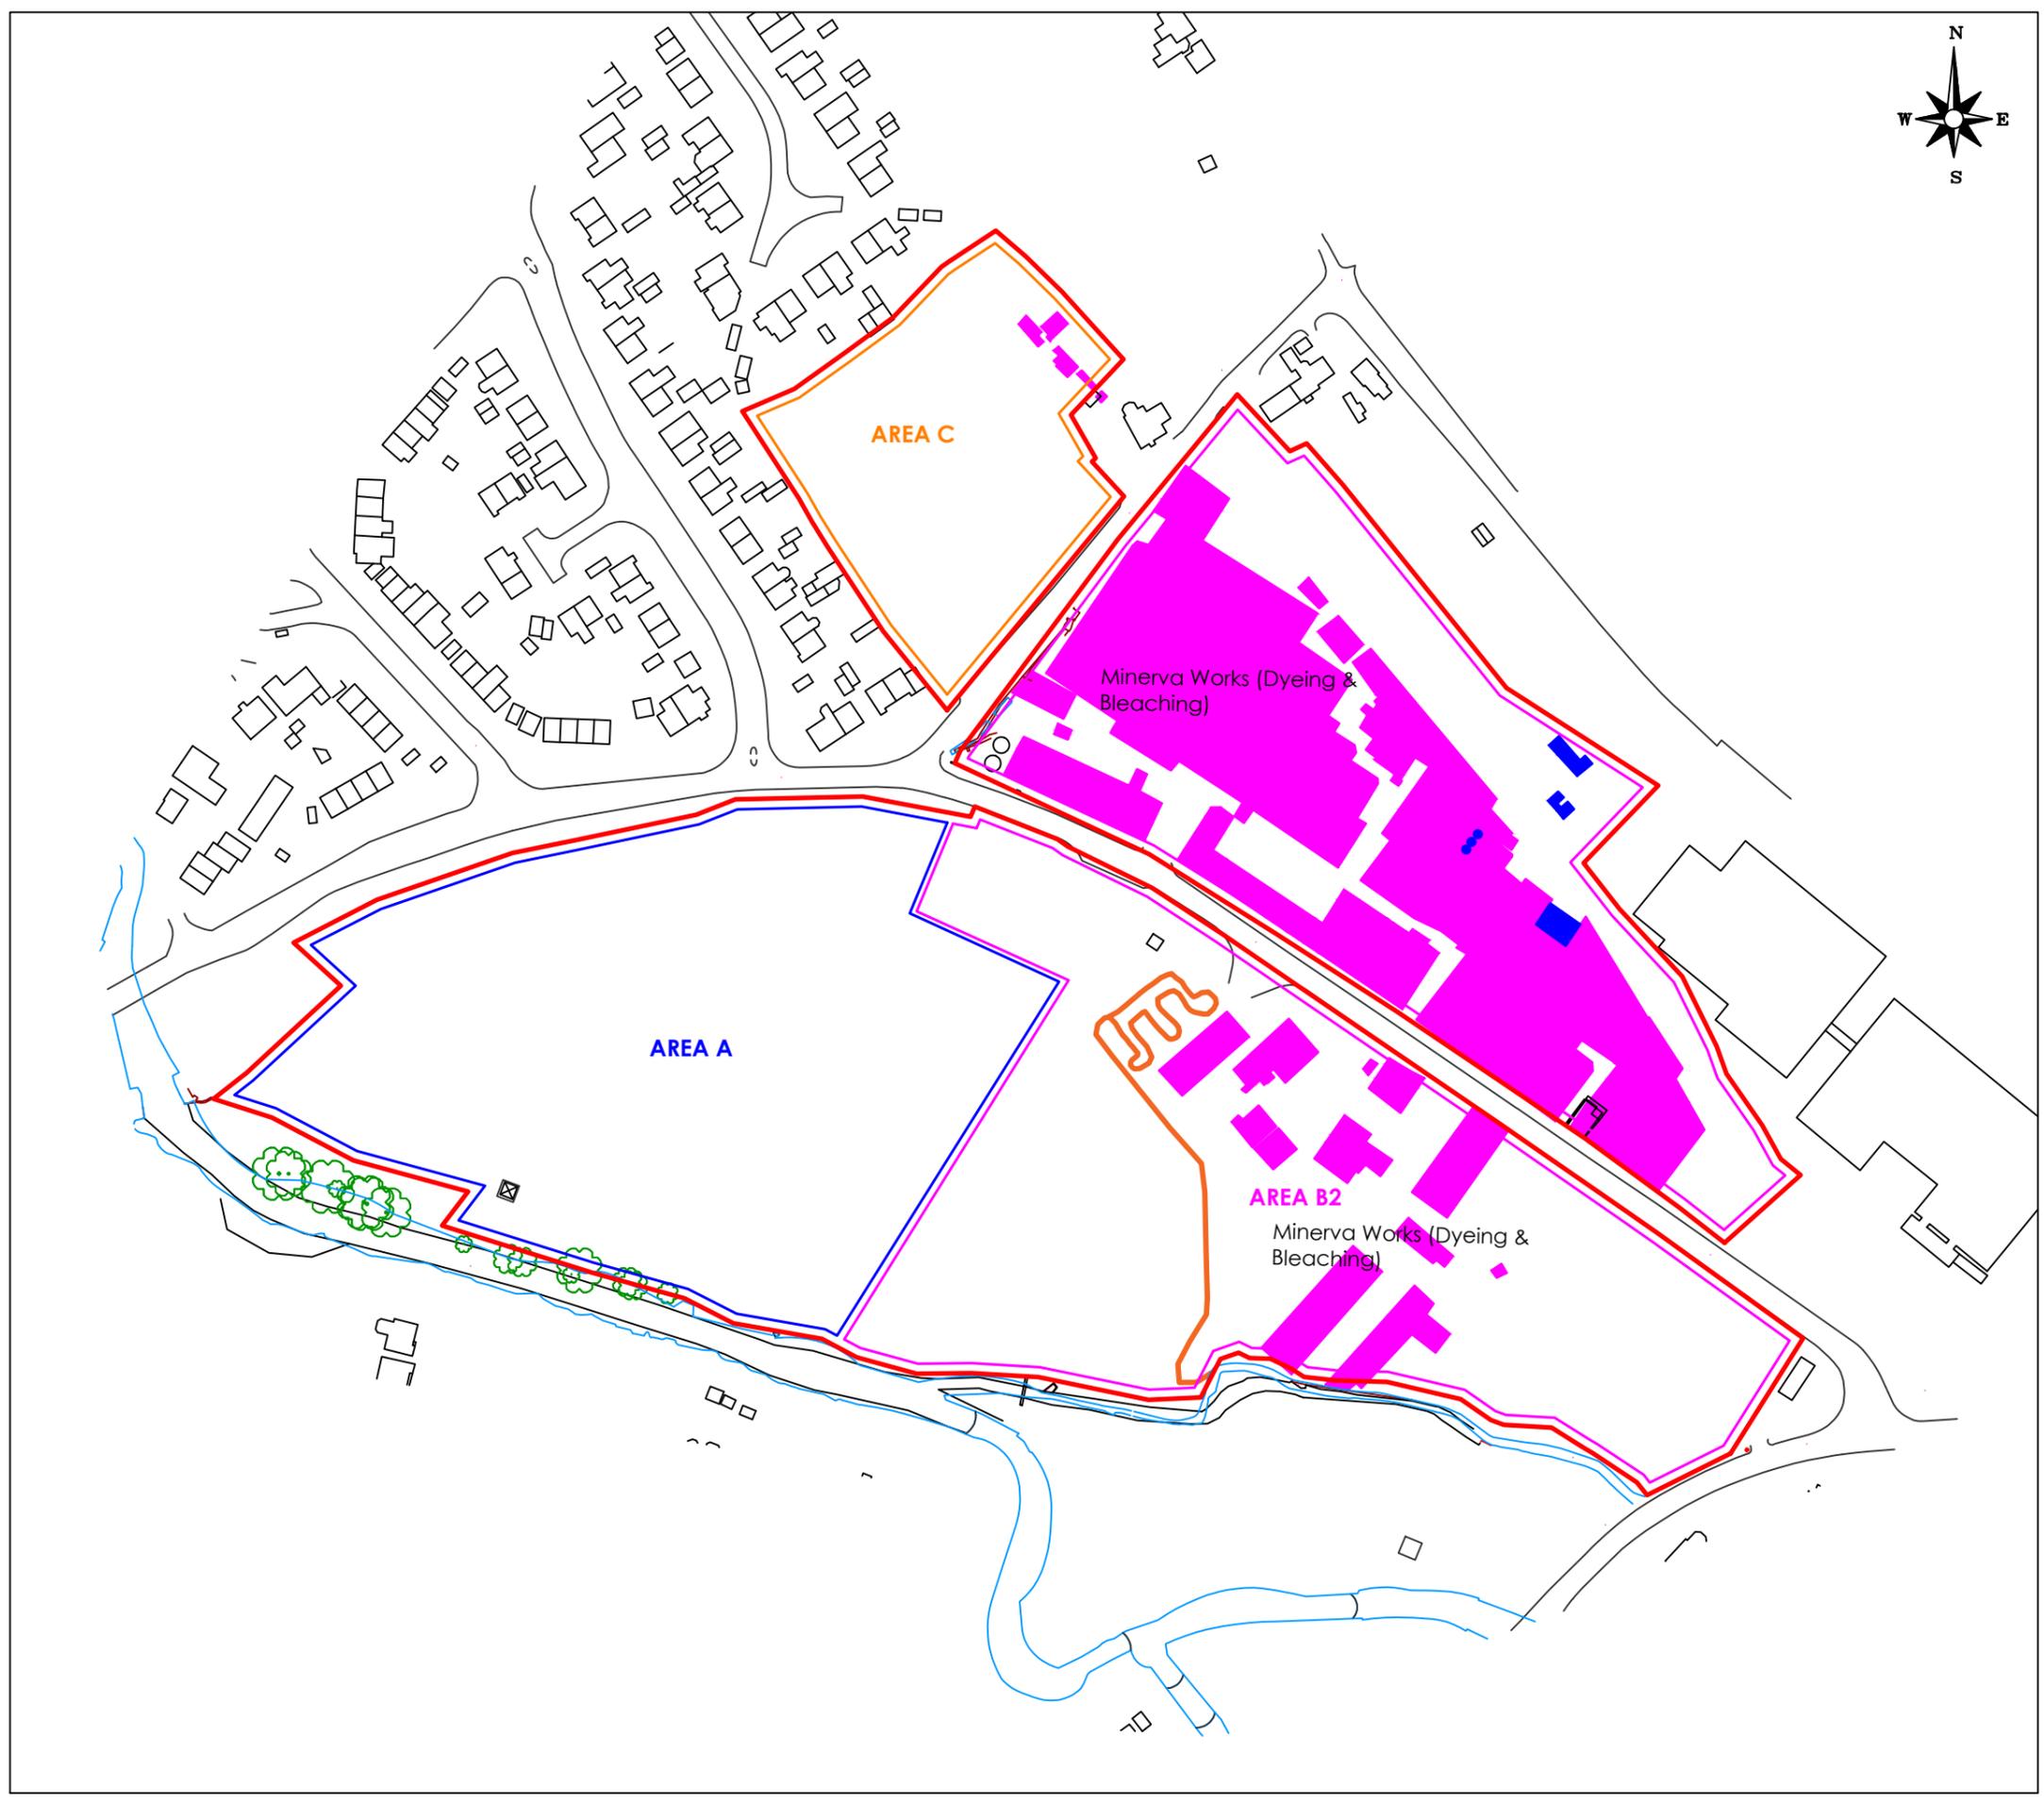
SCALE <b>1:2,000</b>	SHEET <b>A3</b>	DRAWING NO. <b>3435/104C</b>	REVISION
-------------------------	--------------------	---------------------------------	----------

- NOTES
- HISTORICAL BUILDING FOOTPRINT
  - HISTORICAL FUEL STORAGE TANKS
  - LINEAR TOPOGRAPHIC FEATURE
  - APPROXIMATE SITE BOUNDARY
