## Land at Crossley Lane, Dalton For Harron Homes Yorkshire

Report no: 3435/1

Date: March 2020

## SUMMARY OF GEOENVIRONMENTAL ISSUES

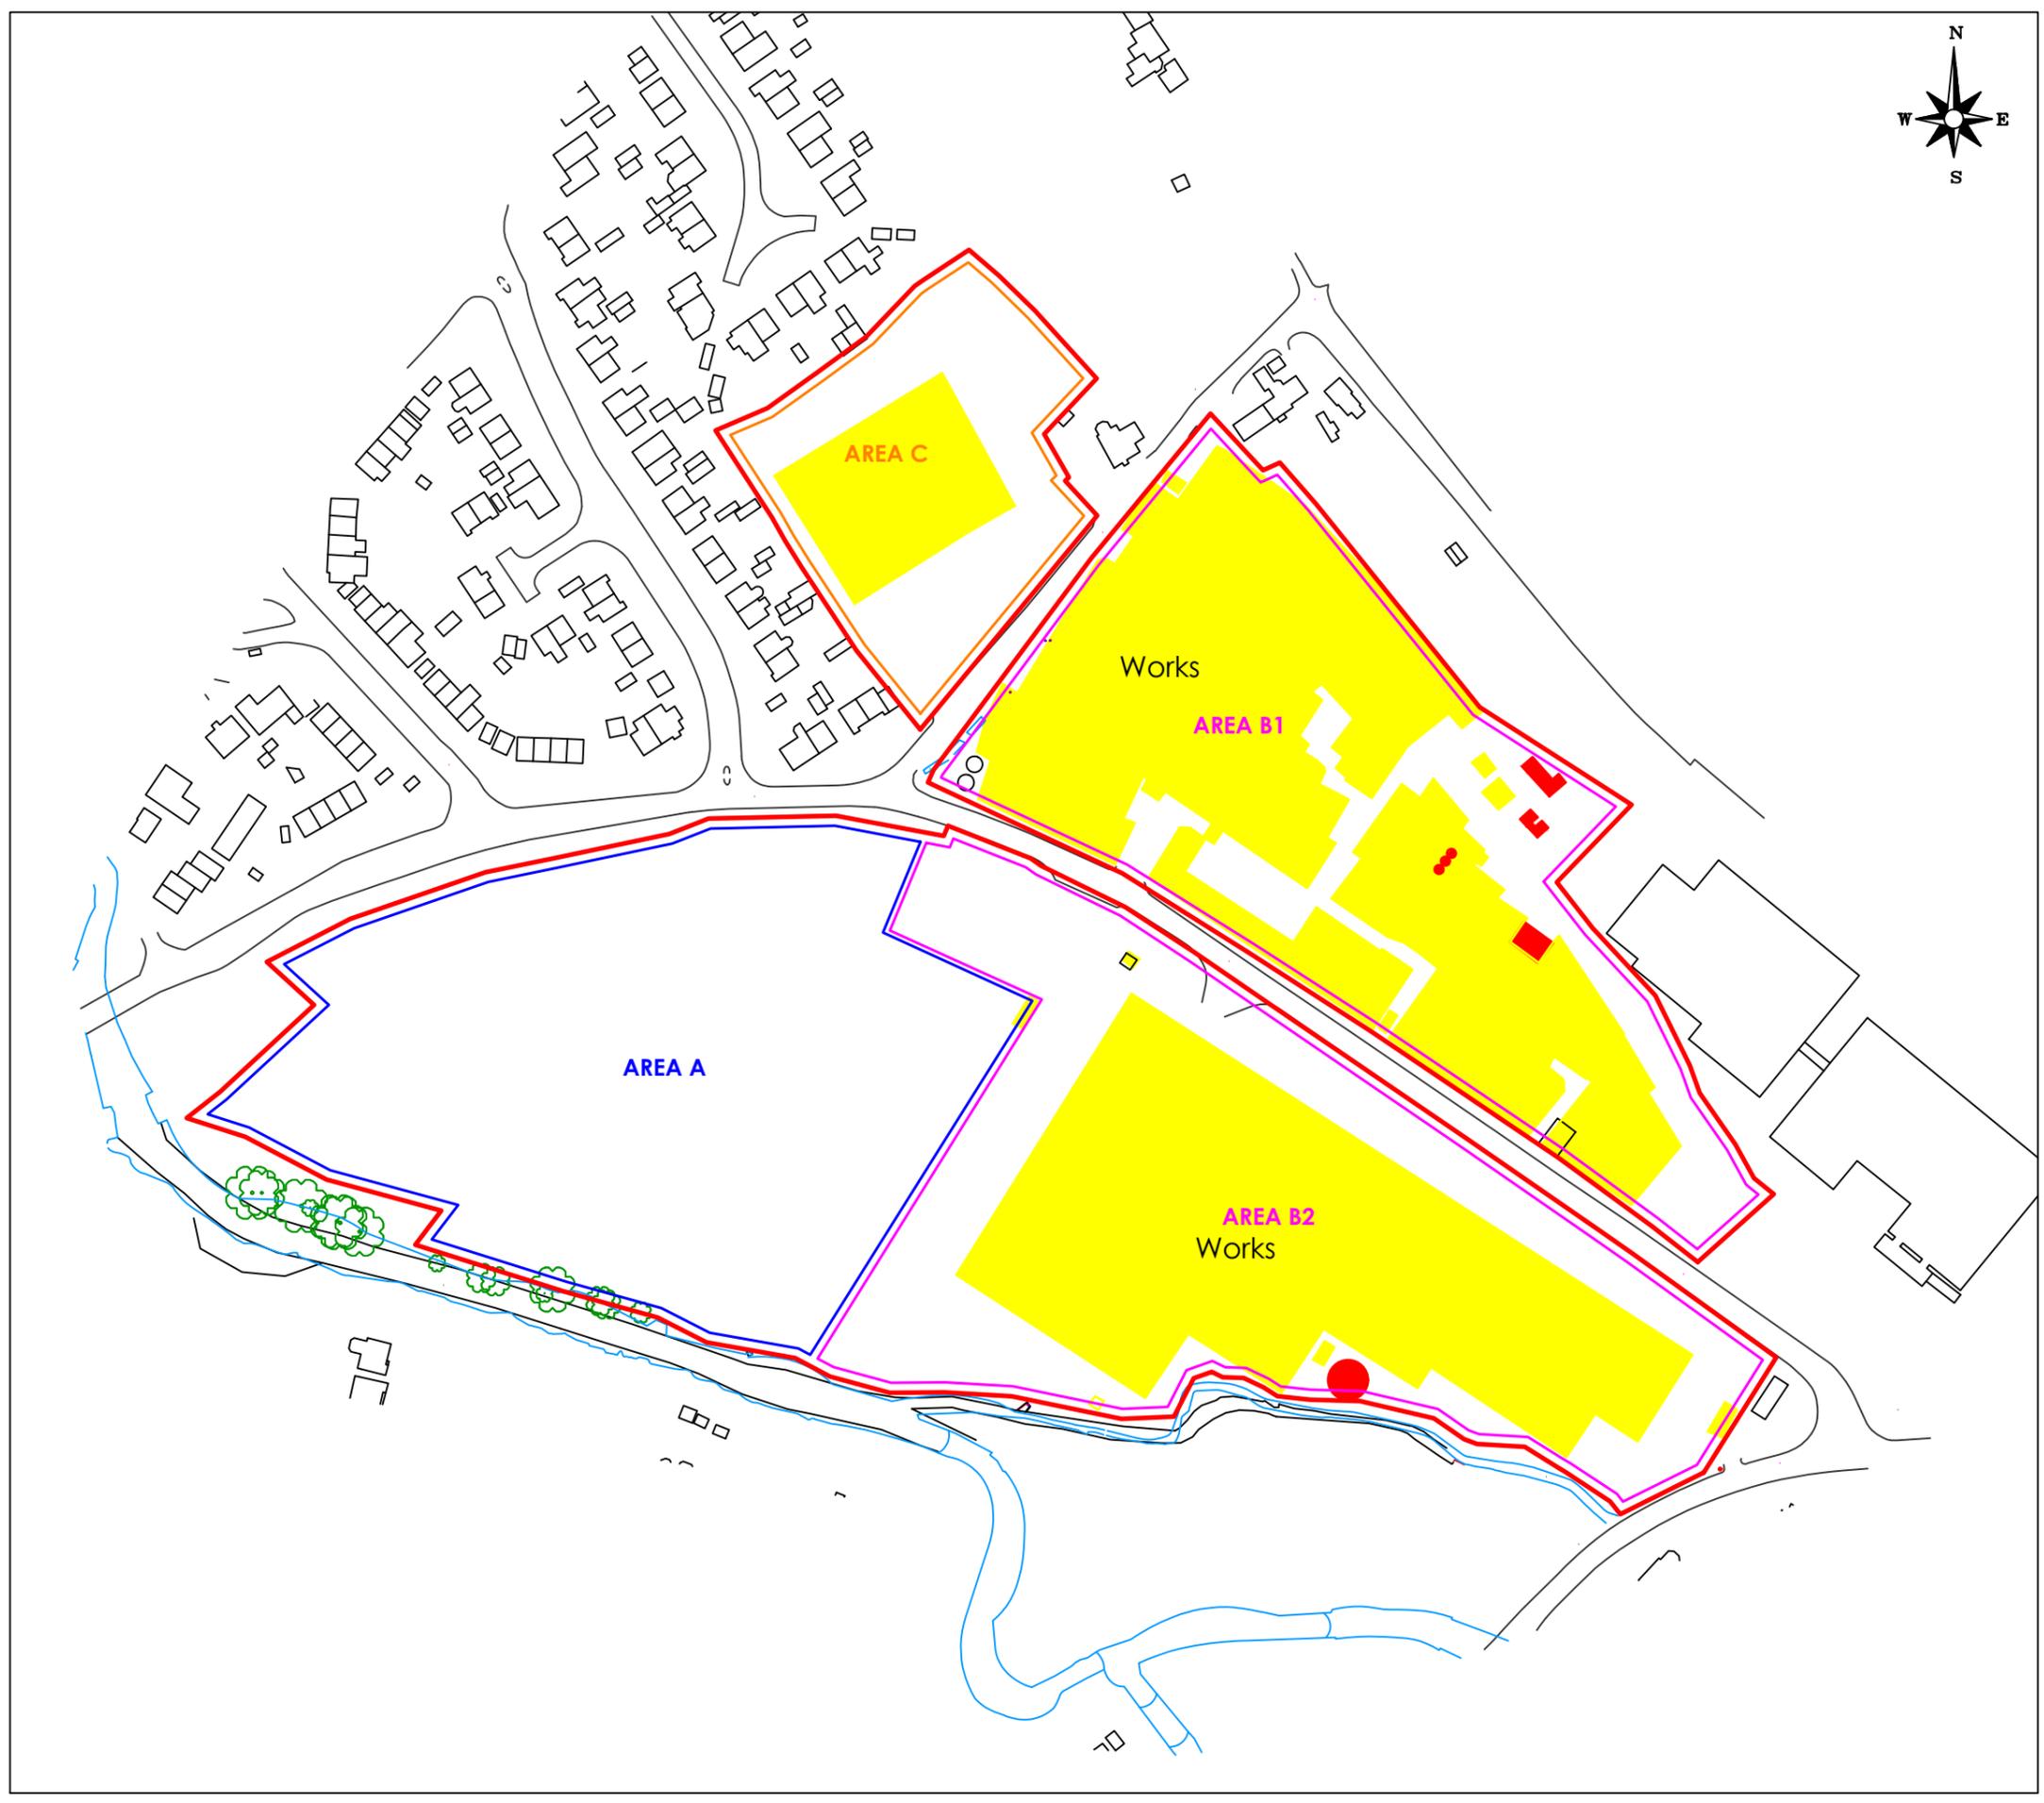
SCALE 1:2,000	SHEET A3	DRAWING NO. 3435/104D	REVISION
------------------	-------------	--------------------------	----------

- NOTES
- HISTORICAL BUILDING FOOTPRINT
  - HISTORICAL FUEL STORAGE TANKS
  - APPROXIMATE SITE BOUNDARY

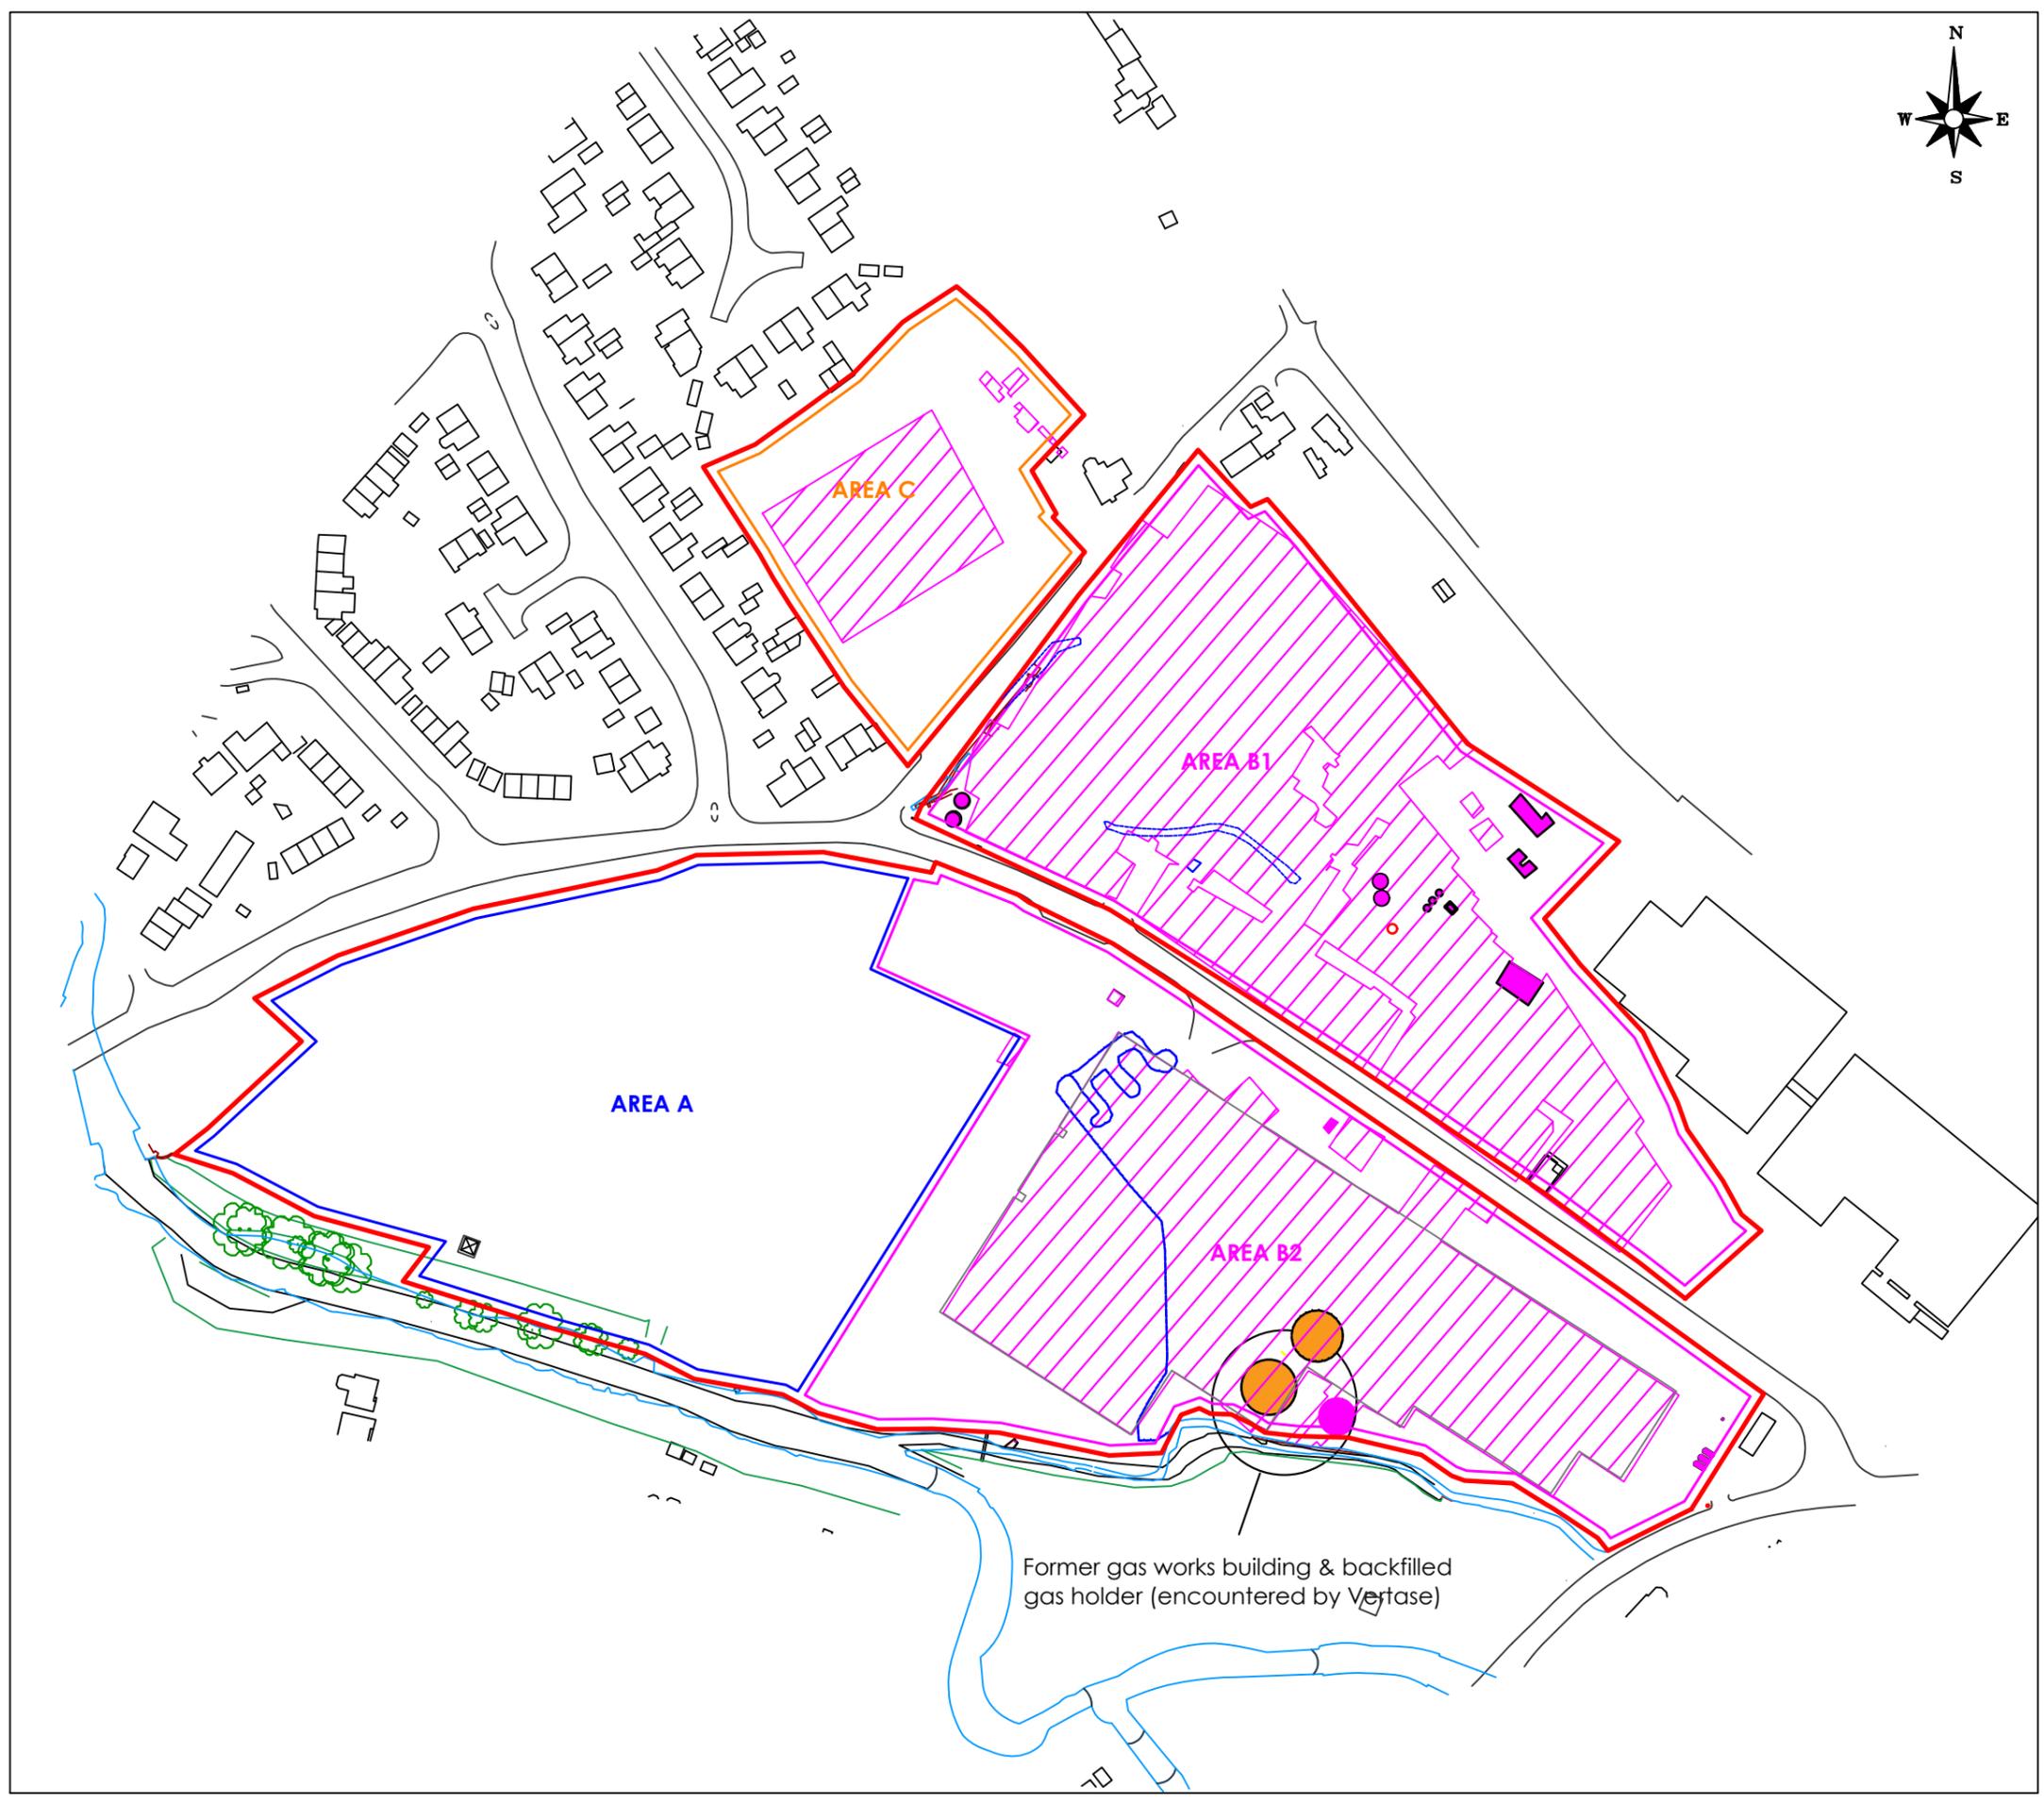
SCALE <b>1:2,000</b>	SHEET <b>A3</b>	DRAWING NO. <b>3435/104E</b>	REVISION
-------------------------	--------------------	---------------------------------	----------

- NOTES
- HISTORICAL GAS HOLDER
  - HISTORICAL BUILDING FOOTPRINT
  - HISTORICAL FUEL STORAGE TANKS
  - HISTORICAL LINEAR FEATURE
  - APPROXIMATE SITE BOUNDARY

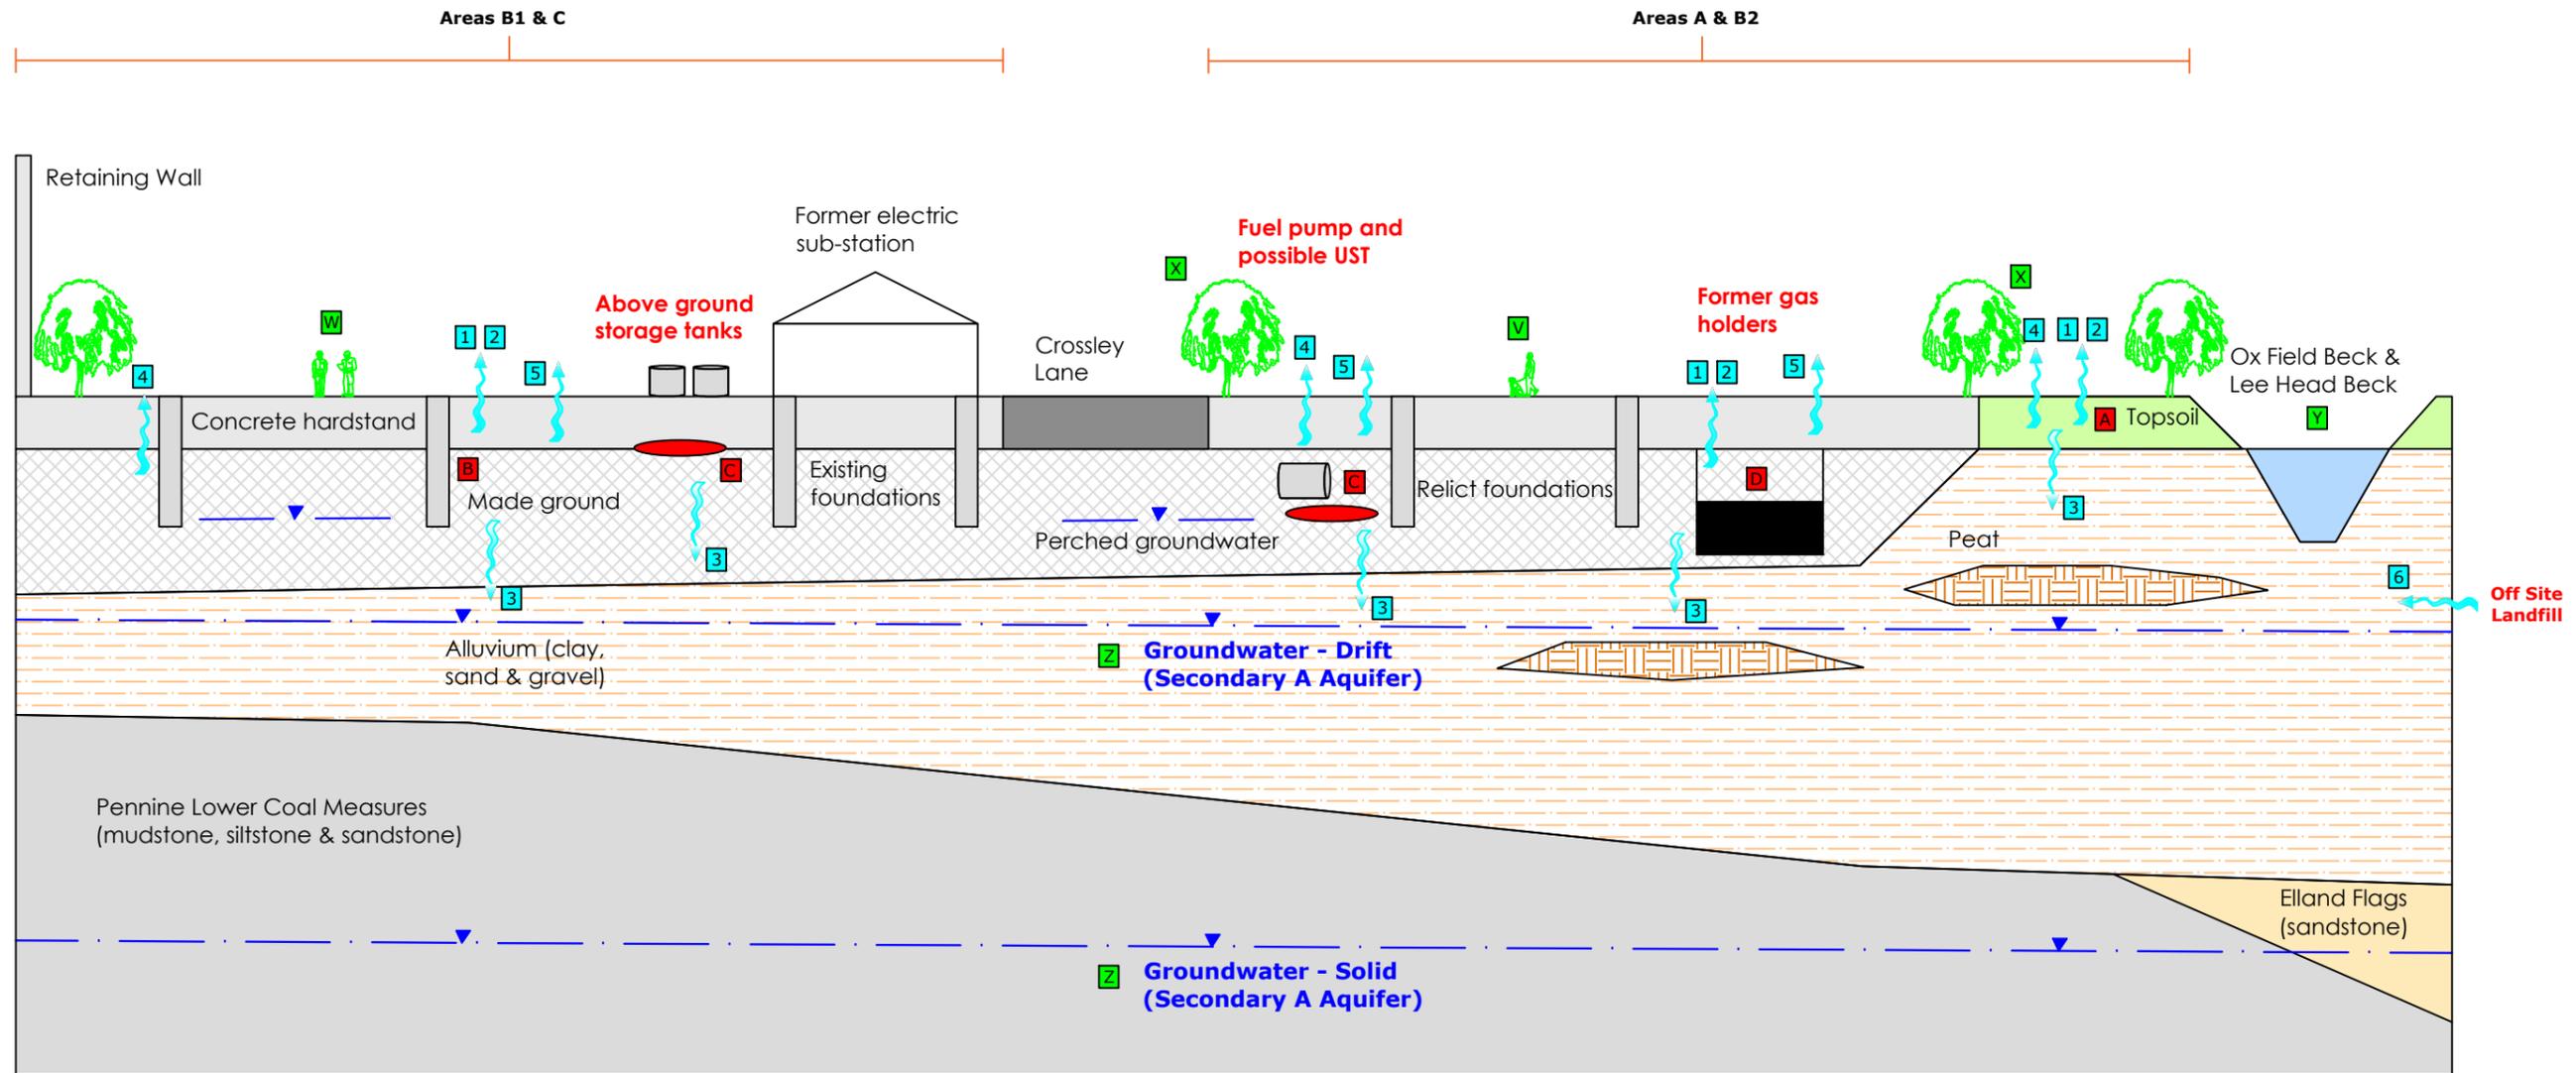
STATUS			
FOR COMMENT	<input type="checkbox"/>	FOR APPROVAL	<input type="checkbox"/>
DRAFT	<input type="checkbox"/>	FINAL	<input checked="" type="checkbox"/>
DRAWN	LEW	DATE	04 02 20
APPROVED	MJT	DATE	04 02 20
SCALE	Not to scale		SHEET
			A3
DRAWING NO.	3435/106		REVISION

SOURCES	
<b>A</b>	NATURALLY OCCURRING CONTAMINANTS (INORGANICS)
<b>B</b>	MADE GROUND (INORGANICS & ORGANICS)
<b>C</b>	LEAKAGE/SPILLAGE (ORGANICS)
<b>D</b>	GAS HOLDERS (ORGANICS)

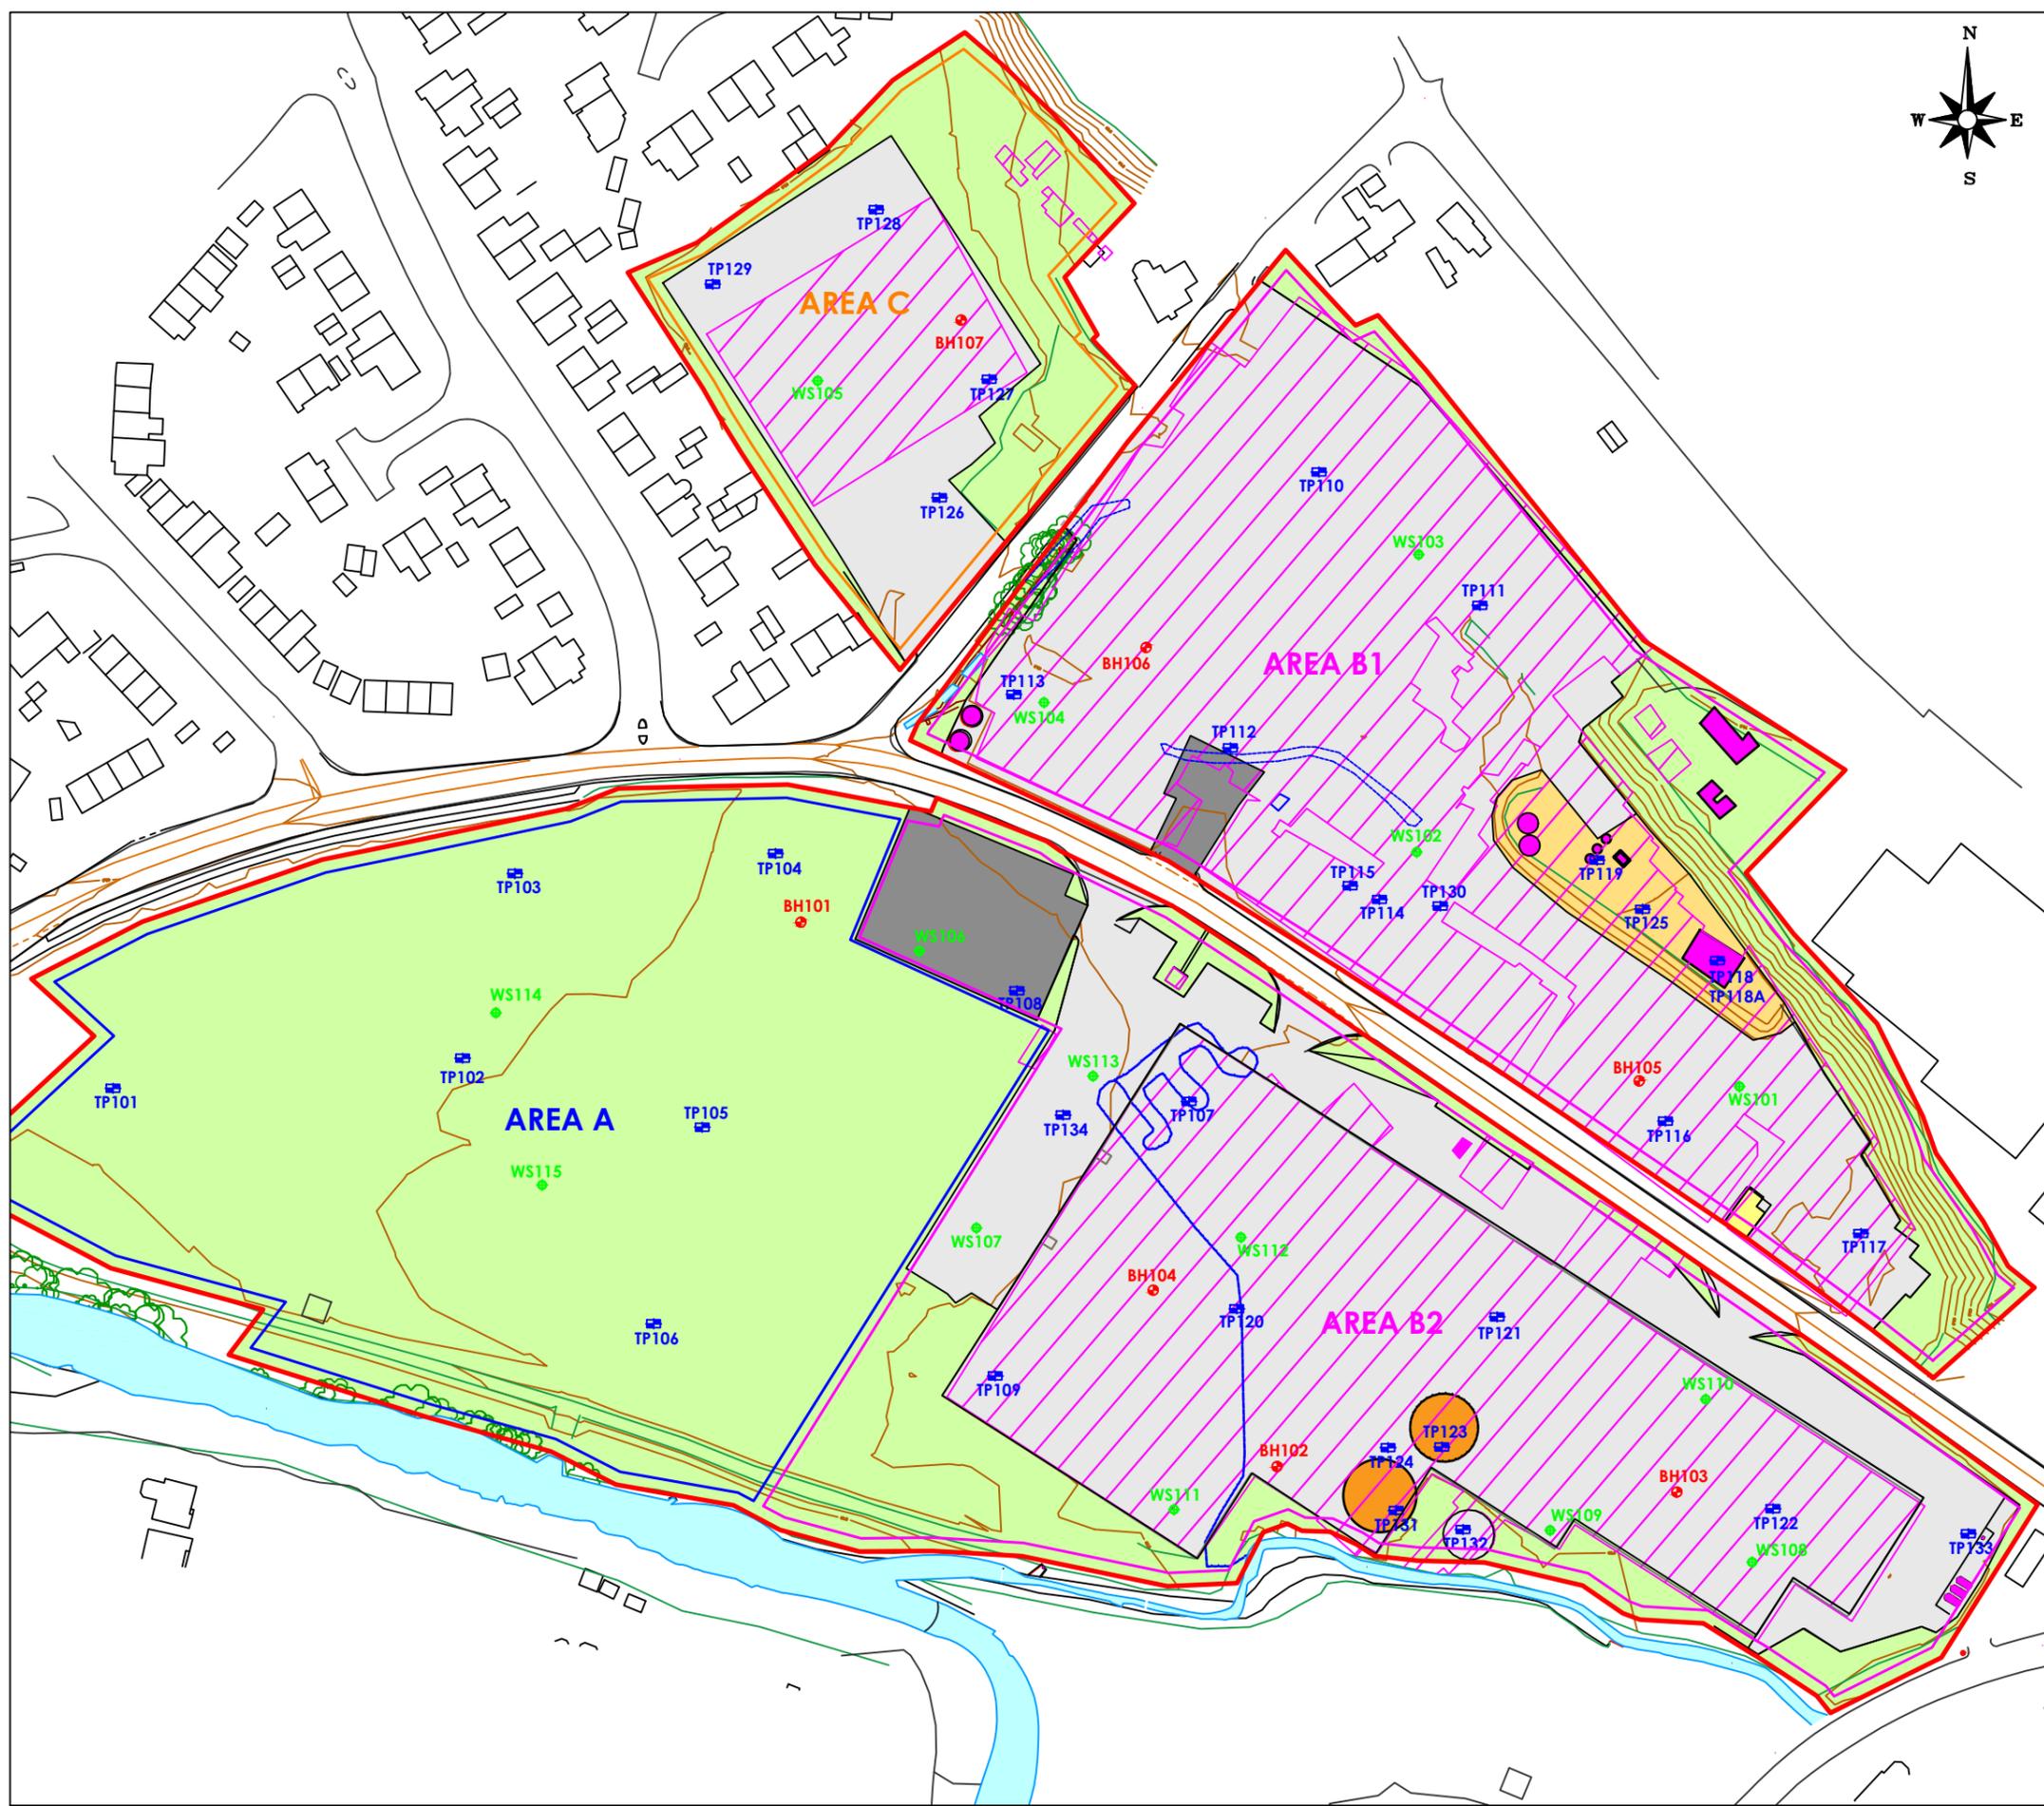
- TRIAL PIT LOCATION
- WINDOW SAMPLE LOCATION
- BOREHOLE LOCATION
- HISTORICAL GAS HOLDER
- HISTORICAL BUILDING FOOTPRINT
- HISTORICAL FUEL STORAGE TANKS
- HISTORICAL LINEAR FEATURE
- APPROXIMATE SITE BOUNDARY

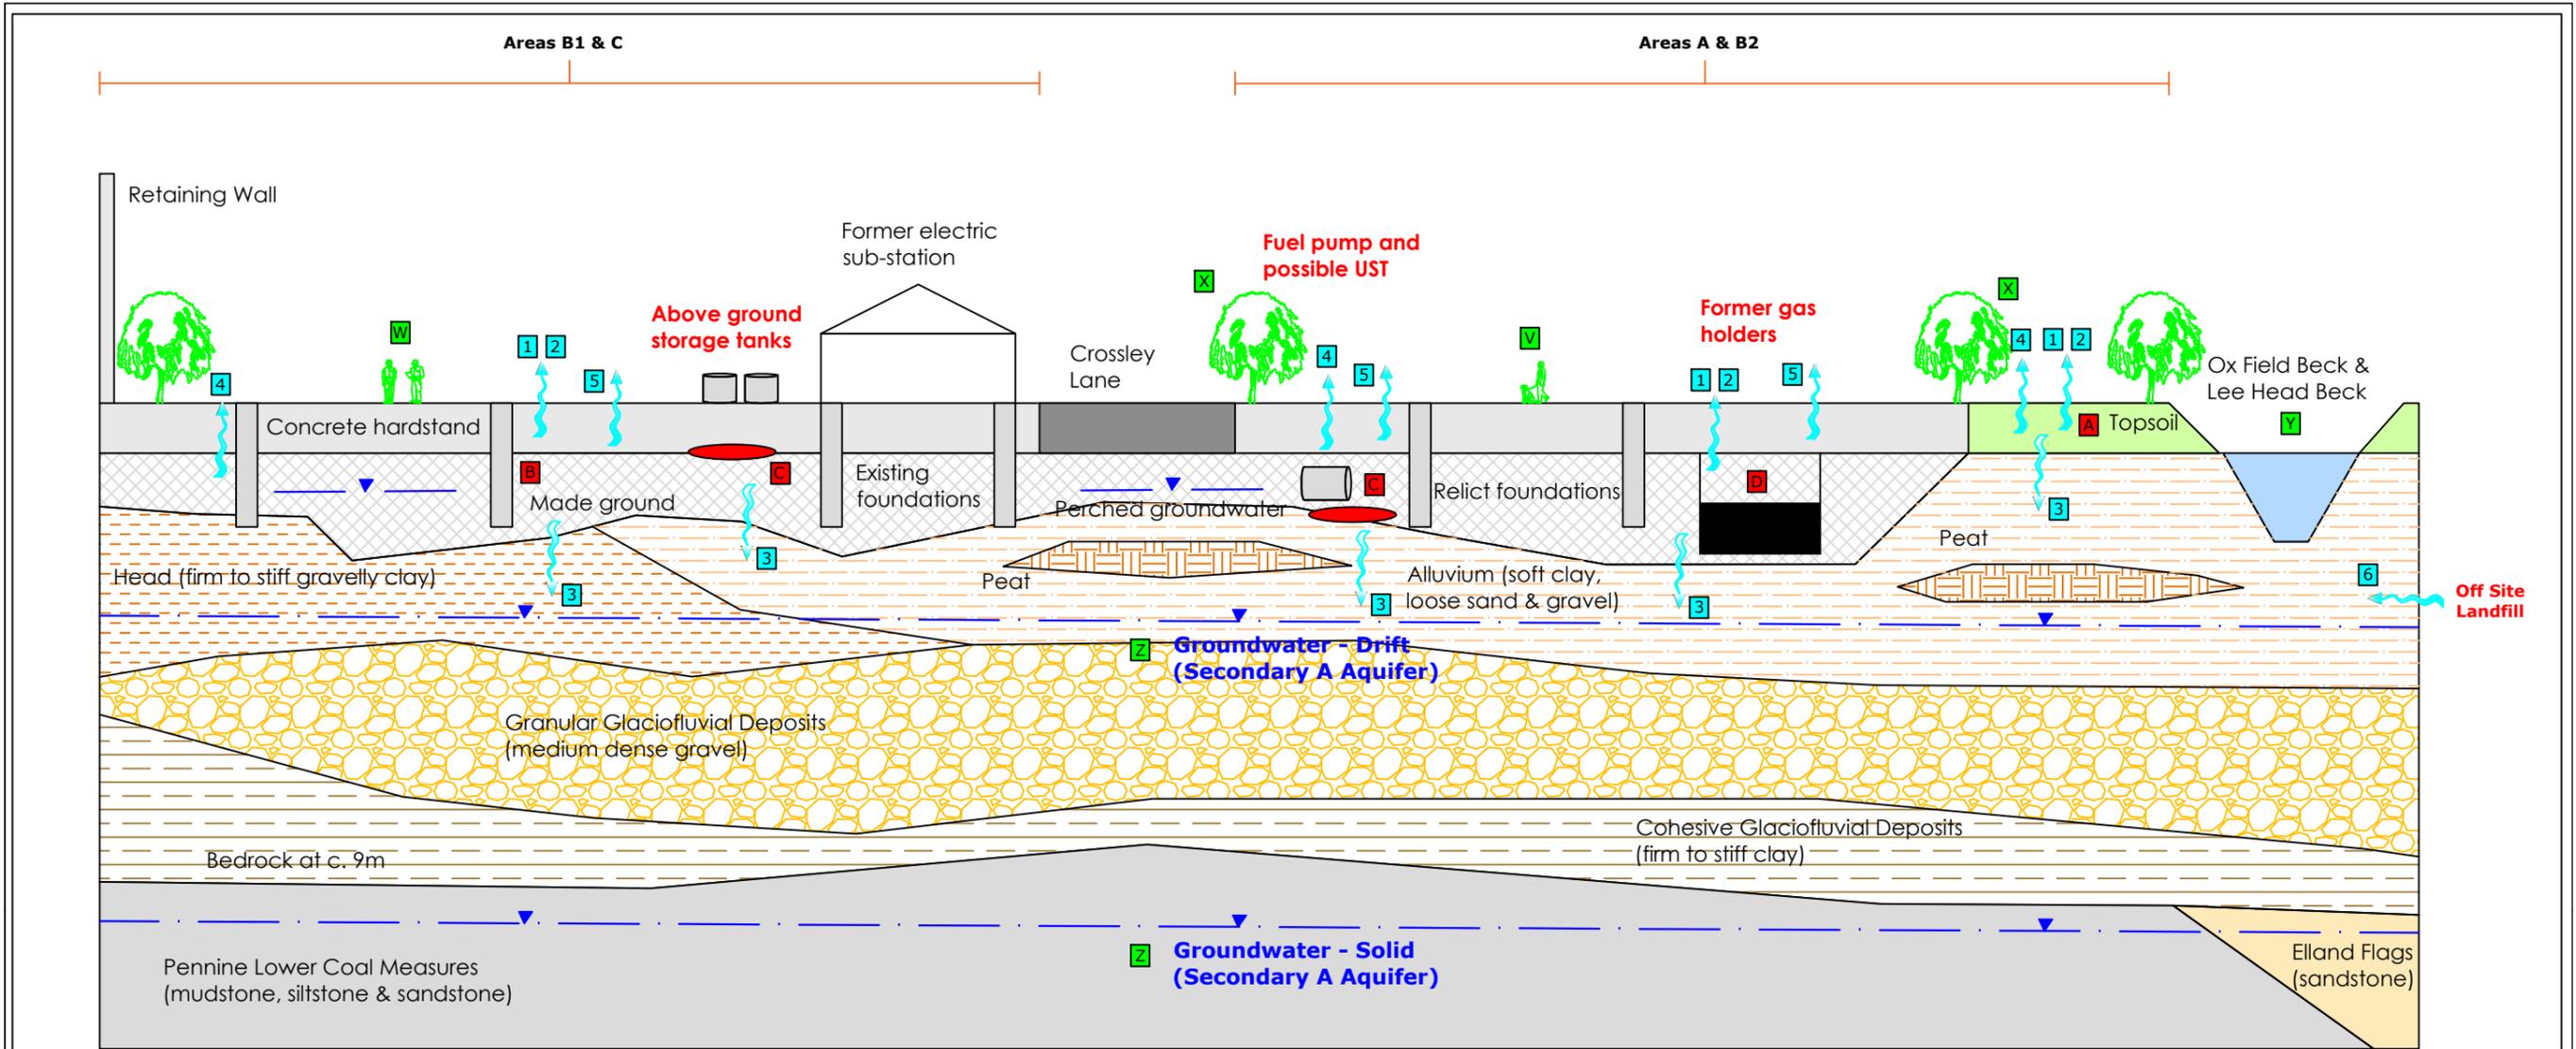
STATUS	
FOR COMMENT <input type="checkbox"/>	FOR APPROVAL <input type="checkbox"/> DRAFT <input type="checkbox"/> FINAL <input checked="" type="checkbox"/>
DRAWN LEW	DATE 27 02 20
APPROVED MJT	DATE 27 02 20
SCALE Not to scale	SHEET A3
DRAWING NO. 3435/108	REVISION

SOURCES	
<b>A</b>	NATURALLY OCCURRING CONTAMINANTS (INORGANICS)
<b>B</b>	MADE GROUND (INORGANICS & ORGANICS)
<b>C</b>	LEAKAGE/SPILLAGE (ORGANICS)
<b>D</b>	GAS HOLDERS (ORGANICS)

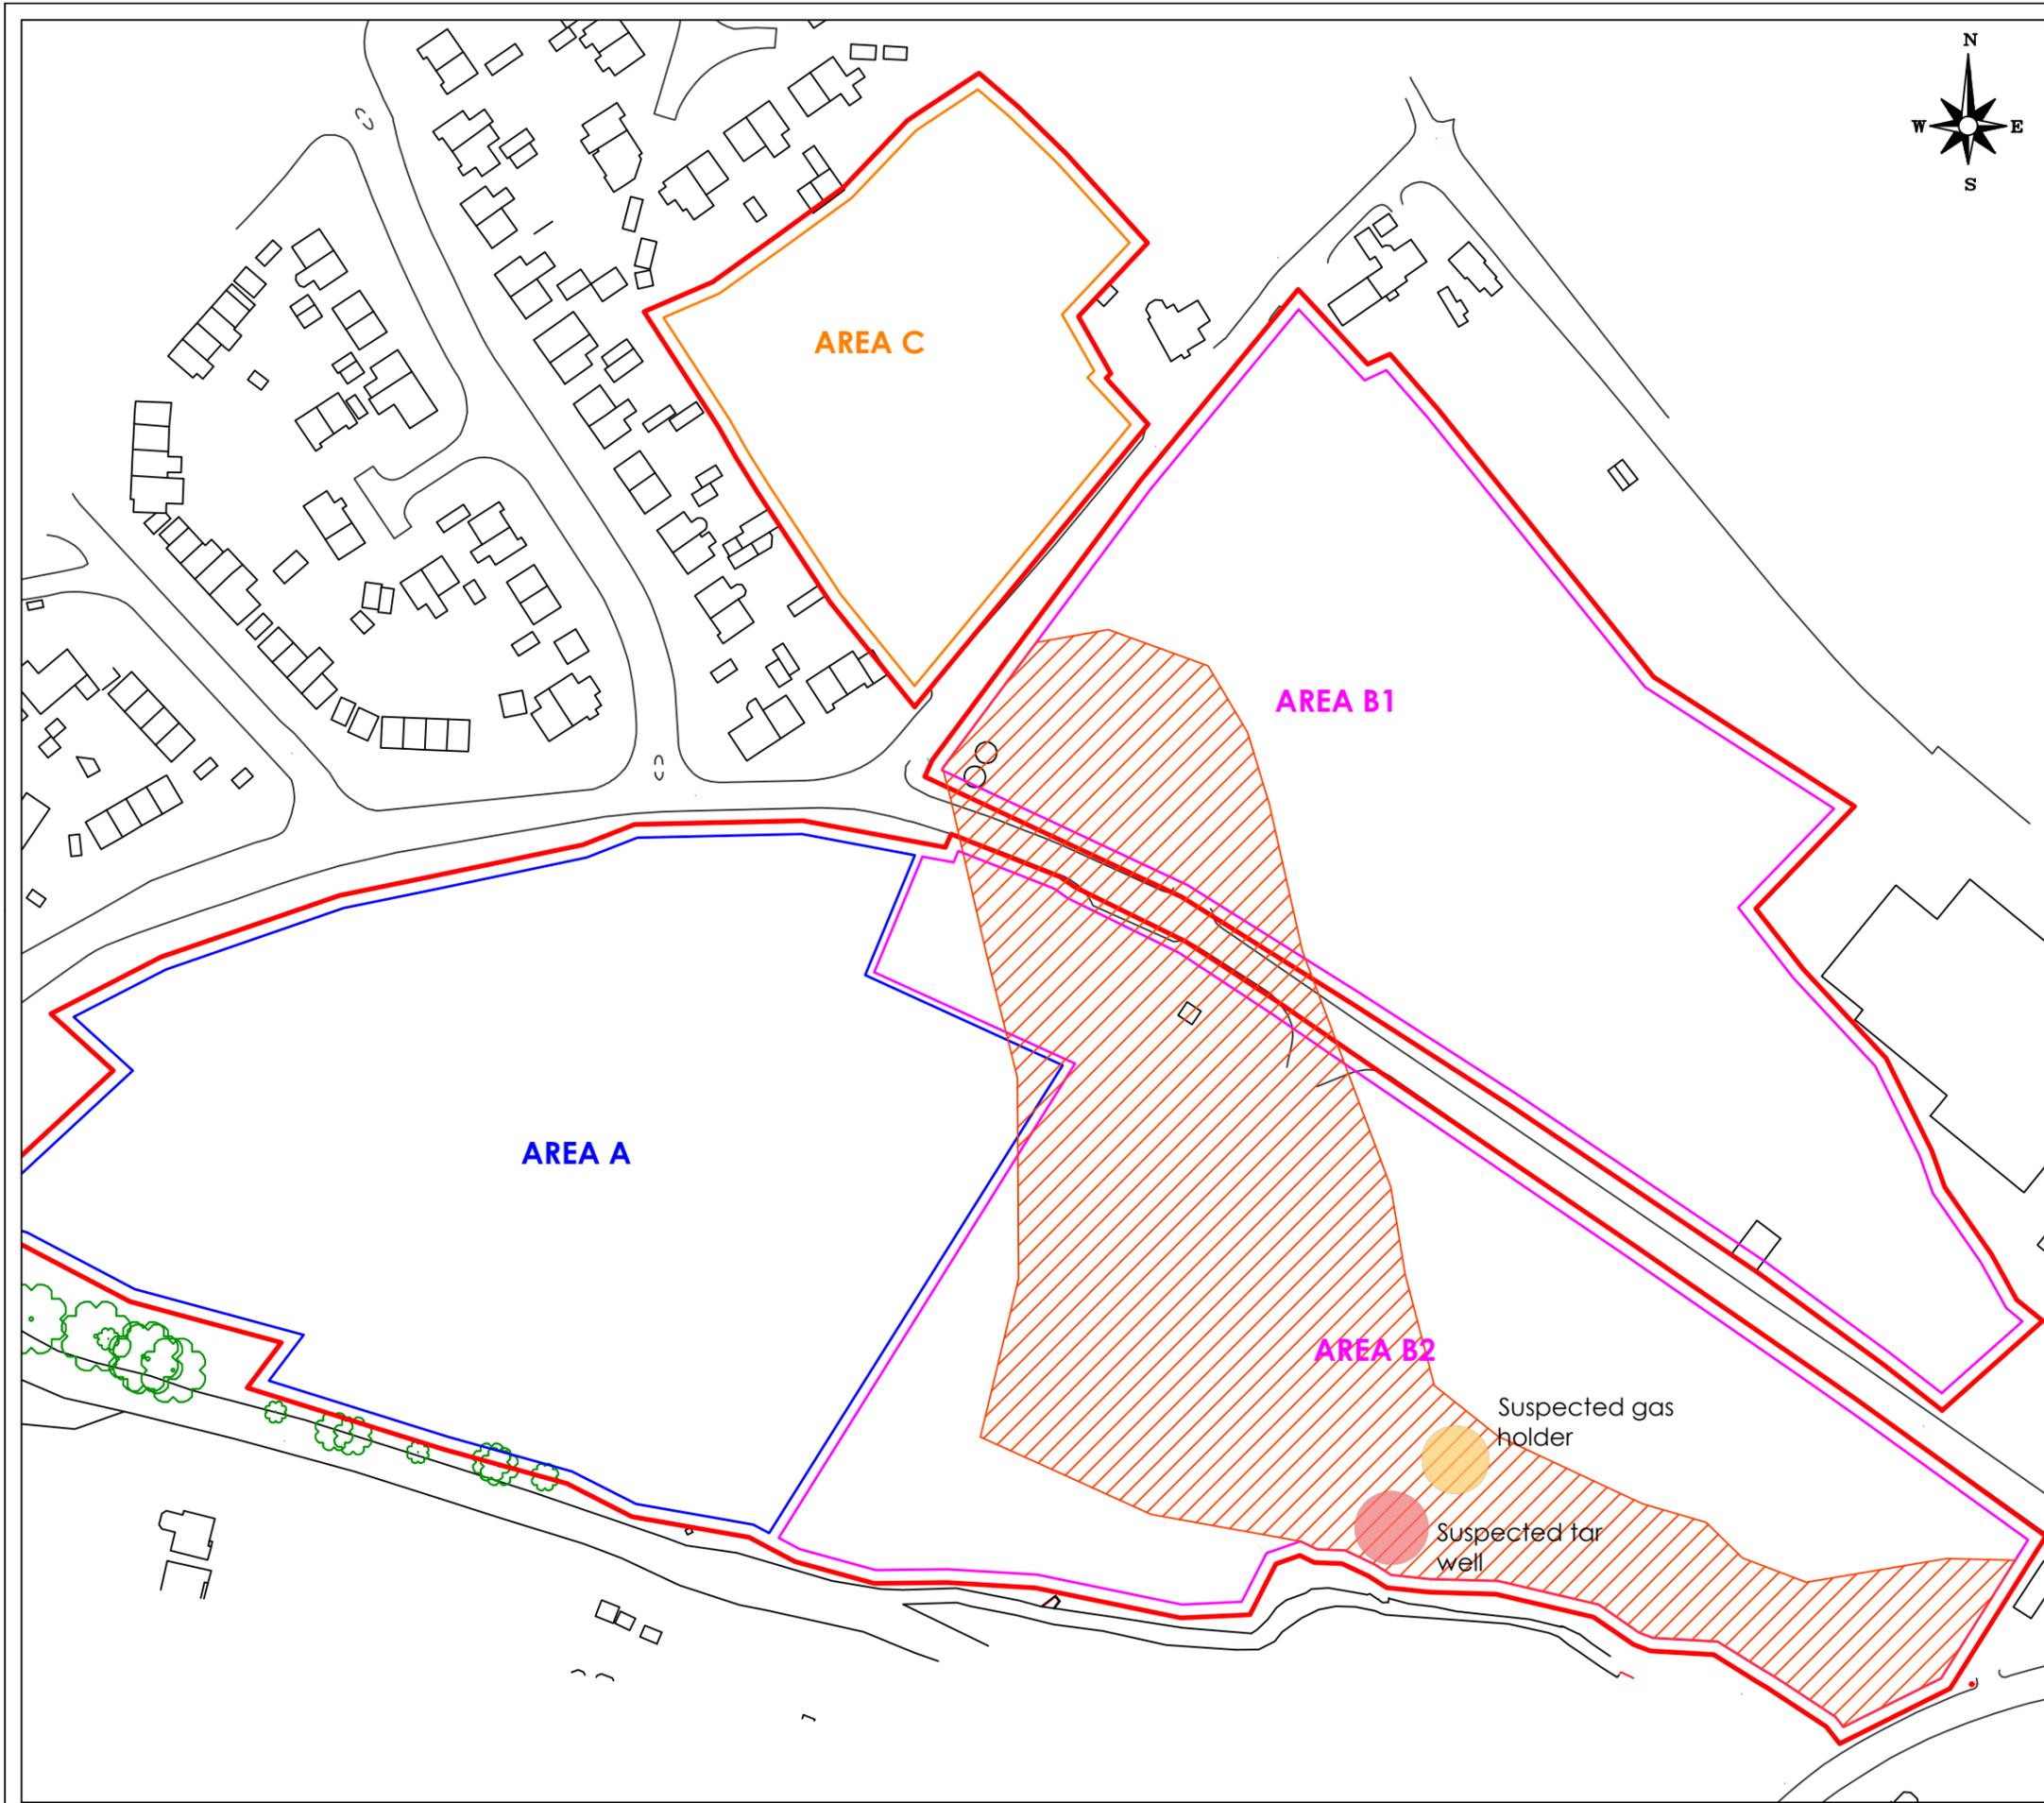
DRAWN <b>LEW</b>	DATE <b>27 02 20</b>	STATUS FOR COMMENT <input type="checkbox"/> FOR APPROVAL <input type="checkbox"/> DRAFT <input type="checkbox"/> FINAL <input checked="" type="checkbox"/>
CHECKED <b>MJT</b>	DATE <b>27 02 20</b>	
SCALE <b>1:1,500</b>	SHEET <b>A3</b>	DRAWING NO. <b>3435/110</b>

- NOTES
- AREA A - Bioaccessibility of Topsoil required to confirm suitability for reuse due to elevated arsenic concentrations
  - AREA B - 600mm clean soil cover and 100mm hard-dig layer
  - AREA C - 600mm clean soil cover and 100mm hard-dig layer
  - ▨ HYDROCARBON PLUME - based on visual and olfactory evidence in exploratory holes

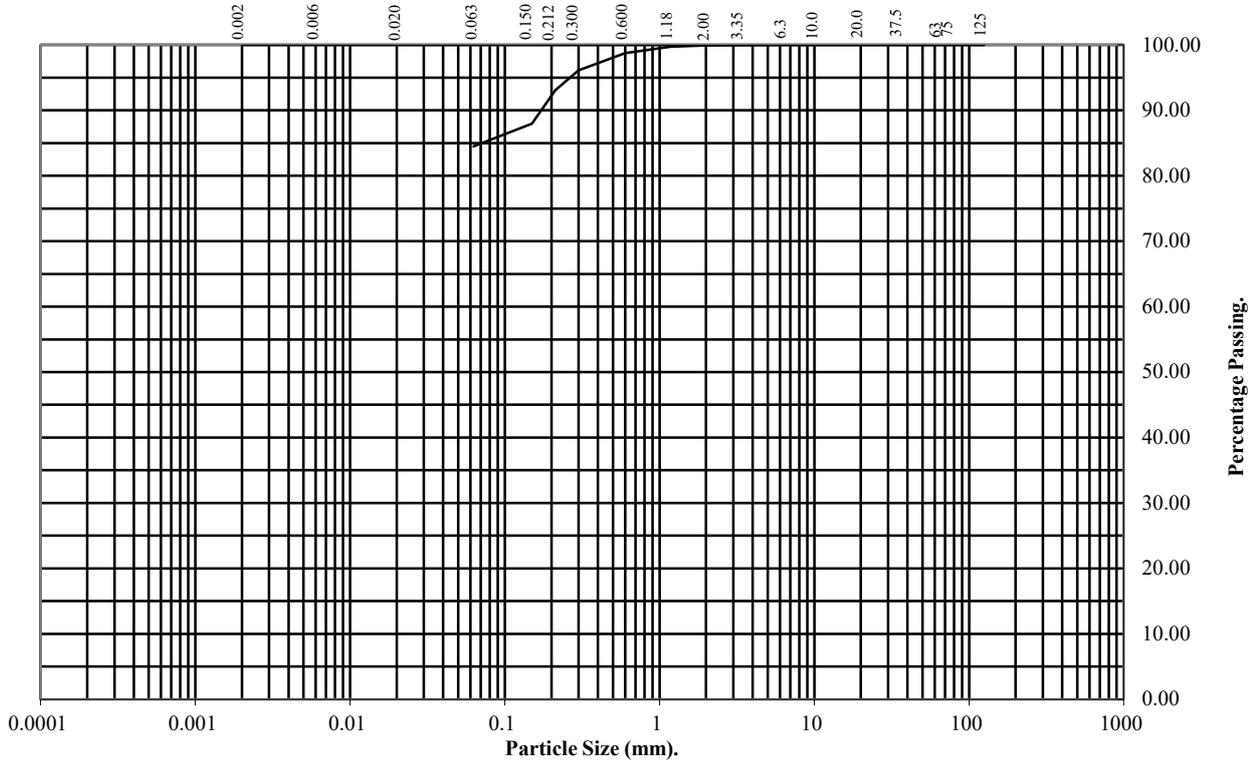
BS Test Sieve (mm)	Percentage Passing
125	100
75	100
63	100
37.5	100
20	100
10	100
6.3	100
3.35	100
2	100
1.18	100
0.6	99
0.3	96
0.212	93
0.15	88
0.063	84
