## Land at Crossley Lane, Dalton For Harron Homes Yorkshire

Report no: 3435/1

Date: March 2020

## SUMMARY OF GEOENVIRONMENTAL ISSUES

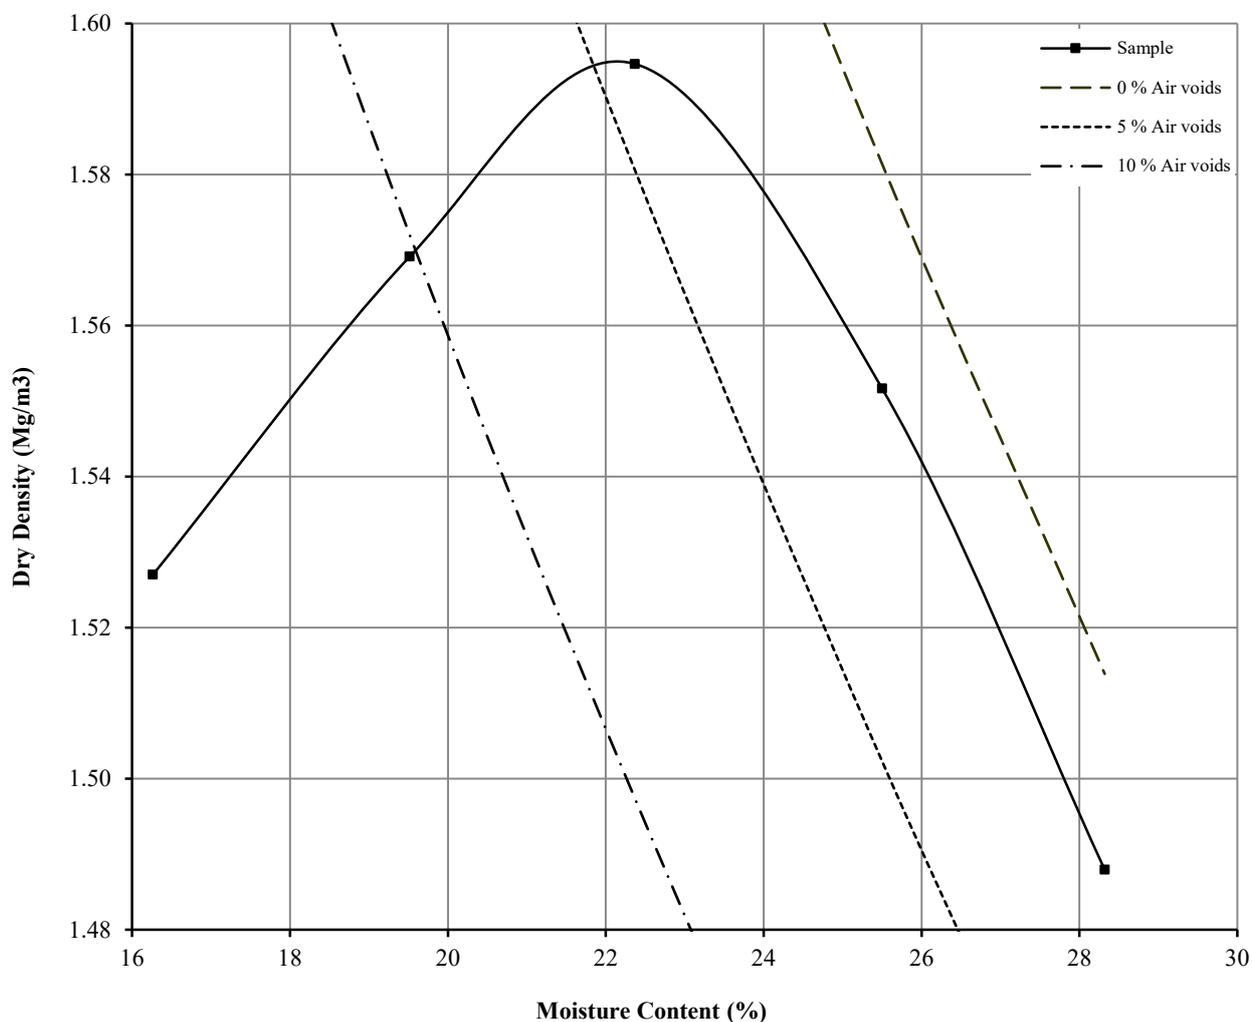
Hole Number: TP101 Top Depth (m) : 1.50  
 Sample Number: 3 Base Depth (m) :  
 Sample Type: B

Initial Moisture Content:	28	Method of Compaction:	2.5kg	Separate Samples
Particle Density (Mg/m <sup>3</sup> ):	2.65	Assumed	Material Retained on 37.5 mm Test Sieve (%):	0
Maximum Dry Density (Mg/m <sup>3</sup> ):	1.59		Material Retained on 20.0 mm Test Sieve (%):	0
Optimum Moisture Content (%):	22			
Remarks				
See summary of soil descriptions.

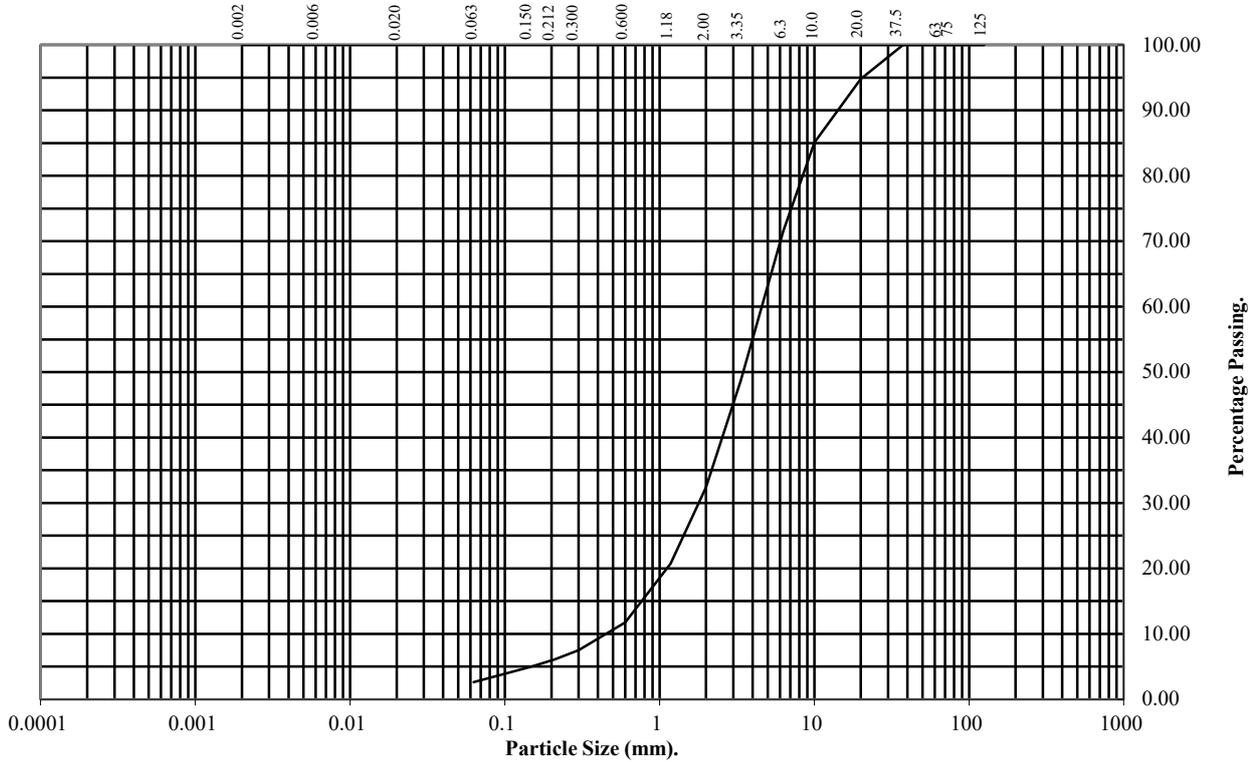
BS Test Sieve (mm)	Percentage Passing
125	100
75	100
63	100
37.5	100
20	95
10	85
6.3	72
3.35	49
2	32
1.18	21
0.6	12
0.3	7
0.212	6
0.15	5
0.063	3

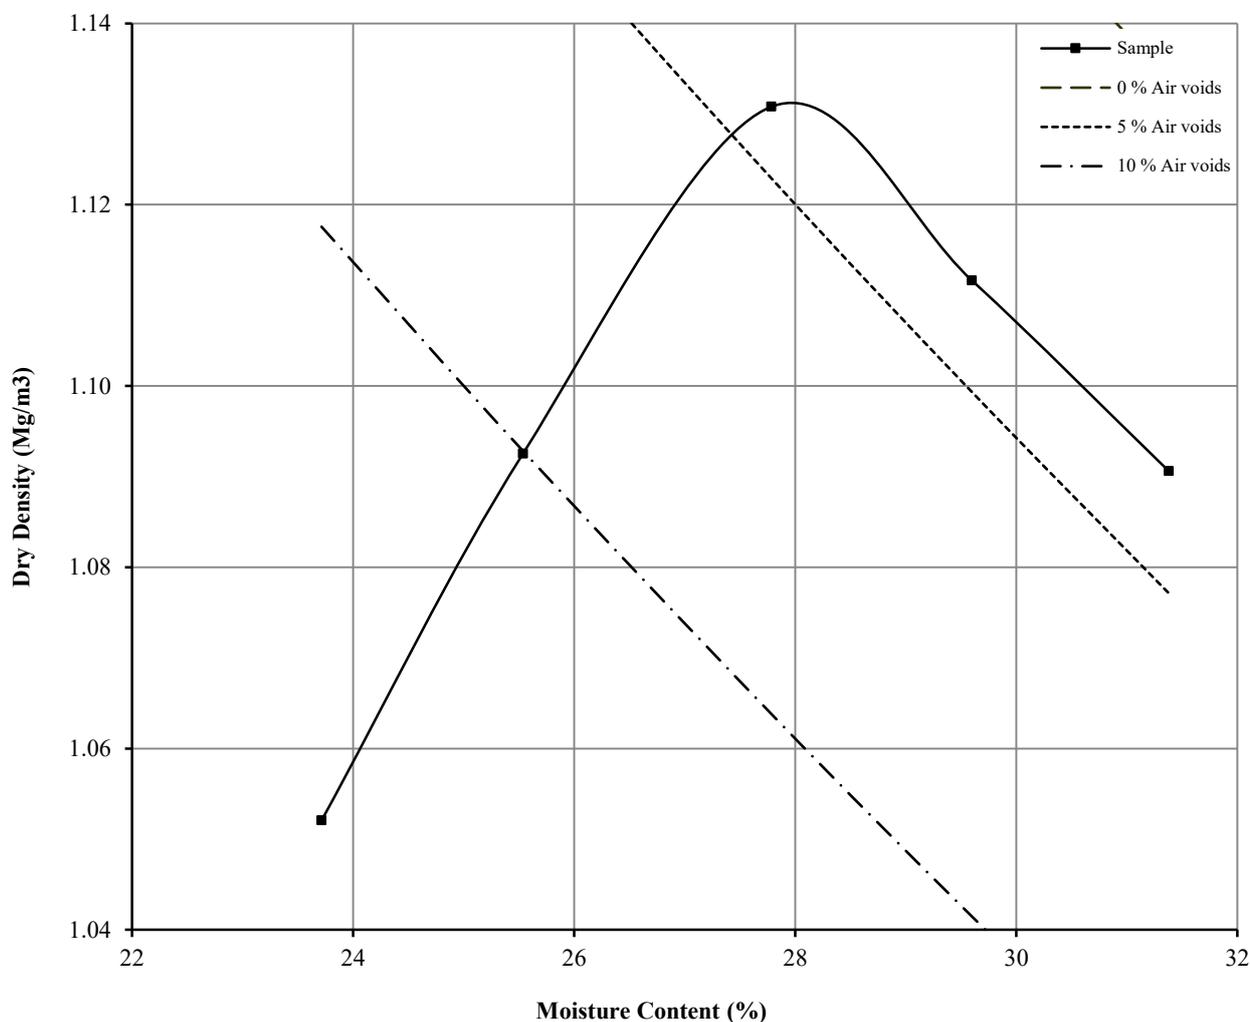
Hole Number: TP112W Top Depth (m) : 0.60  
 Sample Number: 2 Base Depth (m) :  
 Sample Type: B

Initial Moisture Content:	24	Method of Compaction:	2.5kg	Separate Samples
Particle Density (Mg/m <sup>3</sup> ):	1.76	Assumed	Material Retained on 37.5 mm Test Sieve (%):	0
Maximum Dry Density (Mg/m <sup>3</sup> ):	1.13		Material Retained on 20.0 mm Test Sieve (%):	6
Optimum Moisture Content (%):	28			
Remarks				
See summary of soil descriptions.

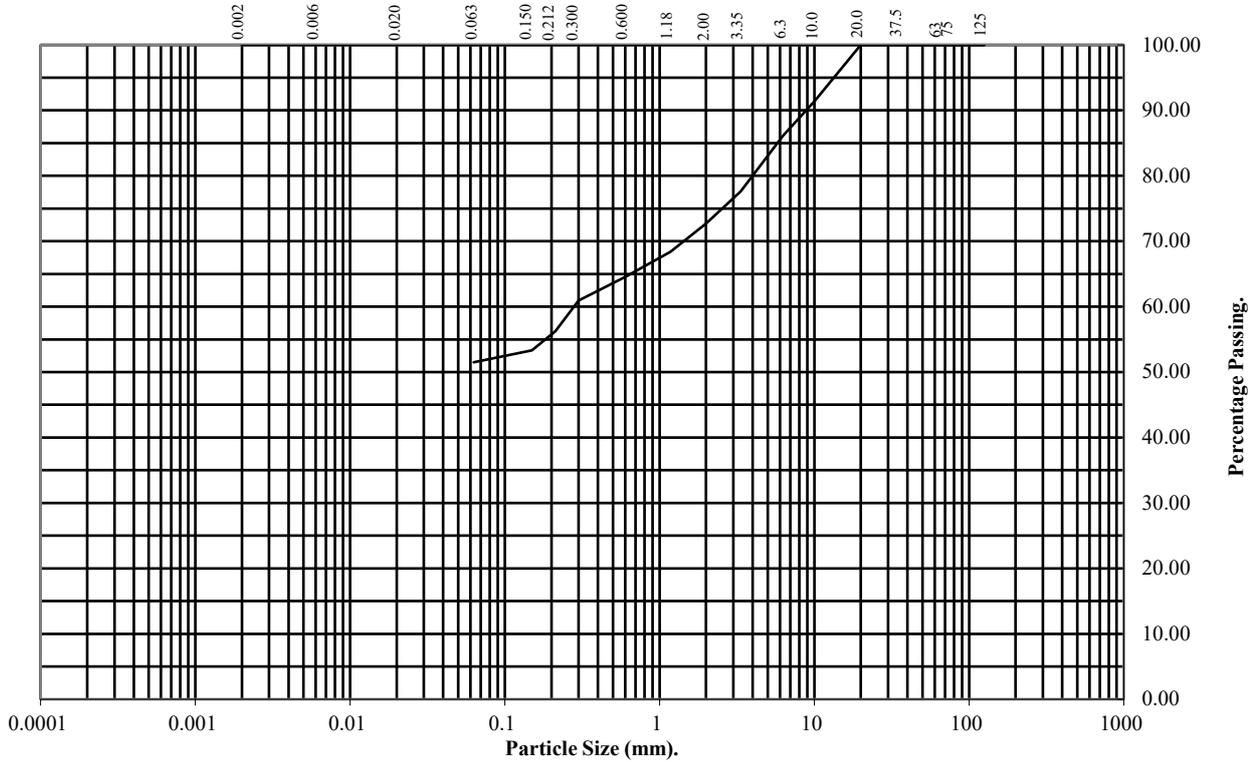
BS Test Sieve (mm)	Percentage Passing
125	100
75	100
63	100
37.5	100
20	100
10	91
6.3	86
3.35	78
2	73
1.18	68
0.6	65
0.3	61
0.212	56
0.15	53
0.063	52
